1.0 Bluewater, New Mexico, Disposal Site

1.1 Compliance Summary

The Bluewater, New Mexico, Uranium Mill Tailings Radiation Control Act (UMTRCA) Title II Disposal Site was inspected on March 7 and March 8, 2023. Minor depressions on the side slopes of the main tailings disposal cell continue to be observed. Depressions continue to be observed on the north portion of the top slope of the main tailings disposal cell. A new potential depression was identified on the southeastern top slope of the main tailings disposal cell. Inspectors identified several routine maintenance needs but found no cause for a follow-up or contingency inspection.

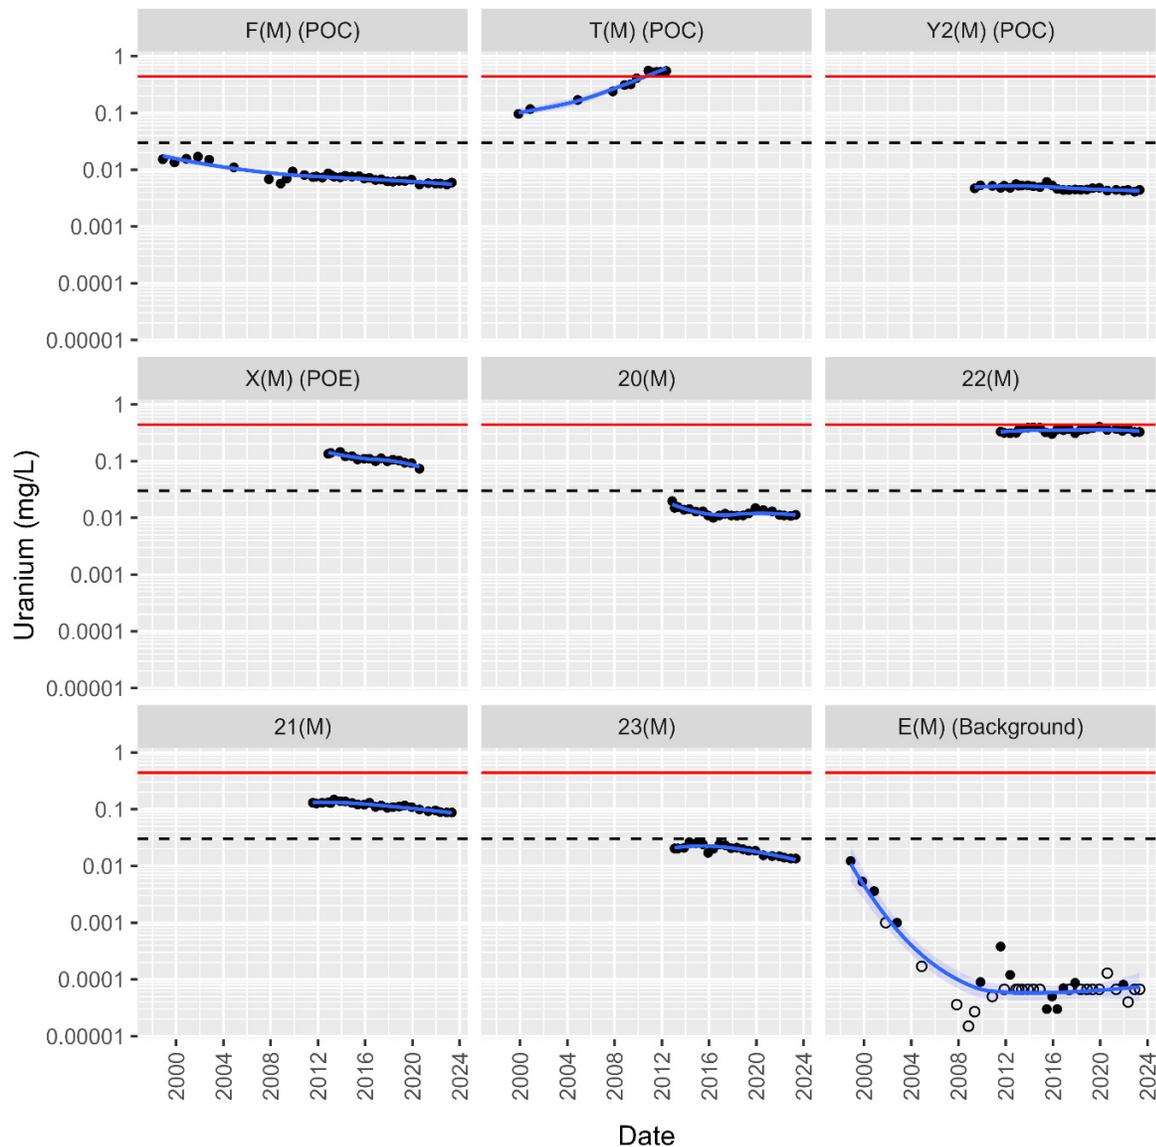
Wells 21(M) and 22(M) were installed in 2011 as a direct response to the ACL exceedance in well T(M) and to better monitor the alluvial aquifer downgradient of well T(M) (Figure 1-3). Although below the ACL, uranium concentrations in these two wells continue to exceed the 0.03 mg/L EPA drinking water standard (Table 1-4; Figure 1-5). Uranium concentrations in well 22(M), at the approximate midpoint between POC well T(M) (Figure 1-3), have been stable between 0.3 and 0.40 mg/L (just below the ACL). Uranium concentrations in downgradient well 21(M), at the southeast corner of the site, have been slightly lower (0.09–0.15 mg/L) and have (along with most other alluvial wells) a statistically significant decreasing trend (Table 1-5). Uranium concentrations in well X(M) have also been consistently above the EPA standard, with levels ranging from 0.073–0.145 mg/L (Figure 1-5). This well has not been sampled since August 2020 because it has been dry or had insufficient water to sample. Uranium concentrations in five of the nine alluvial wells have been consistently below the 0.03 mg/L EPA standard: POC wells F(M) and Y2(M), well 20(M), southeasternmost well 23(M), and background well E(M). Statistically significant decreasing trends in uranium concentrations were identified for all wells except T(M) (increasing trend before going dry) and well 22(M) (no trend) (Table 1-5).

Notes: The date scale begins in 1998, the first sampling event after the LTSP was issued (DOE 1997). Wells are ordered by purpose as follows: POC and POE wells are listed first, followed by the remaining alluvial wells listed in Table 1-2, ordered by flow direction (upgradient to downgradient) as shown in Figure 1-3. Data for background well E(M) are plotted last. Based on observations and measurements during semiannual sampling events, POC well T(M) has been dry since November 2012. POE well X(M) has been dry or had insufficient water to sample since May 2021. Statistically significant decreasing trends in uranium concentrations were identified for all wells except T(M) (increasing trend) and well 22(M) (no trend) (Table 1-5).

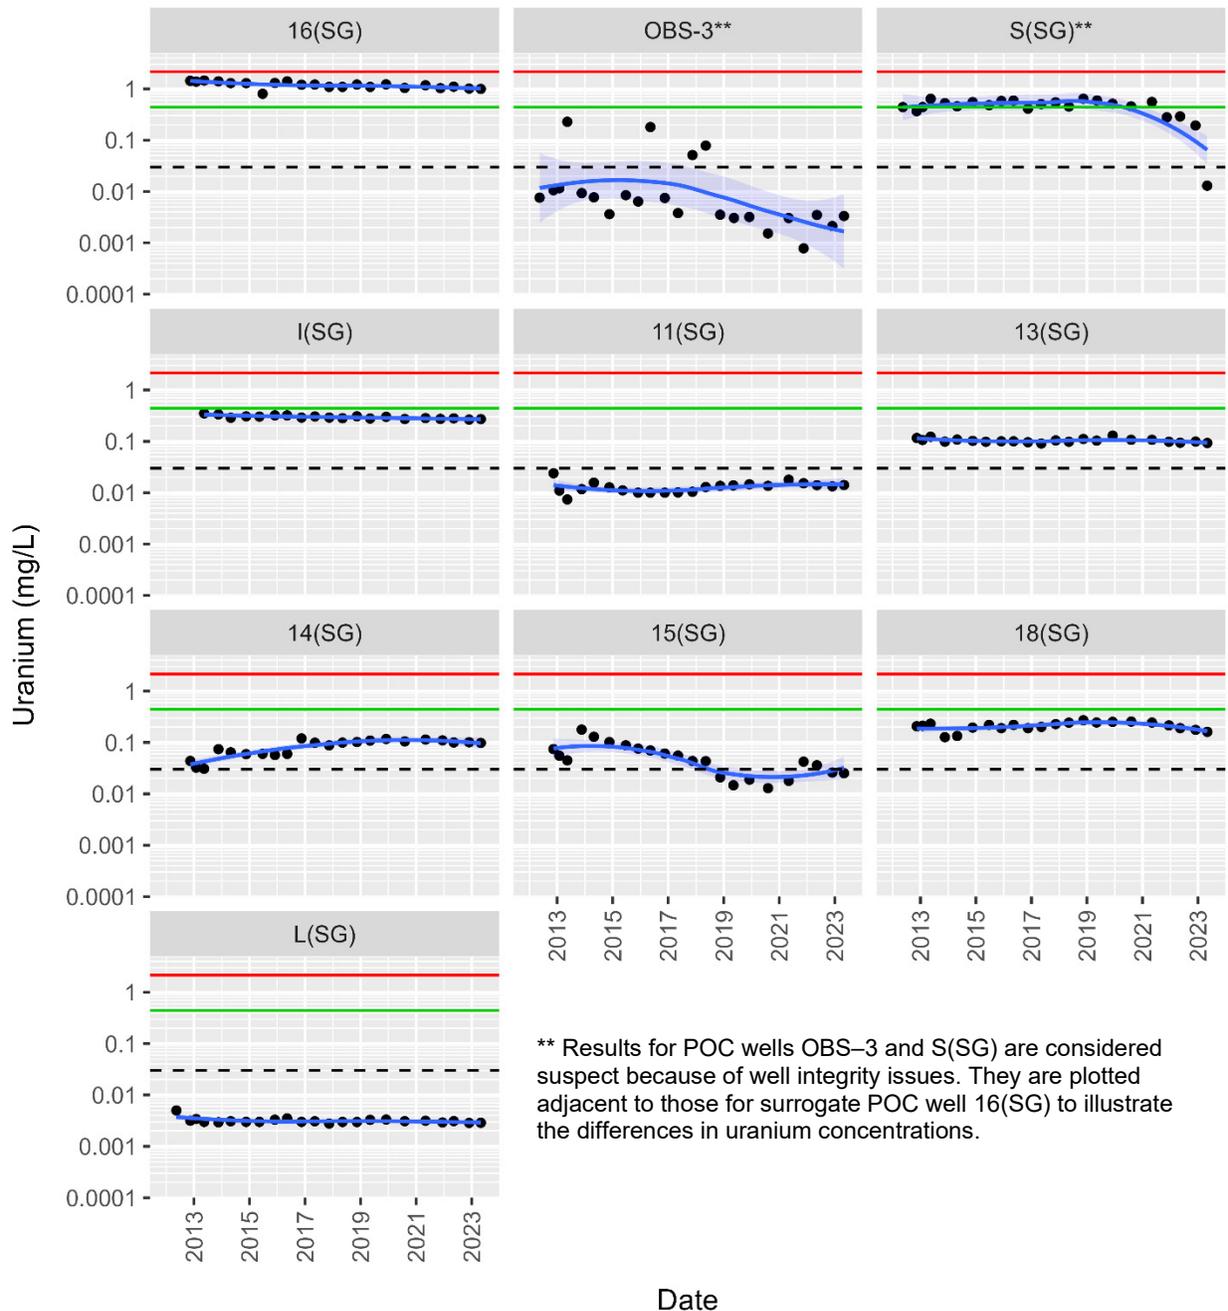
Figure 1-6. Uranium Concentrations in the SAG Aquifer at the Bluewater, New Mexico, Disposal Site

Uranium concentrations in all Bluewater site SAG wells have been consistently below the 2.15 mg/L ACL (Figure 1-6). Uranium concentrations have also been below the site-specific NRC-approved health-based standard of 0.44 mg/L, with the exception of well 16(SG), with concentrations ranging from 0.8–1.45 mg/L. However, onsite SAG wells, including SAG wells near the downgradient site boundary, have consistently exceeded the 0.03 mg/L EPA drinking water standard for uranium. Exceptions are well 11(SG) at the northern site boundary, background well L(SG), and, periodically, well 15(SG) (Figure 1-6). Mann-Kendall trend analysis identified statistically significant decreasing uranium trends in well 15(SG), installed near alluvial well T(M), well 16(SG), and POE well I(SG) (Table 1-7). Uranium concentrations in well I(SG), at the eastern site boundary, have ranged from 0.15–0.35 mg/L; the most recent (May 2023) result was 0.271 mg/L (Table 1-6).

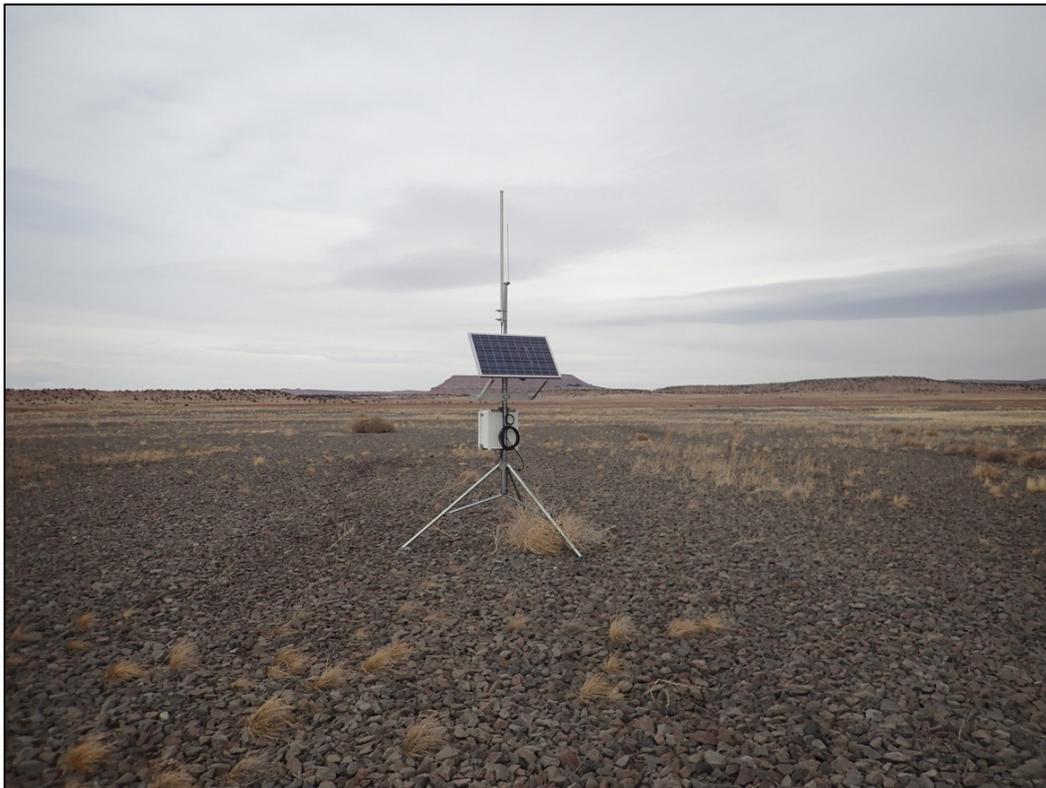
PL-8. SOARS Station

now consists of 19 monitoring wells; 10 are completed in the bedrock aquifer and 9 in the alluvial aquifer. Eleven wells (3 alluvial and 8 bedrock) have telemetry towers, known as System Operation and Analysis at Remote Sites (SOARS) stations to transmit groundwater level and weather data to the LM Field Support Center at Grand Junction, Colorado. The monitoring wells and SOARS stations are identified in Figure 1-2. The wellhead protectors and SOARS stations were observed to be undamaged and locked (PL-8). Animal burrows identified during the 2021 inspection near monitoring well F(M) showed signs of abandonment and filling in with sediment during the 2023 inspection (PL-9). They are not threatening the well integrity and will no longer be monitored. No maintenance needs were identified.

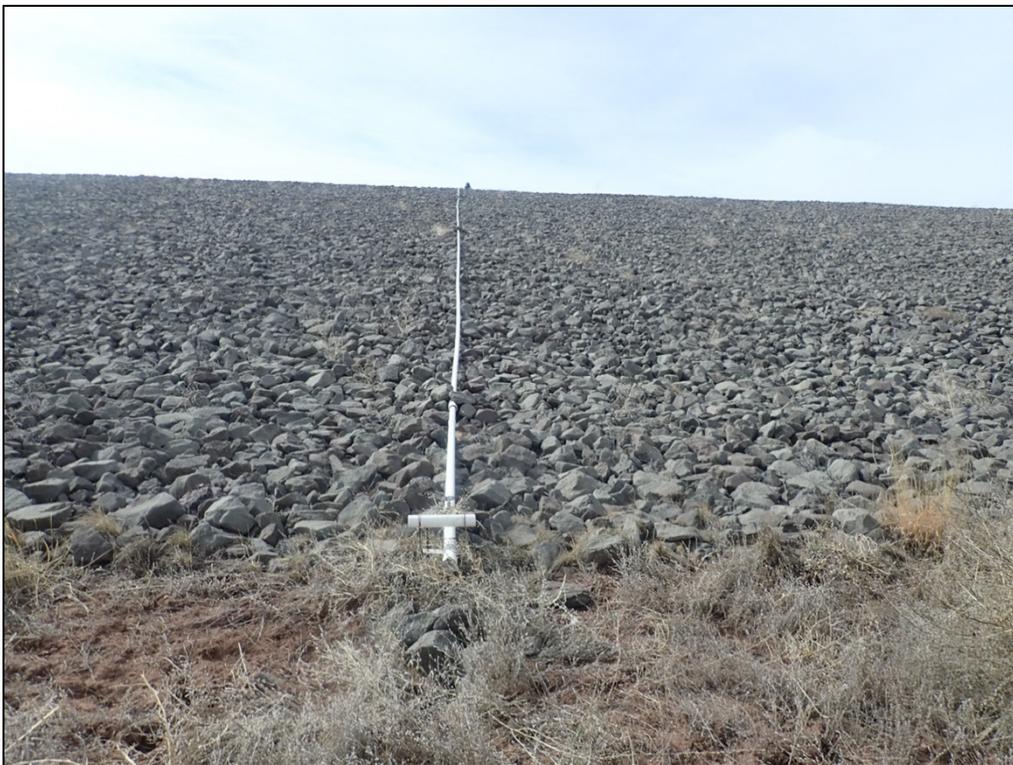
PL-12. Siphon Outlet on Main Tailings Disposal Cell North Side Slope

The siphon is usually operated at least once a year, depending on precipitation, and it successfully removes nearly all the water; any remaining water tends to evaporate. When operated, the siphon discharges water at a rate of approximately 100 gallons per minute at the toe of the north side slope where runoff water was intended to discharge (PL-12). The discharged water ponds over a large area north of the main tailings disposal cell and eventually either evaporates or infiltrates into the soil. The discharged water does not flow off the site. Due to lack of significant precipitation during the 2023 monsoon season (1.93 inches measured by onsite rain gauge), the siphon did not require operation this year.
