2.0 Edgemont, South Dakota, Disposal Site

Figure 2-1. 2023 Annual Inspection Drawing for the Edgemont, South Dakota, Disposal Site

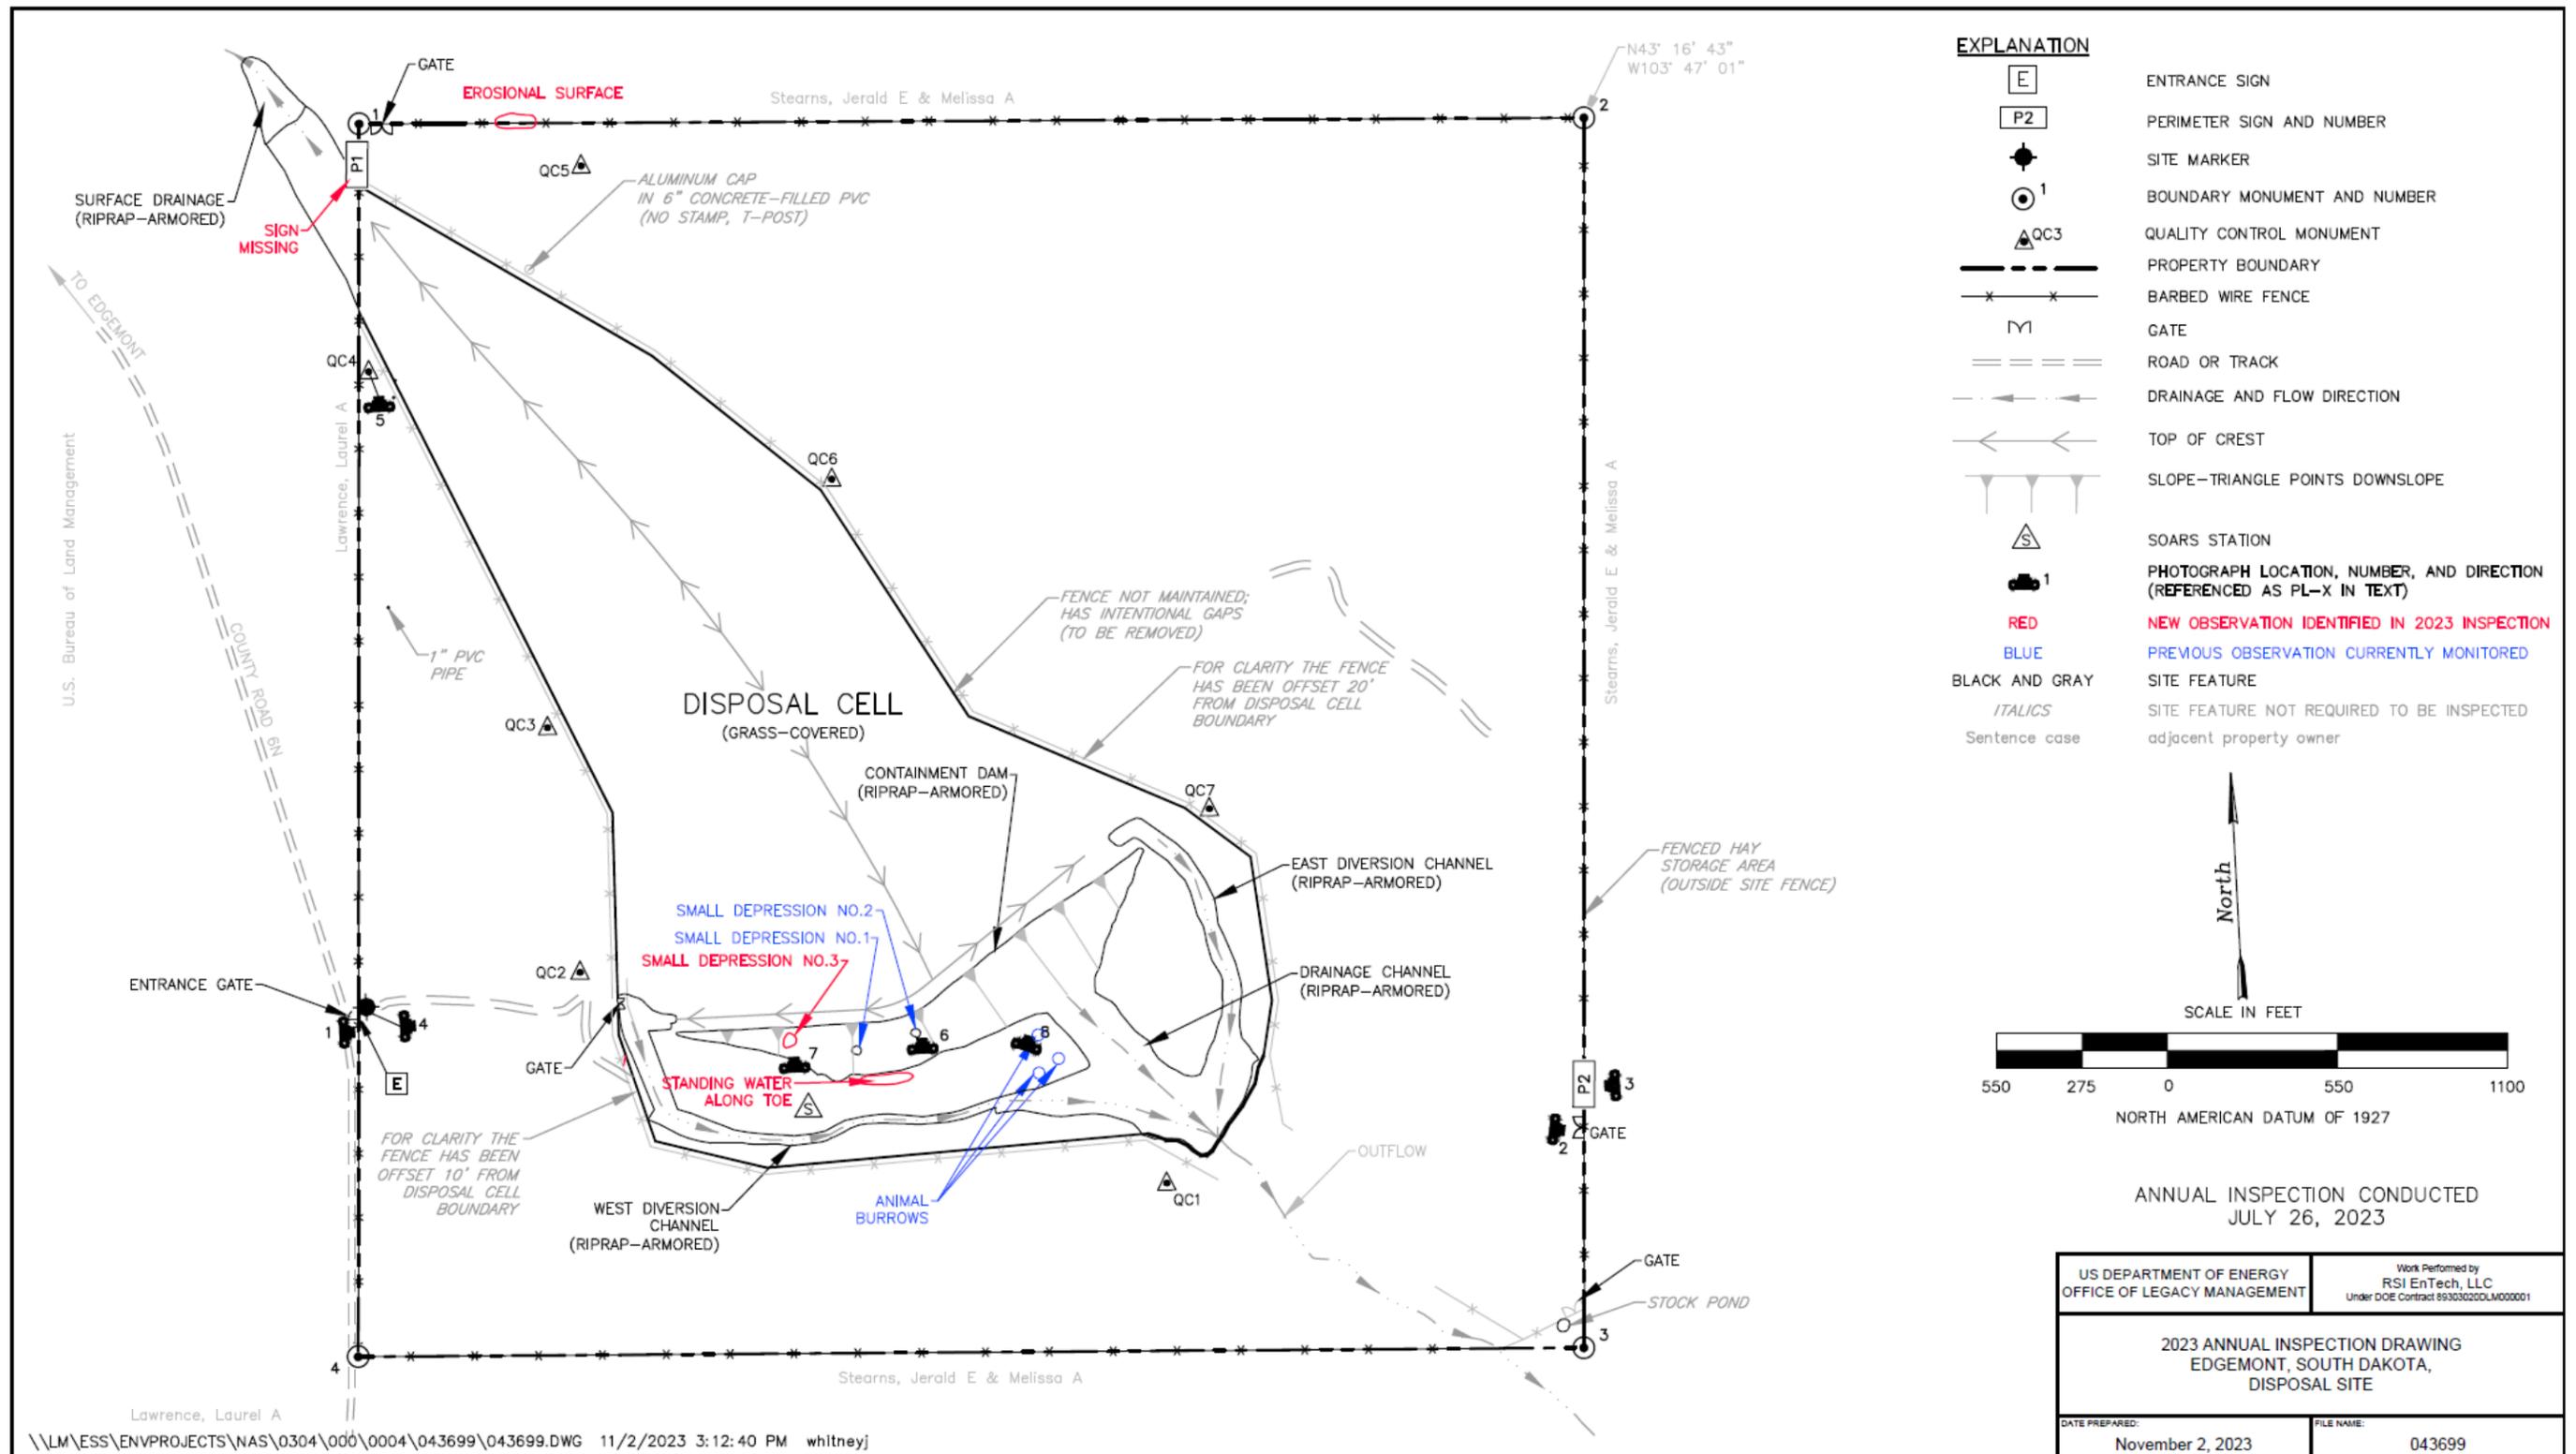
Figure 2-1 shows the locations of site features, including site surveillance features and inspection areas, in black and gray font. Some site features that are present but not required to be inspected are shown in italic font. Observations from previous inspections that are currently monitored are shown in blue, and new observations identified during the 2023 annual inspection are shown in red. Inspection results and recommended maintenance activities associated with site surveillance features are described in the following subsections. Photographs to support specific observations are noted in the text and in Figure 2-1 by photograph location (PL) numbers. The photographs and photograph log are presented in Section 2.9.

There are four boundary monuments, one at each corner of the site. The stock pond was observed to be encroaching BM-3 at the time of inspection. Saturated soils could eventually displace the boundary monument. No maintenance needs were identified.

The face of the containment dam is armored with riprap. Two small depressions were observed on the containment dam during the 2021 annual inspection and measured during the 2023 inspection. Small Depression No. 1 measures approximately 25-inches long, 30-inches wide, and 17-inches deep. Small Depression No. 2 (PL-6) measures approximately 48-inches long 37-inches wide, and 9.5-inches deep. No changes to the two depressions were identified since their discovery. A new depression, Small Depression No. 3, was identified during the 2023 inspection and was measured to be about 32-inches long, 24-inches wide, and 1-foot deep (PL-7). No evidence of sediment deposition, human intervention, or other modifying processes were observed near these depressions. The three depressions do not threaten the integrity or performance of the disposal cell; however, monitoring of the depressions will continue during annual inspections and subsequent surveys. There was standing water at the toe of the containment dam consistent with the above-average water year. Grasses and annual weeds were growing in the riprap in several places. The presence of plants and standing water do not threaten the stability or function of the containment dam.
