## 4.0 Maybell West, Colorado, Disposal Site

### 4.1 Compliance Summary

Figure 4-1. 2023 Annual Inspection Drawing for the Maybell West, Colorado, Disposal Site

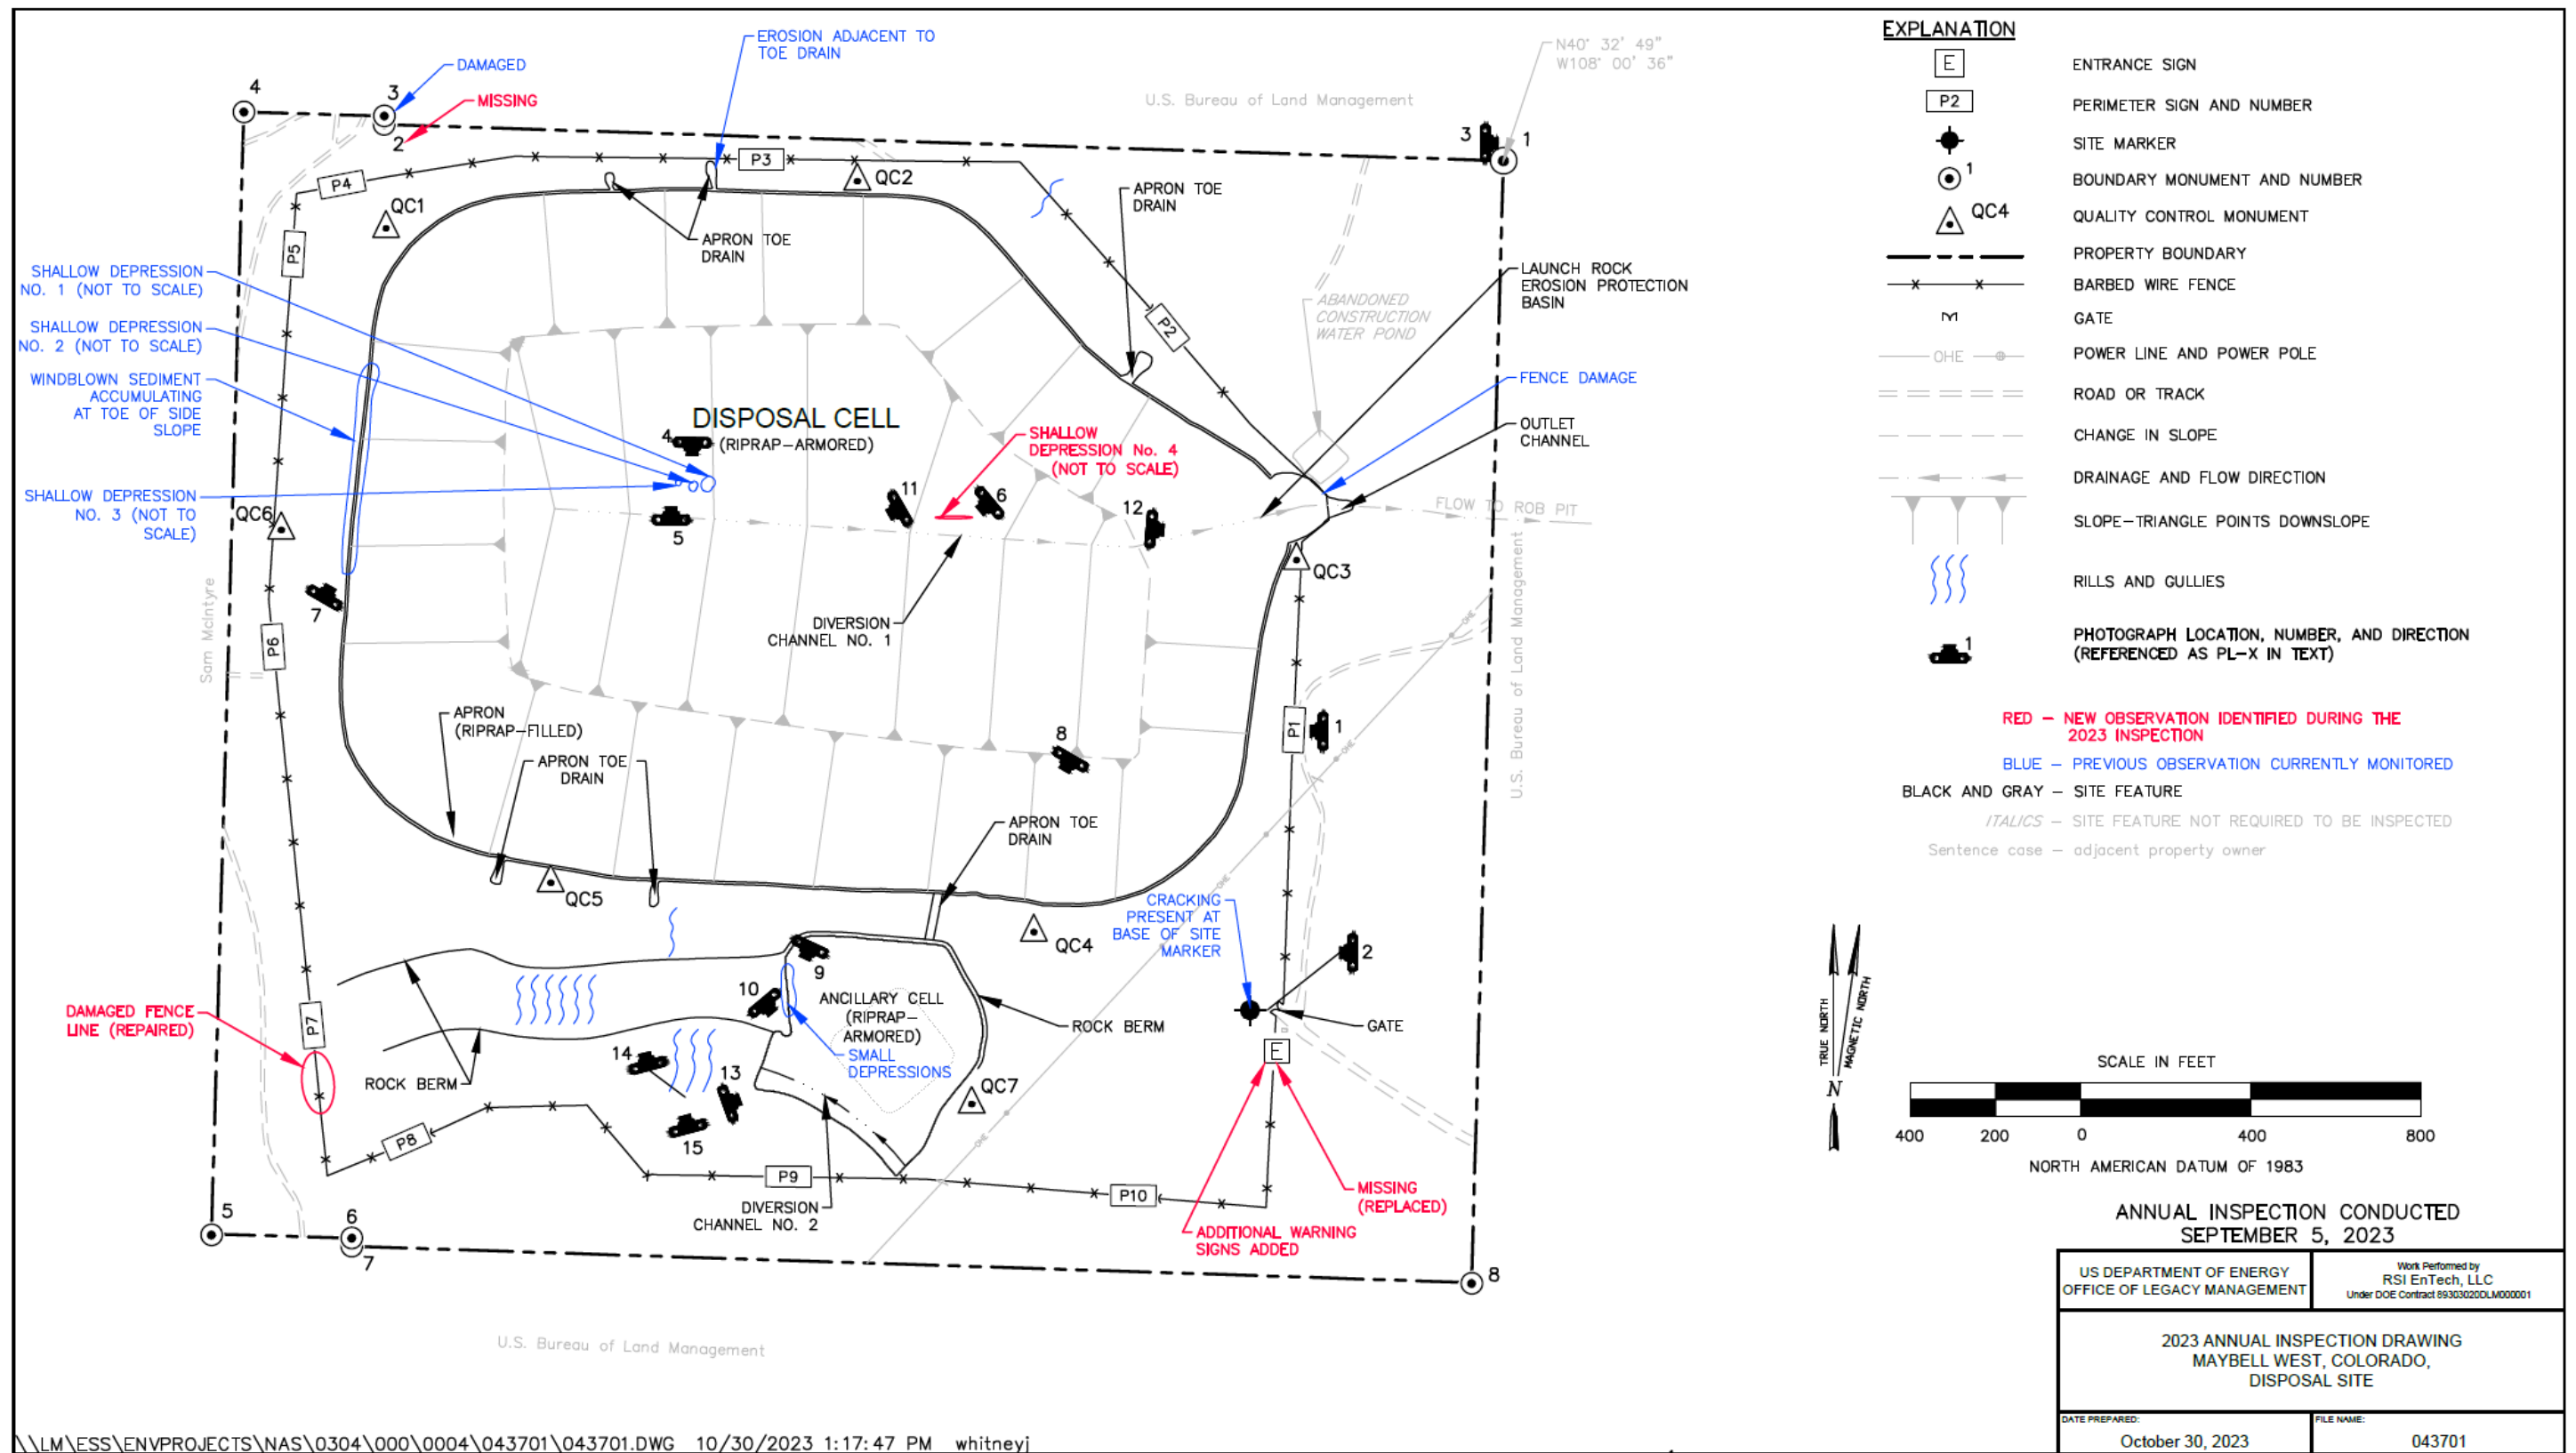
Figure 4-1 shows the locations of site features, including site surveillance features and inspection areas, in black and gray font. Some site features that are present but not required to be inspected are shown in italic font. Observations from previous inspections that are currently monitored are shown in blue, and new observations identified during the 2023 annual inspection are shown in red. Inspection results and recommended maintenance activities associated with site surveillance features are described in the following subsections. Photographs to support specific observations are noted in the text and in Figure 4-1 by photograph location (PL) numbers. The photographs and photograph log are presented in Section 4.9.
