## 6.0 Shirley Basin South, Wyoming, Disposal Site

### 6.1 Compliance Summary

The Shirley Basin South, Wyoming, Uranium Mill Tailings Radiation Control Act (UMTRCA) Title II Disposal Site was inspected on July 27, 2023. No major changes were observed on the disposal cell or in associated drainage features. Inspectors identified maintenance needs and found no cause for a follow-up inspection.

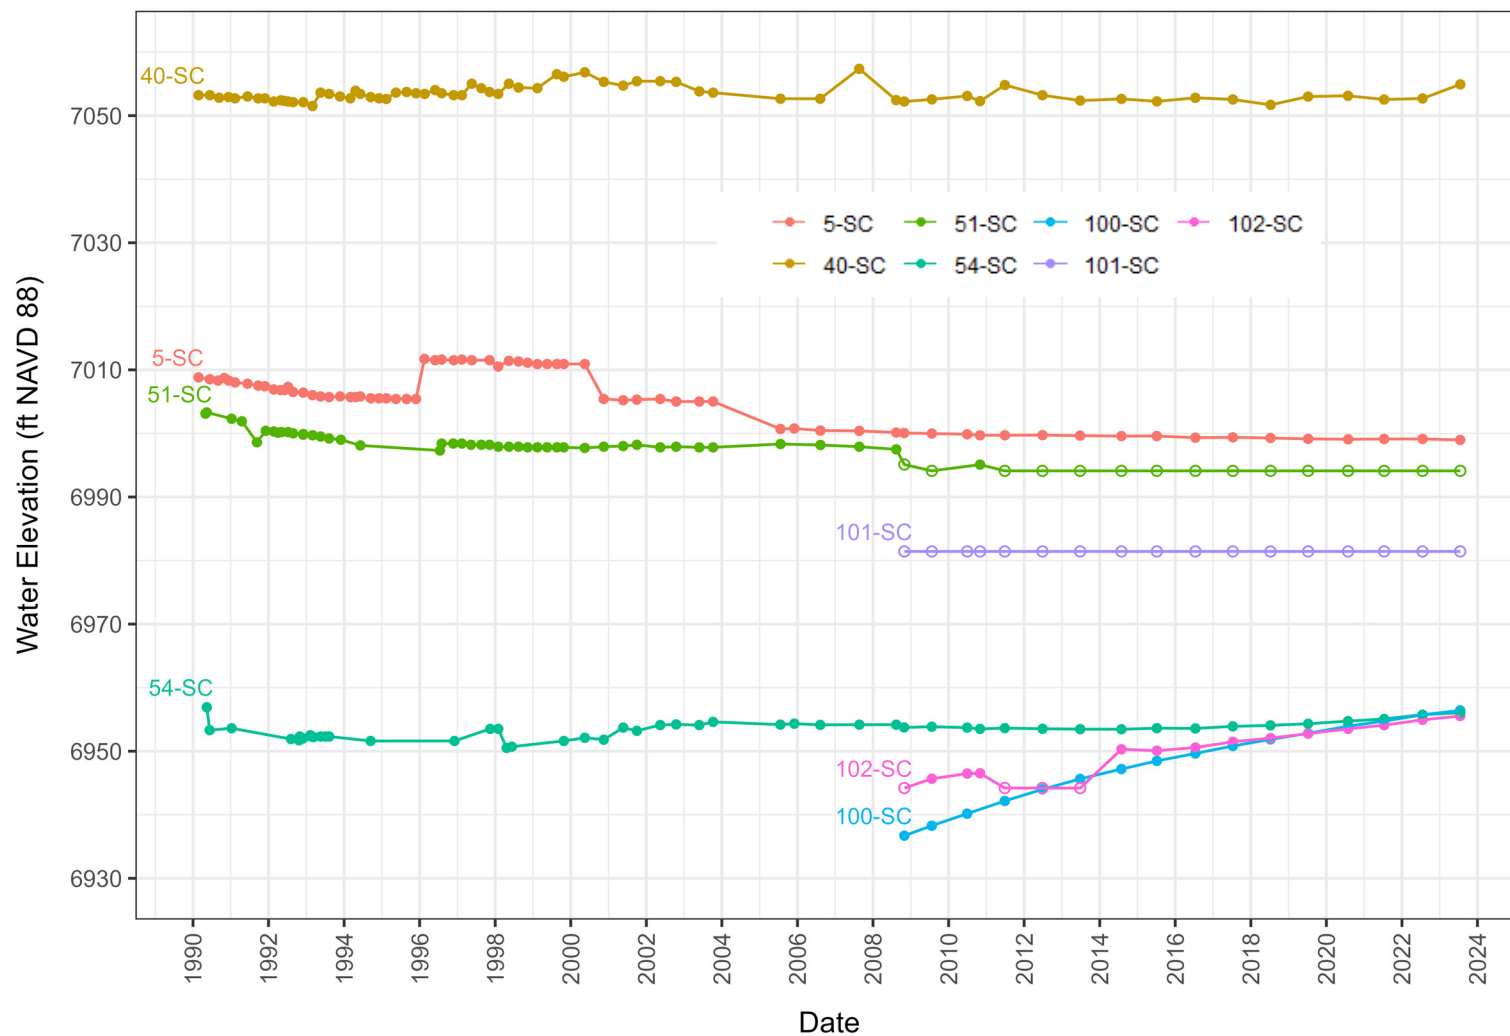
Figure 6-4. Hydrographs for Upper Sand Aquifer Wells at the Shirley Basin South, Wyoming, Disposal Site

**Notes:** Hollow symbols indicate that the well was dry or that the water level was below the pump. For these observations, plotted values are the corresponding bottom screen elevations or, for well 51-SC (with no available well construction information), the minimum recorded water elevation. POC well 51-SC has been dry since 2011, and well 101-SC has been dry since its installation in 2008.

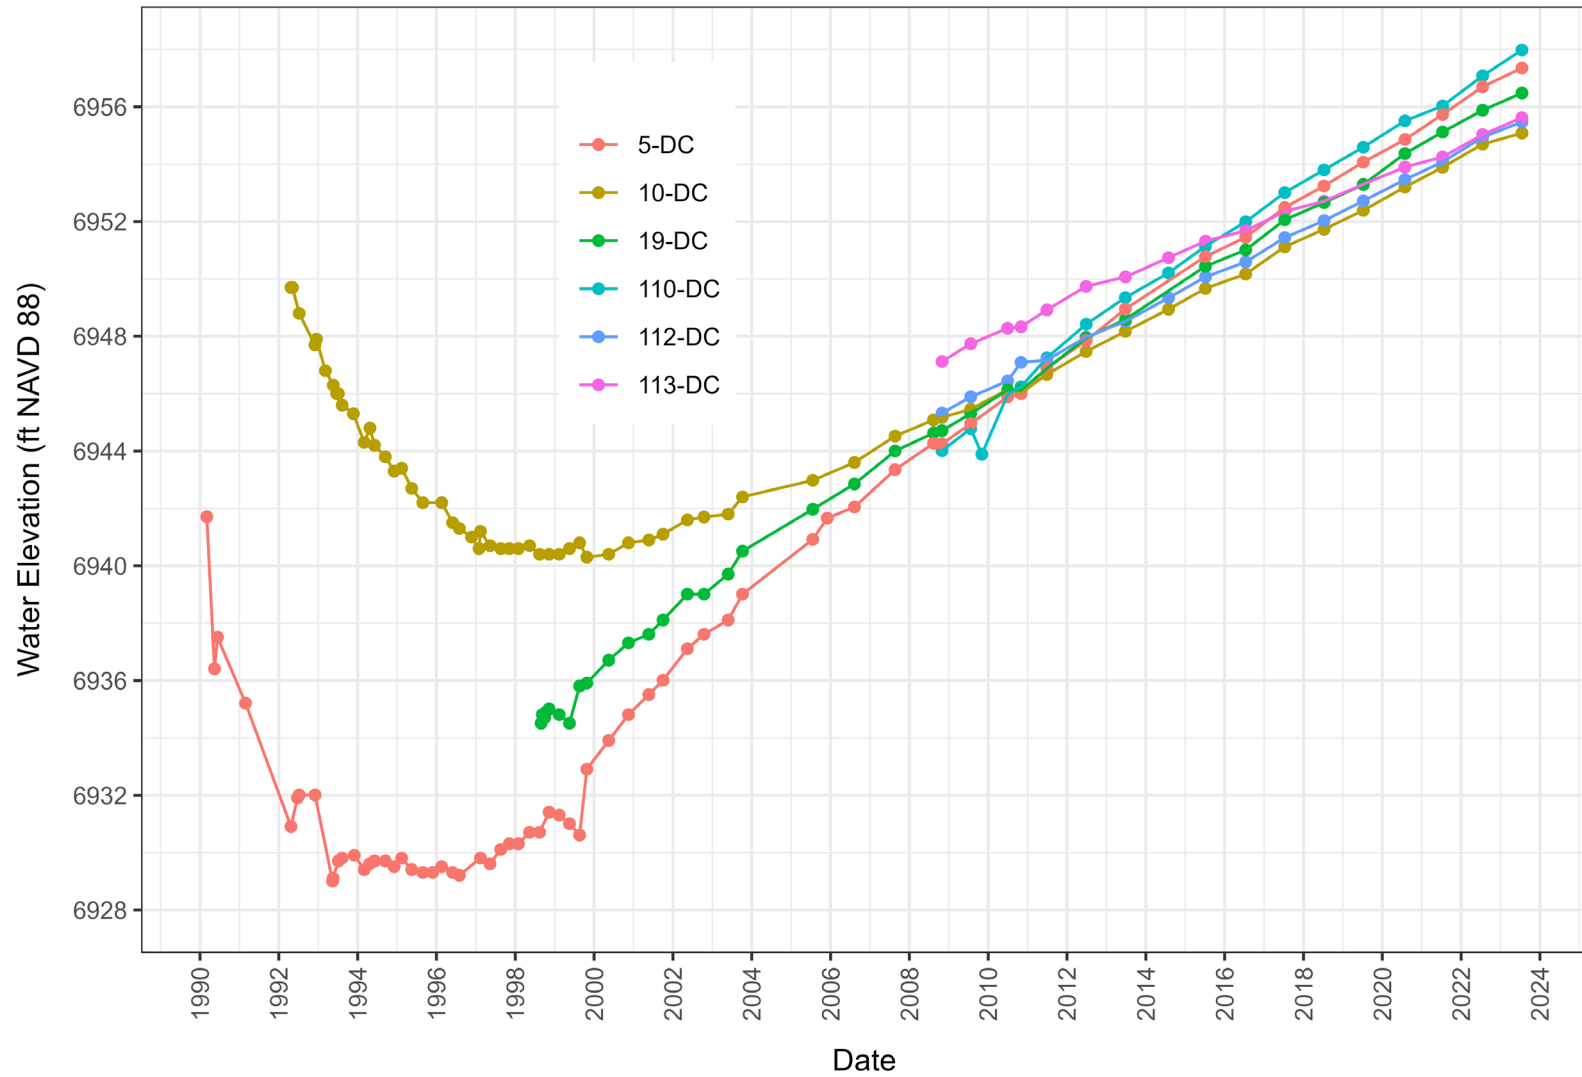
*Figure 6-6. Hydrographs for Main Sand Aquifer Wells at the Shirley Basin South, Wyoming, Disposal Site*

Piezometric heads have been gradually rising at all Main Sand Aquifer wells since 2000, with an average rate of increase of approximately 0.8 foot per year since LM began monitoring water levels in 2005 (Figure 6-6). The rising levels indicate a gradual recovery of the aquifer. However, the altered conditions at Pit 4 might prevent a return to premining elevations of the water table because the Upper Sand and Main Sand units now coalesce at this location.

In response to recent NRC comments on recent annual inspection reports (Orlando 2021; Bolz 2022), DOE will continue monitoring and evaluating groundwater elevations as recovery continues in the Main Sand Aquifer. Once groundwater conditions have stabilized, LM will determine if the monitoring program remains adequate. Groundwater elevations, apparent trends in flow directions, and water quality evaluations from existing Main Sand Aquifer wells will inform LM future actions to track potential offsite migration of site contaminants.

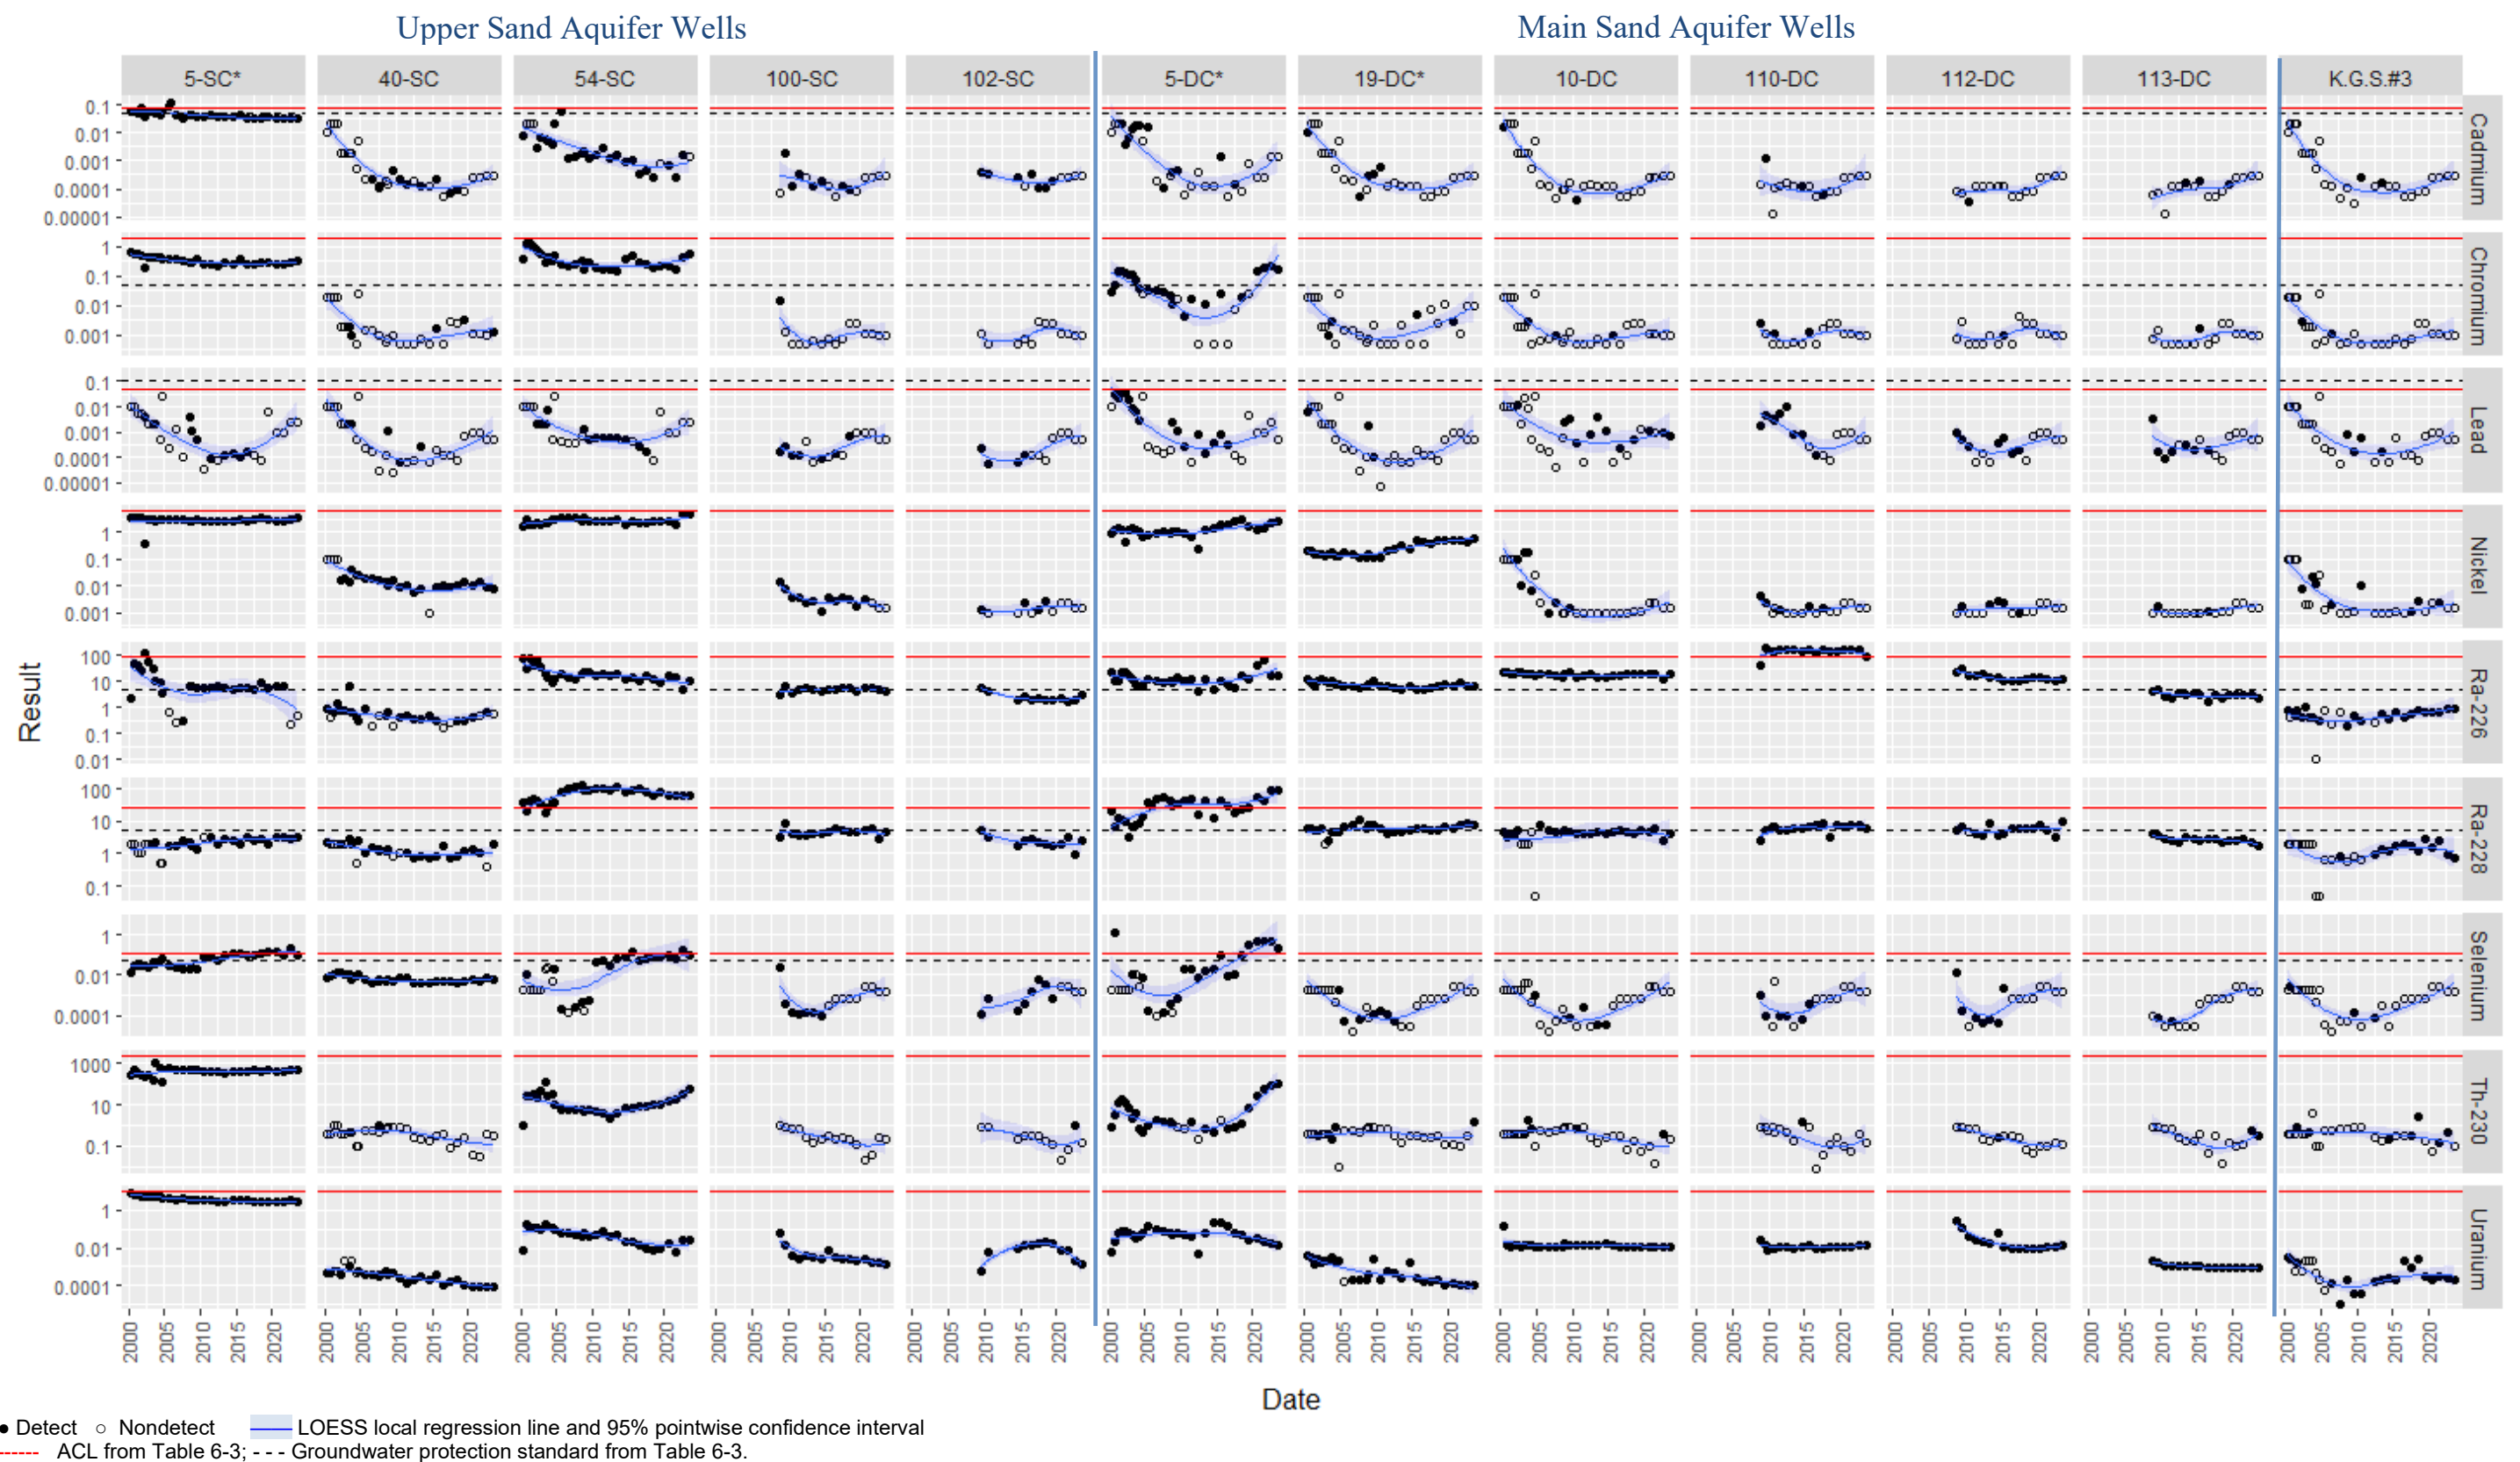
Figure 6-7. Time-Concentration Plots of Hazardous Constituents (Analytes with ACLs) in Monitoring Wells, Shirley Basin South, Wyoming, Disposal Site: 2000–2023

In LM's initial July 2005 sampling, the results for cadmium in POC well 5-SC exceeded the respective ACL of 0.079 milligrams per liter (mg/L). Cadmium concentrations in well 5-SC have since declined to below the ACL (most recent result of 0.03 mg/L) and concentrations in most remaining wells have been below the detection limit (Figure 6-7). For the three wells with detection frequencies greater than 50% (5-SC, 54-SC, and 102-SC), Mann-Kendall trend analysis identified statistically significant decreasing trends in cadmium concentrations (Table 6-7).

Nickel concentrations in Upper Sand Aquifer wells 5-SC and 54-SC have been just below the 6.15 mg/L ACL (Figure 6-7), but trends have been stable (non-trending). The most recent (2023) results were 3.22 and 4.42 mg/L, respectively (Table 6-4). Although statistically significant increasing trends were identified for Main Sand Aquifer wells 5-DC and 19-DC, nickel concentrations are below the ACL (most recent results of 2.57 and 0.56 mg/L, respectively).

Radium-226 concentrations in well 110-DC, installed in 2008, consistently exceeded the 91.3 picocuries per liter (pCi/L) ACL between 2009 and 2022 (Figure 6-7). In 2023, the  $^{226}\text{Ra}$  concentration in this well was 82.7 pCi/L, versus approximately 150 pCi/L in 2021–2022. Well 110-DC was considered a downgradient well at the time of installation in 2008, when groundwater flow direction in the Main Sand Aquifer was generally to the north-northeast. However, due to the recent changes in flow direction noted previously, well 110-DC is currently hydraulically upgradient from well 5-DC near the disposal cell. Although below the ACL,  $^{226}\text{Ra}$  concentrations in most remaining wells (54-SC, 5-DC, 19-DC, and 112-DC) have been elevated

Selenium concentrations have exceeded the 0.12 mg/L ACL (and the 0.05 mg/L groundwater protection standard) in wells 5-SC, 54-SC, and 5-DC (Figure 6-7). Consistent with findings presented in the previous annual report (DOE 2022), Mann-Kendall trend analysis continues to indicate statistically significant increasing selenium trends in these wells (Table 6-7). LM previously noted that selenium is a relatively poor early indicator constituent for tailings seepage, as selenium levels were measured to be relatively low in tailings water and attenuated easily (DOE 2011b).

Thorium-230 concentrations have been below detection limits in most wells as shown in Figure 6-7. Exceptions are wells 5-SC, 54-SC, and 5-DC, but  $^{230}\text{Th}$  levels have been well below the corresponding 2409 pCi/L ACL. Although a statistically significant increasing trend is indicated for well 54-SC based on data since 2005, current levels are sufficiently low (most recent result of 54.2 pCi/L) such that exceedances are not expected in the foreseeable future.

Uranium concentrations have been consistently below the 9.2 mg/L ACL in all wells (Figure 6-7), with statistically significant decreasing trends identified for most wells (Table 6-7). Consistent with trend analysis findings for  $^{226}\text{Ra}$  and  $^{228}\text{Ra}$ , a statistically significant increasing trend was identified for uranium in well K.G.S. #3. However, the most recent uranium result (0.0002 mg/L) is well below the ACL. Radium-226 and  $^{228}\text{Ra}$  concentrations are below corresponding ACLs and the combined  $^{226}\text{Ra}$  plus  $^{228}\text{Ra}$  groundwater protection standard of 5 pCi/L (most recent results of 0.94 and 0.72 pCi/L, respectively). As indicated in Table 6-4 through Table 6-7, concentrations of all monitored parameters in well K.G.S. #3 are below applicable standards, both the ACLs and groundwater protection standards for livestock listed in Table 6-3.

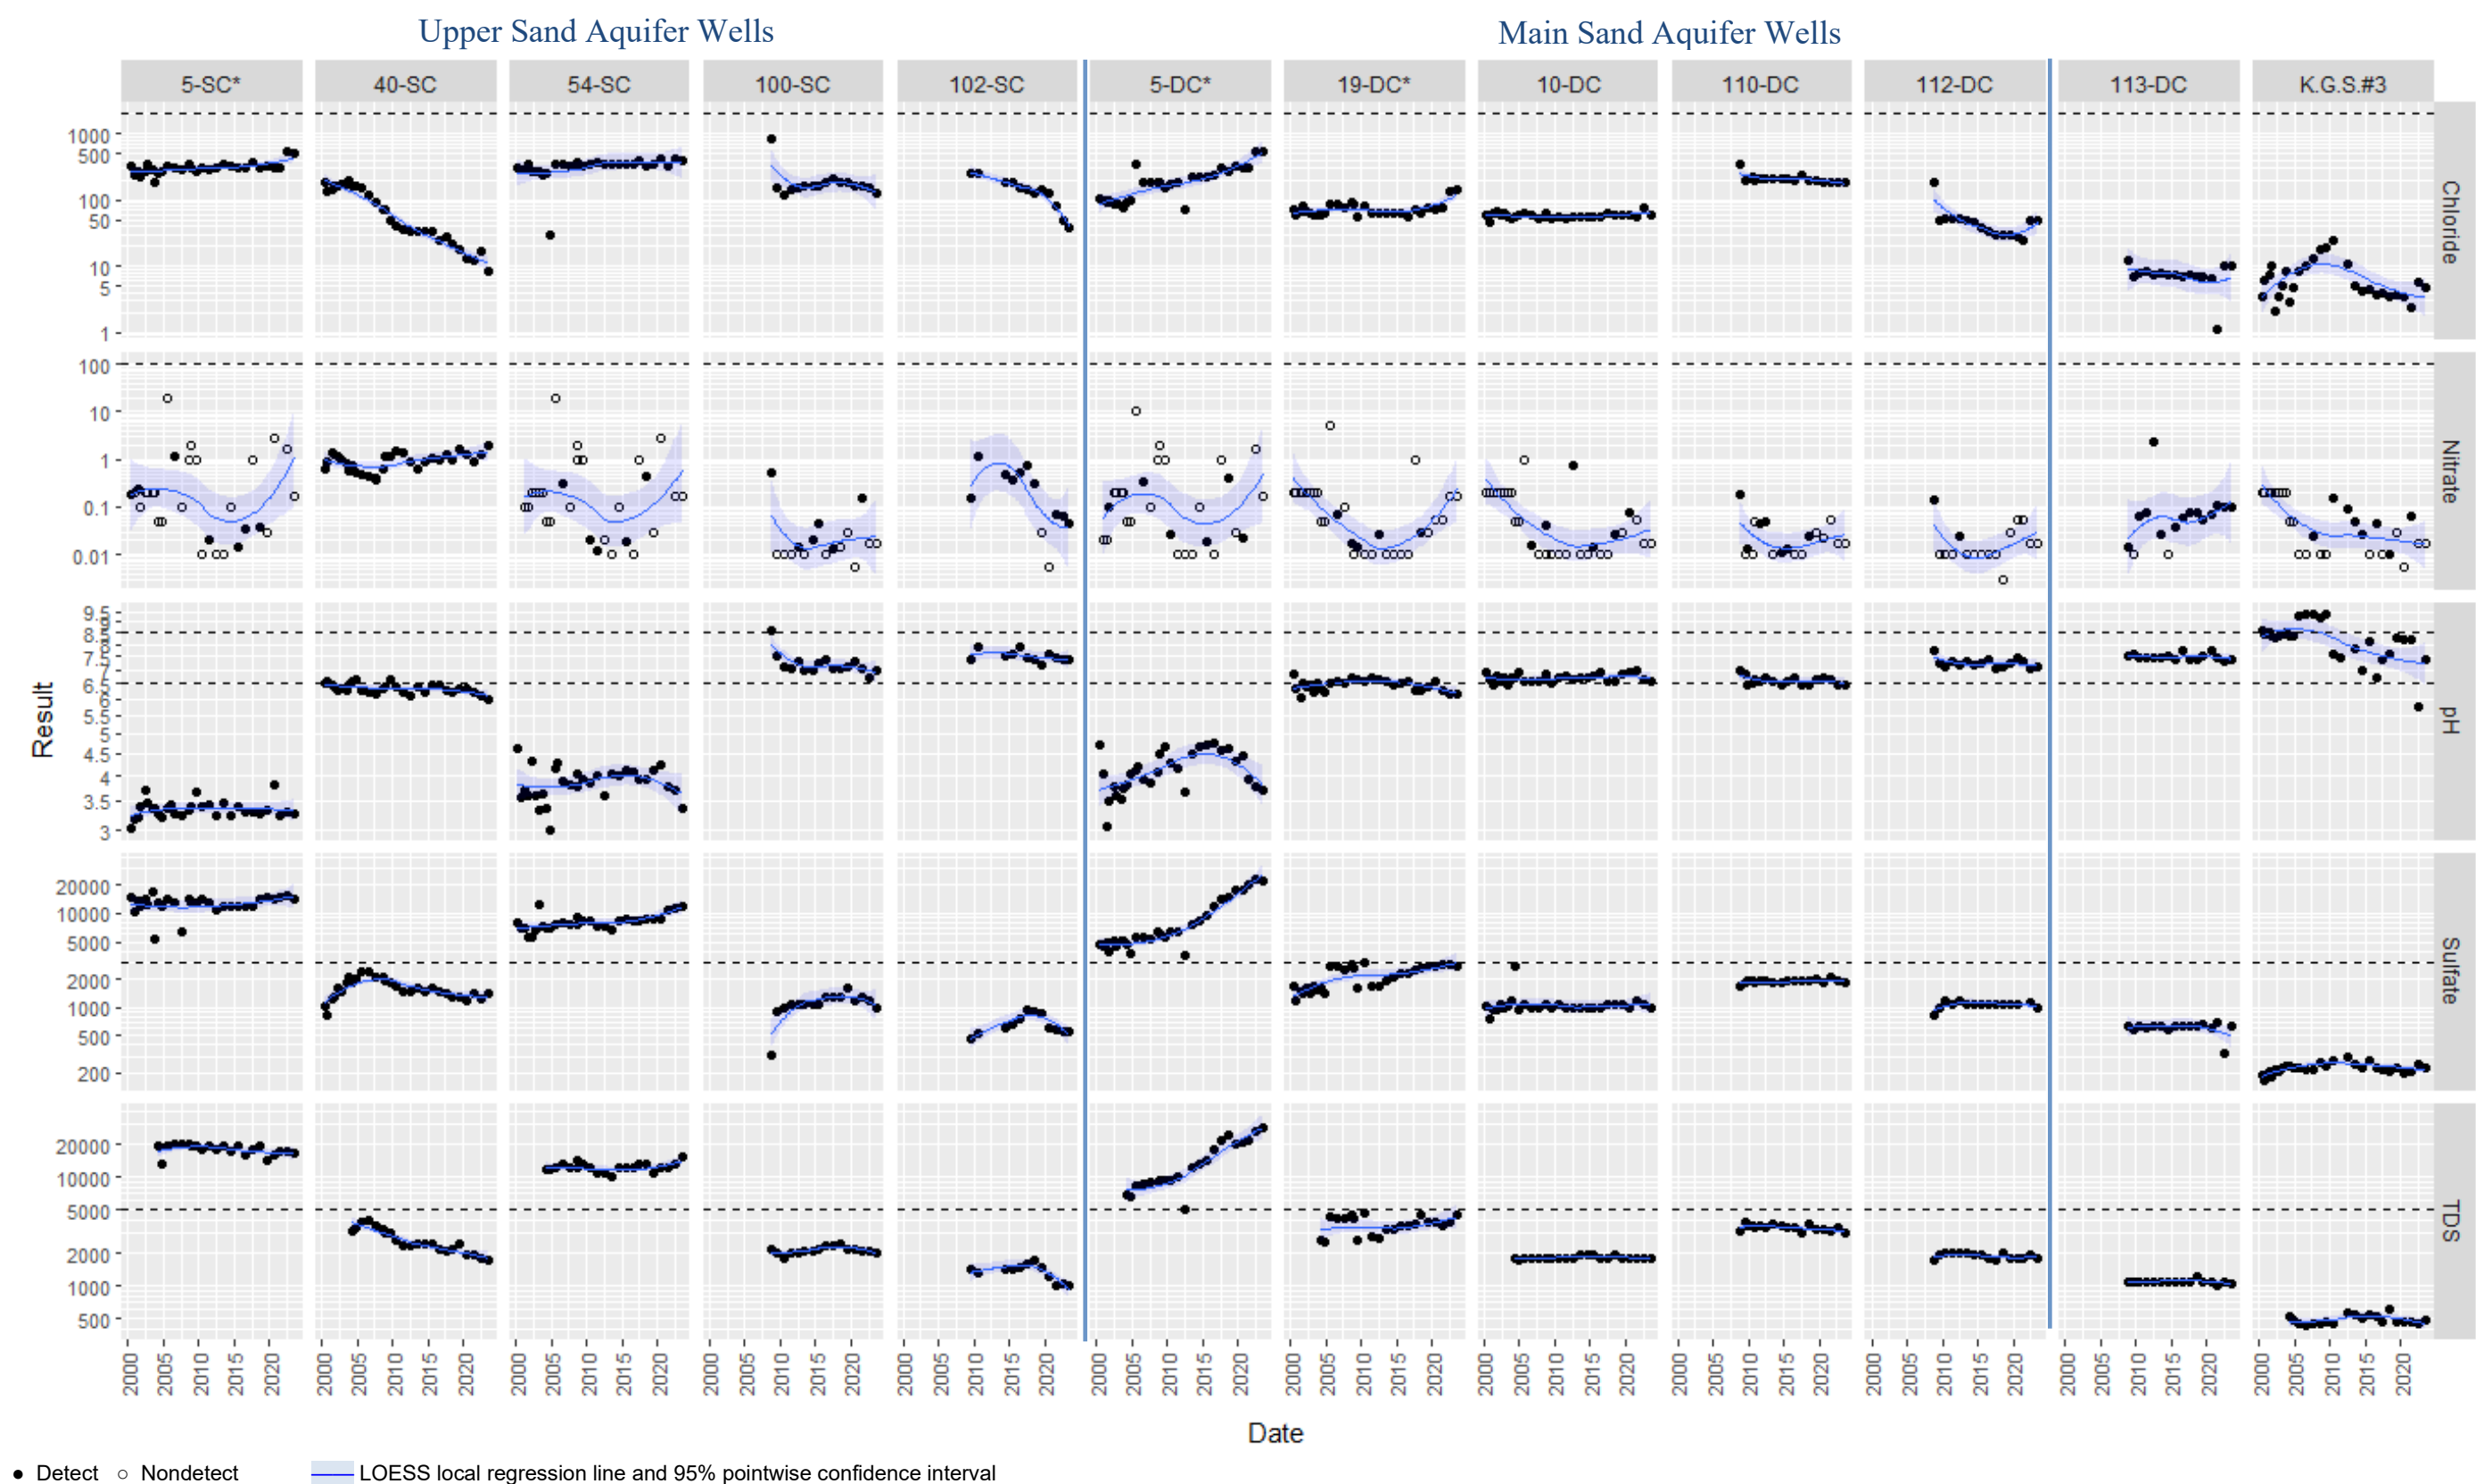
Figure 6-8. Time-Concentration Plots of Indicator Parameters in Monitoring Wells, Shirley Basin South, Wyoming, Disposal Site: 2000–2023

In 2023, Wyoming Class III groundwater protection standards for indicator parameters (chloride, nitrate, sulfate, and TDS) were met at downgradient site boundary wells (100-SC, 102-SC, 110-DC, 112-DC, and 113-DC), but standards continue to be exceeded for sulfate and TDS in wells 5-SC, 54-SC, and 5-DC near the disposal cell (Table 6-4, Table 6-5, and Figure 6-8). Statistically significant increasing trends were identified for several well-indicator parameter combinations as shown in Table 6-7, most notably well 5-DC, where chloride, sulfate, and TDS have also been significantly increasing since 2005 and pH has been decreasing since approximately 2015 (Figure 6-8).
