## 5.0 Sherwood, Washington, Disposal Site

### 5.1 Compliance Summary

The Sherwood, Washington, Uranium Mill Tailings Radiation Control Act (UMTRCA) Title II Disposal Site was inspected on June 8, 2023. No changes were observed to the disposal cell, containment dam, or associated drainage features. Inspectors identified several routine maintenance needs but found no cause for a follow-up or contingency inspection.

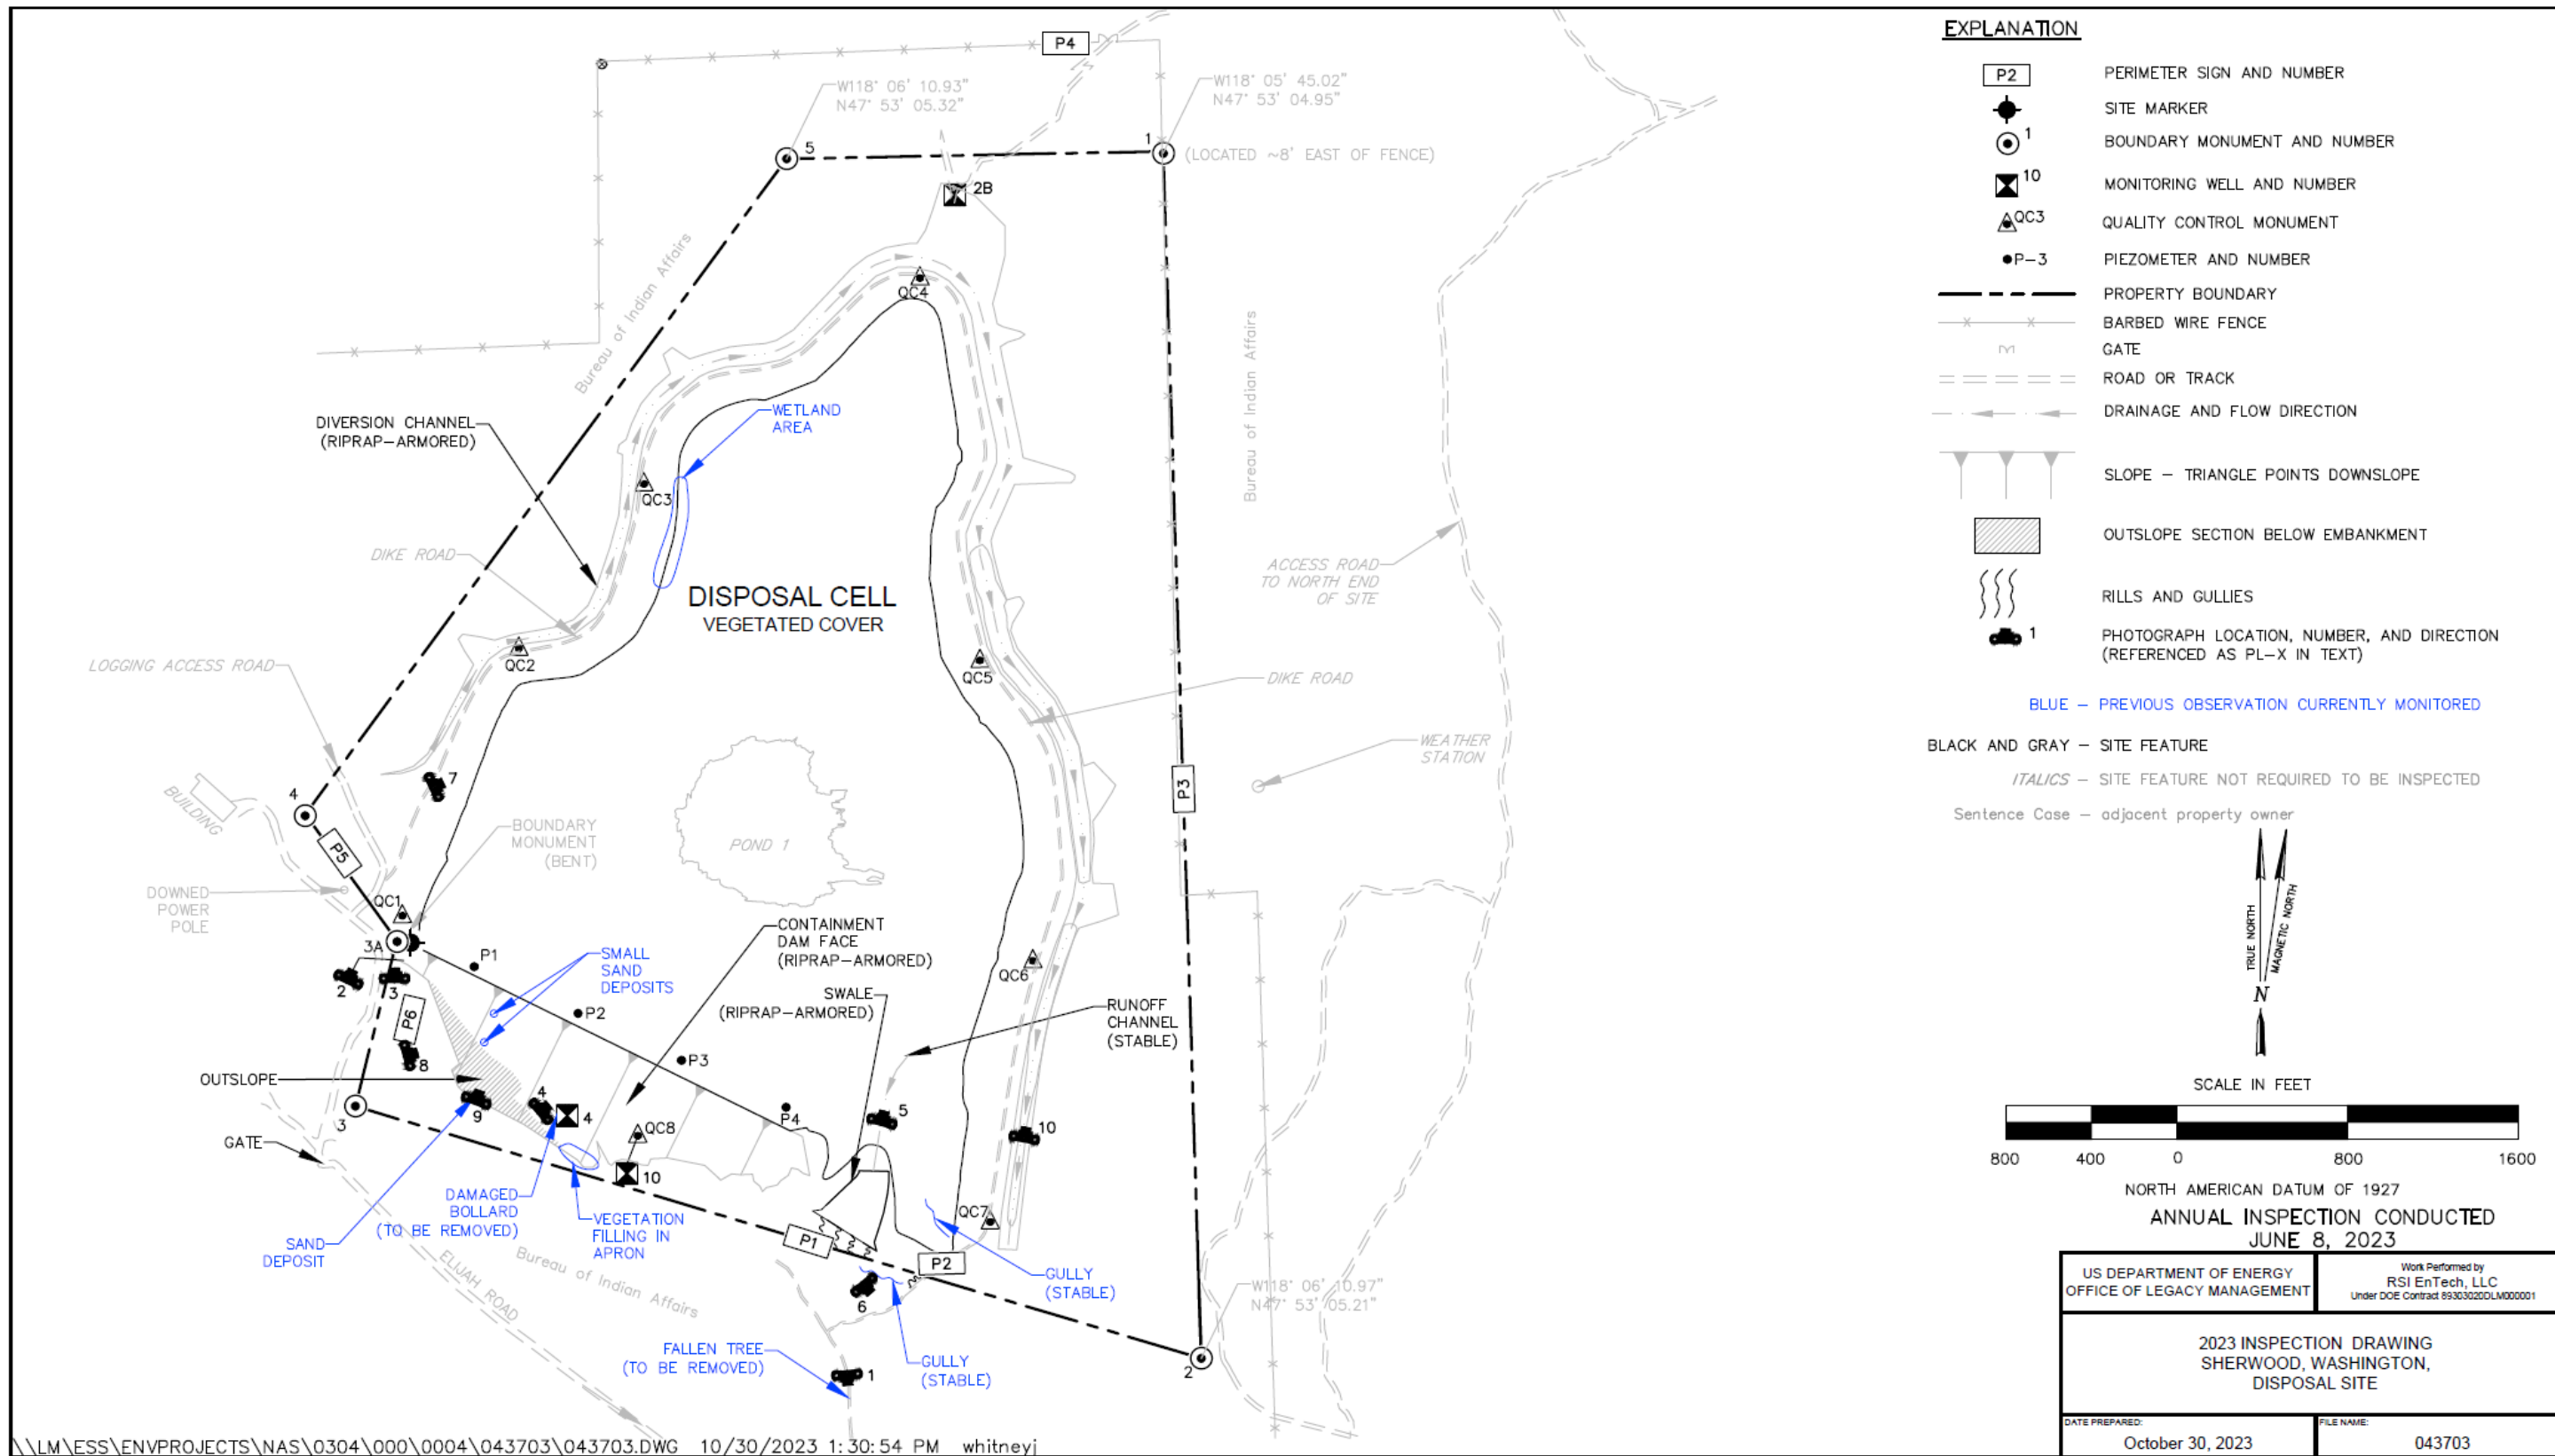
Figure 5-1. 2023 Annual Inspection Drawing for the Sherwood, Washington, Disposal Site

Figure 5-1 shows the locations of site features, including site surveillance features and inspection areas, in black and gray font. Some site features that are present but not required to be inspected are shown in italic font. Observations from previous inspections that are currently monitored are shown in blue. Inspection results and recommended maintenance activities associated with site surveillance features are described in the following subsections. Photographs to support specific observations are noted in the text and in Figure 5-1 by photograph location (PL) numbers. The photographs and photograph log are presented in Section 5.9.

Six boundary monuments set in concrete define the site boundary. Because surrounding vegetation has made it difficult to locate some of the monuments, metal T-posts were installed at each boundary monument location. All boundary monuments were located during the inspection. Boundary monument BM-3A is bent but still visible and intact (PL-3). No maintenance needs were identified.

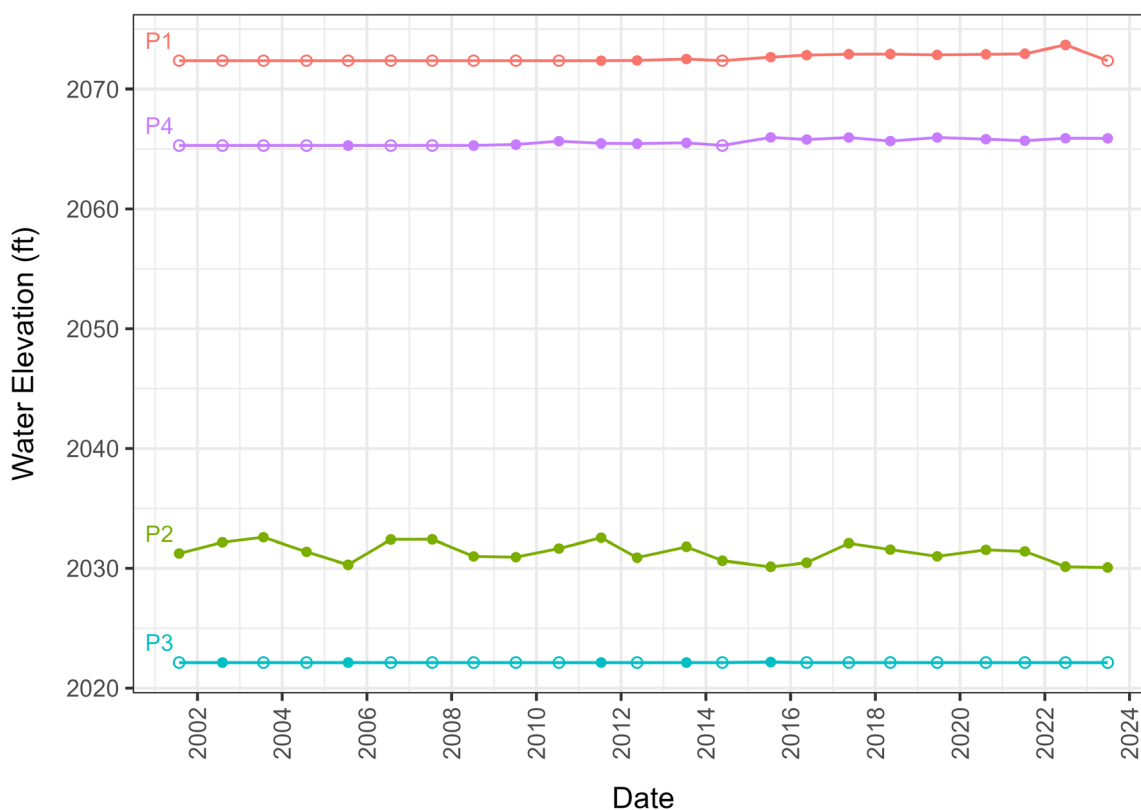
Figure 5-2. Groundwater Elevations at Piezometer Locations P1 Through P4, Sherwood, Washington, Disposal Site

The piezometers, installed in 2000, directly measure moisture conditions in the containment dam. Measurements collected on June 27, 2023, are listed in Table 5-2 and in the attached *Dam Inspection Checklist*. Figure 5-2 plots corresponding historical groundwater elevations. Because the scale in this initial figure spans approximately 50 ft, to provide greater resolution, Figure 5-3 plots the same data but using unique scales (results for piezometer P3 are not shown because this well has been predominantly dry). Since 2001, groundwater elevations have increased 0.6 ft in shallow piezometer P4; this slight increase is not considered indicative of potential performance issues. Between 2011 and 2022, water elevations increased 1.3 ft in piezometer P1, but, consistent with 2001–2010 observations, this location was dry in 2023. As presented in Section 5.7, no statistically significant increasing trends in water elevations were found in monitoring wells MW-4 and MW-10 near the base of the dam.

**Note:** Hollow symbols indicate that the well was dry or that the water level was below the pump (plotted values are corresponding bottom screen elevations).

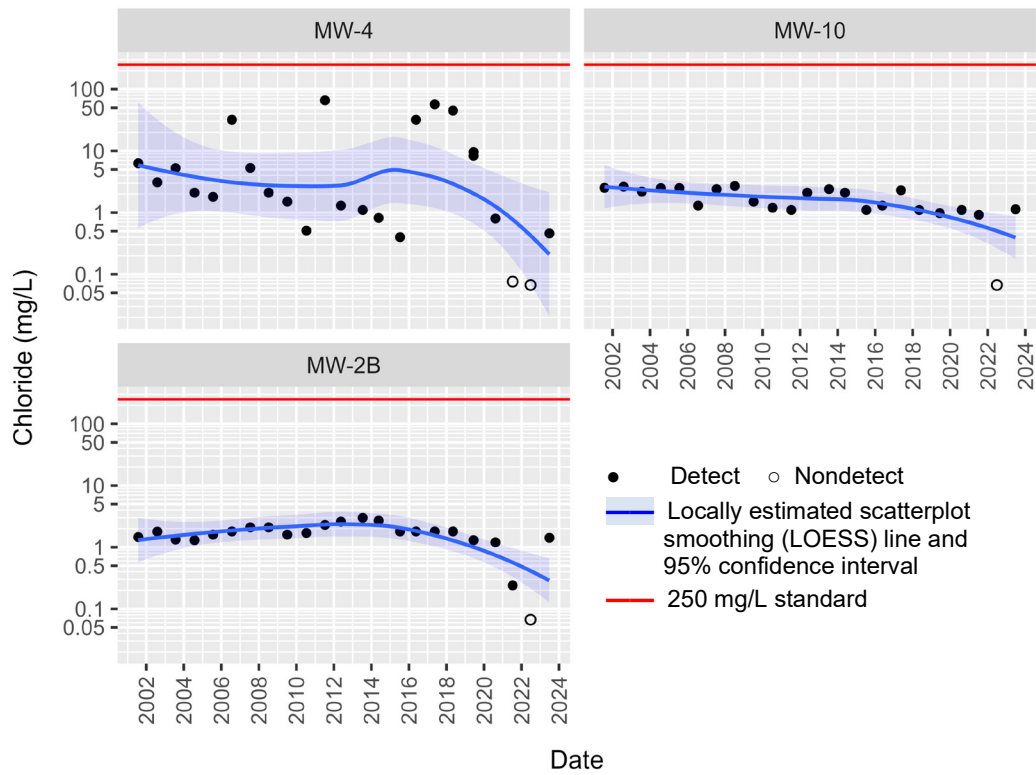
Figure 5-5. Chloride Concentrations in Monitoring Wells at the Sherwood, Washington, Disposal Site

Time-concentration plots of chloride and sulfate measured in monitoring wells MW-4 and MW-10, as well as background well MW-2B are shown in Figure 5-5 and Figure 5-6, respectively. Chloride concentrations in all wells have been consistently below the 250 mg/L water quality criterion and typically less than 10 mg/L. The exceptions shown in Figure 5-5 for monitoring well MW-4 correspond to higher sulfate concentrations measured at the same location. Sulfate concentrations in monitoring well MW-4 have been at or below the 250 mg/L criterion except for the May 2017 result of 260 mg/L (Kreie 2018). As acknowledged in previous annual reports, the elevated concentrations of chloride and sulfate measured in monitoring well MW-4 in 2006, 2011, and 2016–2018 correspond to increases in groundwater elevations in monitoring well MW-4 and in background well MW-2B. Sulfate concentrations in monitoring well MW-10 and background well MW-2B have been consistently below the 250 mg/L criterion (Figure 5-6). In 2022, concentrations of both chloride and sulfate were unusually low relative to historical measurements. Data validation eliminated laboratory error from consideration as a possible explanation for these outlier results. In 2023, chloride and sulfate concentrations in all wells returned to pre-2022 average levels (Figure 5-5; Figure 5-6).

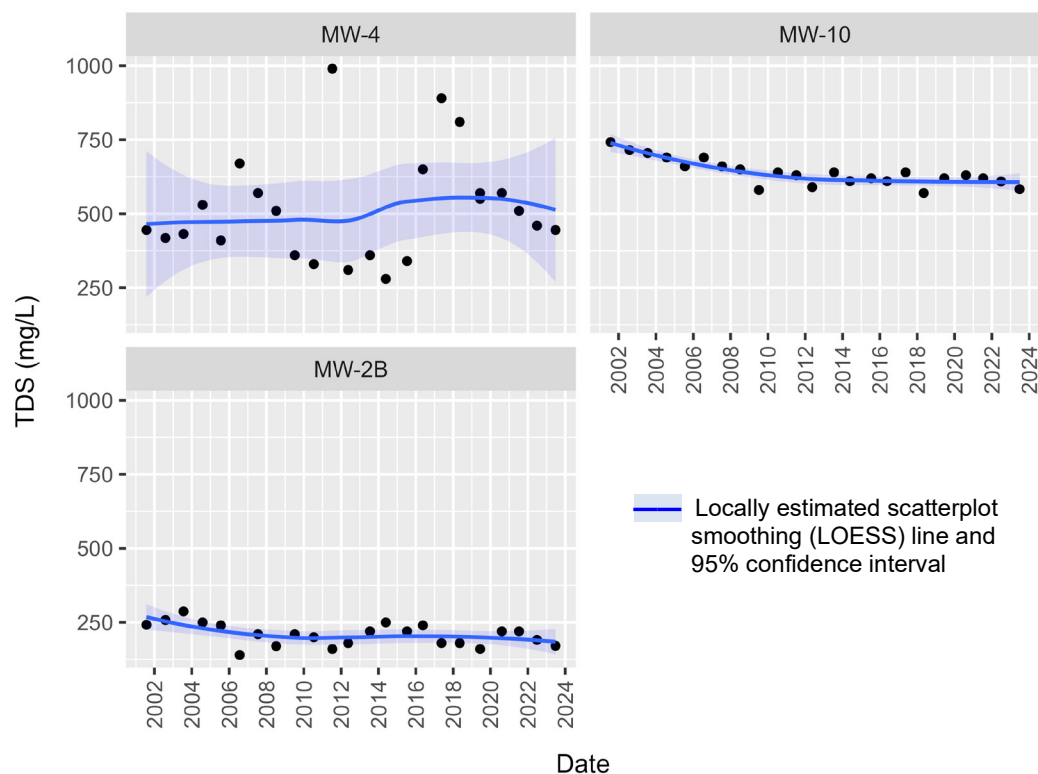
Figure 5-7. TDS Concentrations in Monitoring Wells at the Sherwood, Washington, Disposal Site

Although TDS is not considered an indicator parameter, this analyte is routinely monitored in accordance with the LTSP (DOE 2001; Table 5-3). TDS concentrations in monitoring wells MW-4 and MW-10 have consistently exceeded concentrations measured in background well MW-2B (Figure 5-7). In 2023, TDS concentrations in monitoring wells MW-4 and MW-10 were 445 and 583 mg/L, respectively. In background well MW-2B, the 2023 TDS measurement was 171 mg/L, slightly lower than the historical average concentration of about 210 mg/L.

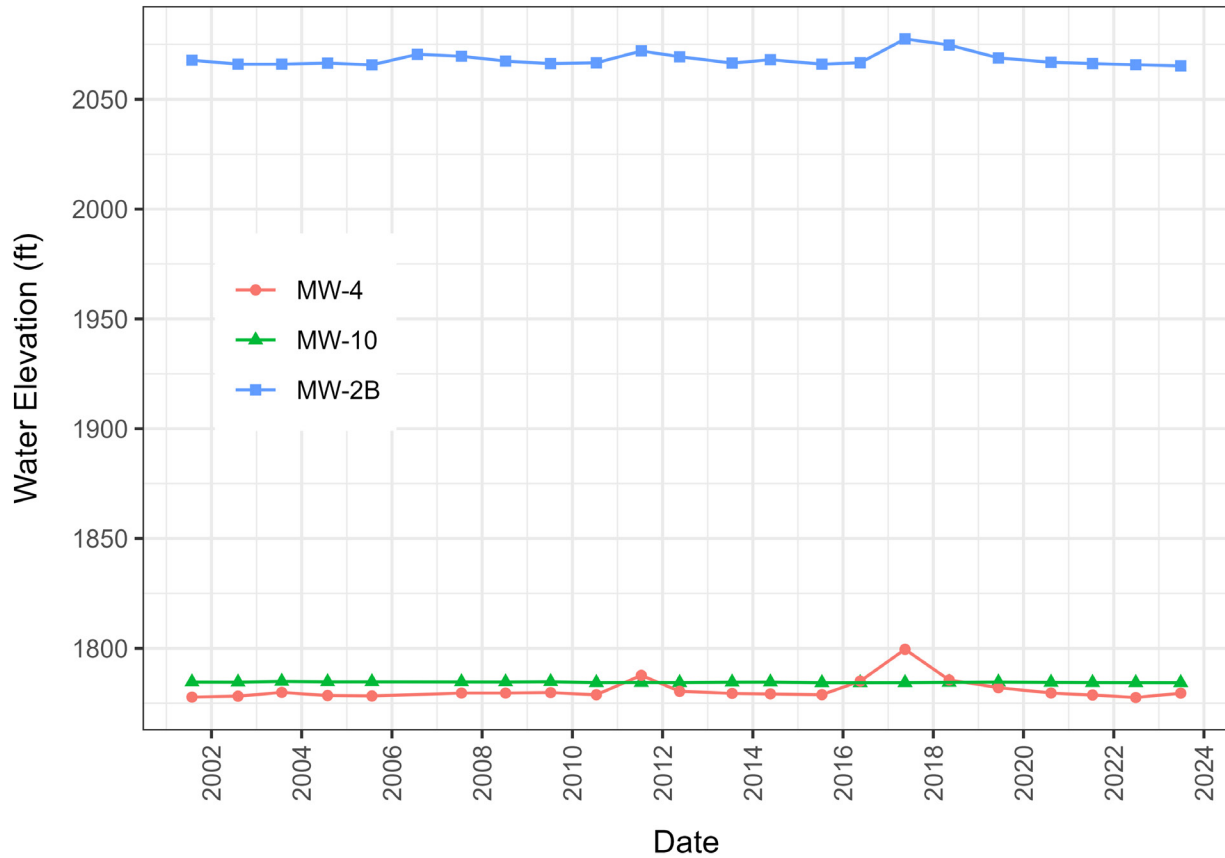
Figure 5-8. Groundwater Elevations in Monitoring Wells at the Sherwood, Washington, Disposal Site

Groundwater elevations recorded at each of the monitoring wells are shown in Figure 5-8 (common y-axis) and Figure 5-9 (unique scaling). Groundwater occurs in two hydrostratigraphic units: (1) the alluvium that lies on top of the bedrock surface and (2) the conductive bedrock, including weathered bedrock in the upper portion and unweathered or competent bedrock below. Monitoring well MW-10 and MW-4 are completed in the alluvium, while background well MW-2B is screened across the alluvium, weathered bedrock, and competent bedrock.

Absolute values of water table elevations plotted in Figure 5-8 and Figure 5-9 differ slightly from those shown in annual reports issued before 2021, but the trends are the same. The reason for the offset is the recent (February 2021) transformation of vertical datum from National Geodetic Vertical Datum of 1929 to North American Vertical Datum of 1988 (NAVD 88) in LM's environmental database.
