# **2024 Annual Inspection Report for the DOE Monticello, Utah, Mill Tailings Site and Monticello Vicinity Properties**

**December 2024**

Legacy  
Management

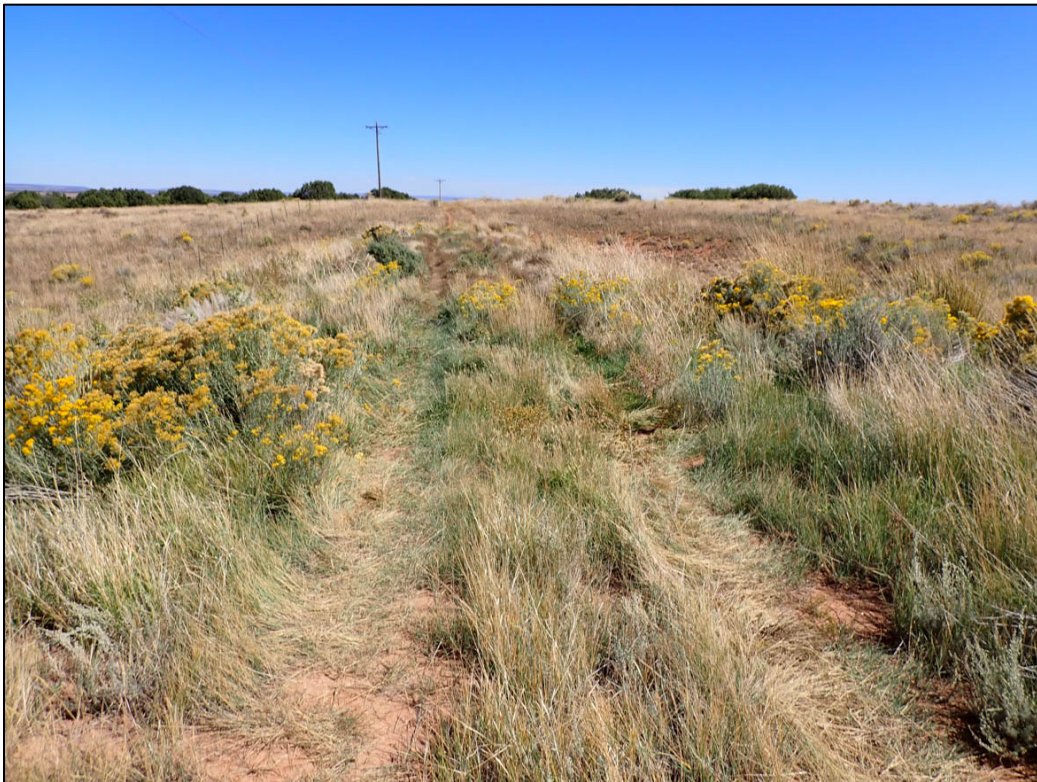
All riprap-armored structures, dams, check dams, berms, and runoff control drainages (Figure 4) were intact and functional. PL-29 shows a portion of the access road near Deer Draw Dam and illustrates the well-vegetated and intact soils that characterize the city-owned properties.

*PL-29. Access Road near Deer Draw Dam, Looking East*

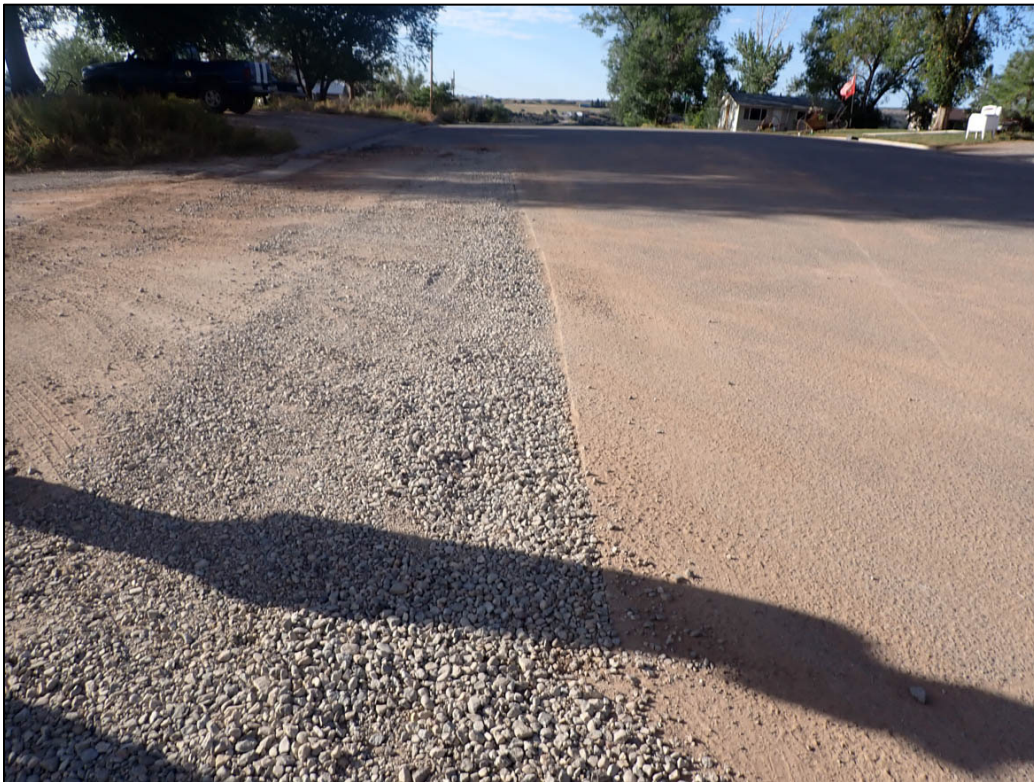
*PL-35. City Utility Line Work at 381 to 397 South 200 East, Looking South*
