3.0 L-Bar, New Mexico, Disposal Site

3.1 Compliance Summary

The L-Bar, New Mexico, Uranium Mill Tailings Radiation Control Act (UMTRCA) Title II Disposal Site was inspected on March 20–21, 2024. Previous inspections performed in 2021, 2022, and 2023, as required by the Long-Term Surveillance Plan (DOE 2004) (LTSP), and associated follow-up site visits identified numerous surface degradation features on the disposal cell top slope. No new degradation features on the top slope were identified during the March 2024 inspection. During an Applied Studies and Technology (AS&T) investigation in September and October 2022, several piping features were discovered on the side slope of the disposal cell. These features continue to be monitored and currently do not affect the performance of the side slope. Inspectors also identified several routine maintenance needs during the March 2024 inspection.

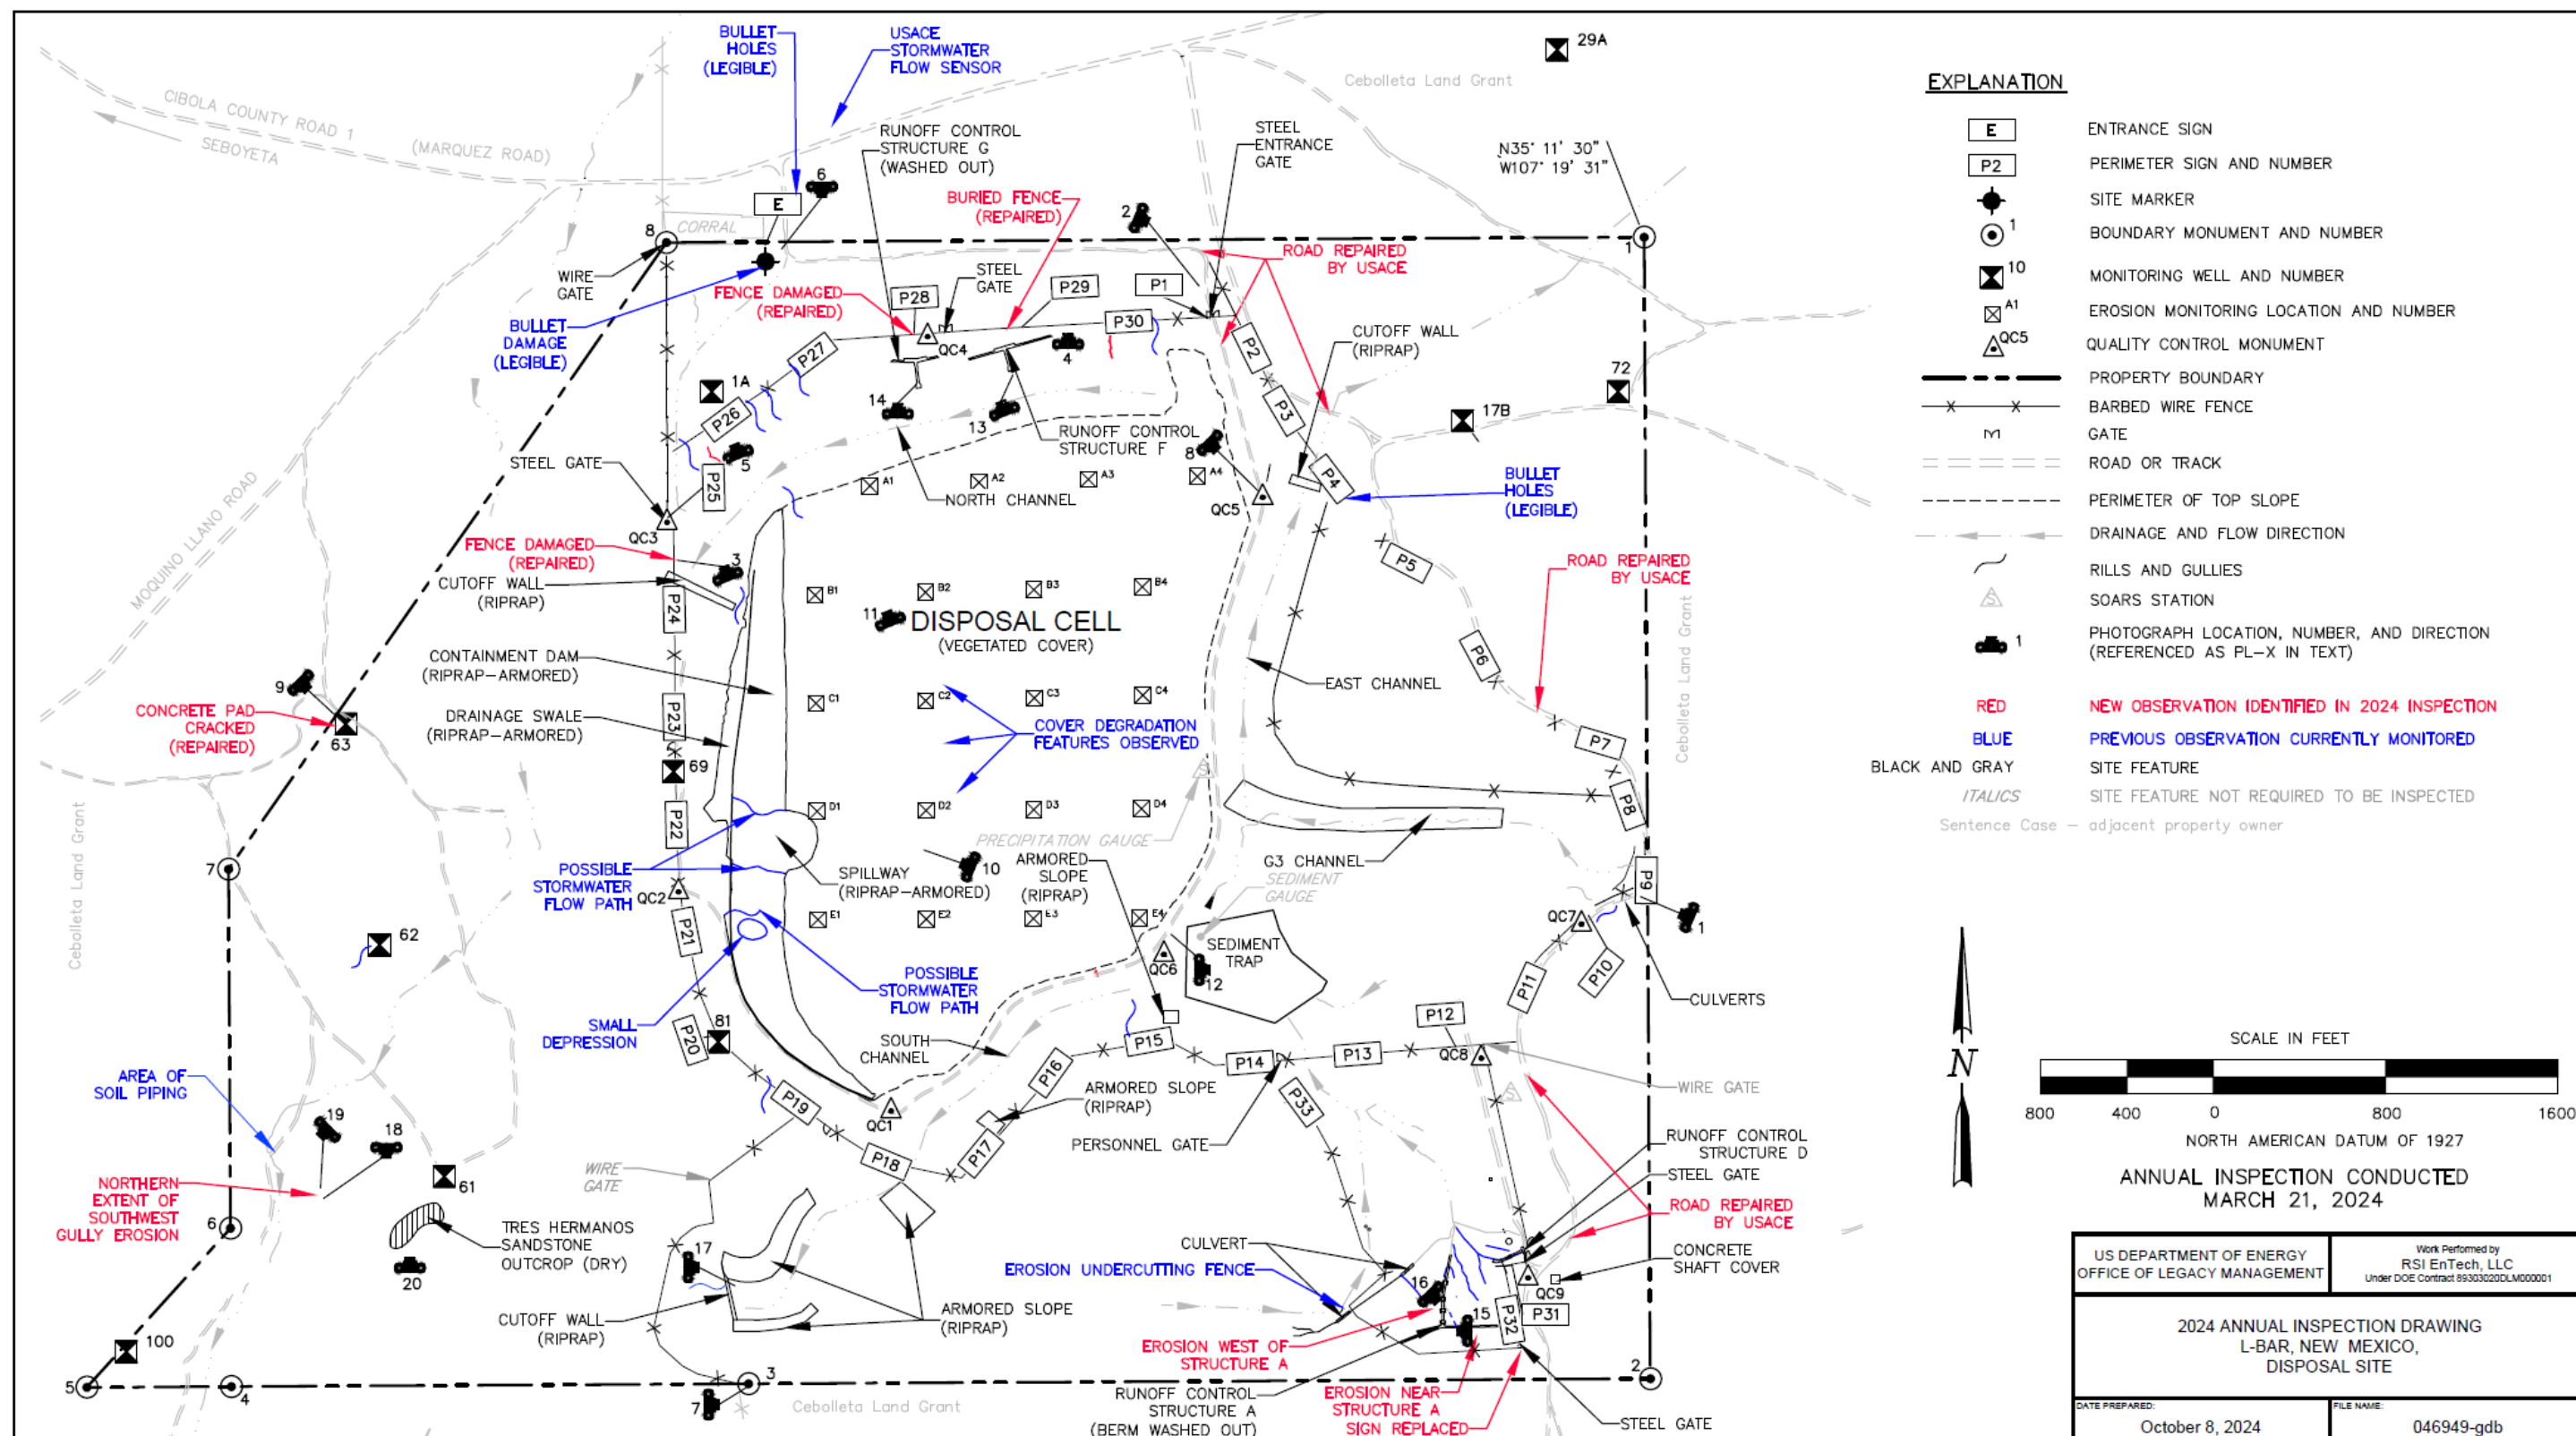
Figure 3-1. 2024 Annual Inspection Drawing for the L-Bar, New Mexico, Disposal Site

Interior roads used to access LM assets consist of two-track dirt roads with drainage culverts to convey stormwater in key locations. A gully that formed through headcutting on a side slope of the G3 channel has encroached on the east site access road. Culverts were installed along the access road in 2016 to prevent washout of the road and to control erosion. Sediment is accumulating around one of the three culvert inlets, and erosion is also undercutting the outlets. Two of the three culverts are functioning as designed (PL-1). The U.S. Army Corps of Engineers (USACE) conducted culvert cleanout in October 2024.

In accordance with the EMP, the former licensee installed a grid of 20 evenly spaced monitoring locations on the cover in November 2003 (Figure 3-1). The locations were initially measured in December 2003 by the former licensee to establish baseline values.

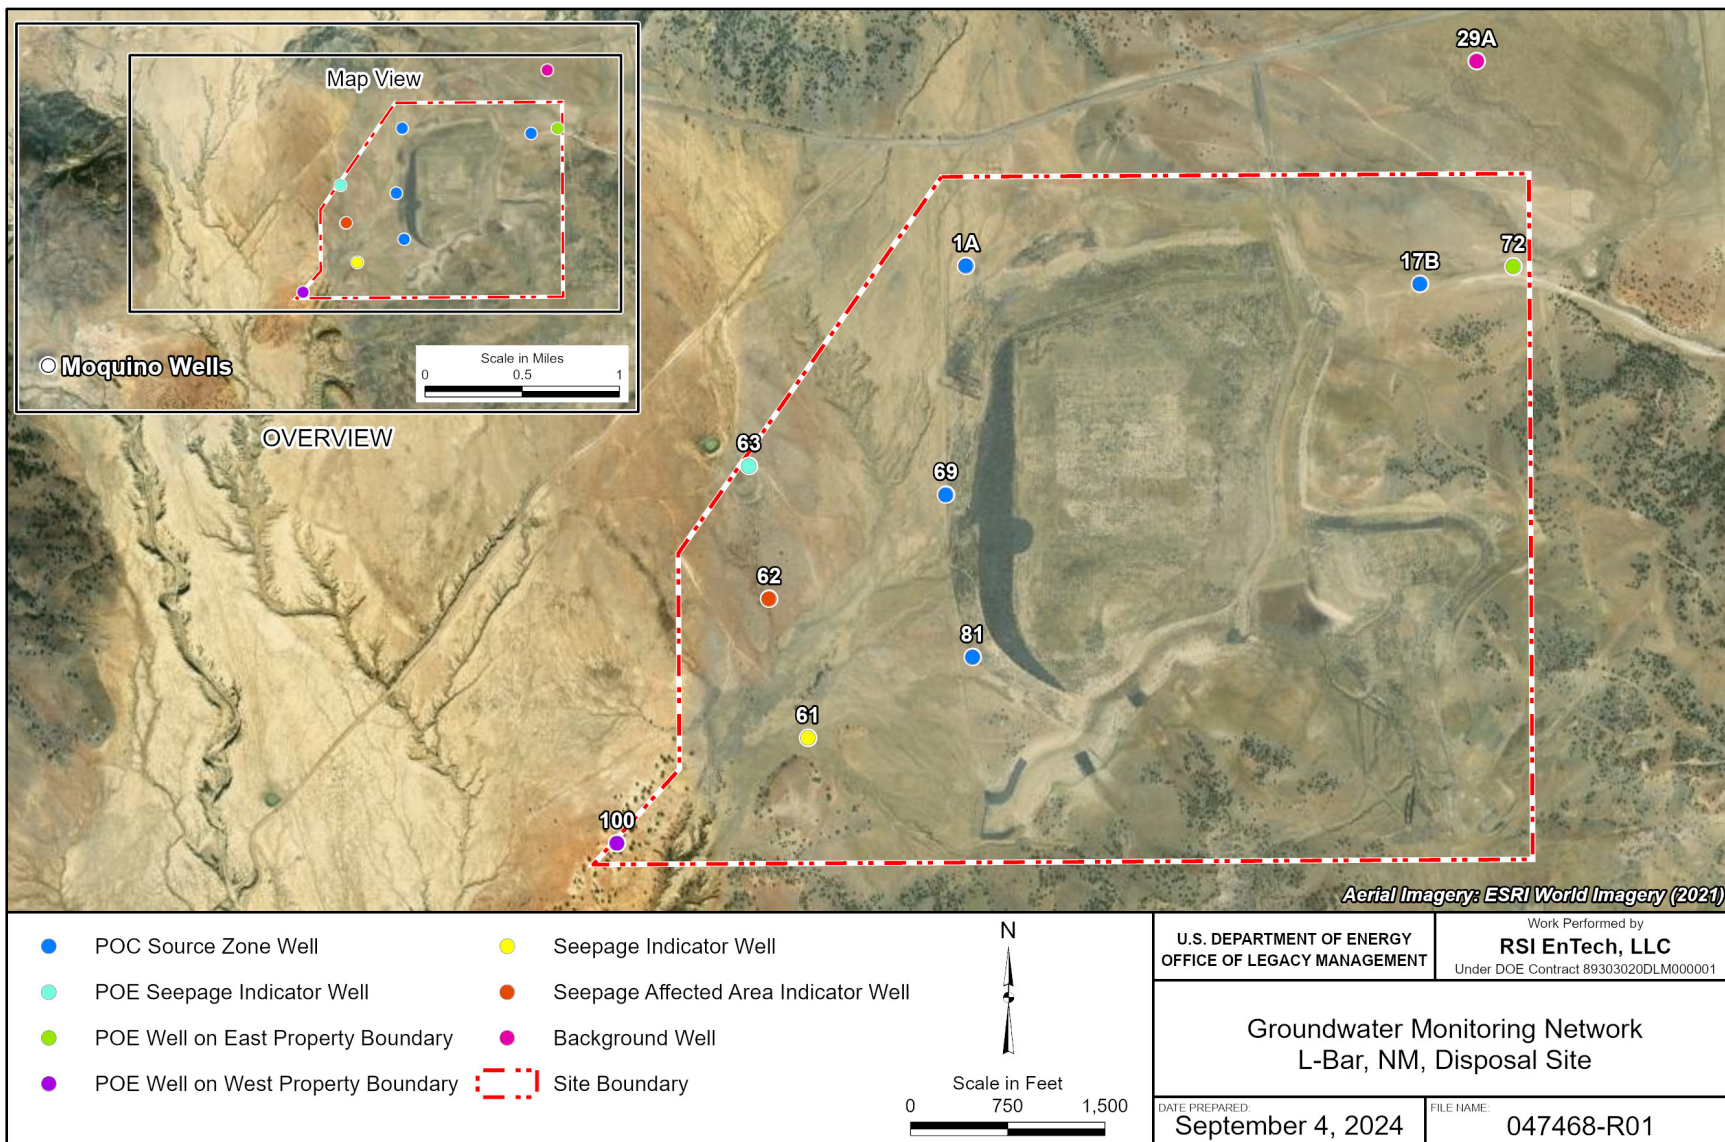
Figure 3-2. Groundwater Monitoring Network at L-Bar, New Mexico, Disposal Site

The site groundwater monitoring network consists of 10 wells (Figure 3-1; Figure 3-2). Nine of the wells are on DOE property; background monitoring well 29A is outside the northeast property boundary of the site. The wellhead protectors observed during the 2024 inspection were undamaged and locked. The concrete pad for well 63 was observed to be severely cracked. It was repaired during the 2024 spring maintenance trip (PL-9). Erosion is propagating upstream near monitoring well 62 and will continue to be monitored to ensure that erosion does not impact the integrity of the well. No additional maintenance needs were identified.

Corresponding locations are shown in Figure 3-2. All monitoring wells are screened within the First Tres Hermanos Sandstone, which is the uppermost permeable unit within the Mancos Shale beneath the site.

Samples collected during the last routine (November 2022) sampling event were analyzed for chloride, nitrate, selenium, sulfate, TDS, and uranium. The same suite of constituents was also analyzed in samples collected from the three easternmost monitoring locations—point of compliance (POC) well 17B, POE well 72, and background well 29A—during the November 2023 nonroutine event. Analytical results are measured in milligrams per liter (mg/L) and compared to the LTSP-required concentration limits listed in Table 3-3 that consist of ACLs granted by NRC and AASs stipulated by NMED. By definition, ACLs are applied to the four POC wells (1A, 17B, 69, and 81) shown in Figure 3-2; these wells also constitute the source zone wells.

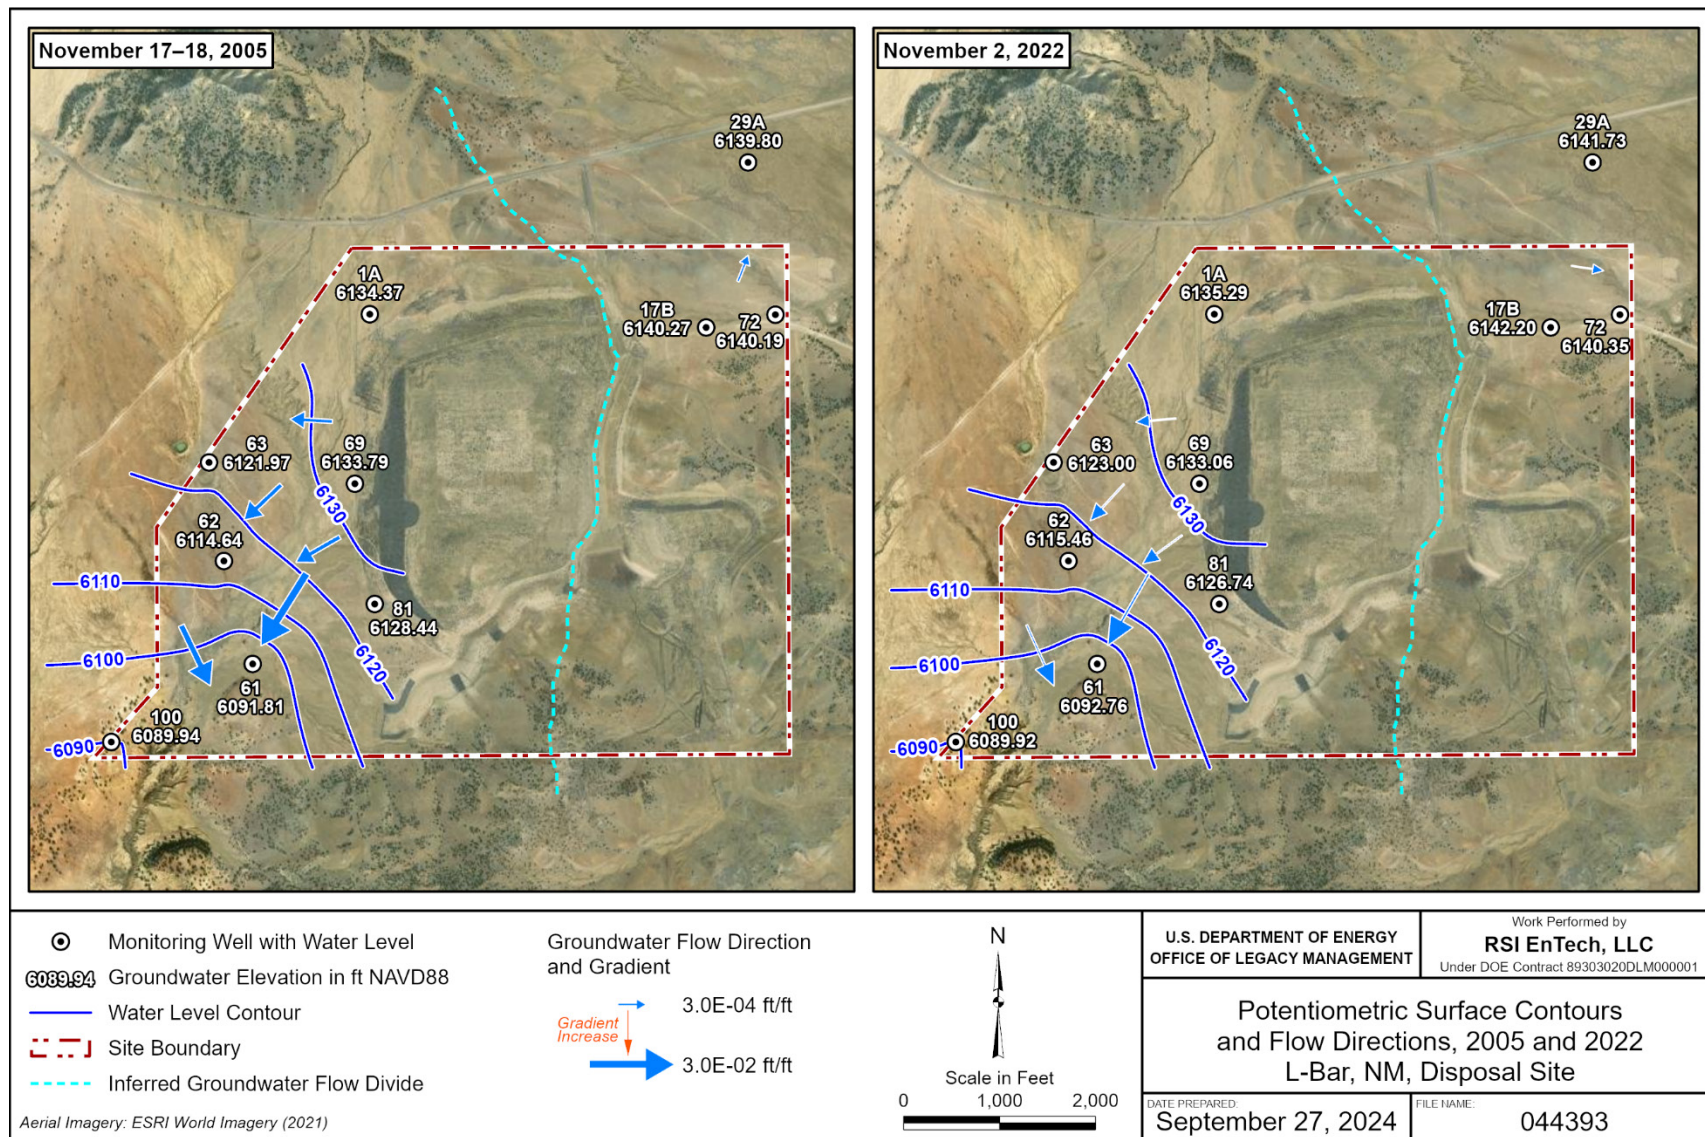
Figure 3-3. Potentiometric Contours and Groundwater Flow Directions in the First Tres Hermanos Sandstone in 2005 and 2022

Previous groundwater-level elevation evaluations for the L-Bar site (Kennecott 1996) showed that groundwater generally flowed to the southwest on the western side of the former tailings impoundment. Three-point vector analysis using 2005 and 2022 water-level elevations show that groundwater still generally flows to the southwest on the western side of the disposal cell, which was constructed over the former tailings impoundment (Figure 3-3).

On the eastern side of the disposal cell, one three-point vector was calculated using the only three wells at this location: wells 72, 17B, and 29A. The three-point vector at this location shows groundwater generally flowing to the northeast. The 180-degree difference in horizontal flow direction between wells on opposite sides of the disposal cell suggests the presence of a groundwater divide somewhere between the two groups of wells (Figure 3-3). Horizontal hydraulic gradients at the site range from 3.0×10^{-4} ft/ft relative to up to 0.03 ft/ft.

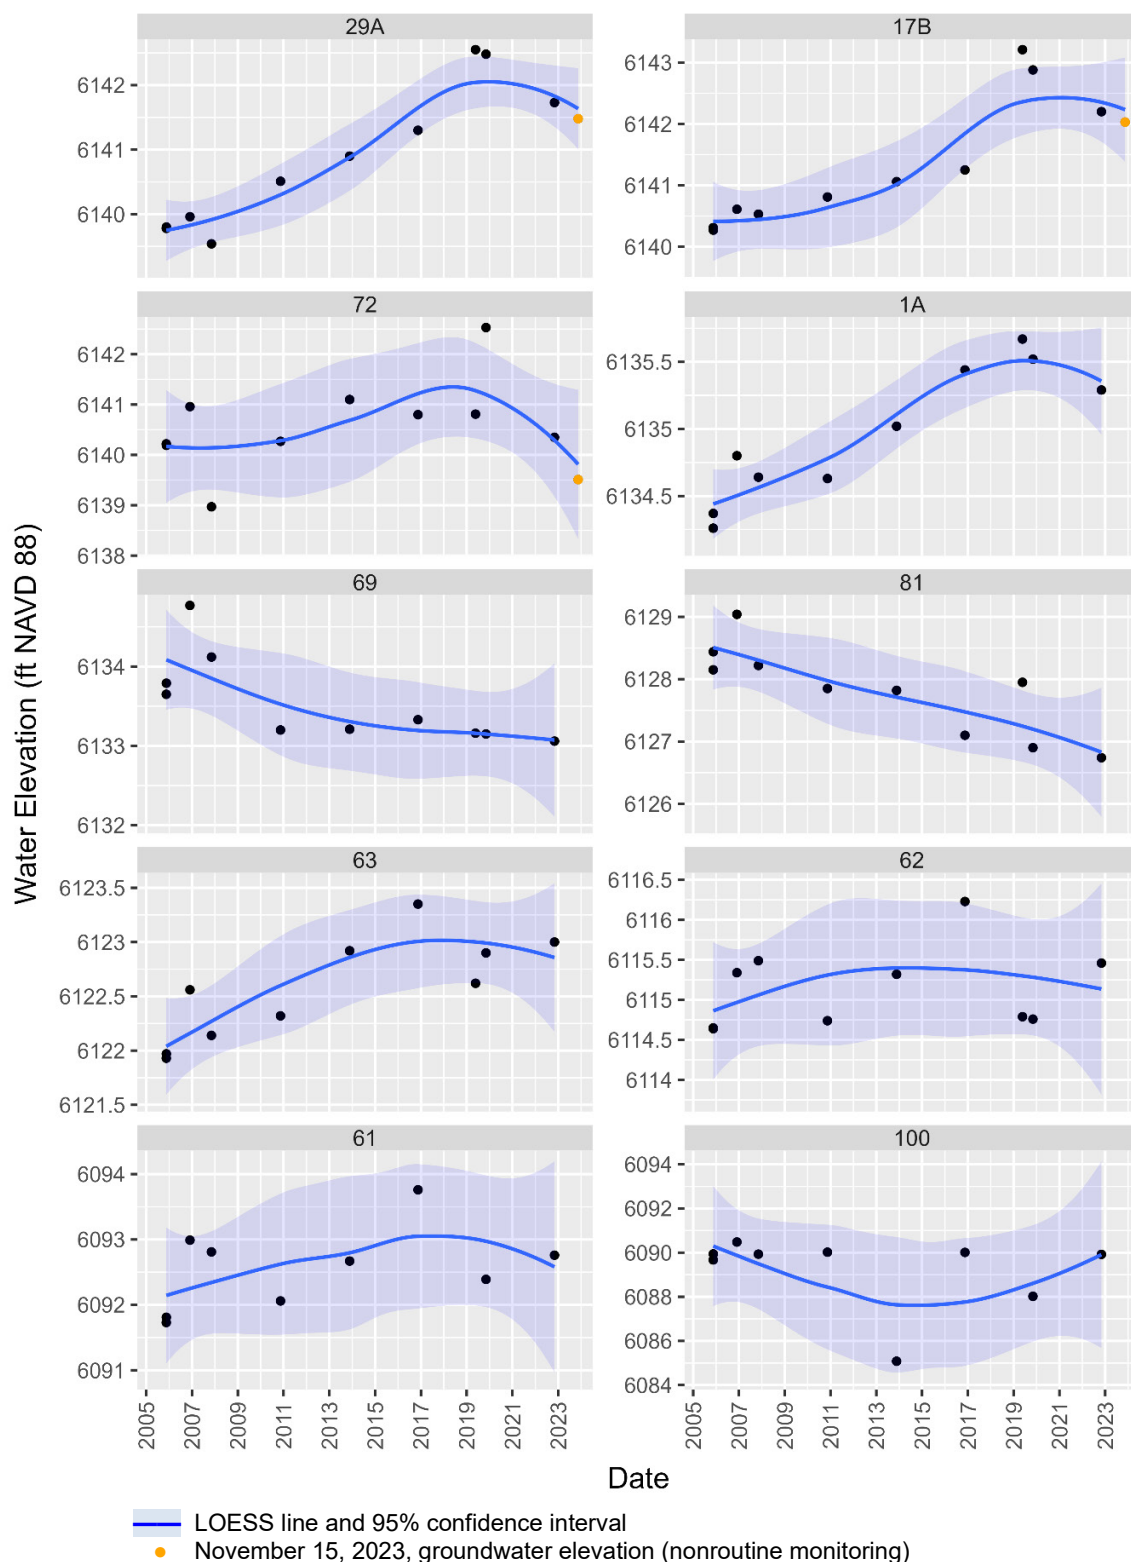
Figure 3-4. Groundwater Elevation Trends in L-Bar Monitoring Wells, 2005–2023

In general, groundwater levels have been relatively stable in L-Bar site monitoring wells (Figure 3-4). Water levels increased by as much as 2 ft in wells 72, 17B, and 29A northeast of the cell from 2005 to 2019, then began decreasing after 2019. Water levels in wells 69 and 81 at the western edge of the disposal cell have decreased as much as 2 ft from 2005 to 2022. The localized groundwater elevation declines immediately downgradient from the western cell embankment indicate a potential reduction in the rate of gravity drainage of tailings fluid from the disposal cell.

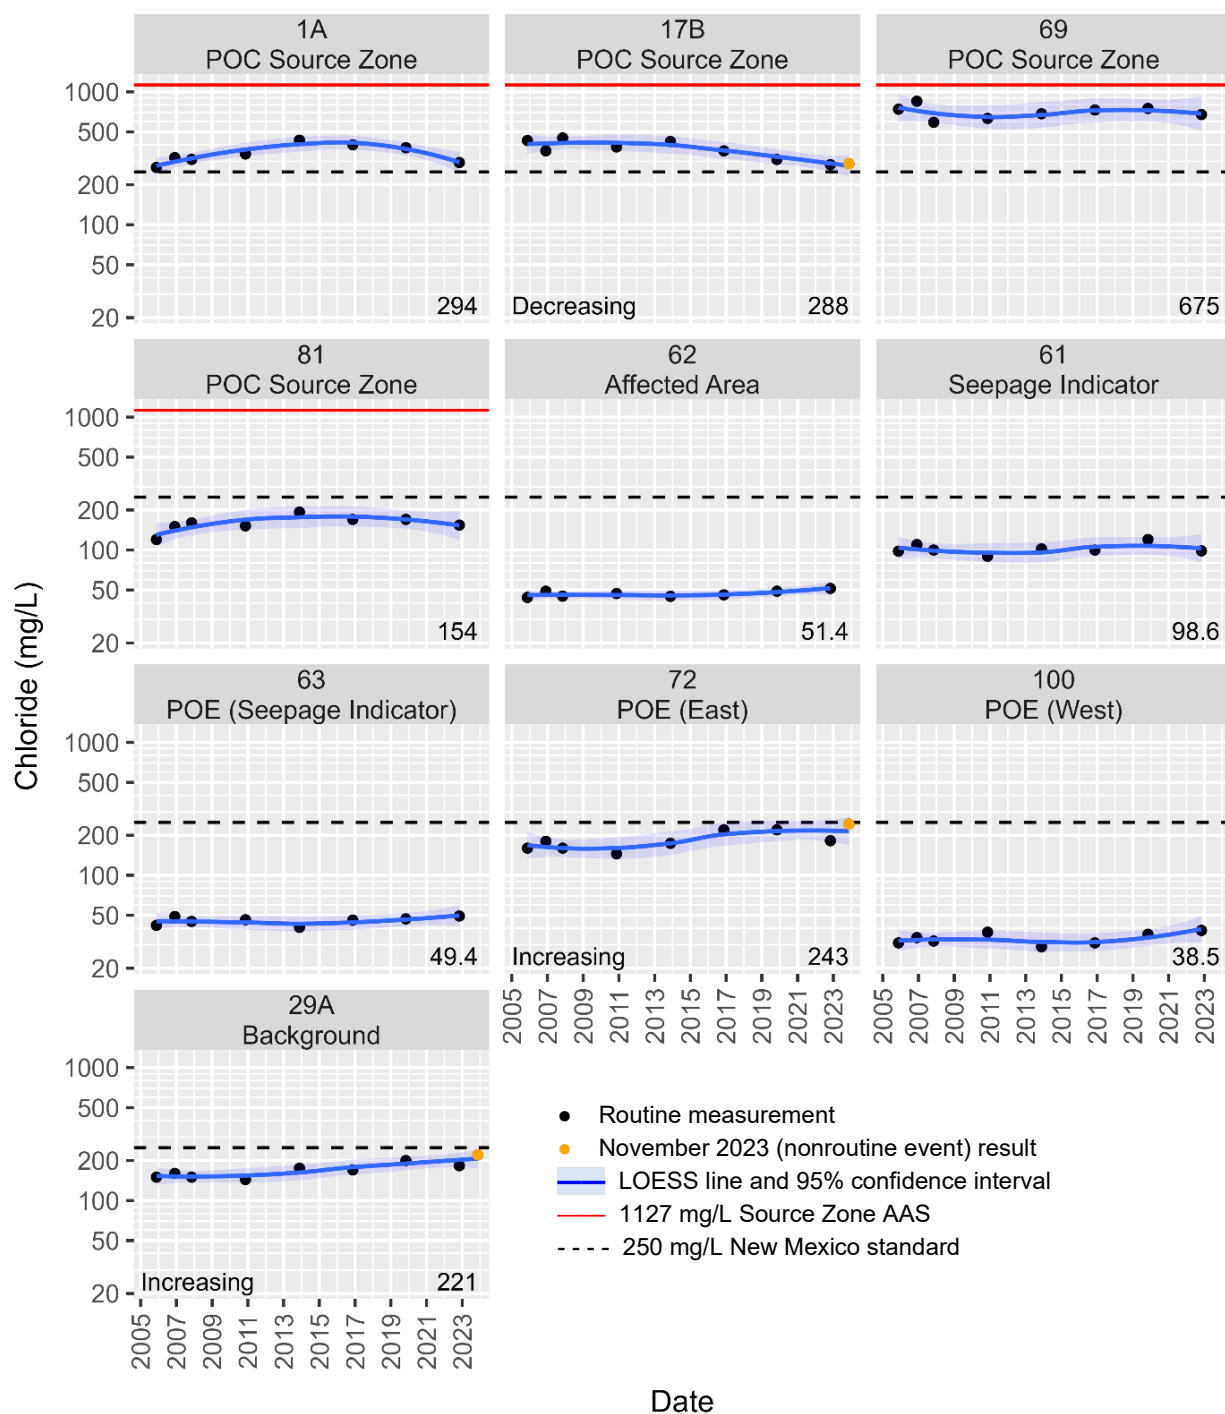
Figure 3-5. Chloride Concentrations in Groundwater at the L-Bar Disposal Site, 2005–2023

Chloride concentrations in POC source zone wells 1A, 17B, and 69 continue to exceed the 250 mg/L State of New Mexico standard but are below the corresponding 1127 mg/L AAS (Figure 3-5). The highest chloride concentrations have been measured in well 69 (590–850 mg/L). Chloride concentrations have decreased significantly in well 17B, from a maximum of 450 mg/L in 2007 to about 280–290 mg/L in 2022 and 2023, slightly exceeding the 250 mg/L standard. Chloride concentrations in the remaining wells, including the remaining POC well (81) and the three POE locations, have been consistently below the state standard. As found for background well 29A, chloride concentrations in POE well 72 have a statistically significant increasing trend and are approaching the 250 mg/L state standard. At both locations, temporal chloride concentrations have been similar (Figure 3-5) and the November 2023 result was the highest on record (221 and 243 mg/L at wells 29A and 72, respectively).

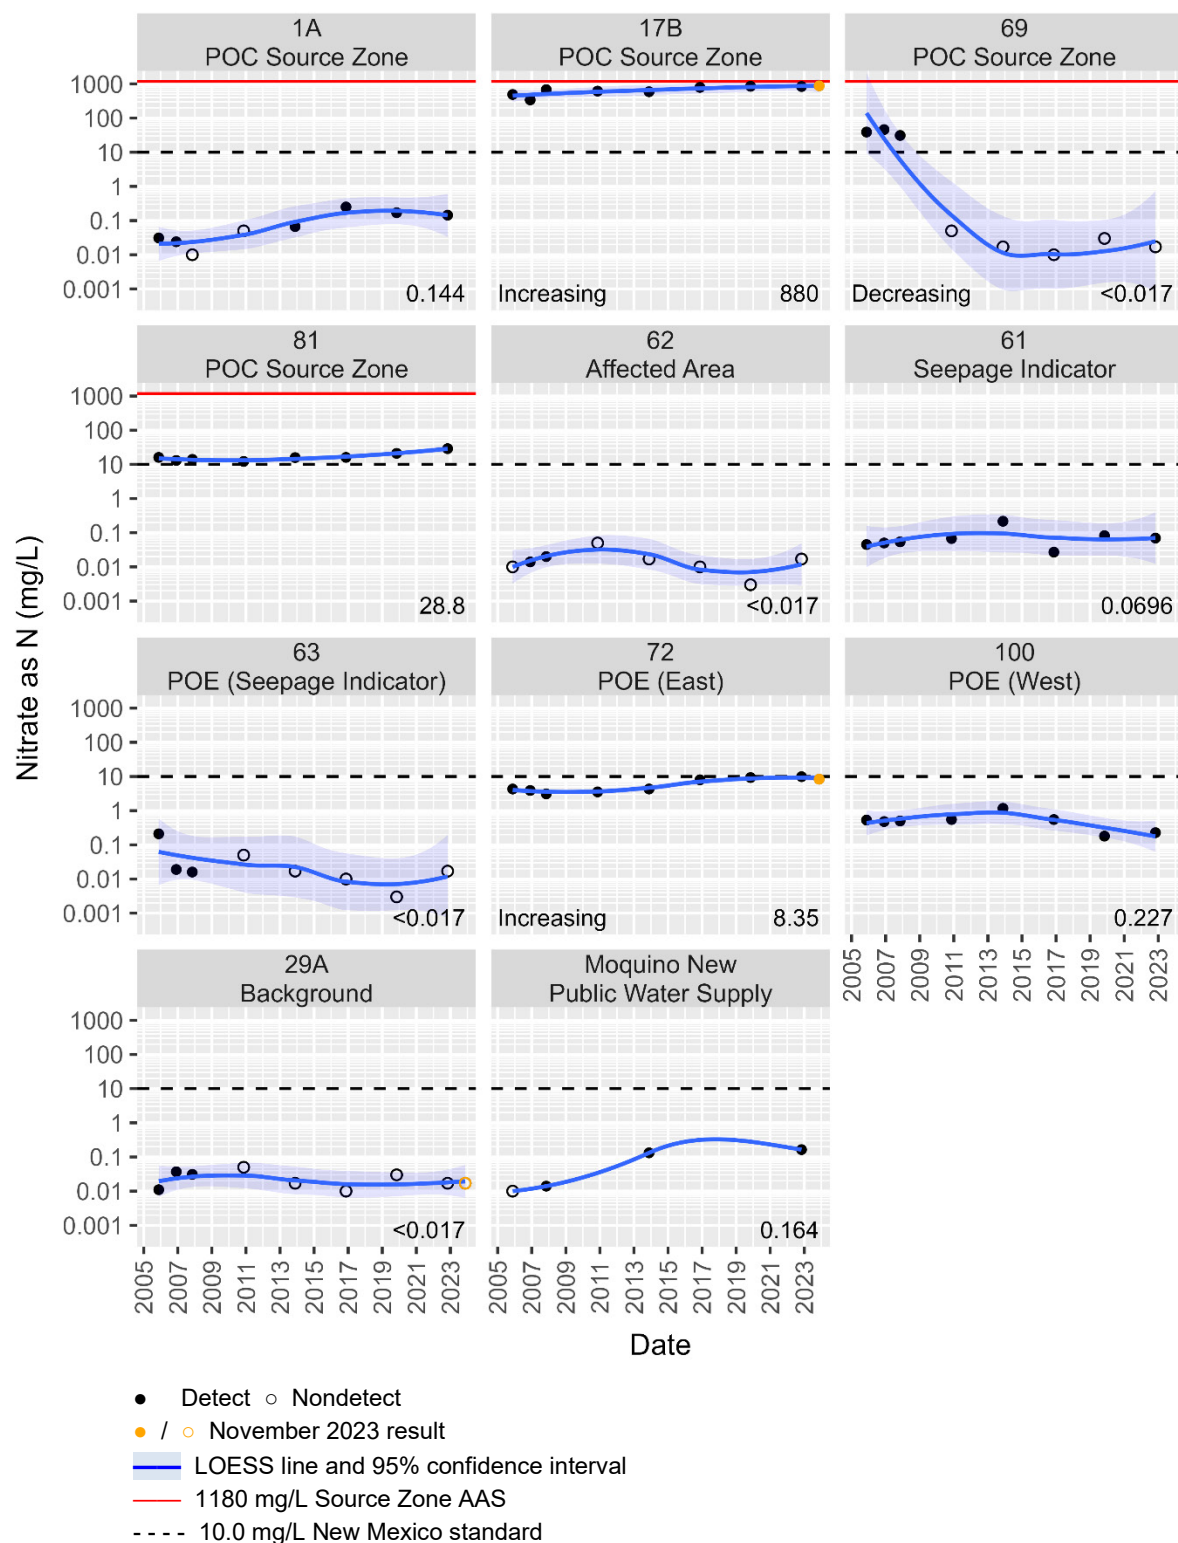
Figure 3-6. Nitrate Concentrations in Groundwater at the L-Bar Disposal Site, 2005–2023

Nitrate (+ nitrite as nitrogen [N]) concentrations have exceeded the 10.0 mg/L State of New Mexico standard in only three wells: POC zone wells 17B, 69, and 81 (Figure 3-6). The highest nitrate concentrations have been measured in well 17B (340–880 mg/L) and, based on Mann-Kendall trend analysis, have a significant increasing trend (Table 3-5). The most recent (2023) measurement (880 mg/L) is the highest on record for this well. Although below the 1180 mg/L AAS, if the increasing trend continues, the AAS could be met or potentially exceeded. Nitrate concentrations in POC source zone well 81 have remained at levels slightly exceeding the 10 mg/L standard but well below the 1180 mg/L AAS.

Nitrate concentrations are increasing in POC well 81, having more than doubled since 2010 (from 12.2 mg/L to a maximum of 28.8 mg/L in 2022), but the trend is not significant. Nitrate levels in POC source zone well 69 exceeded the 10 mg/L standard between 2005 and 2007 (31–46 mg/L), but then declined to nondetectable levels (≤ 0.05 mg/L) (Figure 3-6). In addition to POC well 17B, a statistically significant increasing trend in nitrate concentrations was also found for eastern POE well 72 (Table 3-5), where the November 2022 result (9.88 mg/L) was approximately equal to the 10.0 mg/L State of New Mexico standard. Although the most recent nonroutine (2023) measurement declined somewhat (to 8.35 mg/L), if the increasing concentration trend continues, the State of New Mexico nitrate standard will soon be exceeded.

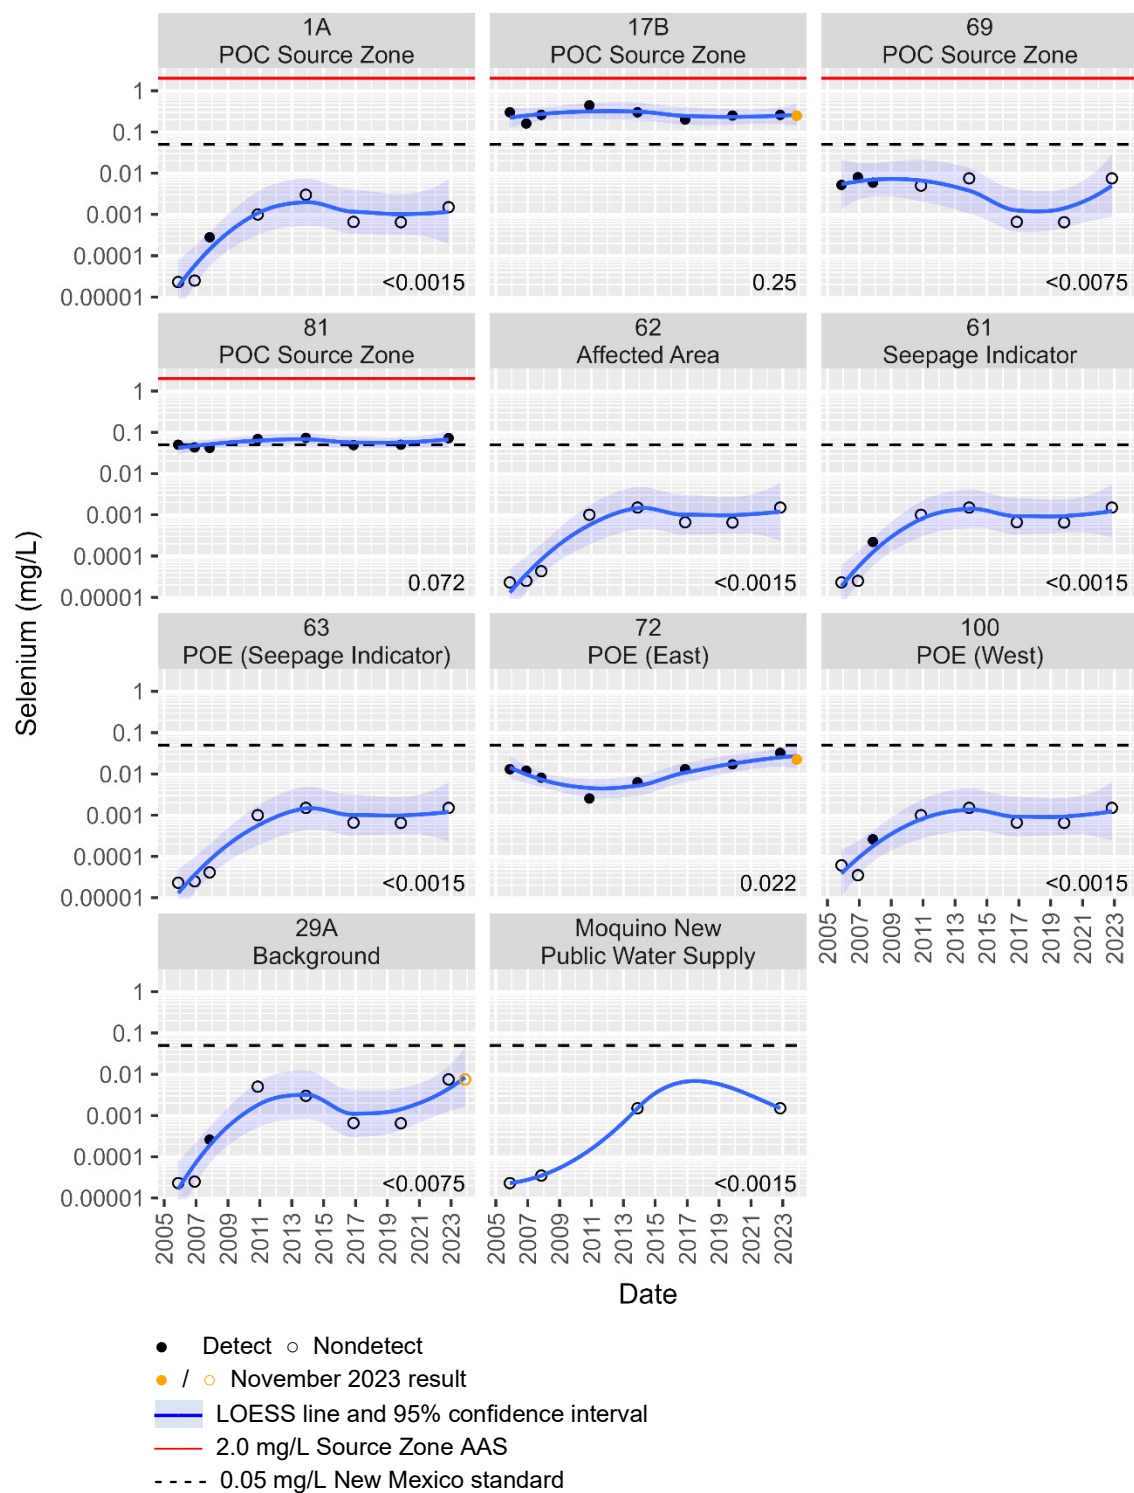
Figure 3-7. Selenium Concentrations in Groundwater at the L-Bar Disposal Site, 2005–2023

Selenium concentrations in POC source zone wells have been consistently below the corresponding 2.0 mg/L ACL and AAS (Figure 3-7). Except for POC wells 17B and 81 (0.16–0.44 and 0.042–0.073 mg/L, respectively), selenium concentrations in all site monitoring wells have also been below the 0.05 mg/L New Mexico standard. Results for most remaining wells have been below the detection limit. An exception is POE well 72, where selenium concentrations are approaching the 0.05 mg/L standard; the most recent (2023) result was 0.022 mg/L. Although concentrations in this well are trending upward (as indicated by a positive tau value), the trend (as true for all site wells) is not statistically significant (Table 3-5).

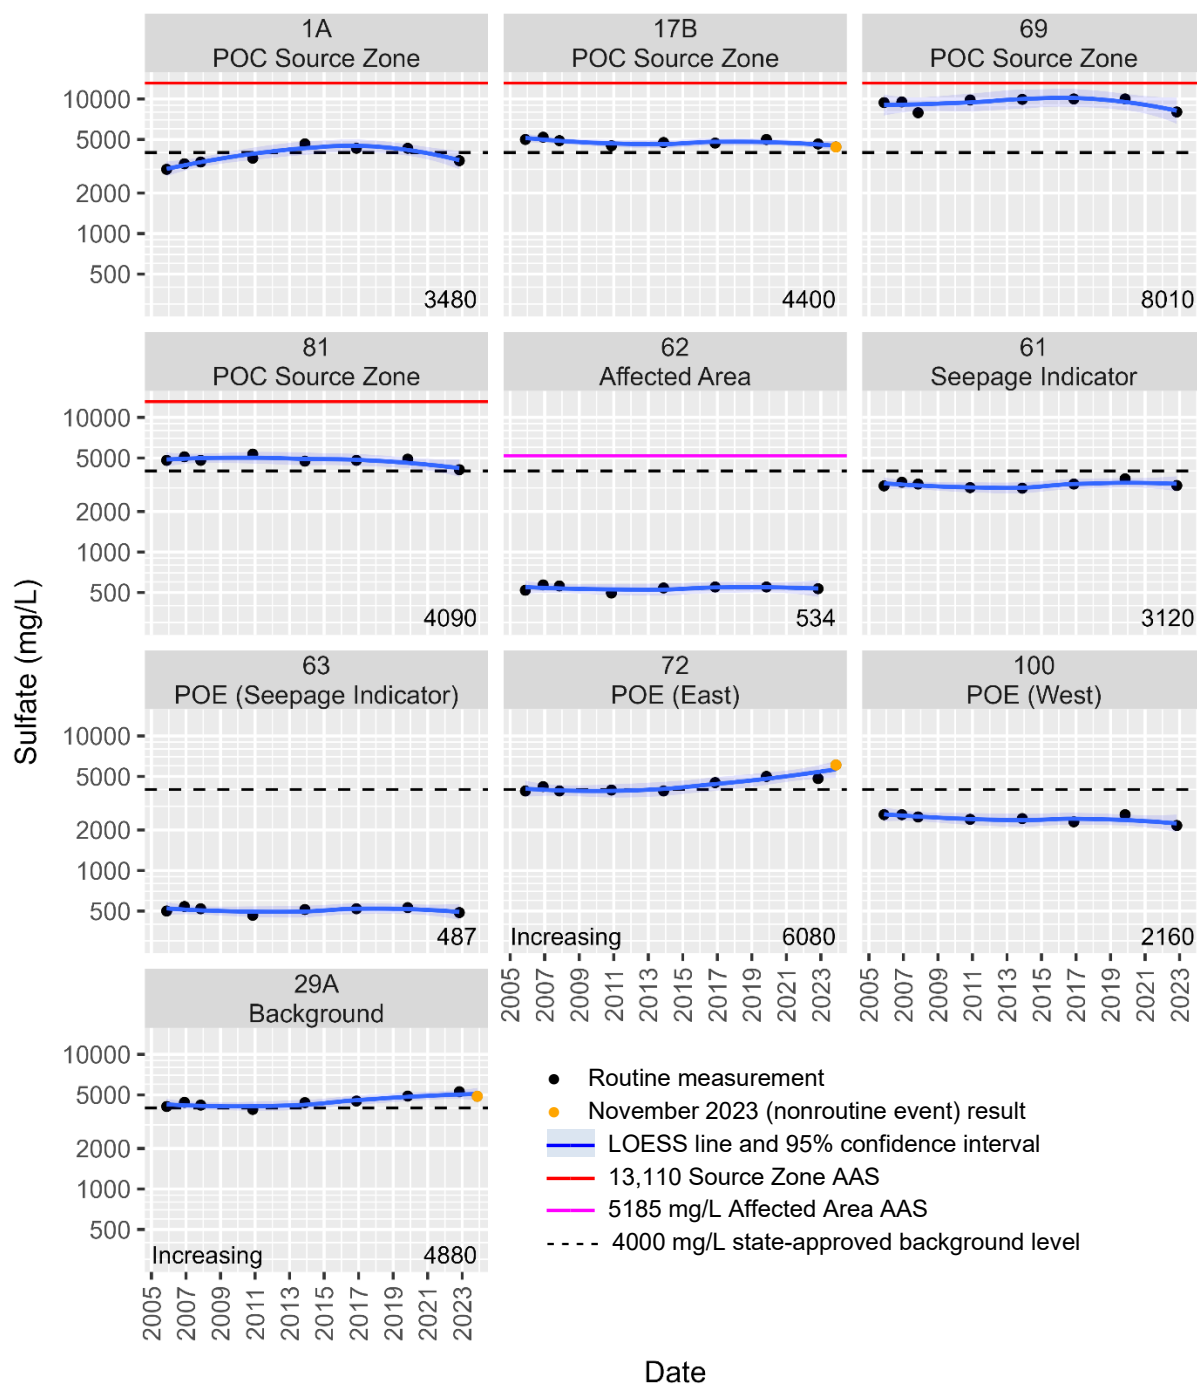
Figure 3-8. Sulfate Concentrations in Groundwater at the L-Bar Disposal Site, 2005–2023

Sulfate concentrations in the four POC source zone wells continue to be below the corresponding 13,110 mg/L AAS. The highest concentrations (7900–10,000 mg/L) have been measured in well 69. Sulfate concentrations in remaining POC source zone wells (1A, 17B, and 81) are comparable to (usually just slightly exceeding) the 4000 mg/L state-approved background level (Figure 3-8). Sulfate concentrations in AAS affected area well 62 (496–570 mg/L) have been well below the corresponding AAS of 5185 mg/L. Similar levels have been measured in POE seepage indicator well 63 (Figure 3-8). Concentrations in seepage indicator well 61 have been higher (2980–3500 mg/L) but stable (non-trending) at levels just below 4000 mg/L.

Sulfate concentrations in all wells are non-trending except for easternmost wells 72 (POE) and 29A (background). Sulfate concentrations in POE well 72 have exceeded the 4000 mg/L standard since 2016 (4500–6080 mg/L) and have a statistically significant increasing trend (Table 3-5). A significant increasing trend is also found for background well 29A, where sulfate concentrations have exceeded the state-approved background level in all but one sample, with the maximum (5280 mg/L) measured in November 2022. The most recent (nonroutine) 2023 result was 4880 mg/L, also exceeding the state-approved background level. As shown in Figure 3-8, sulfate concentrations in POE well 72 are very similar to those measured in well 29A. Both wells have concentrations now exceeding those measured in upgradient POC well 17B.

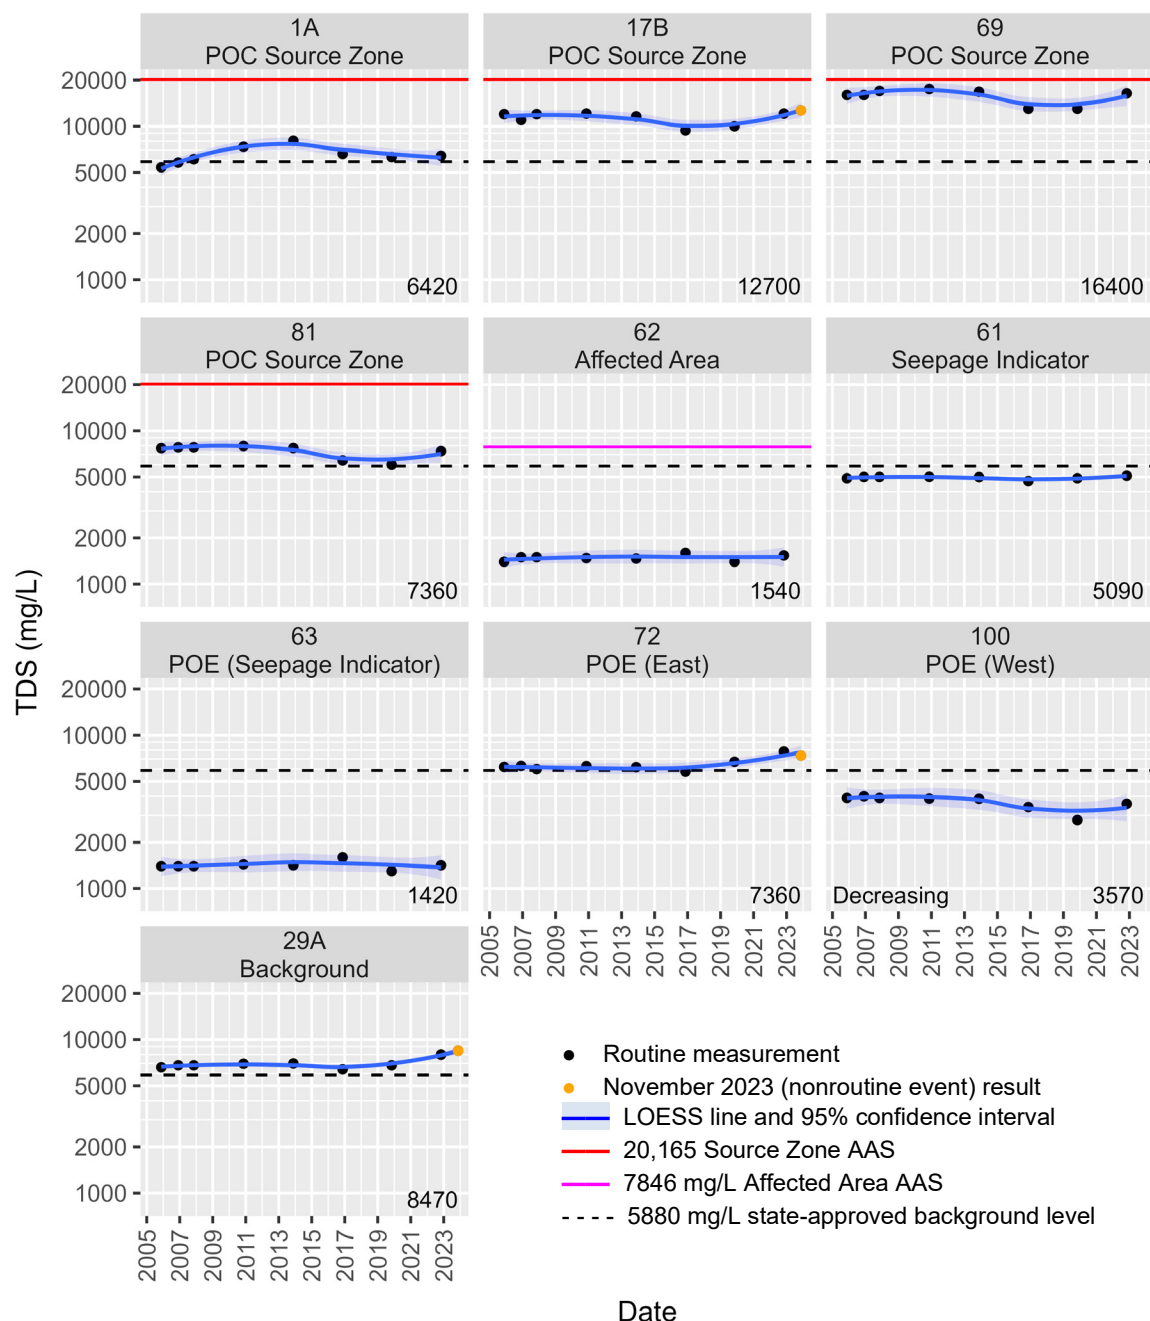
Figure 3-9. TDS Concentrations in Groundwater at the L-Bar Disposal Site, 2005–2023

General observations for TDS in L-Bar site wells are similar to those discussed above for sulfate. TDS levels in POC source zone wells have exceeded the state-approved background level of 5880 mg/L but have been below the corresponding AAS of 20,165 mg/L (Figure 3-9). TDS concentrations have been highest in POC source zone well 69 (13,000–17,500 mg/L) and lowest in affected area well 62 (1400–1600 mg/L, below the corresponding AAS of 7846 mg/L) and POE seepage indicator well 63 (1300–1600 mg/L).

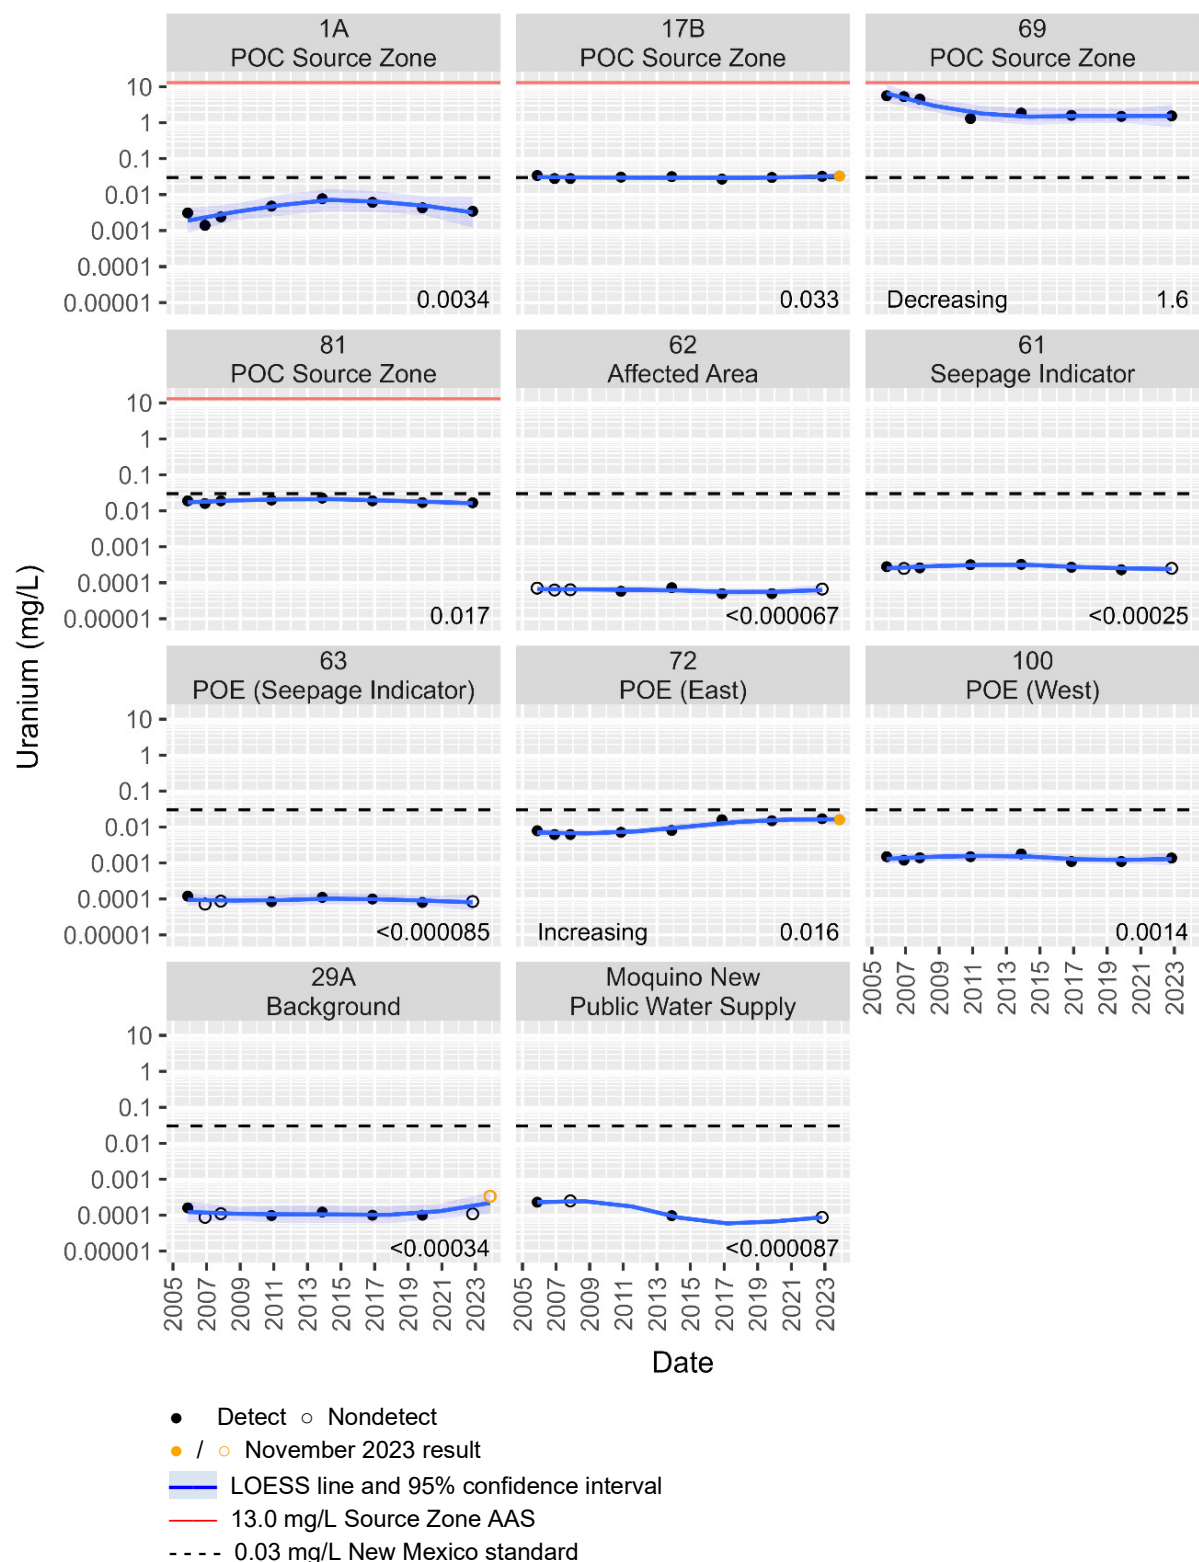
Figure 3-10. Uranium Concentrations in Groundwater at the L-Bar Disposal Site, 2005–2023

Uranium concentrations in POC wells 17B and 69 were above the 0.03 mg/L State of New Mexico standard in 2022–2023 (Figure 3-10). Historically, uranium concentrations in POC source zone well 17B have remained stable at or slightly exceeding the standard (0.027–0.034 mg/L), while concentrations in well 69 have exceeded the standard by 1 to 2 orders of magnitude (1.3–5.6 mg/L). Although Mann-Kendall trend analysis yielded a statistically significant decreasing trend for well 69 from 2005–2022 (Table 3-5), concentrations have stabilized at about 1–2 mg/L since 2010 (Figure 3-10). Uranium concentrations in all POC source zone wells continue to be below the 13.0 mg/L ACL and AAS.
