3.0 L-Bar, New Mexico, Disposal Site

3.1 Compliance Summary

The L-Bar, New Mexico, Uranium Mill Tailings Radiation Control Act (UMTRCA) Title II Disposal Site was inspected on March 20–21, 2024. Previous inspections performed in 2021, 2022, and 2023, as required by the Long-Term Surveillance Plan (DOE 2004) (LTSP), and associated follow-up site visits identified numerous surface degradation features on the disposal cell top slope. No new degradation features on the top slope were identified during the March 2024 inspection. During an Applied Studies and Technology (AS&T) investigation in September and October 2022, several piping features were discovered on the side slope of the disposal cell. These features continue to be monitored and currently do not affect the performance of the side slope. Inspectors also identified several routine maintenance needs during the March 2024 inspection.

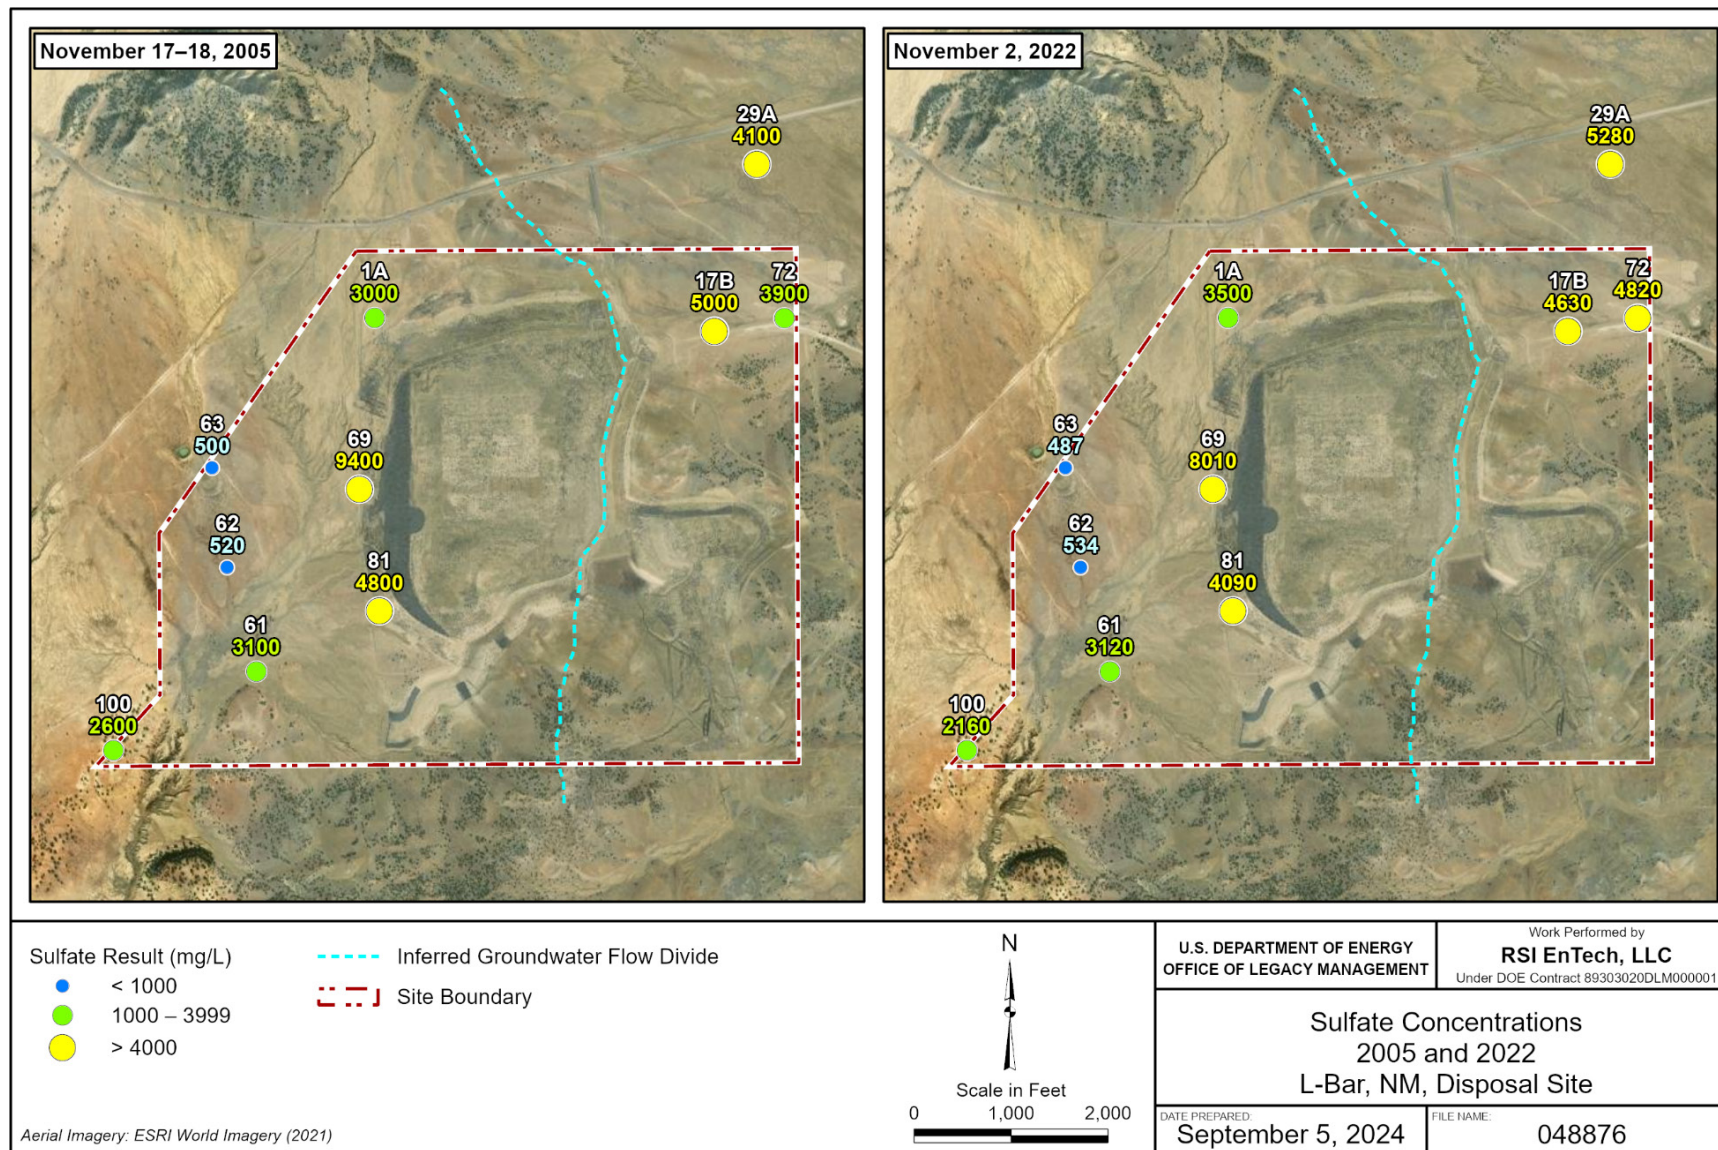
Figure 3-11. Sulfate Concentrations in 2005 and 2022, L-Bar Site Monitoring Wells

Figure 3-11 was developed to satisfy a requirement in Section 3.7.1 of the LTSP, which states that annual inspection reports are to include a groundwater level contour map (provided in Figure 3-3) and a sulfate isoconcentration map for the years that sampling has been conducted (DOE 2004). As discussed in previous annual reports (DOE 2023), bubble plot maps for sulfate were generated in lieu of isoconcentration maps because of the limited number of well locations. No water quality measurements have been taken directly beneath the tailings impoundment, so interpolated isoconcentrations would likely not be representative of site conditions.

Notes: Because wells are monitored triennially (last routine sampling conducted in 2022), this figure duplicates that presented in the previous annual report (DOE 2023). For the three wells sampled in November 2023 (nonroutine event), sulfate results were as follows: 4400 mg/L at well 17B, 6080 mg/L at well 72 (duplicate result of 5060 mg/L), and 4880 mg/L at offsite background well 29A.

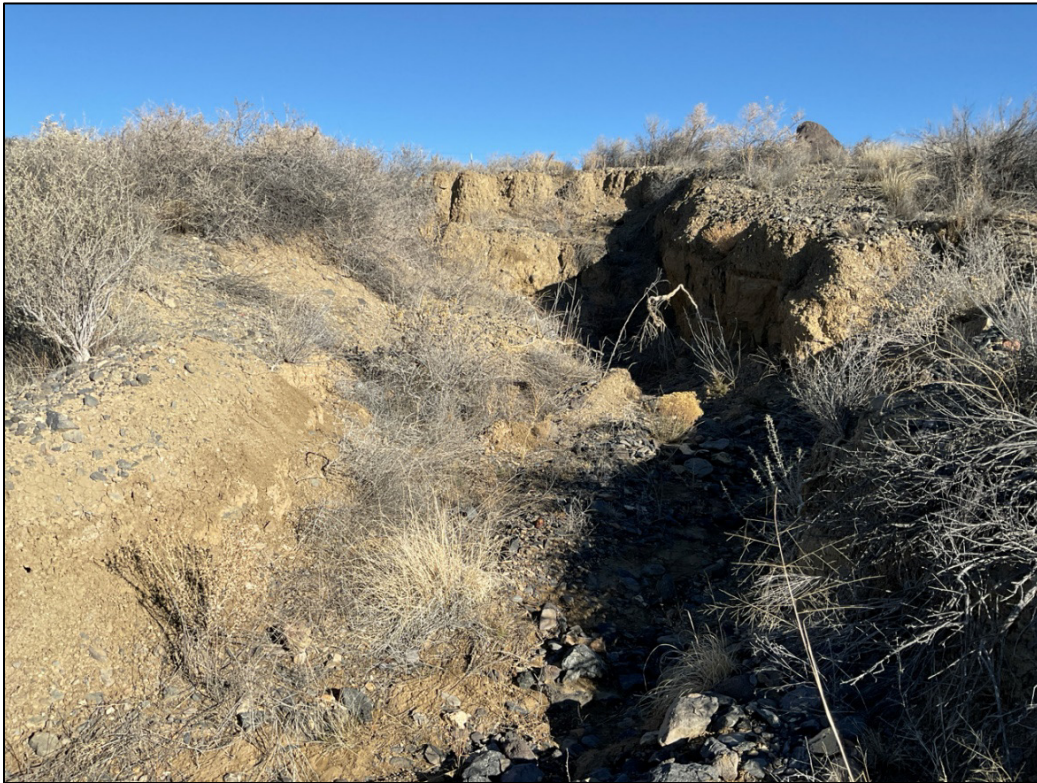
PL-5. Erosion near Fence Line

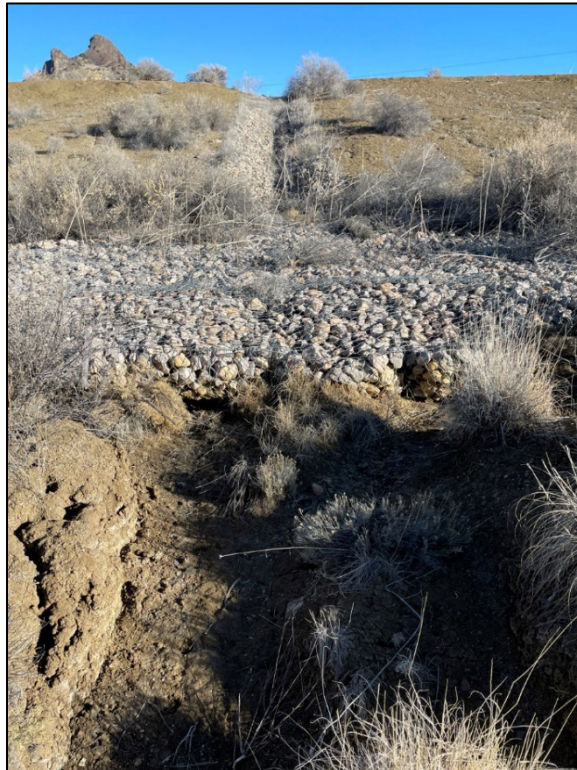
Since the completion of site reclamation, multiple high-intensity storms have caused deep gullies to form in the highly erodible soils and fill materials upgradient of the sediment trap. Construction of runoff control structures to reduce the rate of erosion in the area and prevent headward migration of gullies into adjoining private property was completed in December 2009. Runoff from a storm event in September 2011 overtopped an earthen runoff control berm of Runoff Control Structure A and caused substantial damage to the berm. Subsequent runoff events have caused erosion adjacent to gabion drop structures associated with Runoff Control Structure A near Runoff Control Structure D. Because of continued excessive erosion, an interagency agreement was established with USACE to repair these structures and construct additional structures in the watershed. Runoff water from the area north of the disposal cell is captured by the north channel. The water is diverted away from the site to the west. Deep gullies had formed in the alluvium and weathered shale along a portion of the north bank of the channel, and headward erosion was rapidly migrating to the north toward the site access road and property boundary. The eroded channel bank was restored to the original design configuration, and two runoff control structures were constructed in 2009 to reduce erosion and sedimentation. Runoff Control Structure F is showing signs of undermining erosion but was stable and functional at the time of the inspection (PL-13). However, Runoff Control Structure G suffered severe erosion during runoff events in August and September 2011 and continues to erode (PL-14). Runoff Control Structure A is experiencing gully erosion (PL-15) and undermining at portions of the gabion block sections (PL-16), and it is likely that continued erosion will lead to failure of the structure. DOE will continue to monitor these structures and, as part of the interagency agreement, USACE will complete a design for repairs and modifications to these structures.

PL-13. Runoff Control Structure F

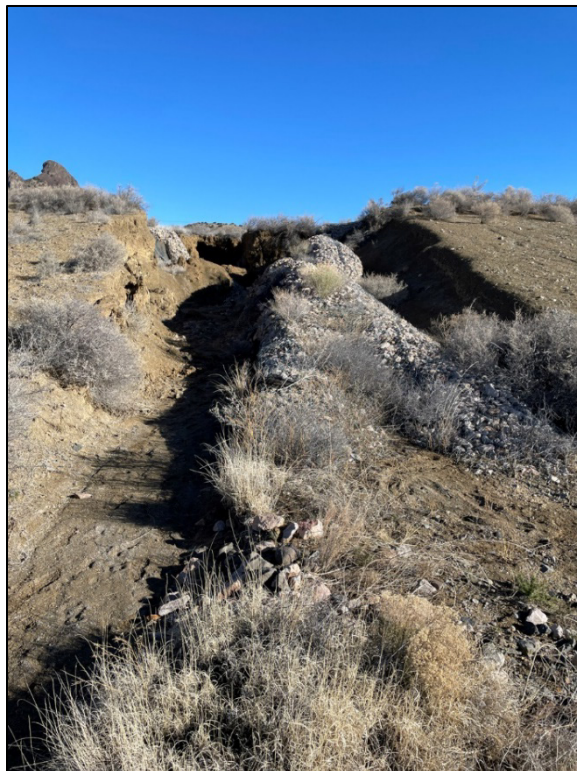
PL-14. Runoff Control Structure G

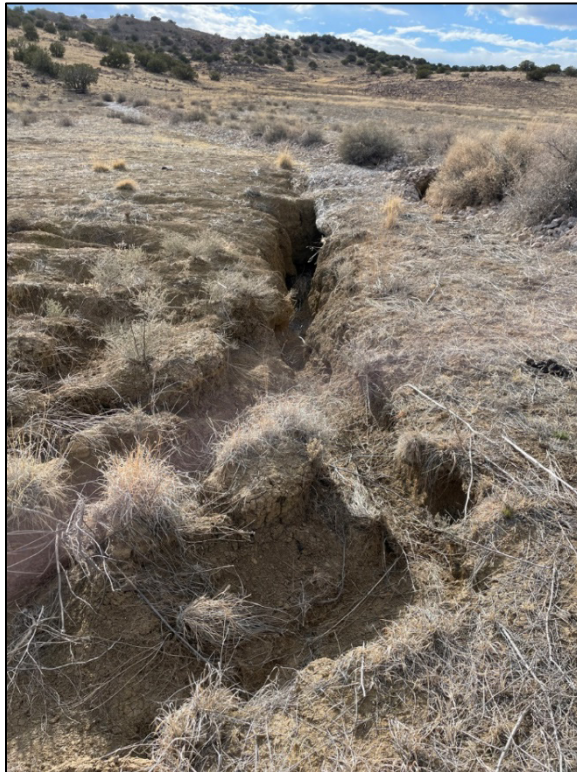
PL-15. Erosion near Runoff Control Structure A

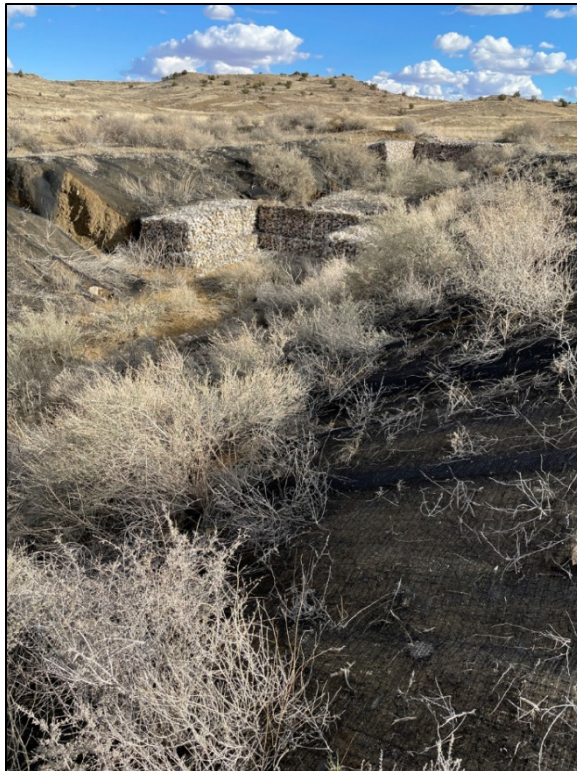
PL-16. Runoff Control Structure A
