6.0 Shirley Basin South, Wyoming, Disposal Site

The Shirley Basin South, Wyoming, Uranium Mill Tailings Radiation Control Act (UMTRCA) Title II Disposal Site was inspected on July 25, 2024. No significant changes were observed on the disposal cell or in associated drainage features. Inspectors identified routine maintenance needs but found no cause for a follow-up inspection.

Figure 6-1. 2024 Annual Inspection Drawing for the Shirley Basin South, Wyoming, Disposal Site

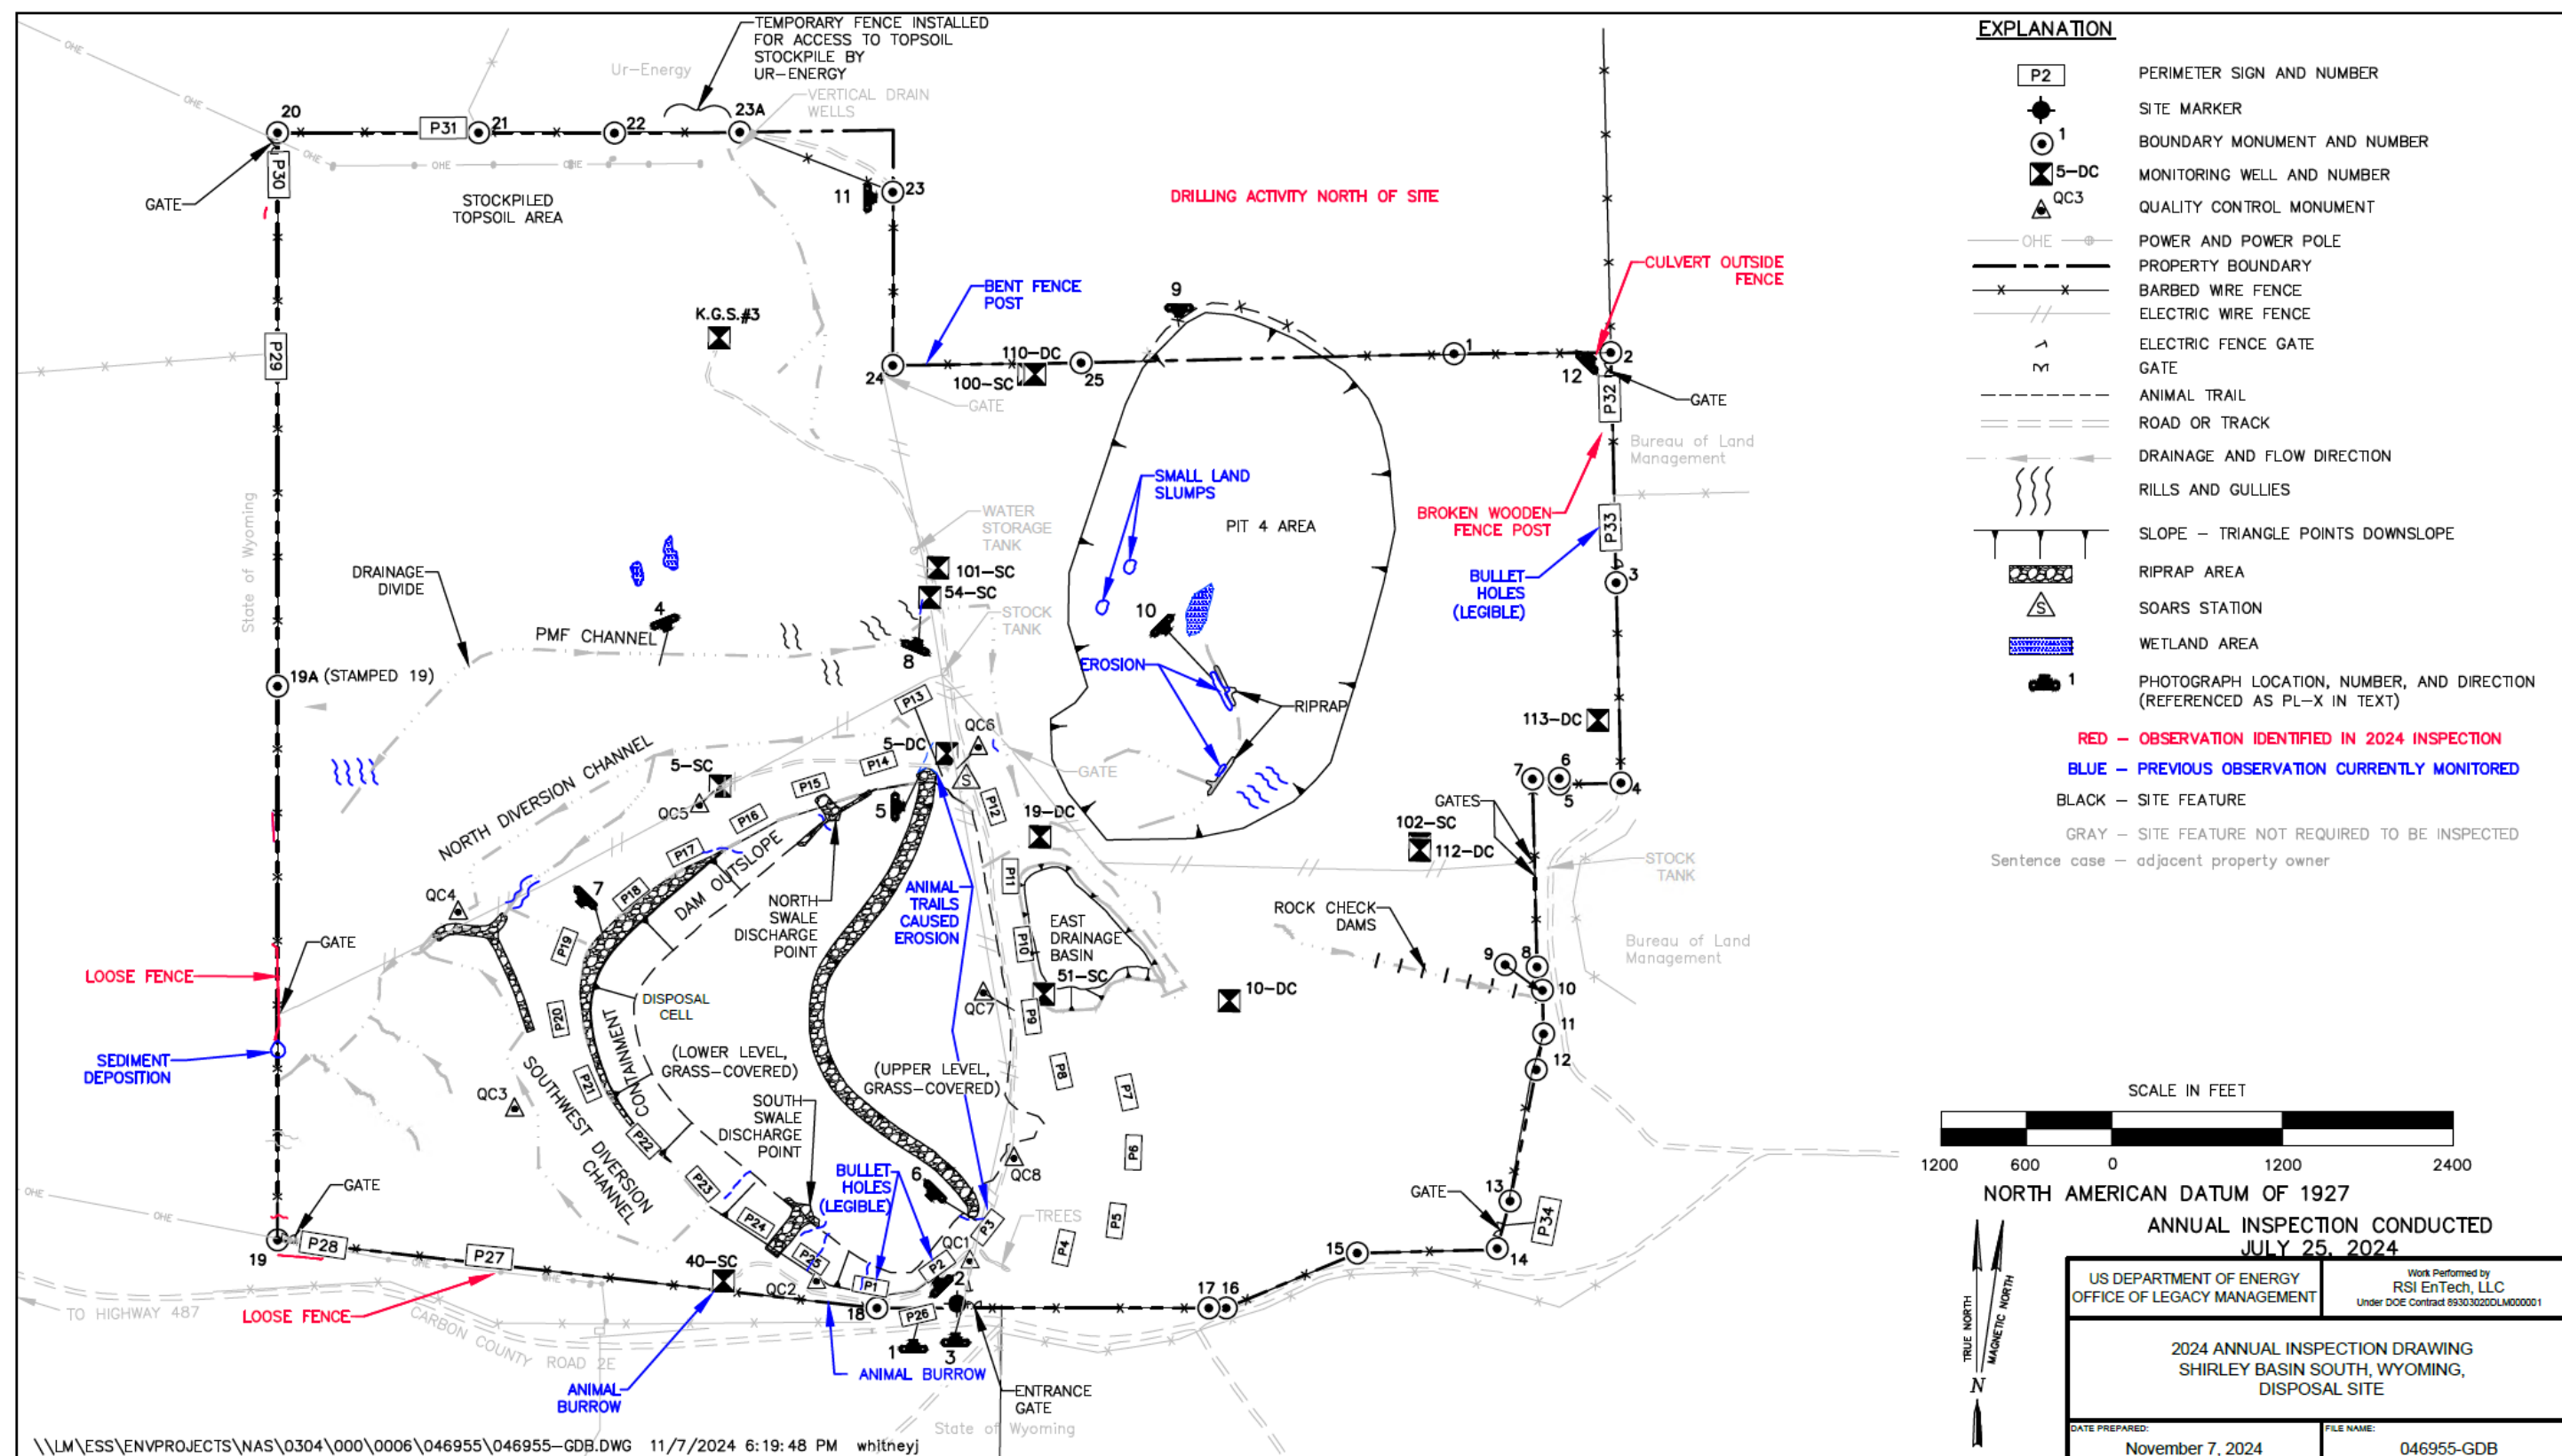
Figure 6-1 shows the locations of site features, including site surveillance features and inspection areas, in black and gray font. Site features that are present but not required to be inspected are shown in gray font. Observations from previous inspections that are currently monitored are shown in blue, and new observations identified during the 2024 annual inspection are shown in red. Inspection results and recommended maintenance activities associated with site surveillance features are described in the following subsections. Photographs to support specific observations are noted in the text and in Figure 6-1 by photograph location (PL) numbers. The photographs and photograph log are presented in Section 6.9.

An arroyo formed beneath the fence on the southern portion of the west boundary in 2023. The arroyo formed in line with the fence, damaging several sections. Sediment from the erosional event was deposited below the slope break. The damaged fence was removed and the perimeter fence was realigned approximately 30 feet east and away from the arroyo in October 2023. The new fence has slacked and needs maintenance to stabilize. No other maintenance needs were identified.

In July 2019, eight permanent aerial survey quality control monuments were installed at the site for an aerial survey of the disposal cell. The quality control monument locations are shown in Figure 6-1. Concrete is spalling around quality control monument QC-8, but it is still functioning as intended. No maintenance needs were identified.

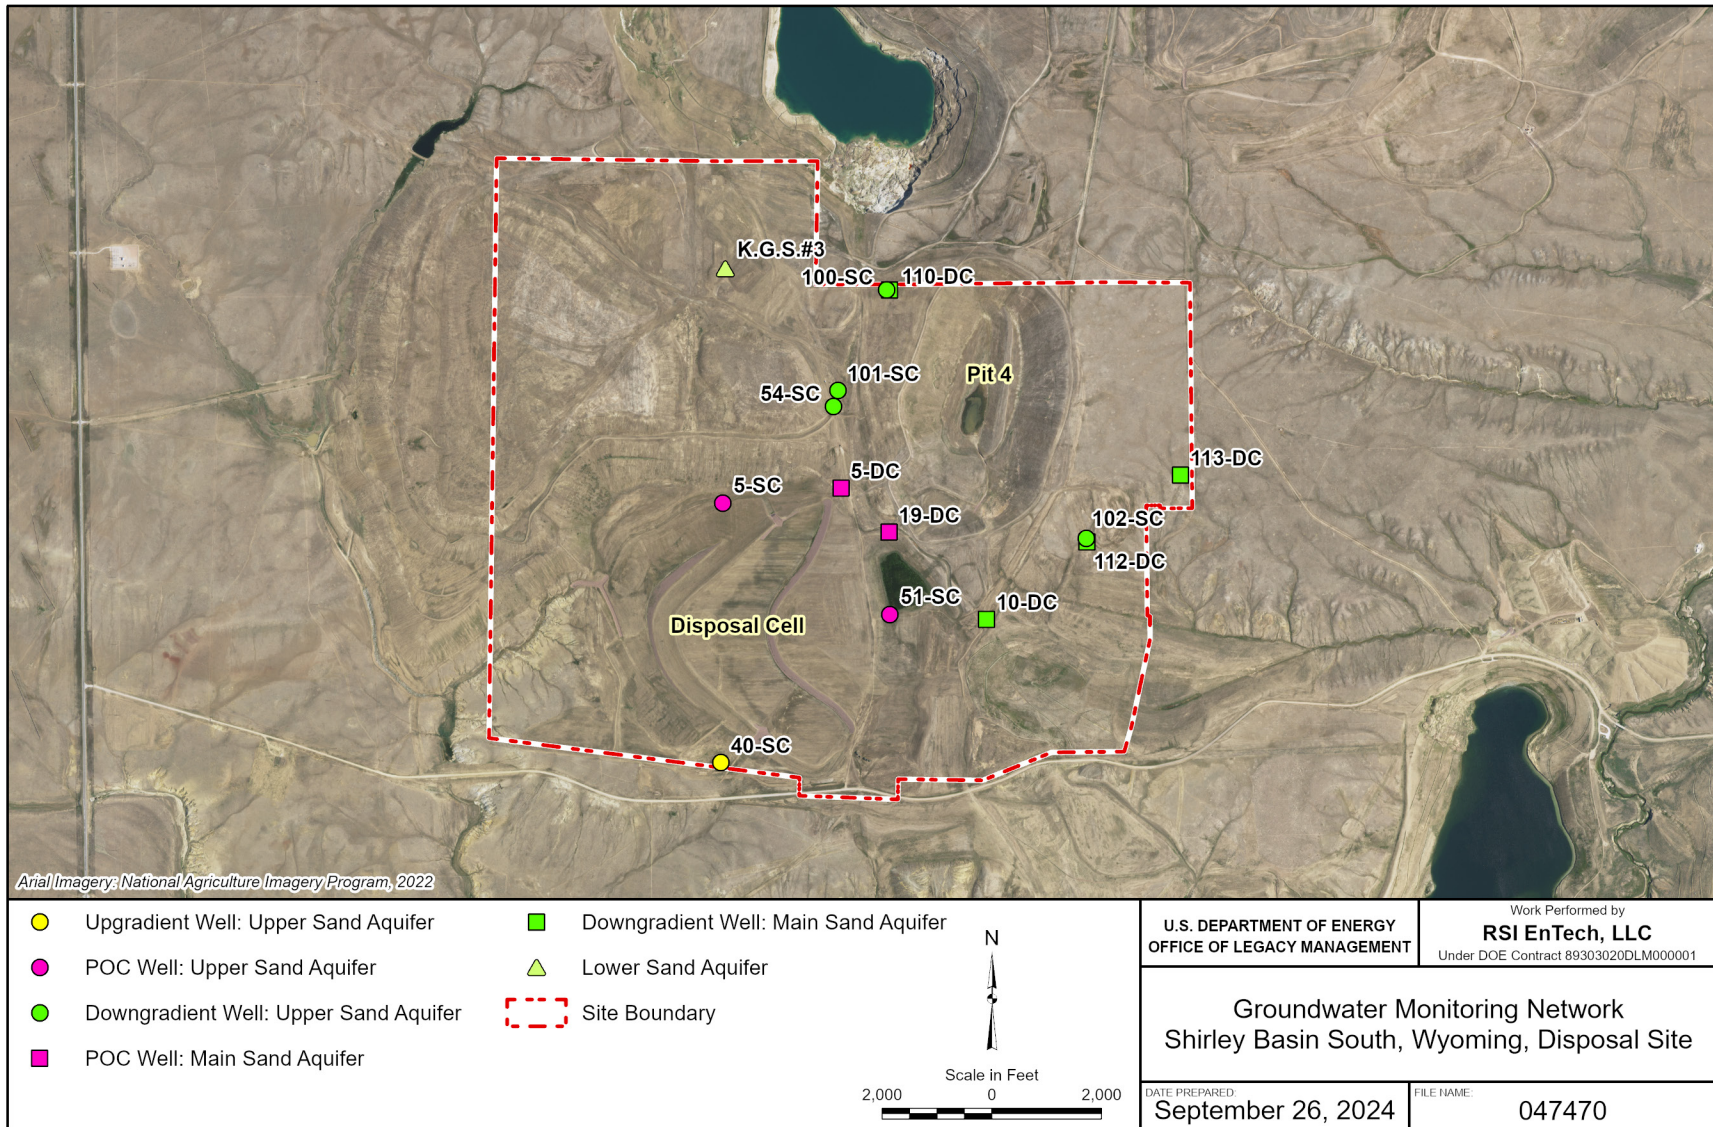
Figure 6-2. Groundwater Monitoring Network at Shirley Basin South, Wyoming, Disposal Site

The current monitoring network is described in Table 6-2 and shown in Figure 6-2. Although no monitoring wells are designated as points of exposure, groundwater chemistry at downgradient wells 100-SC, 102-SC, 110-DC, and 113-DC represents groundwater quality for groundwater flowing offsite in the Upper Sand and Main Sand Aquifers.

Monitoring well 54-SC is screened across the Upper Sand and Main Sand Aquifers. In 2010, DOE submitted a request to decommission the well, stating that it represented a conduit for potential contamination migration between the Upper Sand and Main Sand Aquifers. DOE withdrew this request in 2011 based on a determination that, although difficult to discern the exact unit the screen is located within, groundwater elevations and updated hydrogeological evaluations indicated that well 54-SC is most likely screened in the Upper Sand Aquifer (Surovchak 2011).

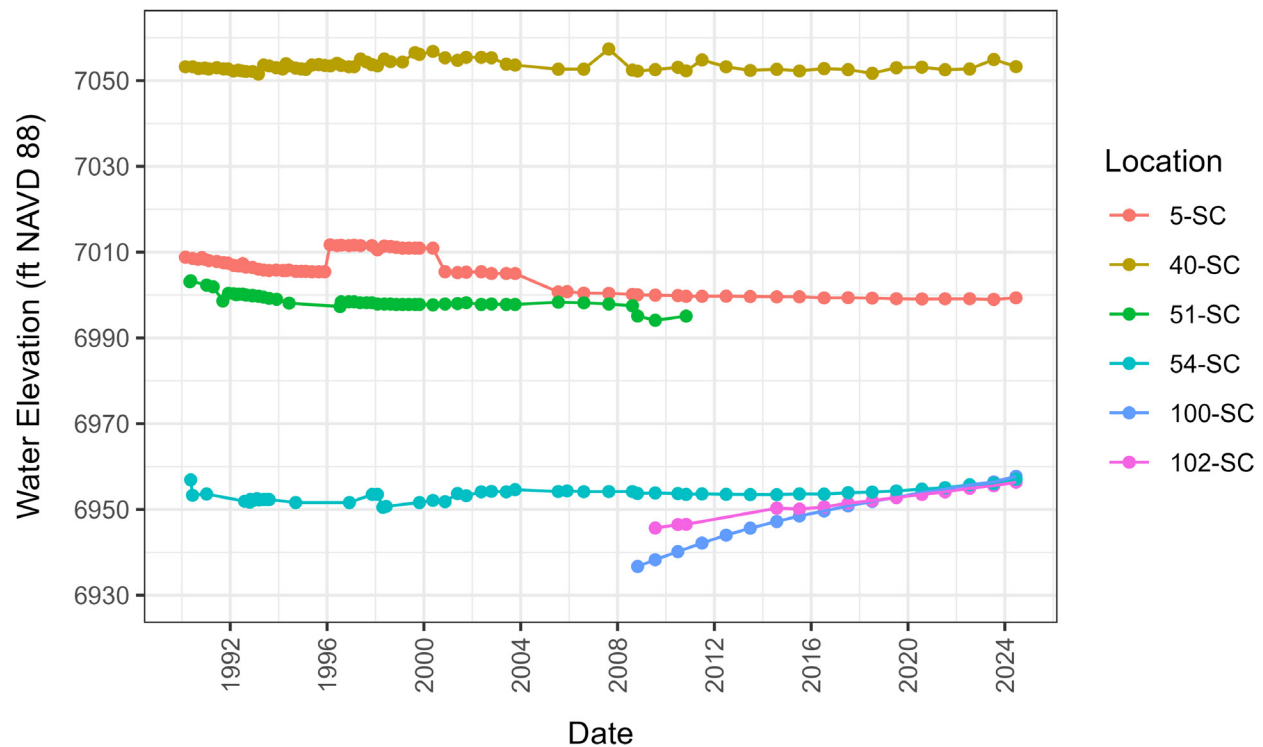
Figure 6-4. Hydrographs for Upper Sand Aquifer Wells at the Shirley Basin South, Wyoming, Disposal Site, 1990–2024

The site map showing 2024 groundwater level elevations for the Upper Sand Aquifer wells is provided in Figure 6-3. Corresponding water elevations over time are plotted in Figure 6-4.

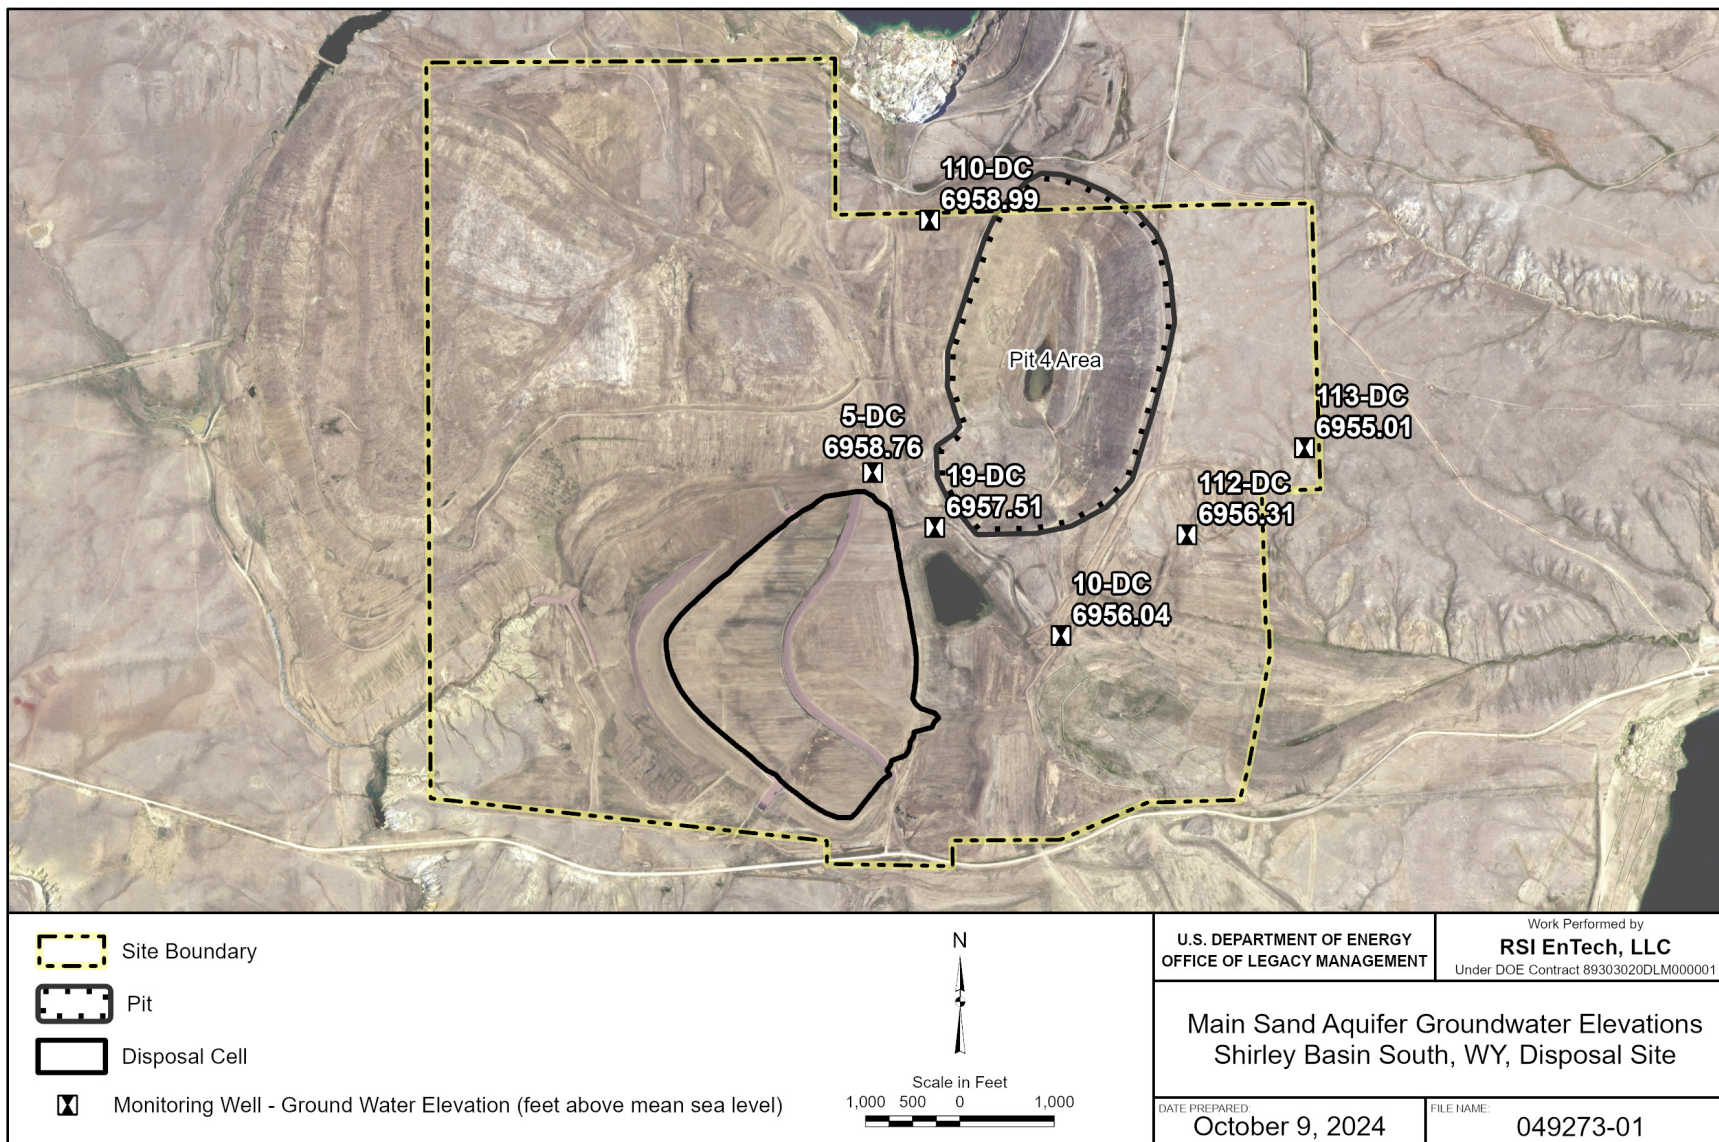
Figure 6-5. June 2024 Groundwater Elevations in the Main Sand Aquifer Wells at the Shirley Basin South, Wyoming, Disposal Site

The map in Figure 6-5 shows the groundwater elevations measured in wells screened in the Main Sand Aquifer in 2024. Figure 6-6 plots corresponding groundwater elevations over time. Piezometric heads have been gradually rising at all wells since 2000, with an average rate of increase of approximately 0.8 foot per year since LM began monitoring water levels in 2005 (Figure 6-6). The rising levels indicate a gradual recovery of the aquifer. However, the altered conditions at Pit 4 might prevent a return to premining elevations of the water table because the Upper Sand and Main Sand units now coalesce at this location.

DOE will continue monitoring and evaluating groundwater elevations as recovery continues in the Main Sand Aquifer. Once groundwater conditions have stabilized, LM will evaluate the adequacy of the monitoring program.

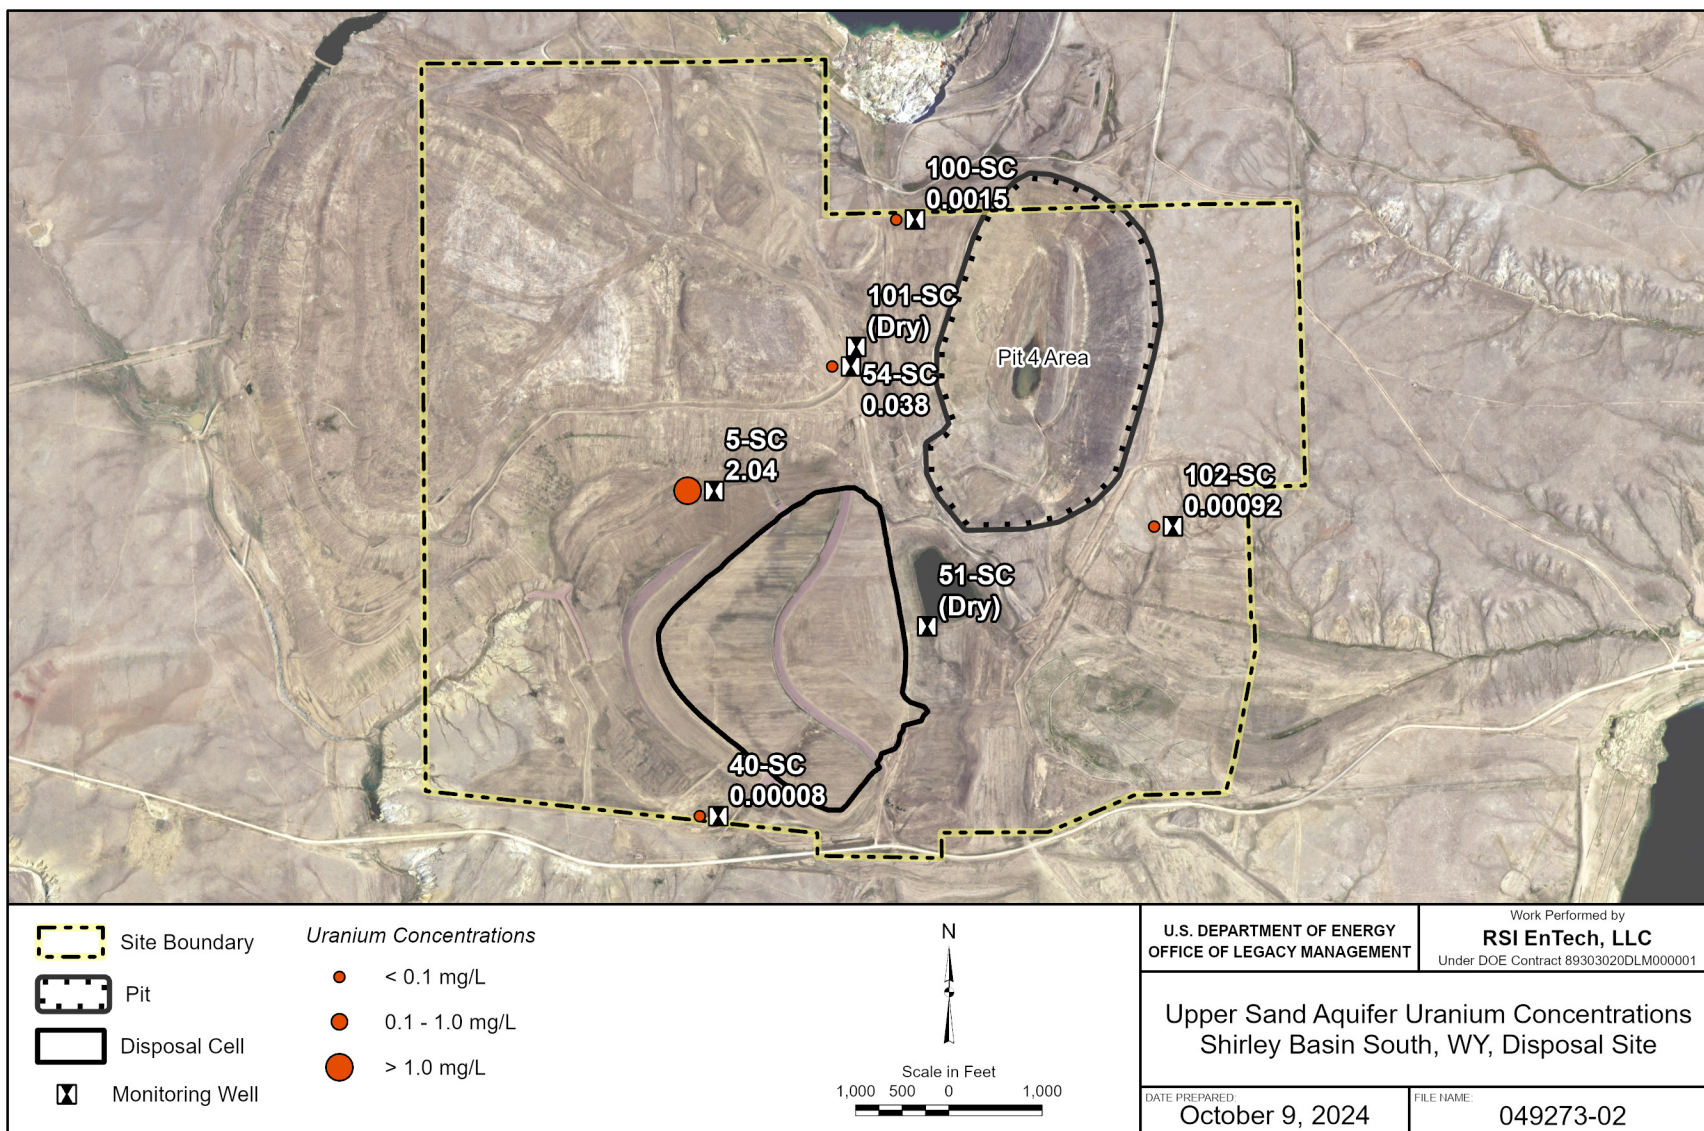
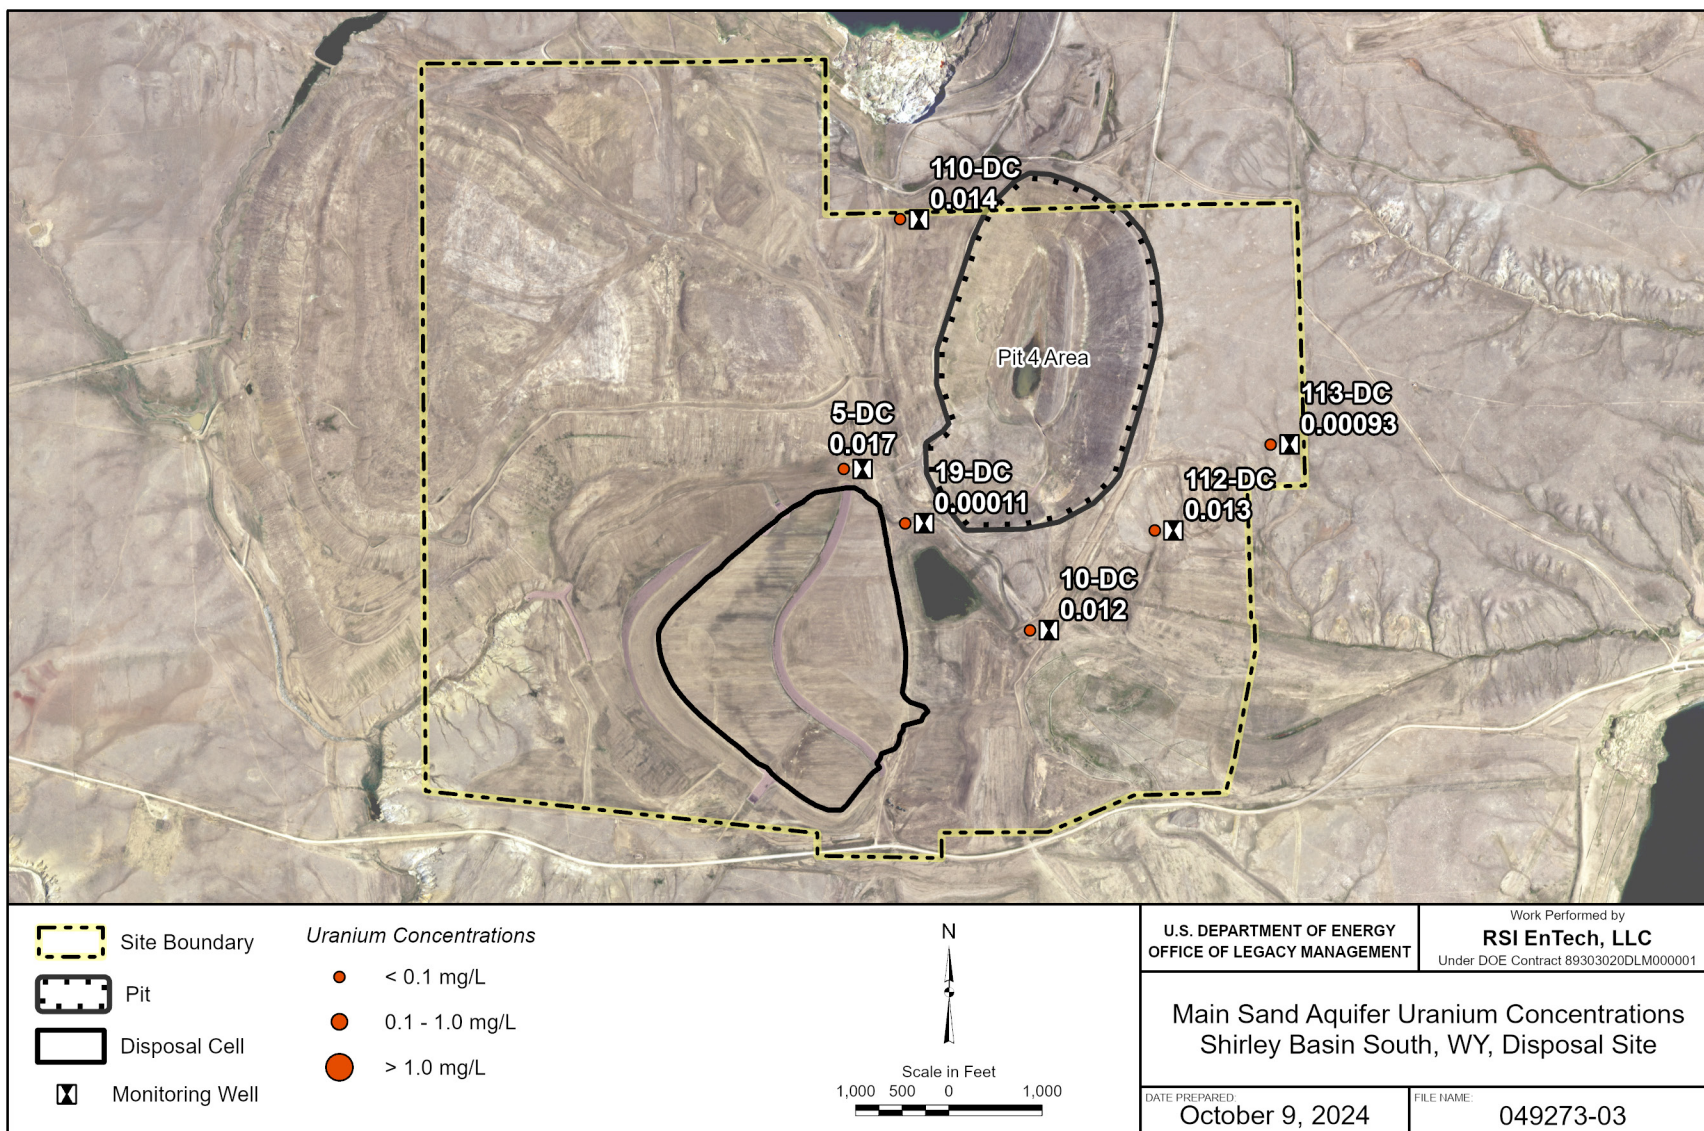
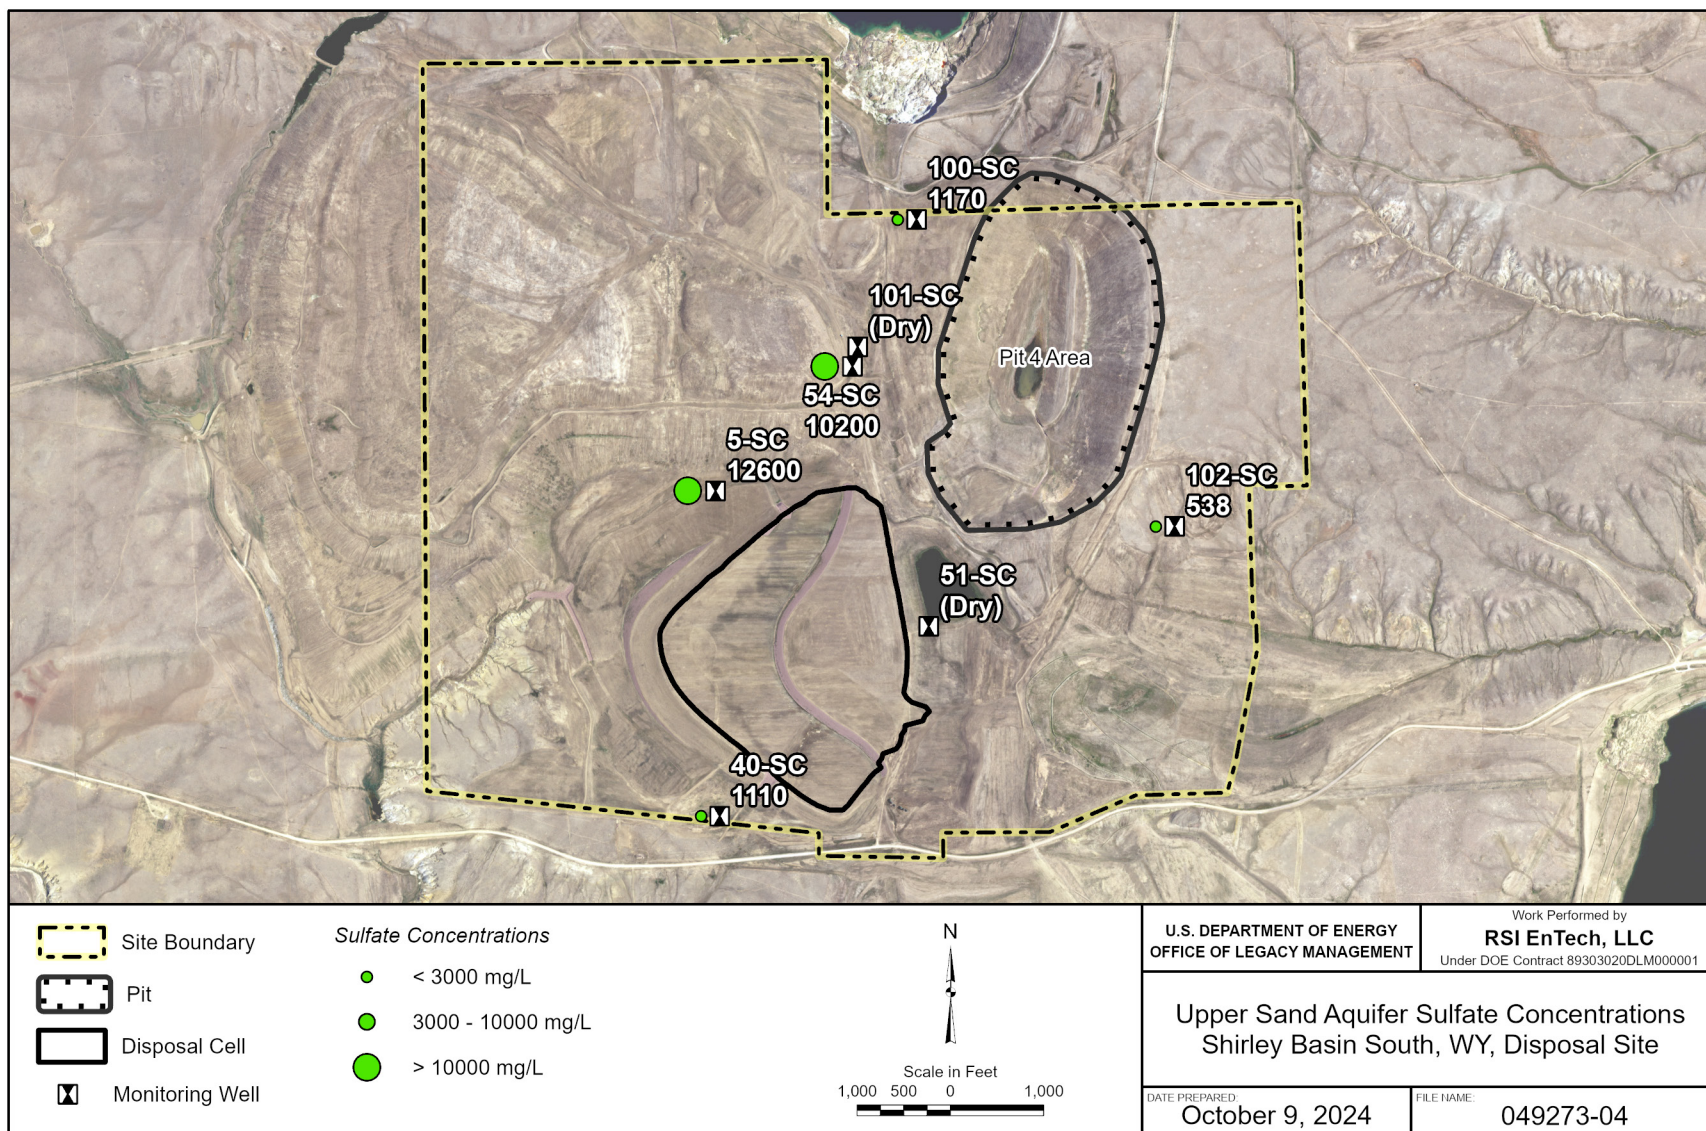
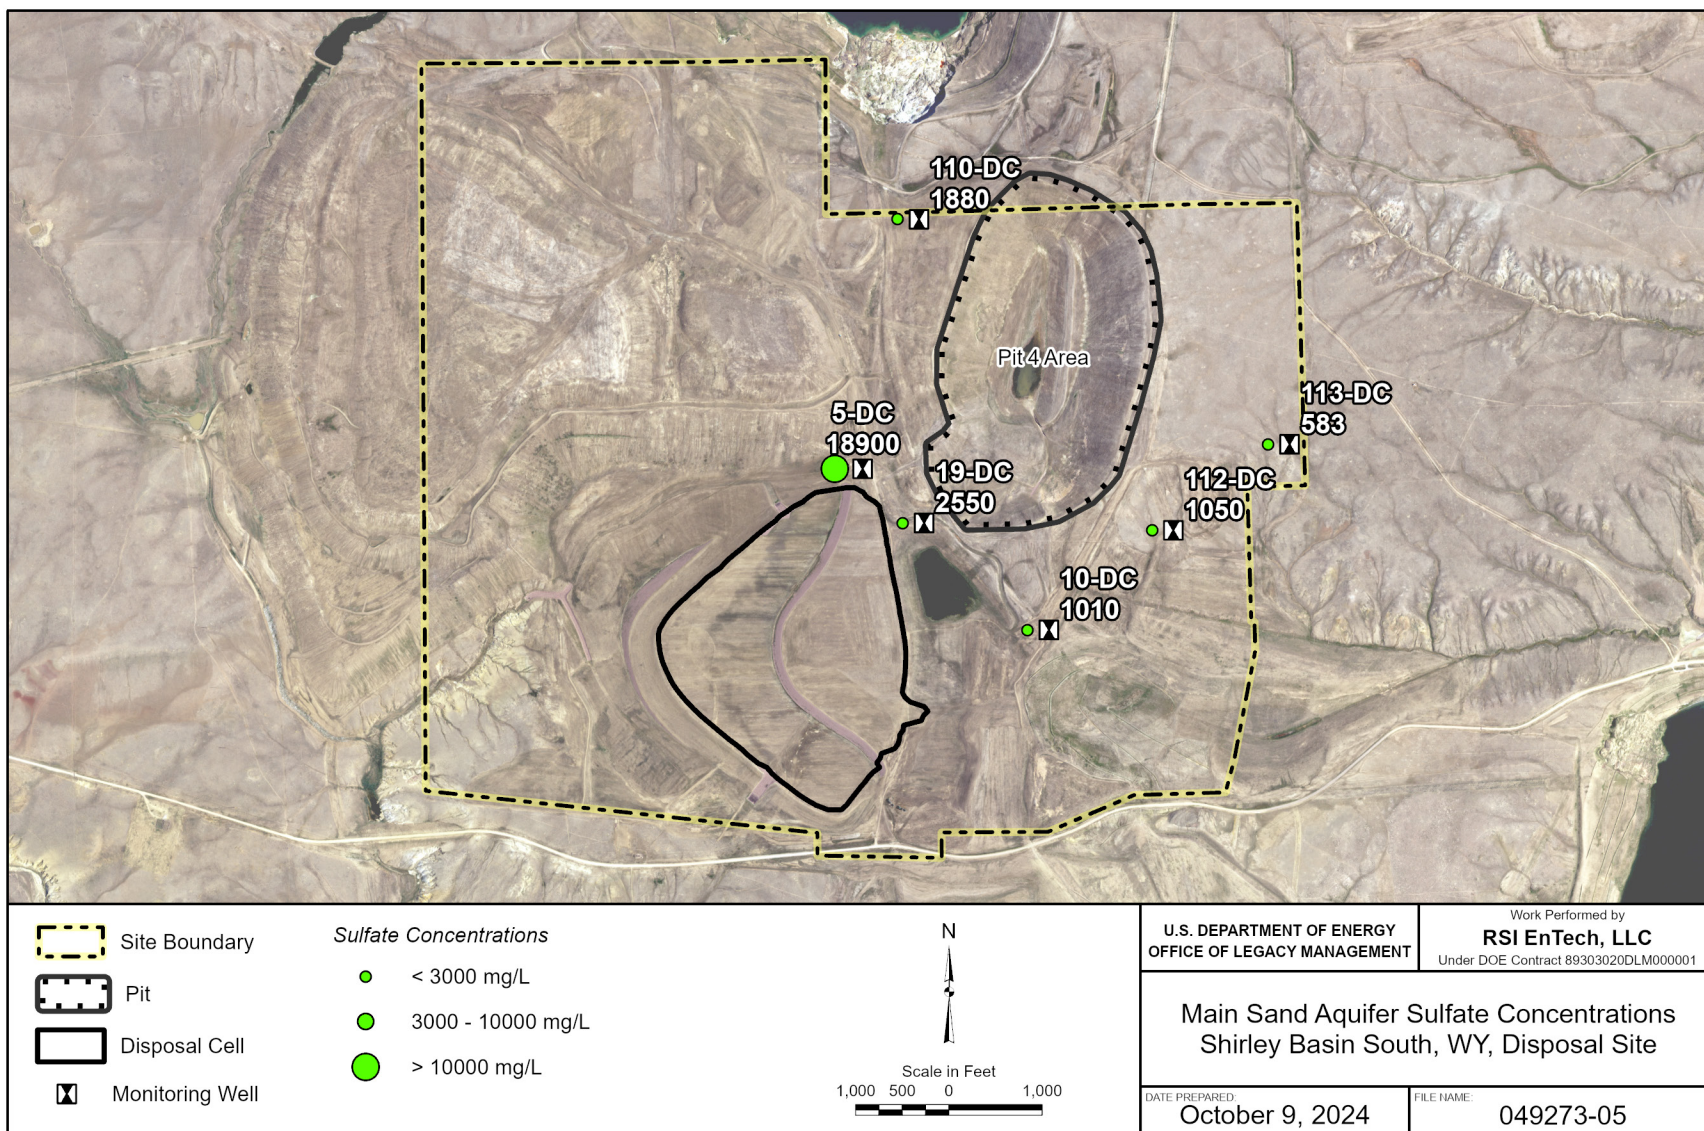
The LTSP (DOE 2004) specifies that this report will include isoconcentration maps for uranium and sulfate in each aquifer; however, the monitoring well network LM inherits from the former licensee does not provide sufficient data points to interpolate a statistically defensible contaminant plume. Uranium concentrations from 2024 are shown in Figure 6-9 and Figure 6-10 for the Upper Sand and Main Sand Aquifers, respectively. Corresponding sulfate concentration data are plotted in Figure 6-11 and Figure 6-12. Uranium concentrations remain below the ACL; however, as stated above, sulfate concentrations exceeded the State of Wyoming groundwater protection standard in Upper Sand Aquifer wells 5-SC and 54-SC and Main Sand Aquifer well 5-DC but not in livestock well K.G.S. #3 or in wells near the boundary.
