## 5.0 Sherwood, Washington, Disposal Site

### 5.1 Compliance Summary

The Sherwood, Washington, Uranium Mill Tailings Radiation Control Act (UMTRCA) Title II Disposal Site was inspected on May 16, 2024. No changes were observed to the disposal cell, containment dam, or associated drainage features. Inspectors identified several routine maintenance needs but found no cause for a follow-up or contingency inspection.

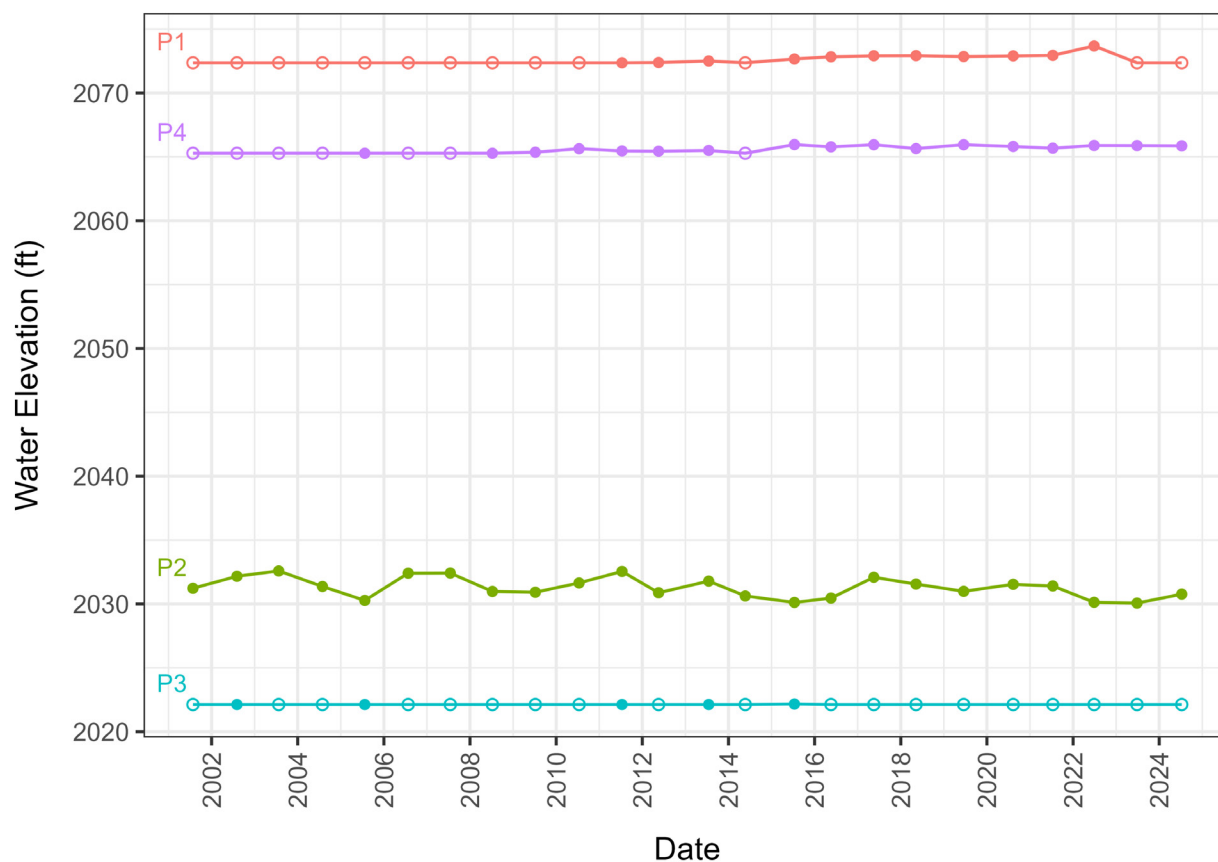
Figure 5-2. Groundwater Elevations at Piezometer Locations P1 Through P4, Sherwood, Washington, Disposal Site

The piezometers, installed in 2000, directly measure moisture conditions in the containment dam. Measurements collected on July 10, 2024, are listed in Table 5-2 and in the attached *Dam Inspection Checklist*. Figure 5-2 plots corresponding historical groundwater elevations; the vertical datum used in this and subsequent water elevation plots is North American Vertical Datum of 1988 (NAVD 88). Because the scale in this initial figure spans approximately 50 ft, to provide greater resolution, Figure 5-3 plots the same data but using unique scales (results for piezometer P3 are not shown because this well has been predominantly dry). Following a 0.7-ft increase in water elevation between 2021 and 2022, piezometer P1 has been dry the last 2 years. Since 2001, water elevations in P2 have declined by approximately 1 ft (general trend), while those in shallow piezometer P4 have increased 0.6 ft (Figure 5-2). This slight increase is not considered indicative of potential performance issues.

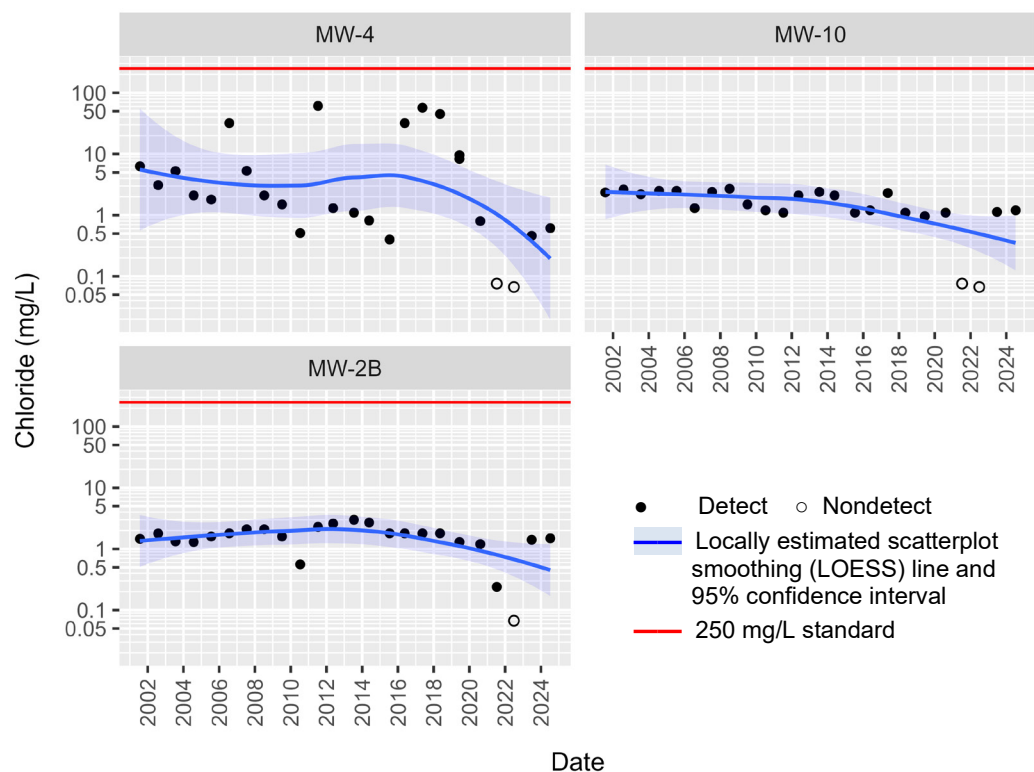
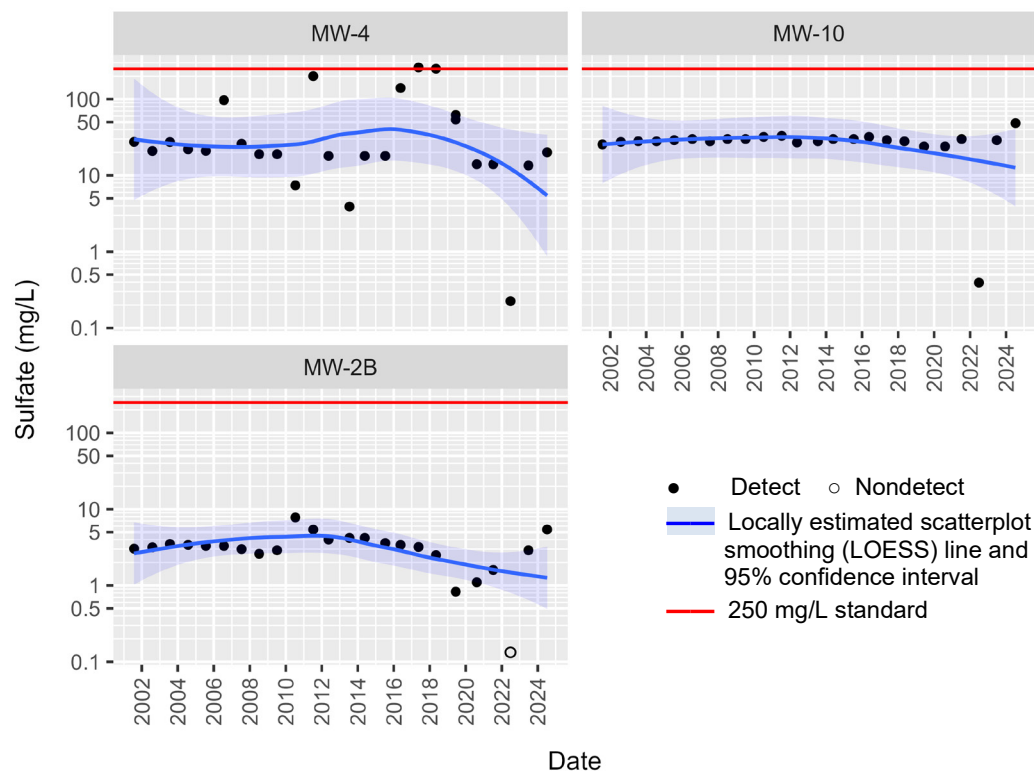
Time-concentration plots of chloride and sulfate measured in monitoring wells MW-4 and MW-10, as well as background well MW-2B are shown in Figure 5-5 and Figure 5-6, respectively. Chloride concentrations in all wells have been consistently below the 250 mg/L water quality criterion and typically less than 10 mg/L. The exceptions shown in Figure 5-5 for monitoring well MW-4 correspond to higher sulfate concentrations measured at the same location. In 2024, the highest chloride concentration (1.49 mg/L) was measured in background well MW-2B (Table 5-3).

Sulfate concentrations in monitoring well MW-4 have been at or below the 250 mg/L criterion except for the May 2017 result of 260 mg/L (Kreie 2018). The elevated concentrations of chloride and sulfate measured in monitoring well MW-4 in 2006, 2011, and 2016–2018 correspond to increases in groundwater elevations in monitoring well MW-4 and in background well MW-2B. Sulfate concentrations in monitoring well MW-10 and background well MW-2B have been consistently below the 250 mg/L criterion (Figure 5-6). In 2022, concentrations of both chloride and sulfate were unusually low relative to historical measurements. Data validation eliminated laboratory error from consideration as a possible explanation for these outlier results. In 2023, chloride and sulfate concentrations in all wells returned to pre-2022 average levels (Figure 5-5; Figure 5-6). In 2024, sulfate concentrations in all three wells increased slightly relative to 2023 results, with the highest value at 48.5 mg/L at monitoring well MW-10.

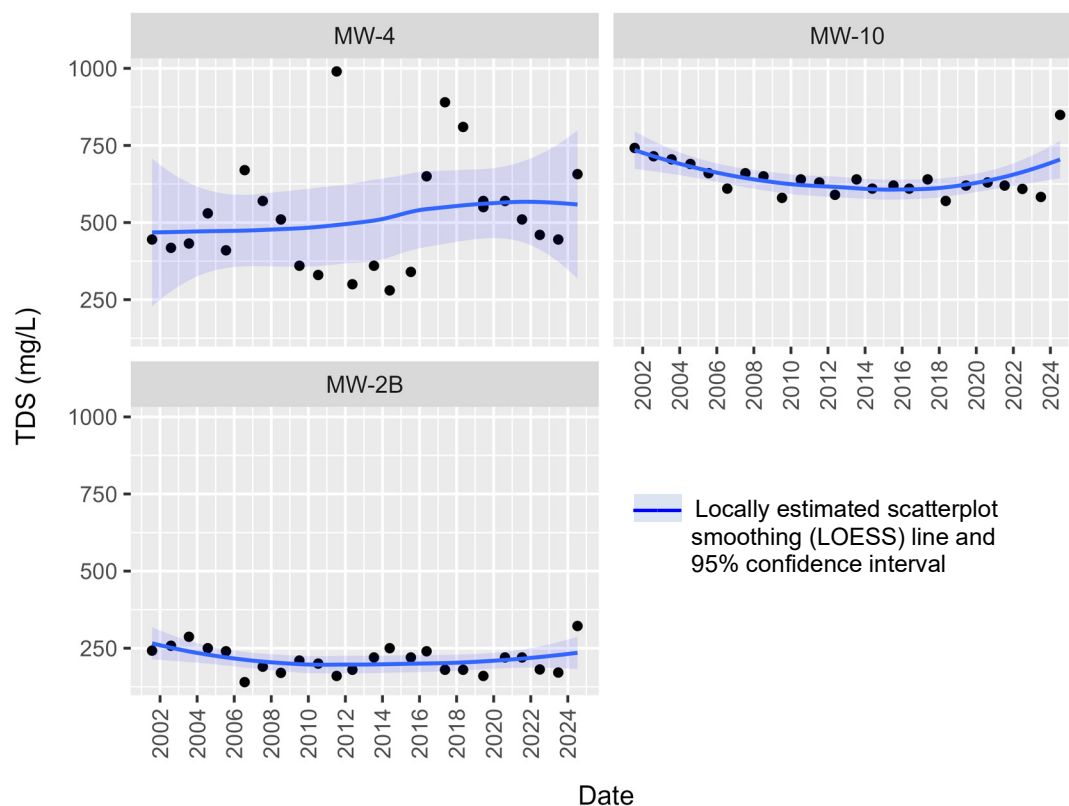
Figure 5-7. TDS Concentrations in Monitoring Wells at the Sherwood, Washington, Disposal Site

Although TDS is not considered an indicator parameter, this analyte is routinely monitored in accordance with the LTSP (DOE 2001; Table 5-3). TDS concentrations in monitoring wells MW-4 and MW-10 have consistently exceeded concentrations measured in background well MW-2B (Figure 5-7). In 2024, TDS concentrations in monitoring wells MW-4 and MW-10 were 657 and 849 mg/L, respectively, an increase relative to 2023 measurements (445 and 583 mg/L). Relative to 2023 results, TDS concentrations also increased in background well MW-2B, from 171 to 322 mg/L.

Regarding the observed fluctuations in indicator parameter concentrations in monitoring well MW-4, an early technical evaluation report prepared by the Washington State Department of Health attributed the variable water quality in this well to seasonal variation in annual infiltration (rainfall) and static water levels (WDOH 2000).

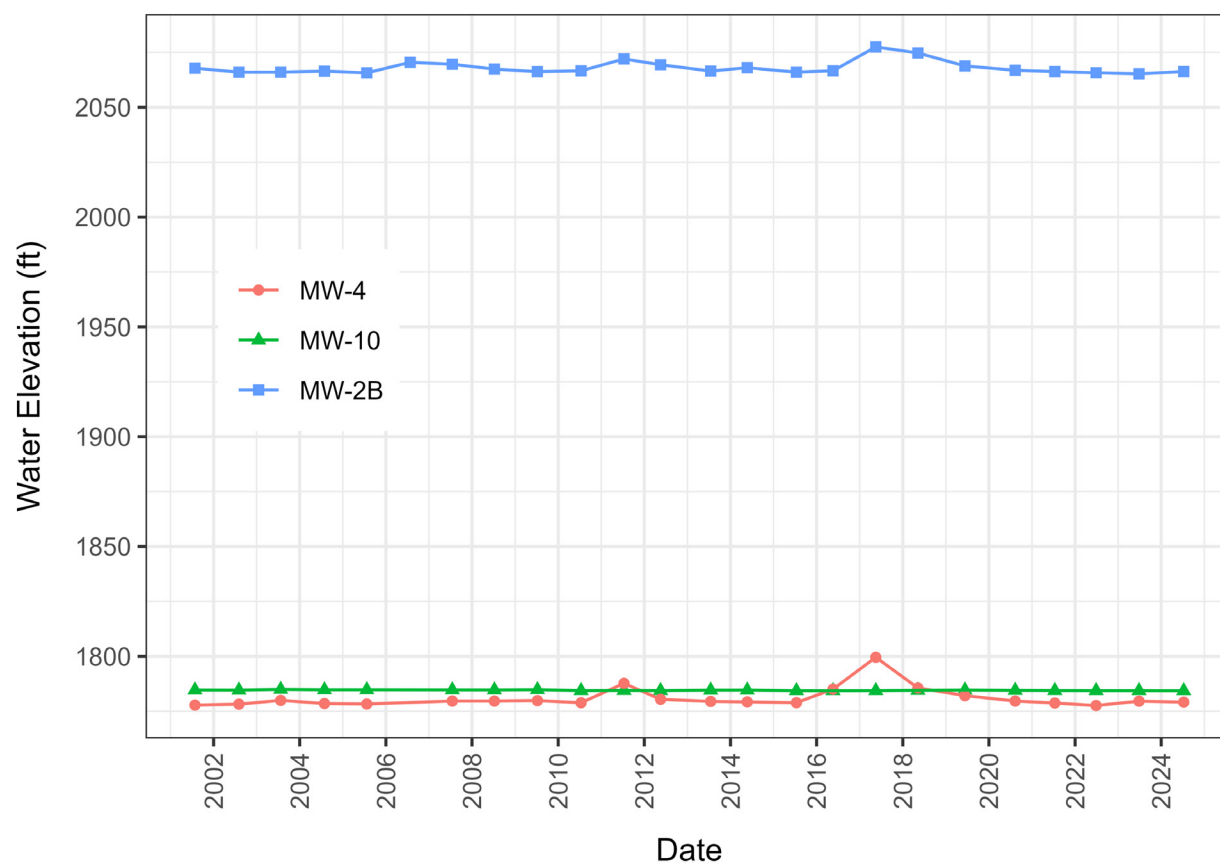
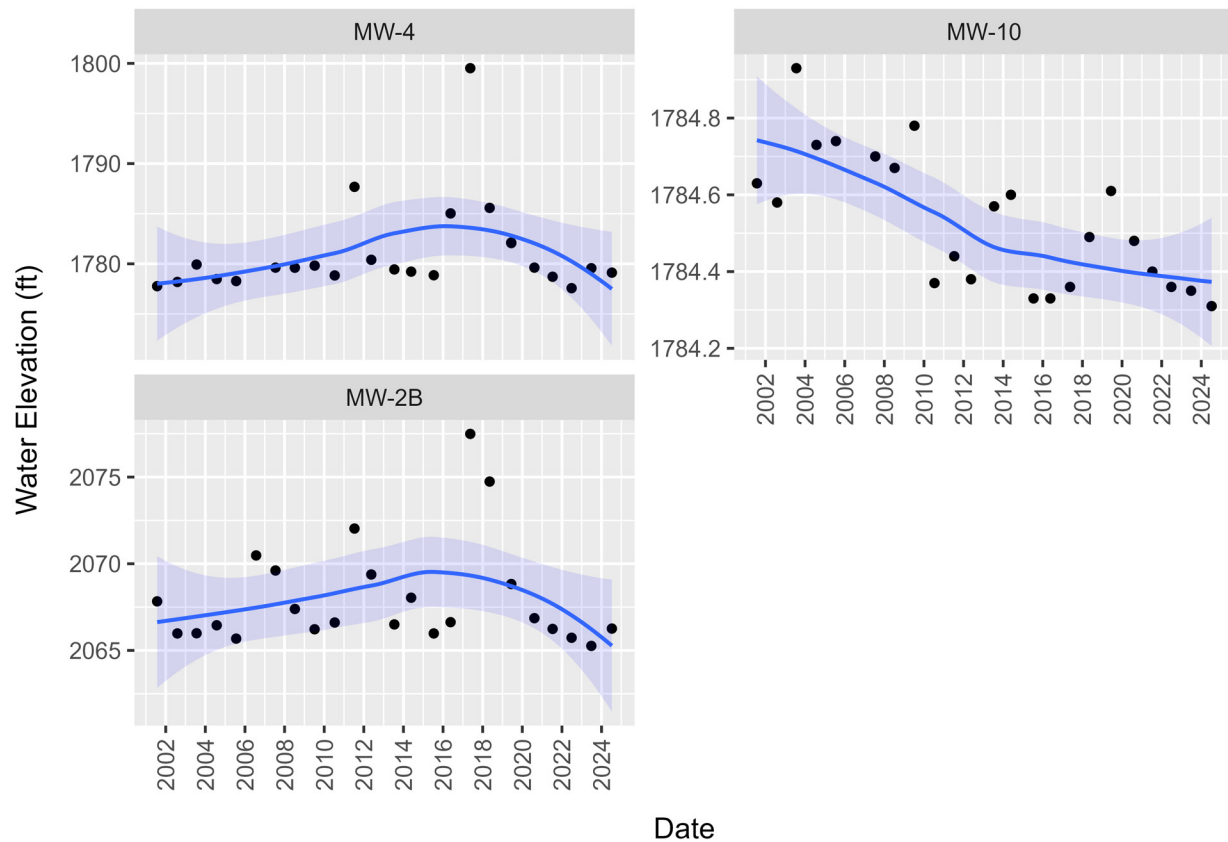
Figure 5-8. Groundwater Elevations in Monitoring Wells at the Sherwood, Washington, Disposal Site

No statistically significant increasing trends in water elevations were found for monitoring wells MW-4 and MW-10 near the base of the dam (see Section 5.7).

**Notes:** Mann-Kendall trend analysis identified a statistically significant decreasing trend in groundwater elevations for monitoring well MW-10; no trend was found for monitoring wells MW-4 or MW-2B. Vertical datum is NAVD 88.
