2.0 Annual Inspection of the Burrell, Pennsylvania, UMTRCA Title I Disposal Site

The Burrell, Pennsylvania, Uranium Mill Tailings Radiation Control Act (UMTRCA) Title I Disposal Site, inspected on October 17, 2012, was in excellent condition. The disposal cell and all associated drainage diversion structures were in good condition and functioning as designed. No maintenance needs or cause for a follow-up or contingency inspection was identified.

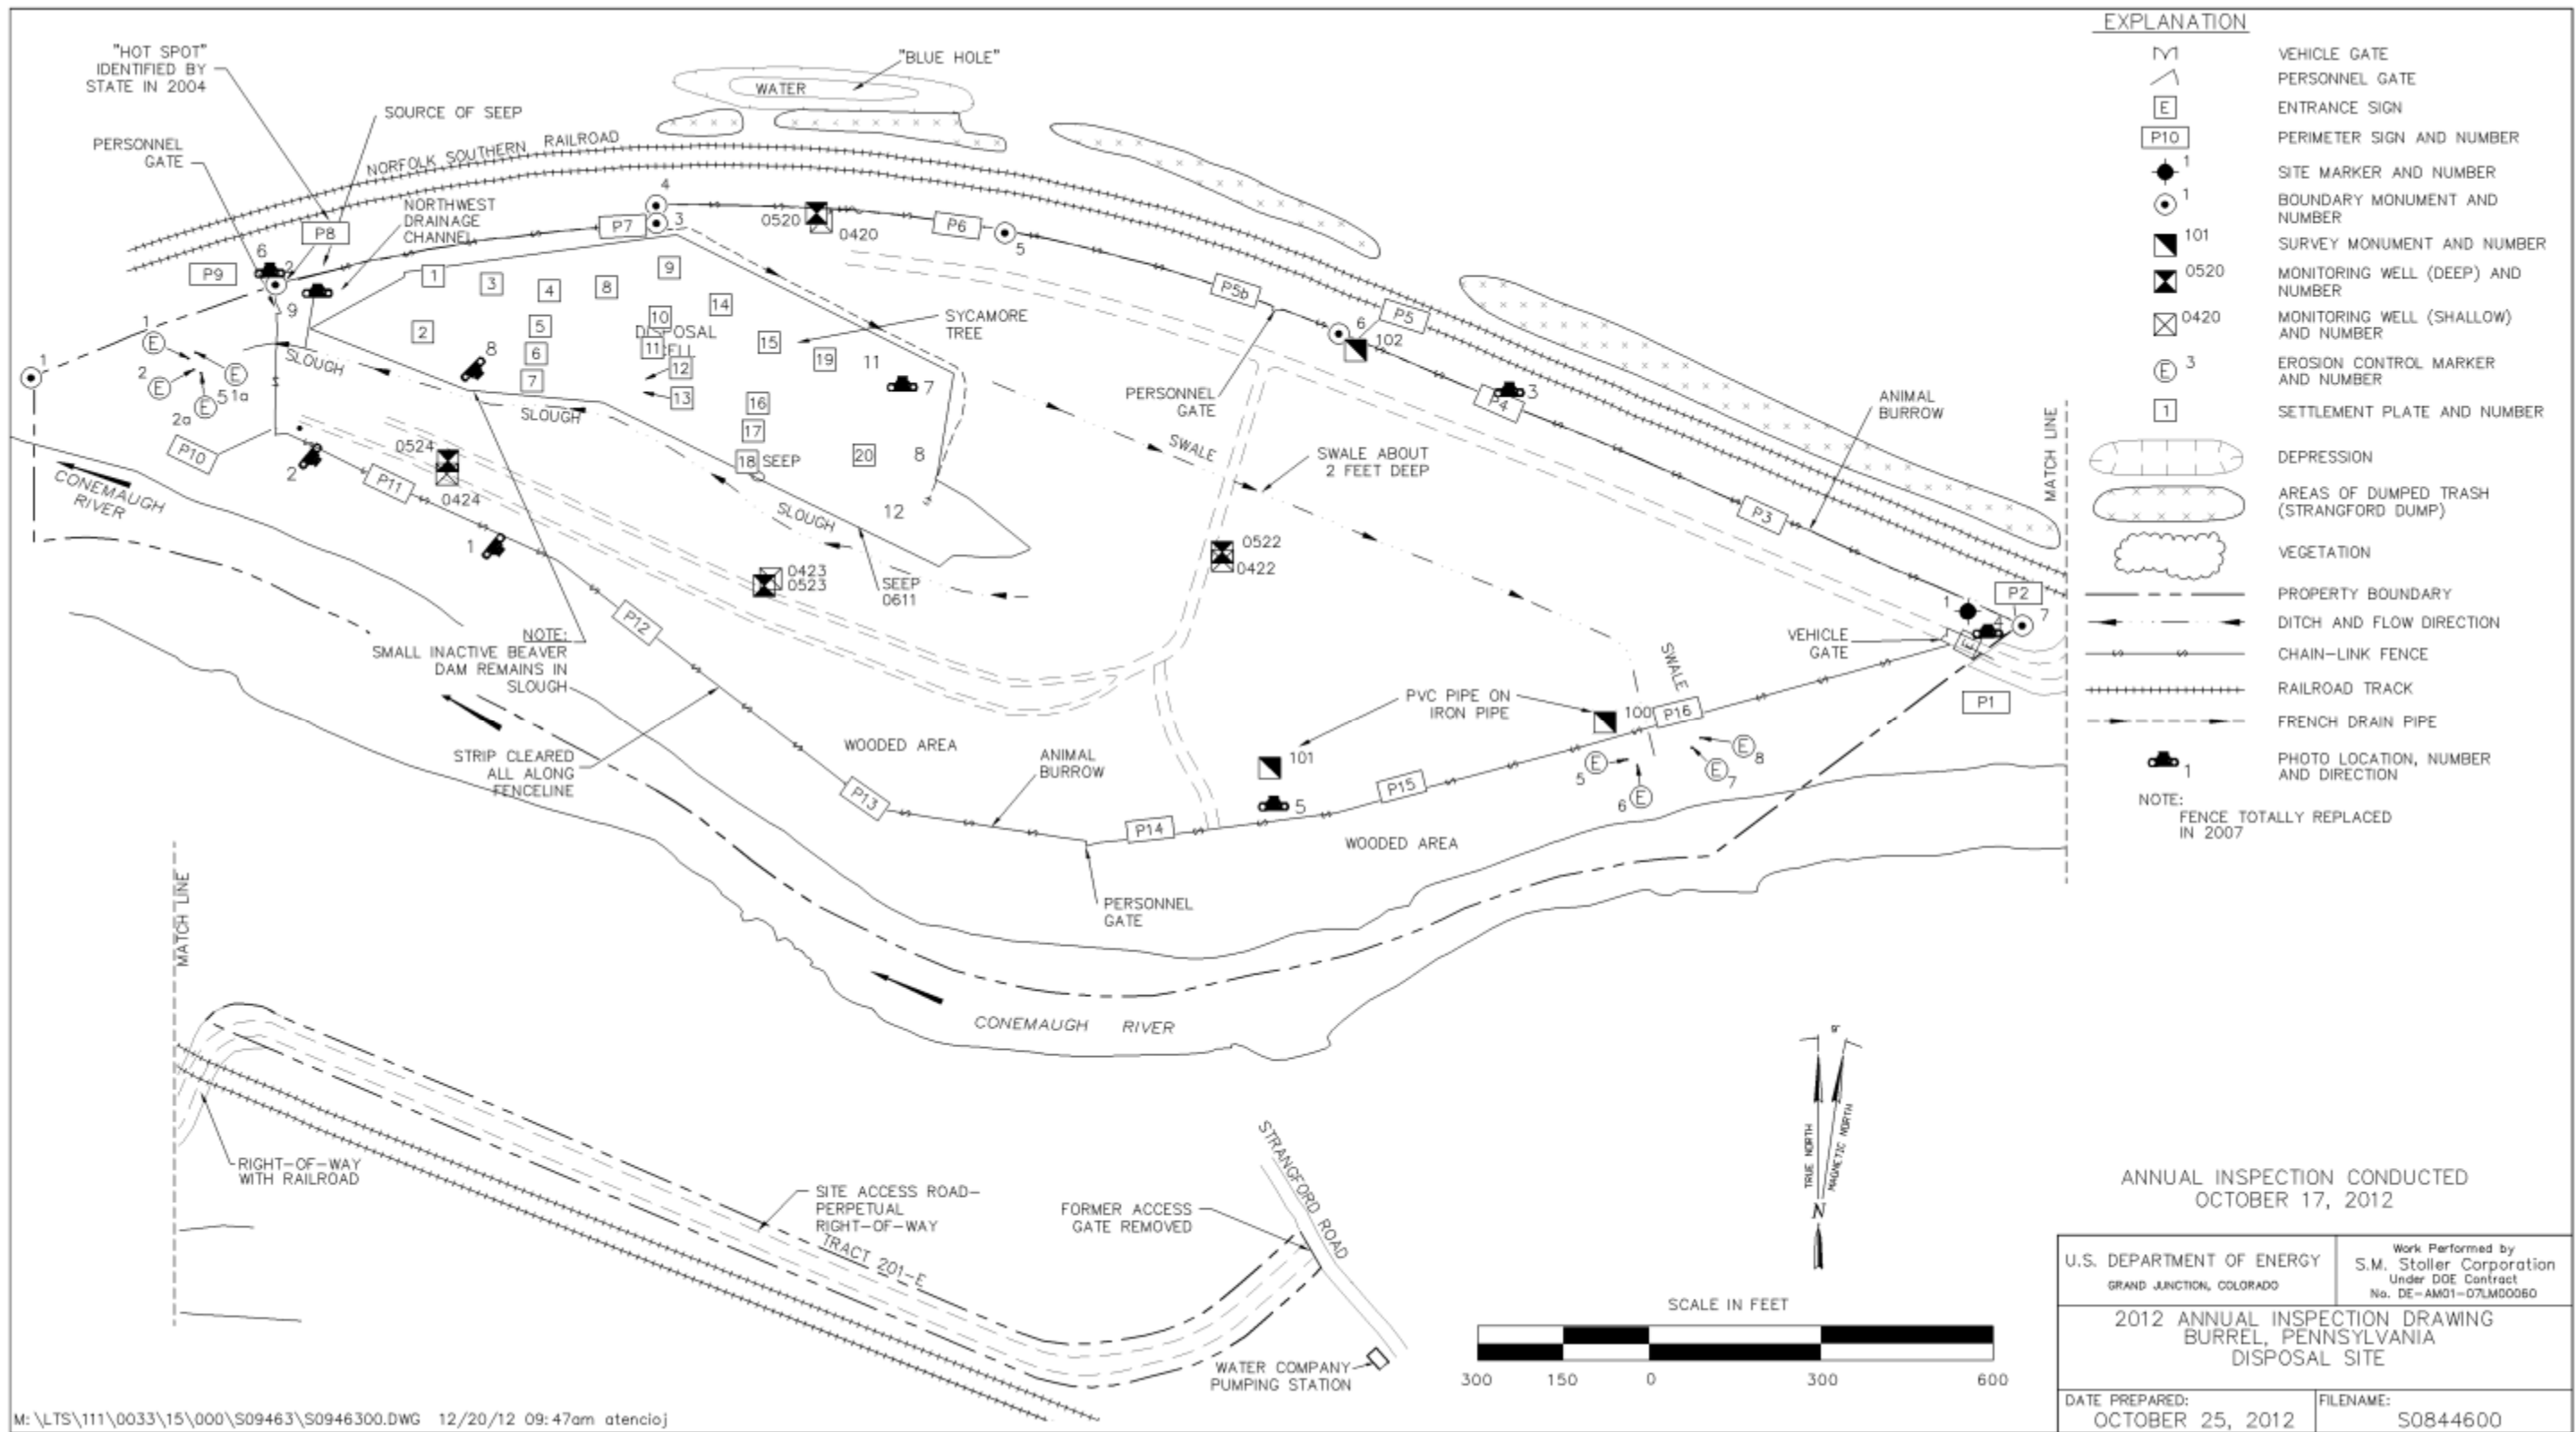
Figure 2-1. 2012 Annual Compliance Drawing for the Burrell Disposal Site

The locations of site surveillance features are shown in Figure 2–1. Inspection results and recommended maintenance activities associated with site surveillance features are included in the following subsections. Photographs to support specific observations are identified in the text and in Figure 2–1 by photograph location (PL) numbers.
