2.0 Burrell, Pennsylvania, Disposal Site

2.1 Compliance Summary

The site, east of Blairsville, Pennsylvania, was inspected on October 19, 2010. The results of the inspection are described below. Figure 2–1 shows features and photograph locations (PLs) mentioned in this report. Numbers in the left margin of this report refer to items summarized in the “Executive Summary” table.

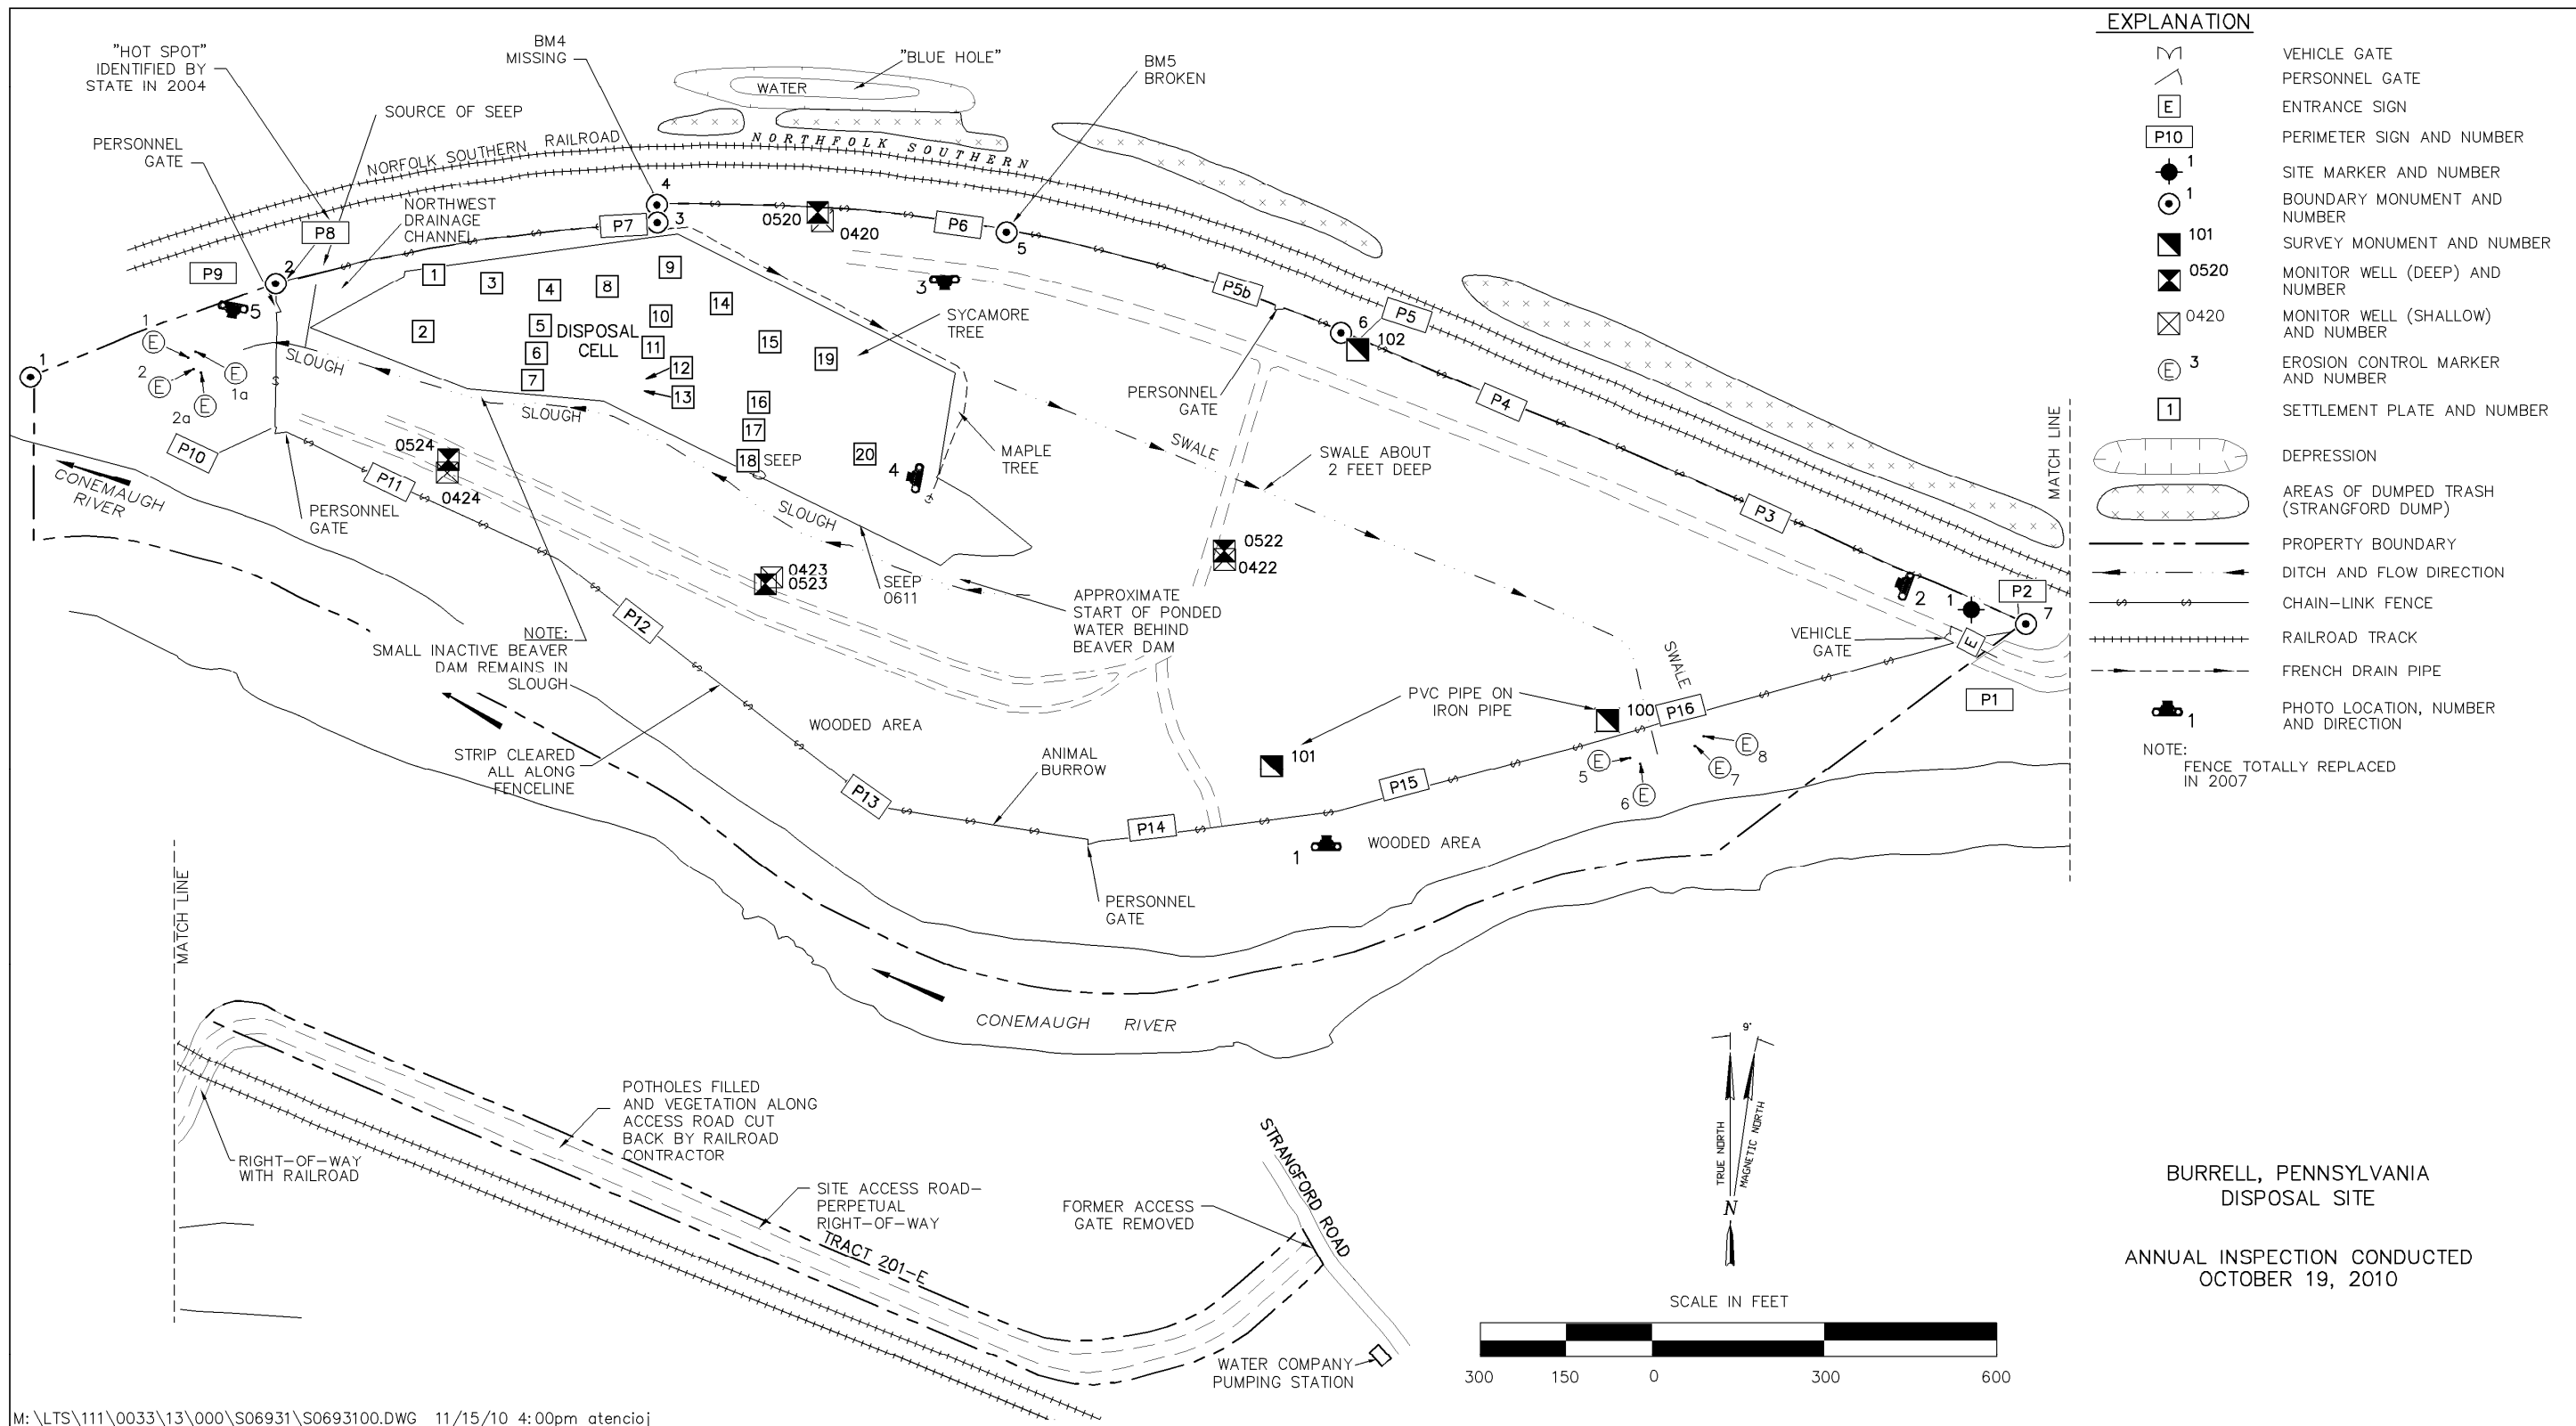
Figure 2-1. 2010 Annual Compliance Drawing for the Burrell Disposal Site

The chain-link security fence, replaced in 2007, remains in excellent condition, with the exception of a bent rail on the south fence (PL–1). The top rail was bent when a tree fell across it in the spring of 2010. The tree was safely removed from the fence shortly after being discovered. The top rail, although bent, remains serviceable. A vegetation-free corridor remains established along the fence line (PL–2). The entrance gate and four personnel gates were in good condition. Of the 17 perimeter signs mounted on the security fence, four have been damaged by bullet holes, but they remain serviceable.

Site Markers and Monuments—The site has nine markers (a site marker and eight erosion control markers). Site marker SMK–1 was in excellent condition. All eight erosion control markers were located during the inspection, and seven were in good condition. Erosion control marker E–7 remains damaged and is identified as a minor maintenance item for the site that will be addressed in 2011. Dense vegetation is once again growing around the erosion control markers. The dense vegetation will be targeted for removal in 2011 so that inspectors can safely access the markers.

The site has 10 monuments (three survey monuments and seven boundary monuments). All three survey monuments were in good condition. Of the seven boundary monuments, five were in good condition. Boundary monument BM–4 was missing, and boundary monument BM–5 was damaged. Both are considered to be minor maintenance items that will be addressed in 2011.

Disposal Cell—The riprap-covered disposal cell was in excellent condition (PL–3). There were no indications of cell instability, such as slumping, bulging, or differential settlement. Rock quality was excellent; degradation of the limestone riprap was not evident.
