2.0 Burrell, Pennsylvania, Disposal Site

2.1 Compliance Summary

Figure 2-1. 2009 Annual Compliance Drawing for the Burrell Disposal Site

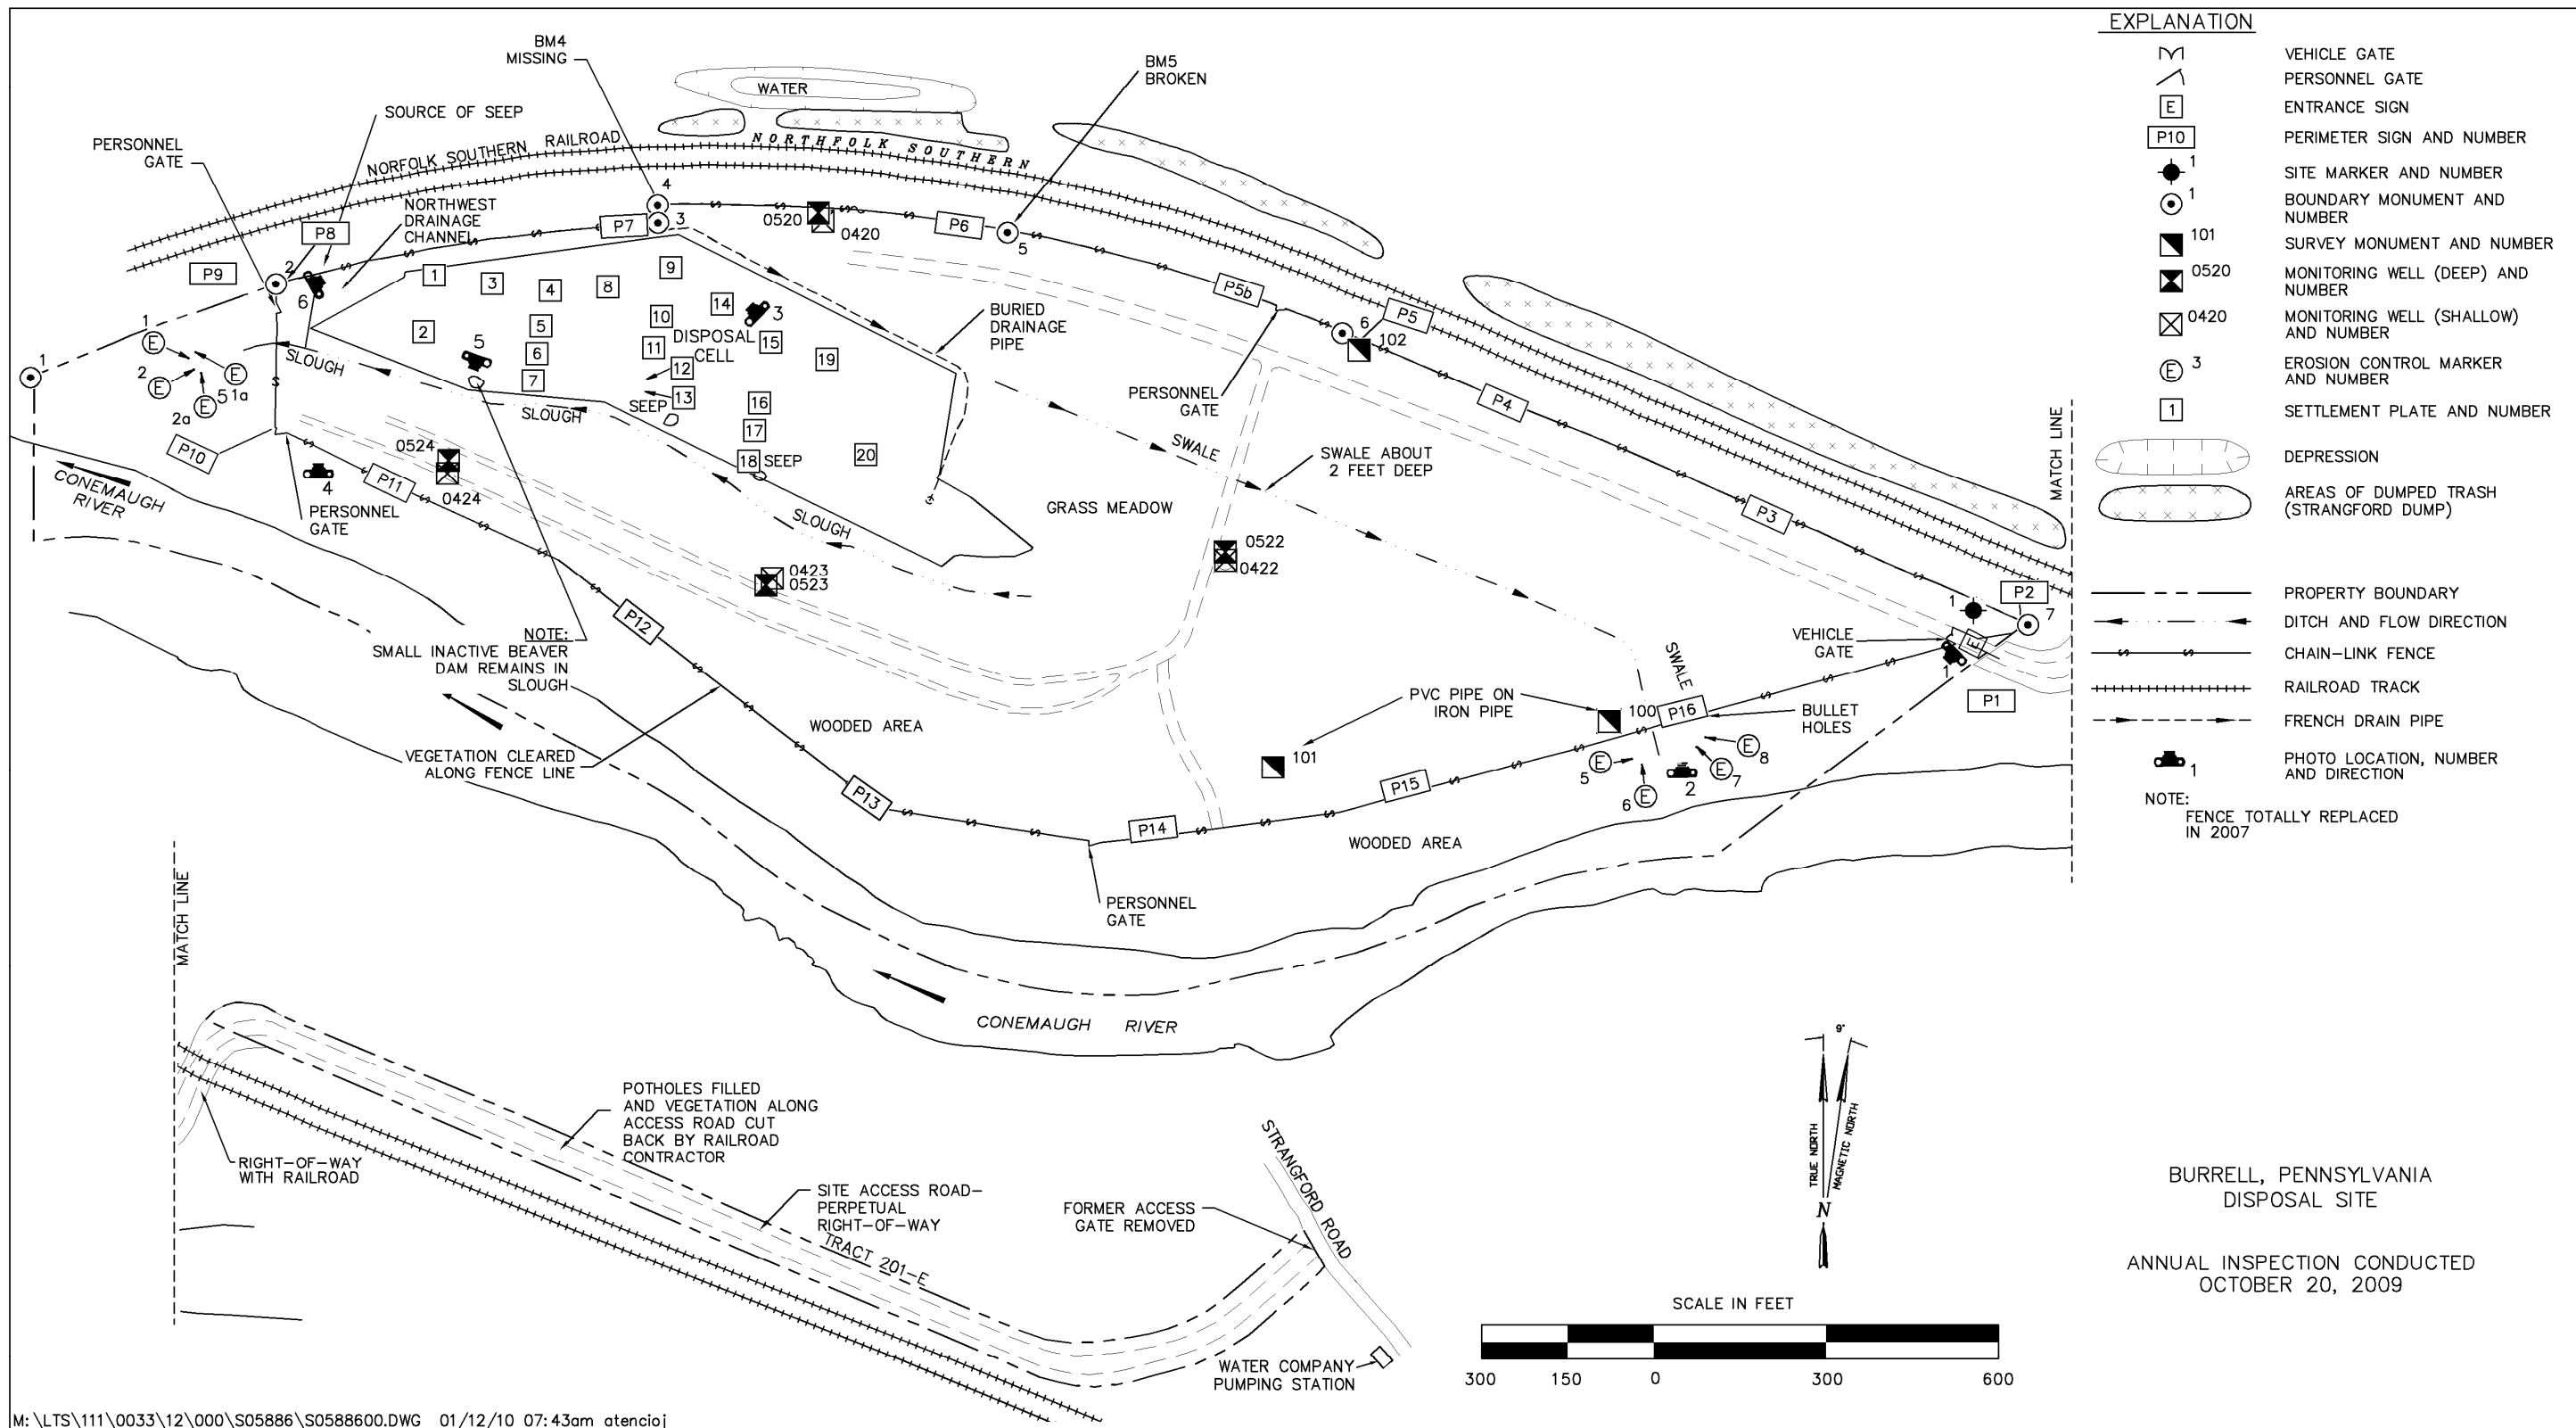
The chain-link security fence, replaced in 2007, remains in excellent condition. A vegetation-free corridor has been established along the fence line (PL–1). The entrance gate and four personnel gates were in good condition. Of the 17 perimeter signs mounted on the security fence, 15 were in good condition. Perimeter signs P5 and P16 have bullet holes in them but remain legible.

Site Markers and Monuments—The site has nine markers (a site marker and eight erosion control markers). Site marker SMK–1 was in excellent condition. All eight erosion control markers were located during the inspection, and seven were in good condition. Erosion control marker E–7 was damaged this past year and will be repaired or replaced (PL–2). Vegetation control efforts this past year have made the erosion control markers easier to find.

The site has 10 monuments (three survey monuments and seven boundary monuments). All three survey monuments were in good condition. Of the seven boundary monuments, five were in good condition. Boundary monument BM–4 was missing, and boundary monument BM–5 was damaged. Both are considered to be minor maintenance items that will be addressed in 2010.

Monitoring wells—The site has four pairs of monitoring wells. Each pair consists of a shallow (alluvial) completion and a deeper (bedrock) completion. All wells were located and observed to be secured with a lock, labeled with identification numbers, and in good condition. The protective casings, although rusted, remain functional.
