## 2.0 Burrell, Pennsylvania, Disposal Site

### 2.1 Compliance Summary

Figure 2-1. 2008 Annual Compliance Drawing for the Burrell Disposal Site

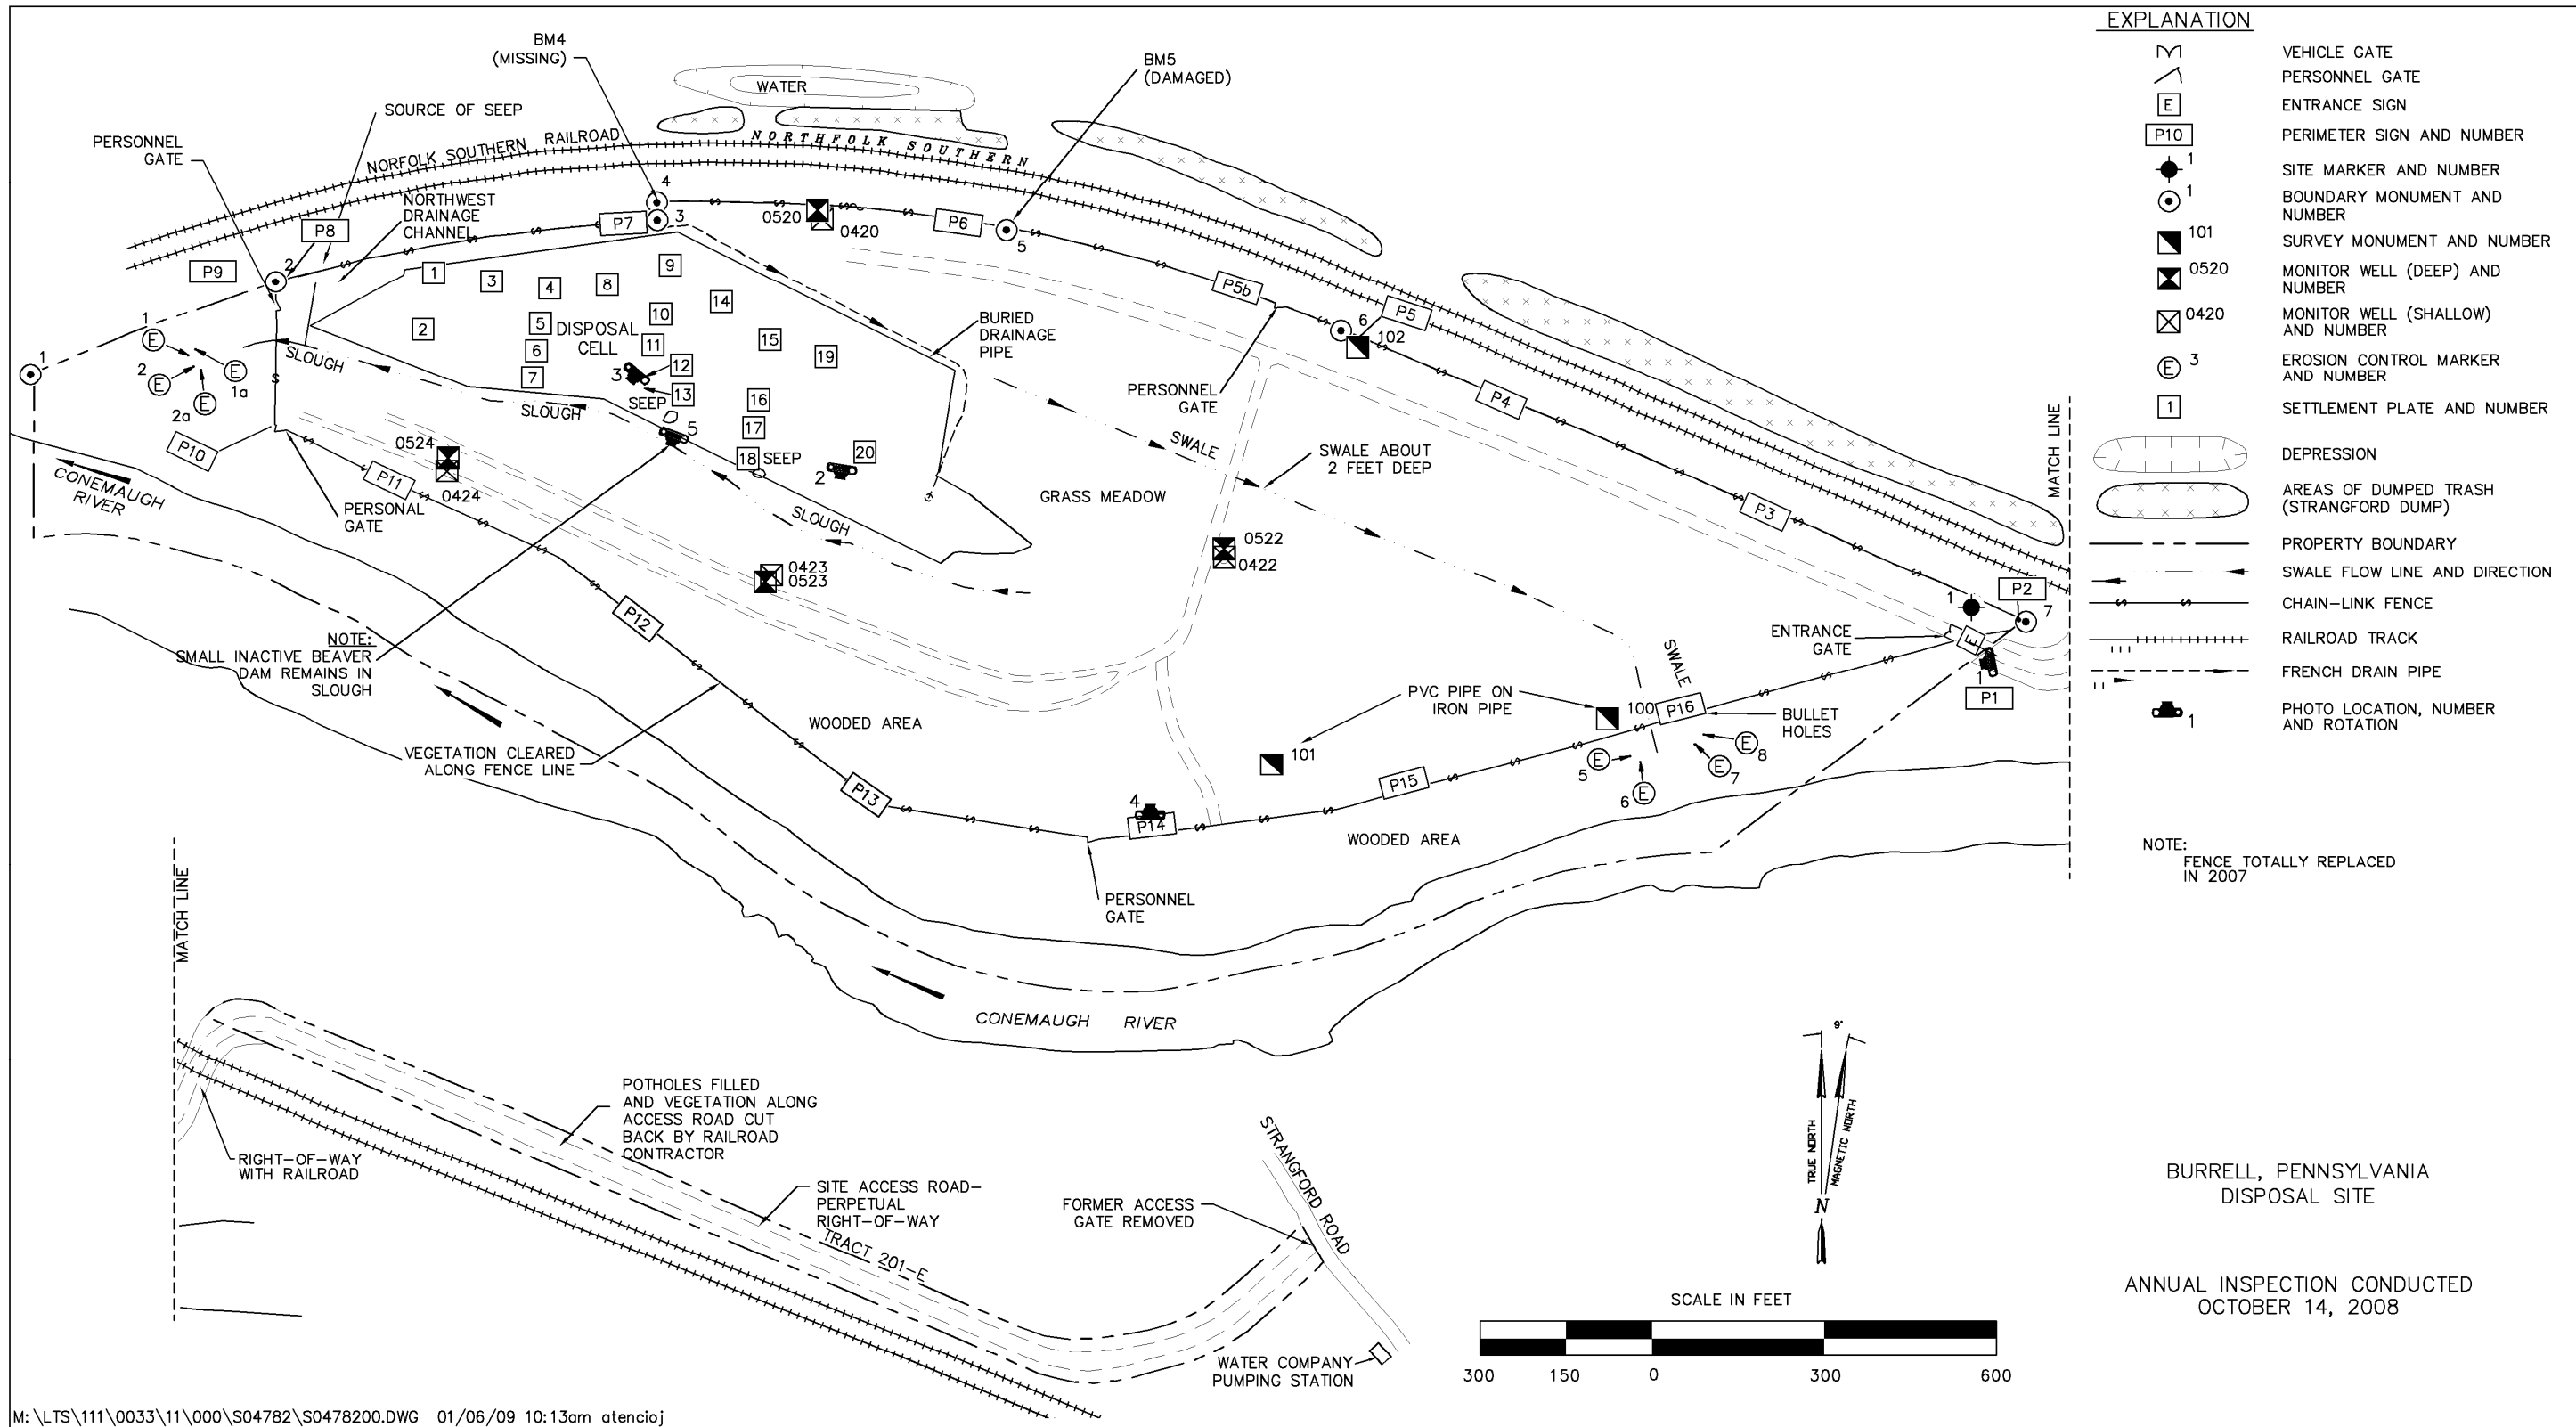
The chain-link security fence, replaced in 2007, was in excellent condition. A vegetation-free corridor has been established along the fence line (PL–1). The entrance gate and four personnel gates were in good condition.

- 2A The entrance sign and four perimeter signs were replaced in 2008. Of the 17 perimeter signs mounted on the security fence, 16 were in good condition. Perimeter sign P16 has bullet holes in it but still remains legible.

The site has seven boundary monuments and three survey monuments. Of the seven boundary monuments, five were in good condition. Boundary monument BM–4 was missing, and boundary monument BM–5 was damaged; replacement and repair will be performed in 2009. All four pairs of erosion control markers were located during the inspection and were in good condition. Vegetation control efforts near the erosion control markers have improved. There was no sign of erosion at the site.

2C An inactive beaver dam (PL-5) remains within the slough at the base of the south slope of the disposal cell; several feet of water continue to collect behind the dam. In November 2005, DOE coordinated with State wildlife officials to remove the beavers, in accordance with State regulations, and then breached a dam downstream of the site that caused the water to backup against the base of the cell. The water levels behind the inactive dam are not high enough to saturate the tailings or impact the integrity of the disposal cell. Therefore, DOE has elected not to mobilize equipment to remove the dam. Instead, DOE will continue to monitor the dam and possible impacts to the disposal site.
