## 2.0 Burrell, Pennsylvania, Disposal Site

### 2.1 Compliance Summary

The Burrell, Pennsylvania, Disposal Site, inspected on September 19, 2007, was in excellent condition. The disposal cell, its cover, and associated drainage features are performing as designed. The security perimeter fence was replaced in 2007. Control of undesirable vegetation and noxious weeds continued at the site. Groundwater monitoring is required every 5 years and was not performed in 2007. The 2004 monitoring indicated there is no contamination being released and that the disposal cell is performing as designed. No cause for a follow-up or contingency inspection was identified.

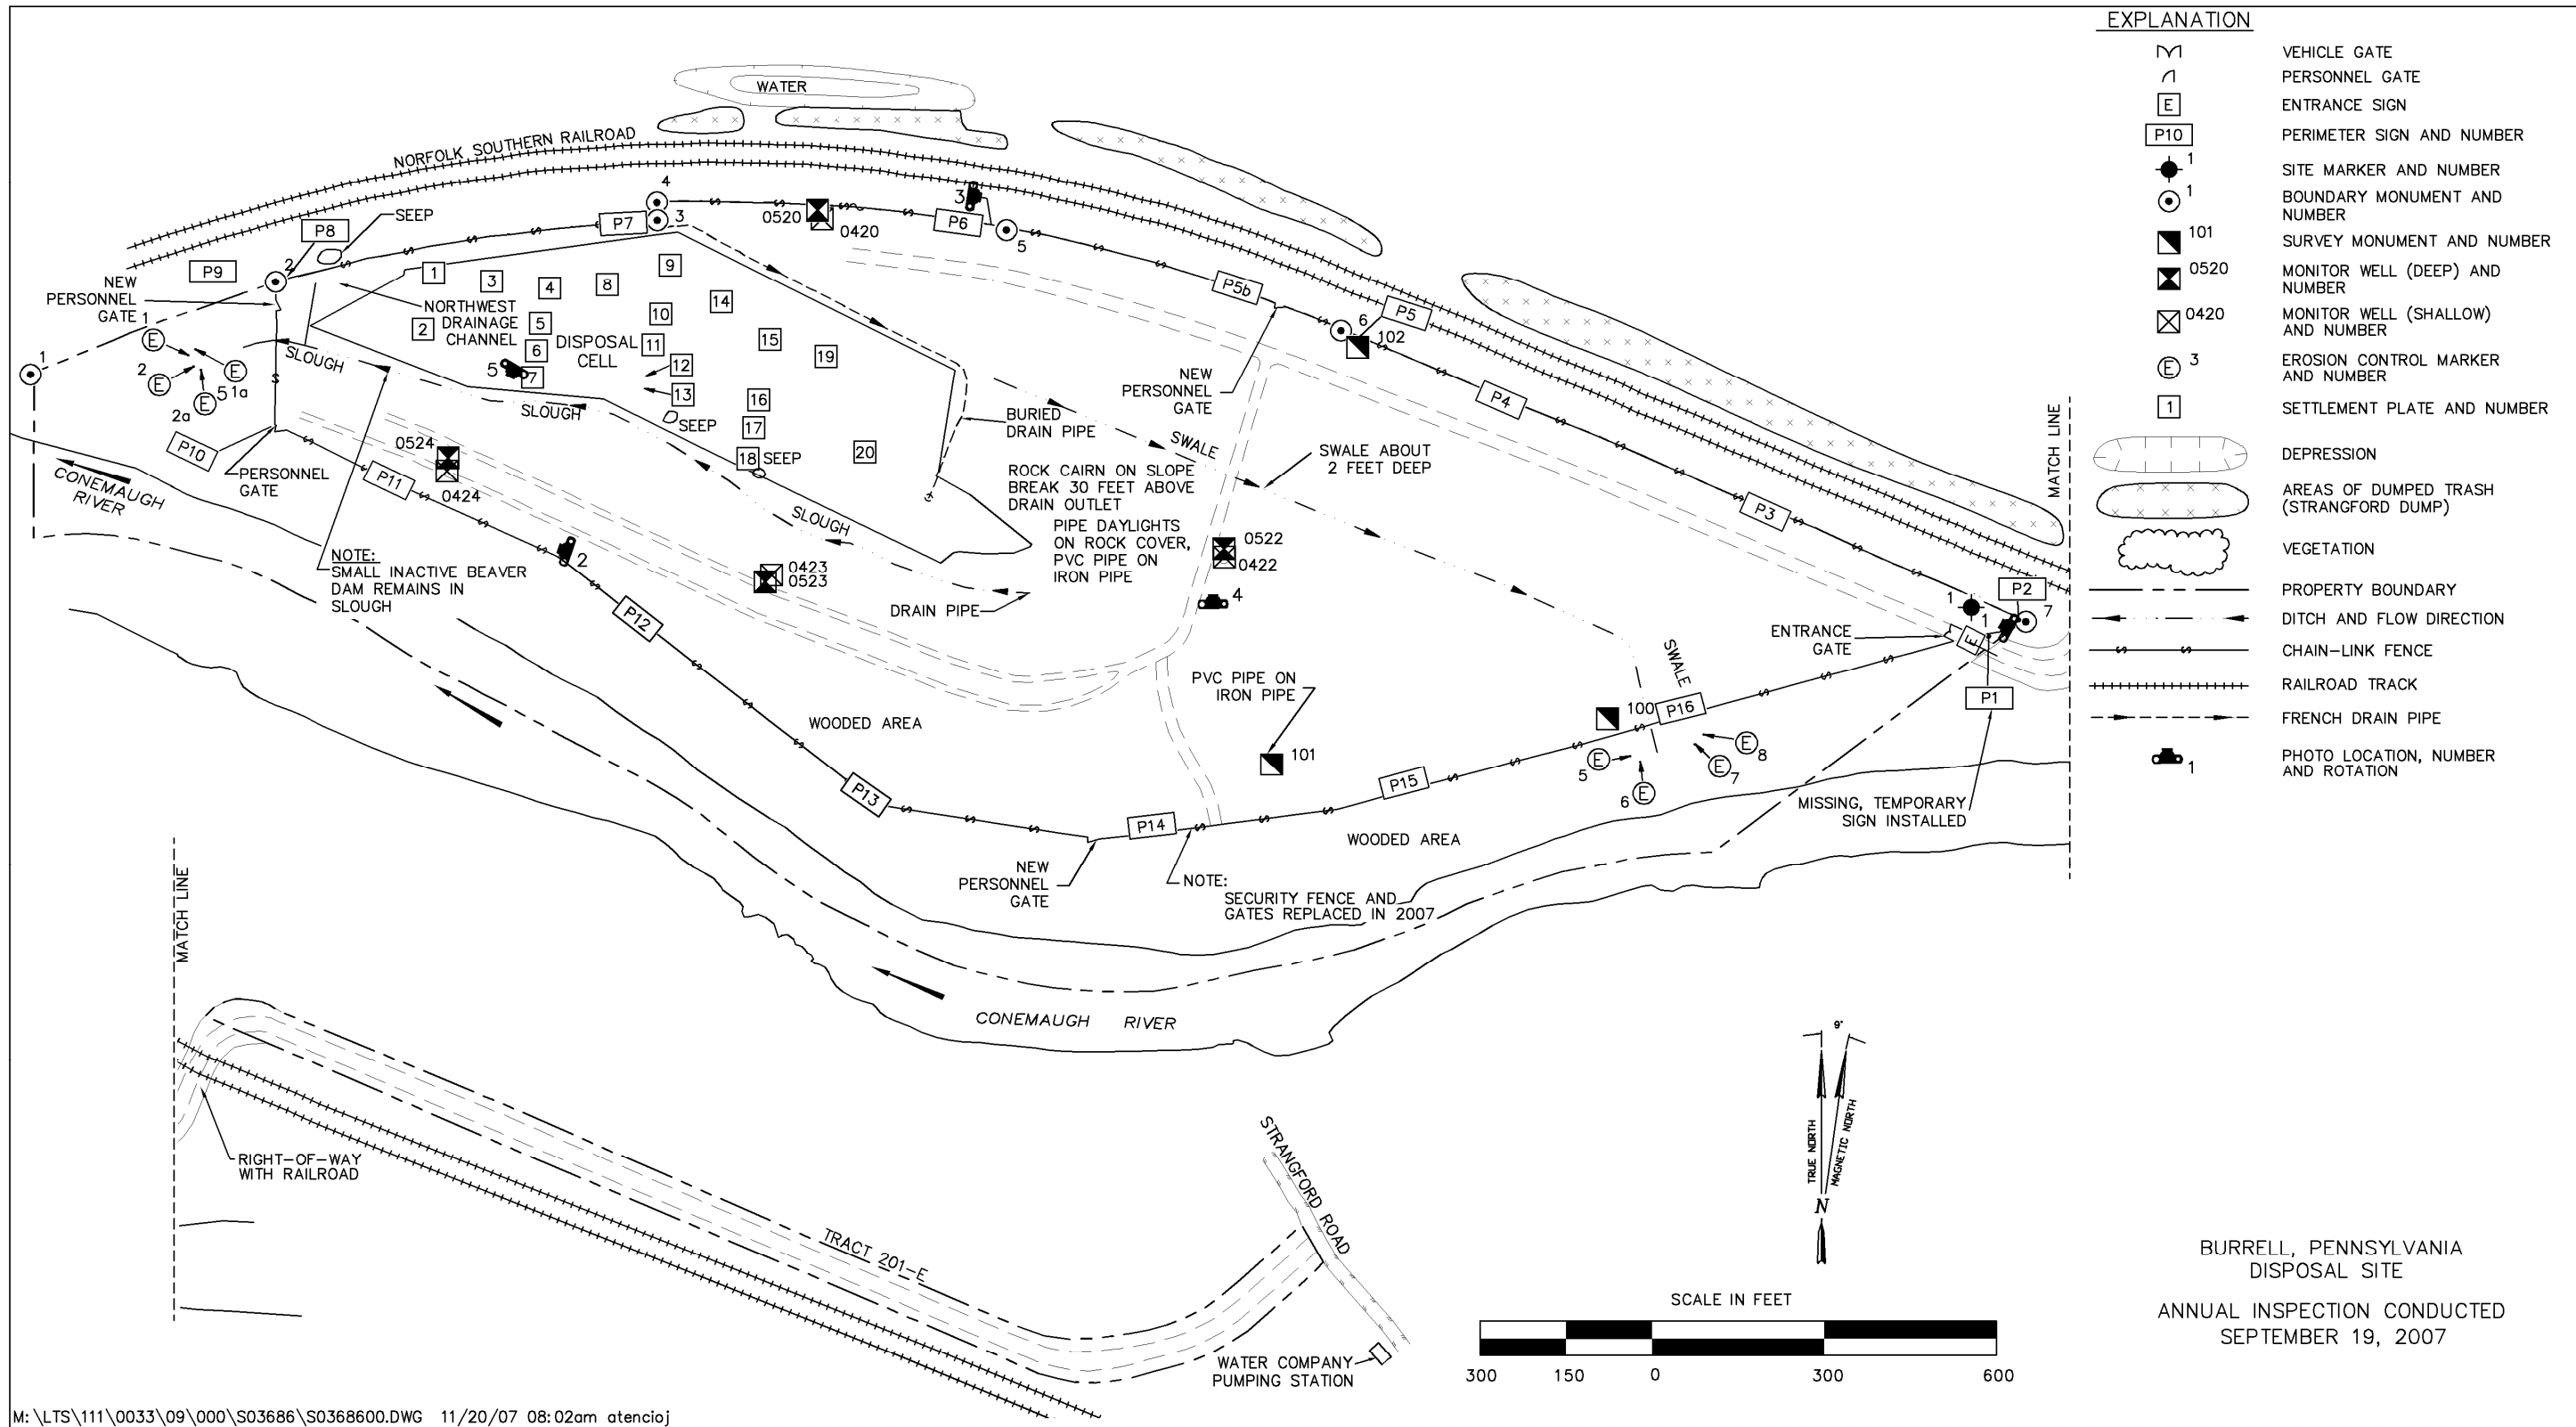
Figure 2-1. 2007 Annual Compliance Drawing for the Burrell, Pennsylvania, Disposal Site

All gates to the site are new and in excellent condition. Three new personnel gates have been added to the site in addition to the existing personnel and entrance gates. Locations of the new gates are shown on Figure 2-1. Vegetation (i.e., primarily Japanese knapweed) is rapidly encroaching upon areas of the new fence; a vegetation free maintenance corridor is maintained along the fence line (PL-2).
