## 2.0 Burrell, Pennsylvania, Disposal Site

### 2.1 Compliance Summary

Figure 2-1. 2006 Annual Compliance Drawing for the Burrell, Pennsylvania, Disposal Site

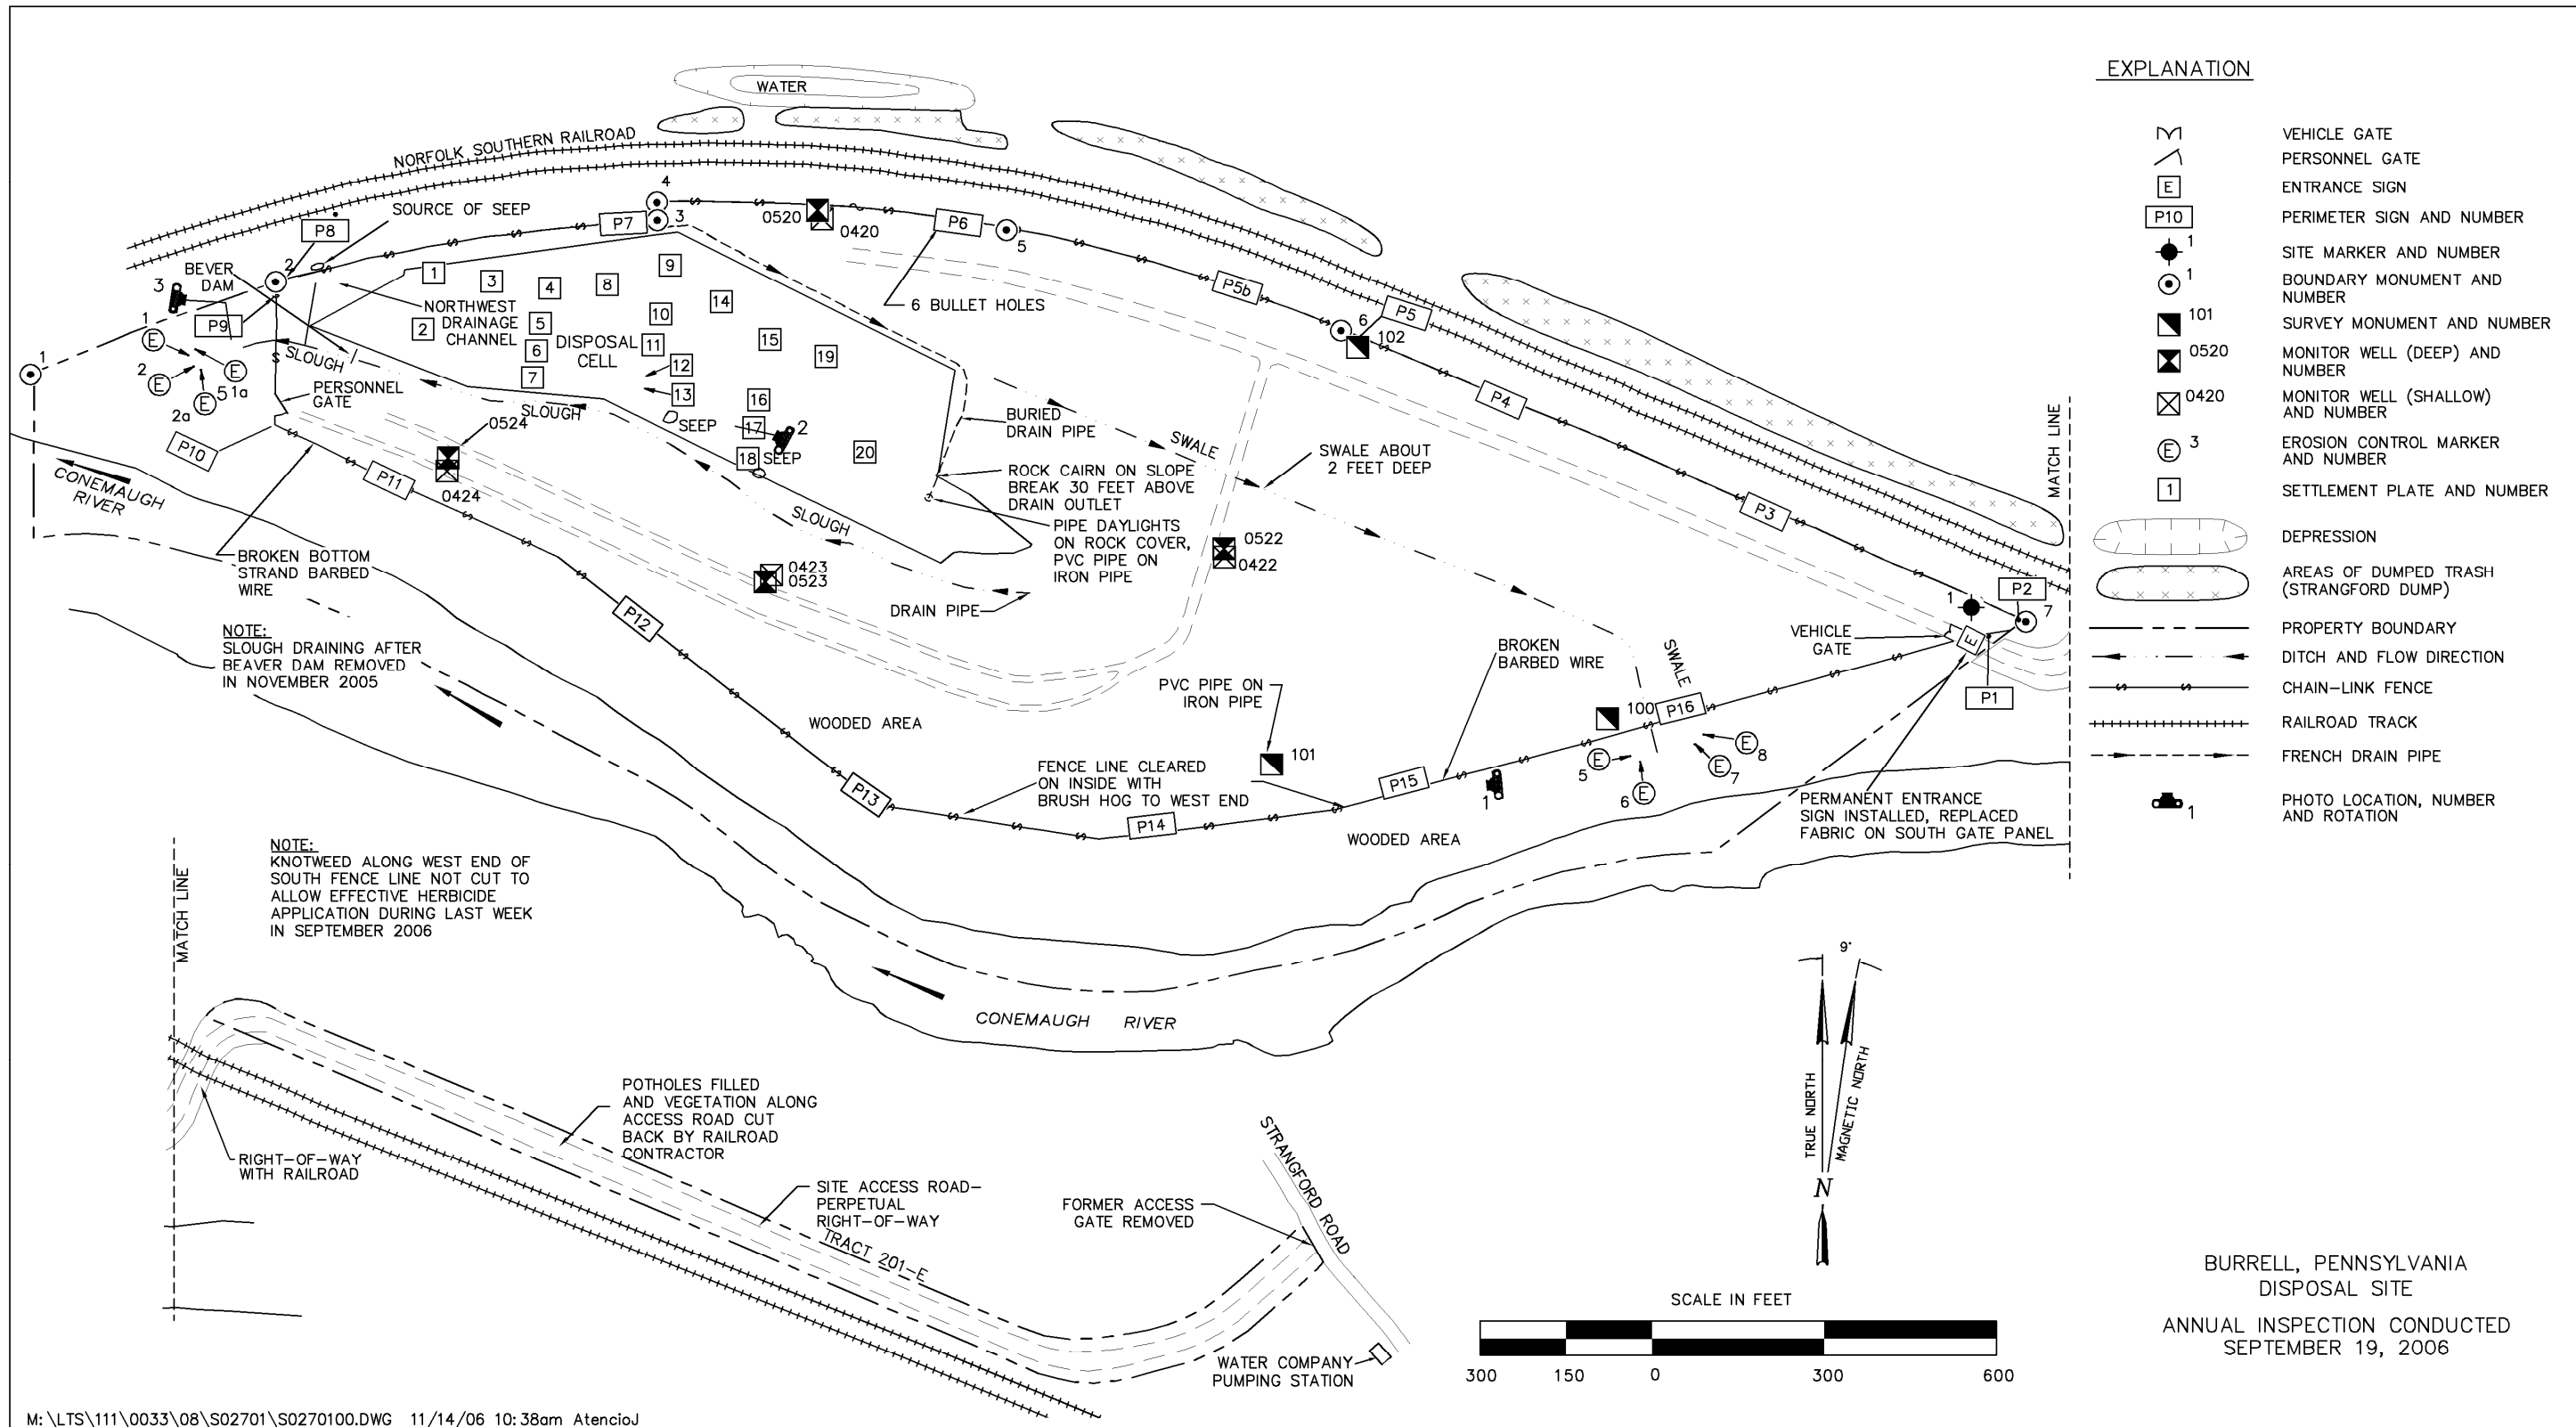
The site, located southeast of Blairsville, Pennsylvania, was inspected on September 19, 2006. Results of the inspection are described below. Features and photograph locations (PLs) mentioned in this report are shown on Figure 2-1. Numbers in the left margin of this report refer to items summarized in the Executive Summary table.
