3.0 Canonsburg, Pennsylvania, Disposal Site

3.1 Compliance Summary

Figure 3-1. 2013 Annual Inspection Drawing for the Canonsburg Disposal Site

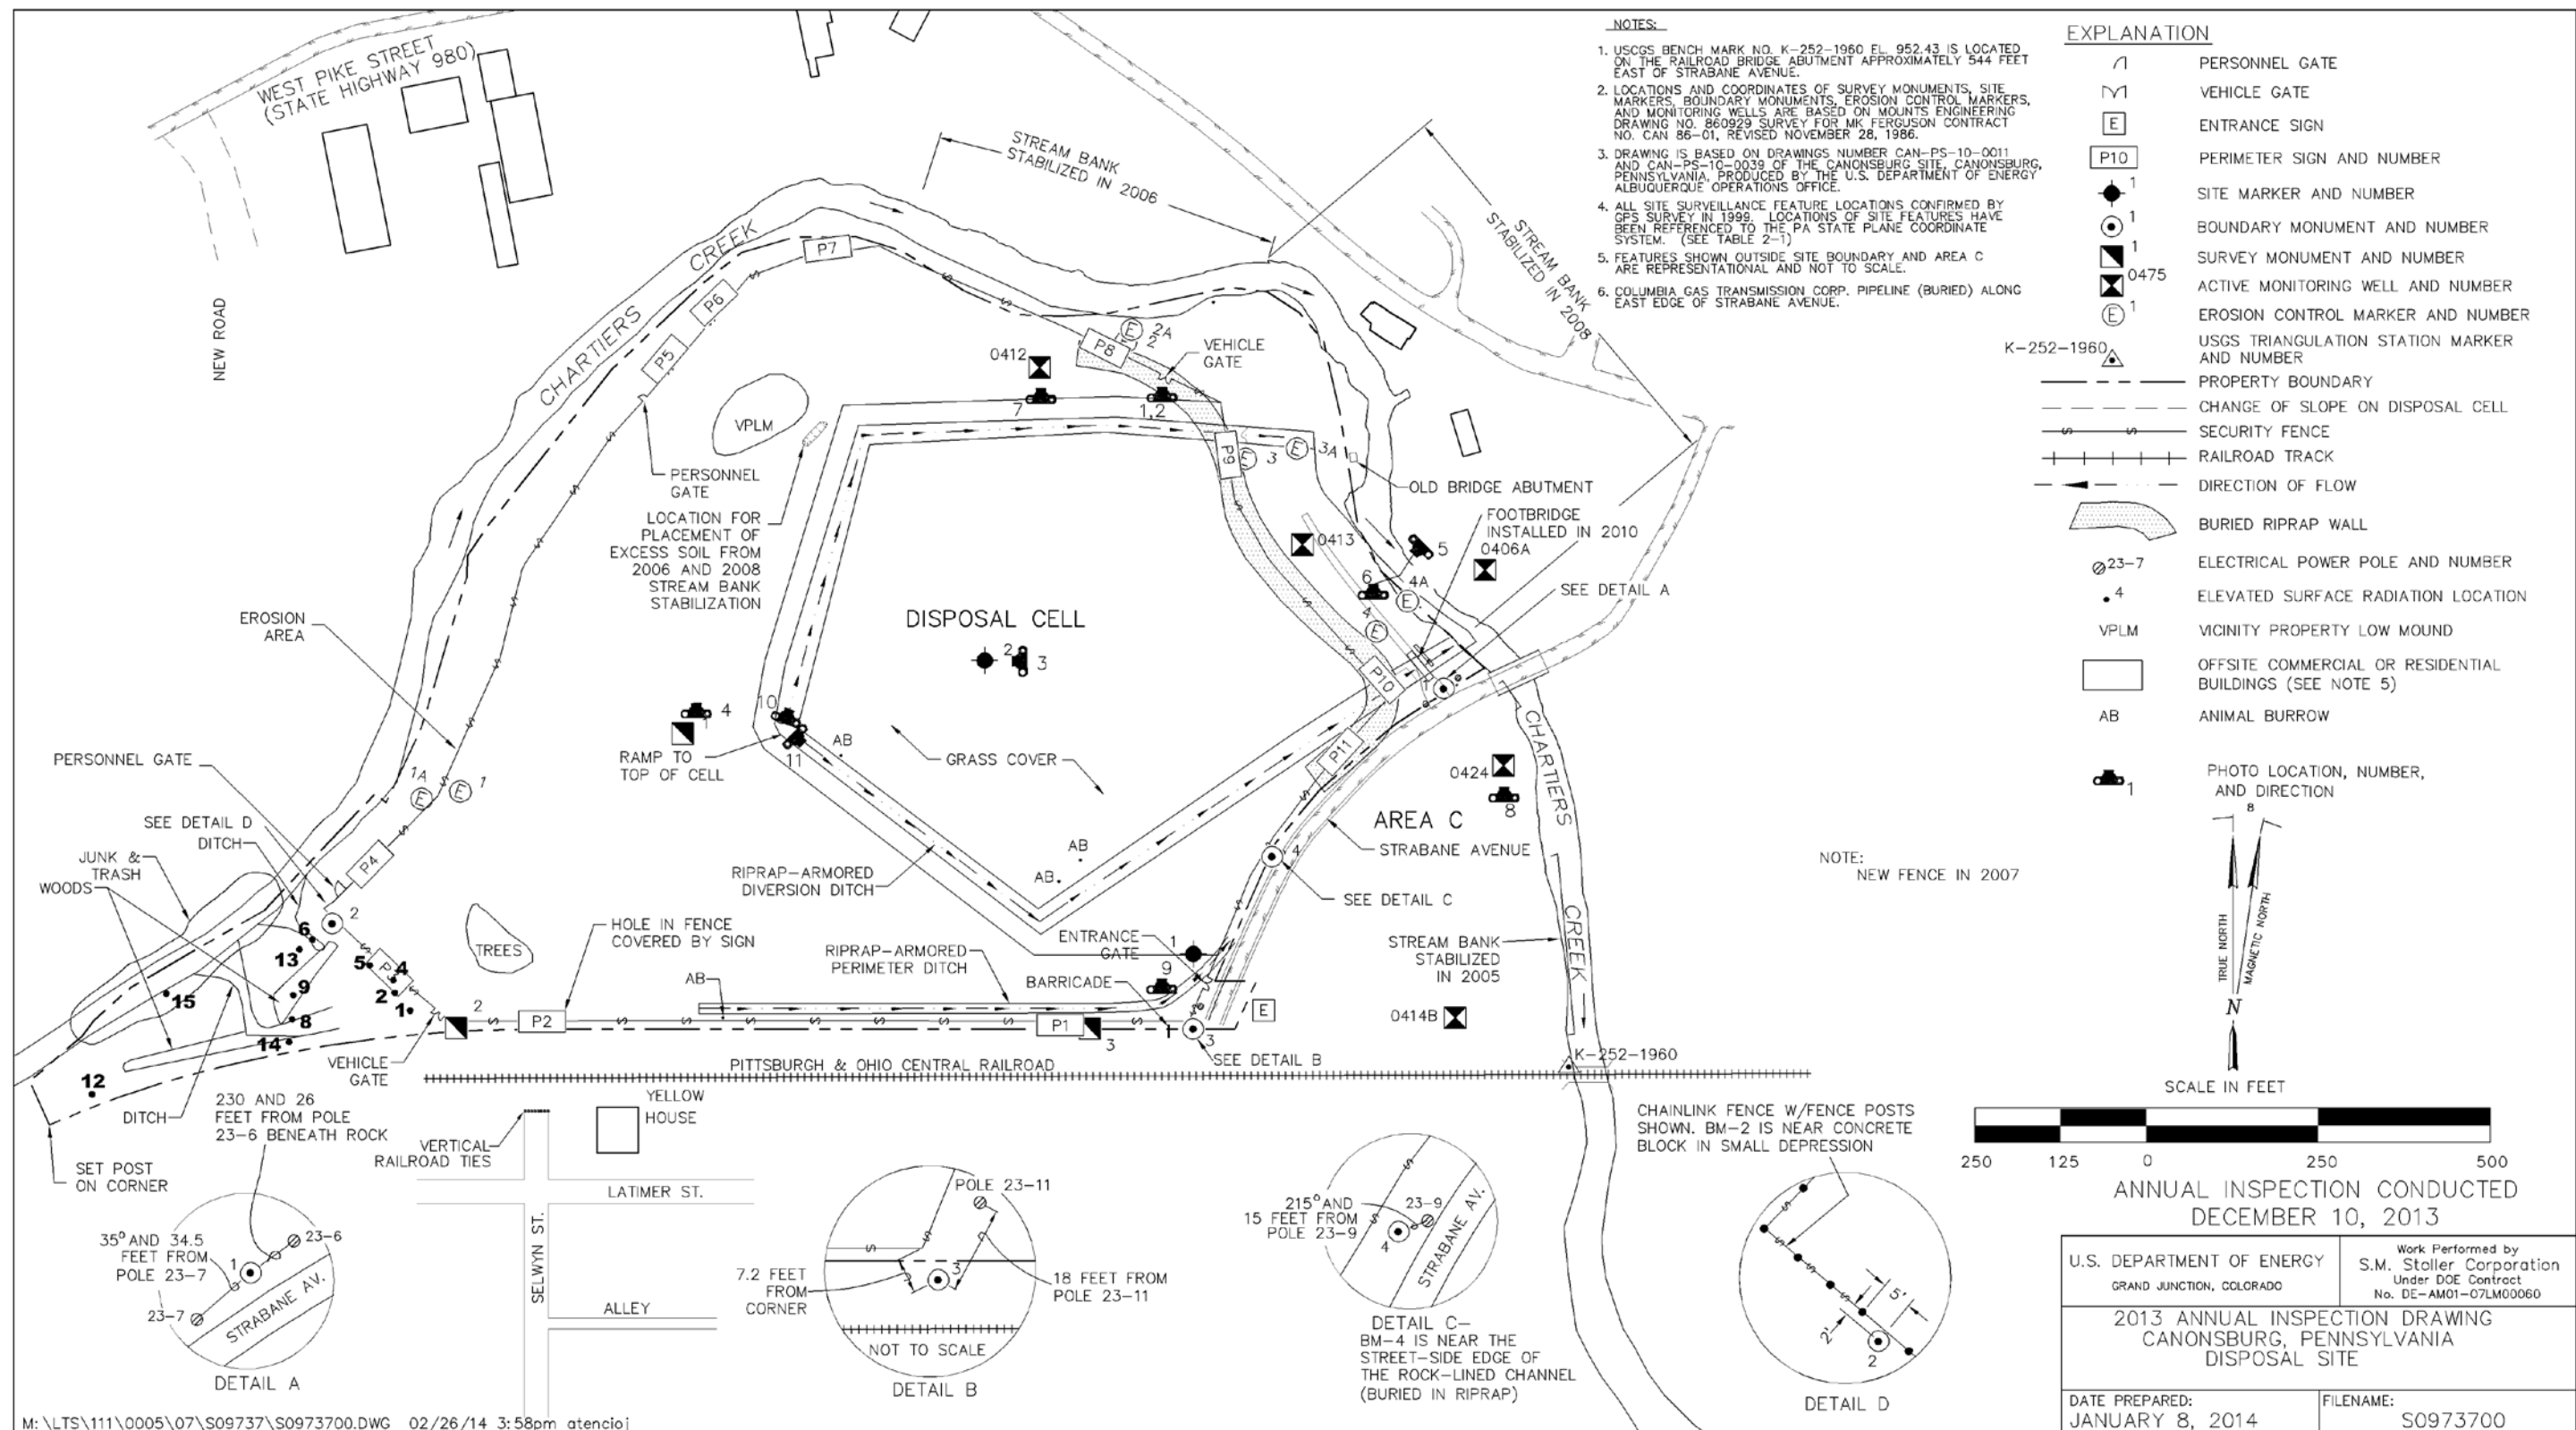
Figure 3-1 shows the locations of site surveillance features. Inspection results and recommended maintenance activities associated with site surveillance features are included in the following subsections. Photographs to support specific observations are identified in the text and in Figure 3-1 by photograph location (PL) numbers.

The security fence was replaced in 2007 and remains in excellent condition, with the exception of the north vehicle gate. The hinge on the north vehicle gate requires minor adjustment (PL-1 and PL-2). A vegetation-free buffer zone is being maintained around the entire site security fence.

An area of erosion under the fence is present along the western edge of the site where the old fence line was located. The area appears to be stable and does not need to be filled in at this time. The area will be checked during future inspections to determine if conditions have changed such as to require some type of maintenance action.

The perimeter security fence has 11 attached signs identifying the site. With the exception of perimeter sign P2, all perimeter signs were in good condition. Perimeter sign P2 is held in place with zip-ties, and covers a small hole in the fence where the original P2 perimeter sign was stolen in 2011.
