3.0 Canonsburg, Pennsylvania, Disposal Site

3.1 Compliance Summary

The Canonsburg, Pennsylvania, Uranium Mill Tailings Radiation Control Act (UMTRCA) Title I Disposal Site was inspected on October 4, 2011. The disposal cell and all associated surface water diversion and drainage structures were in excellent condition and functioning as designed. No other maintenance needs or cause for a follow-up or contingency inspection was identified.

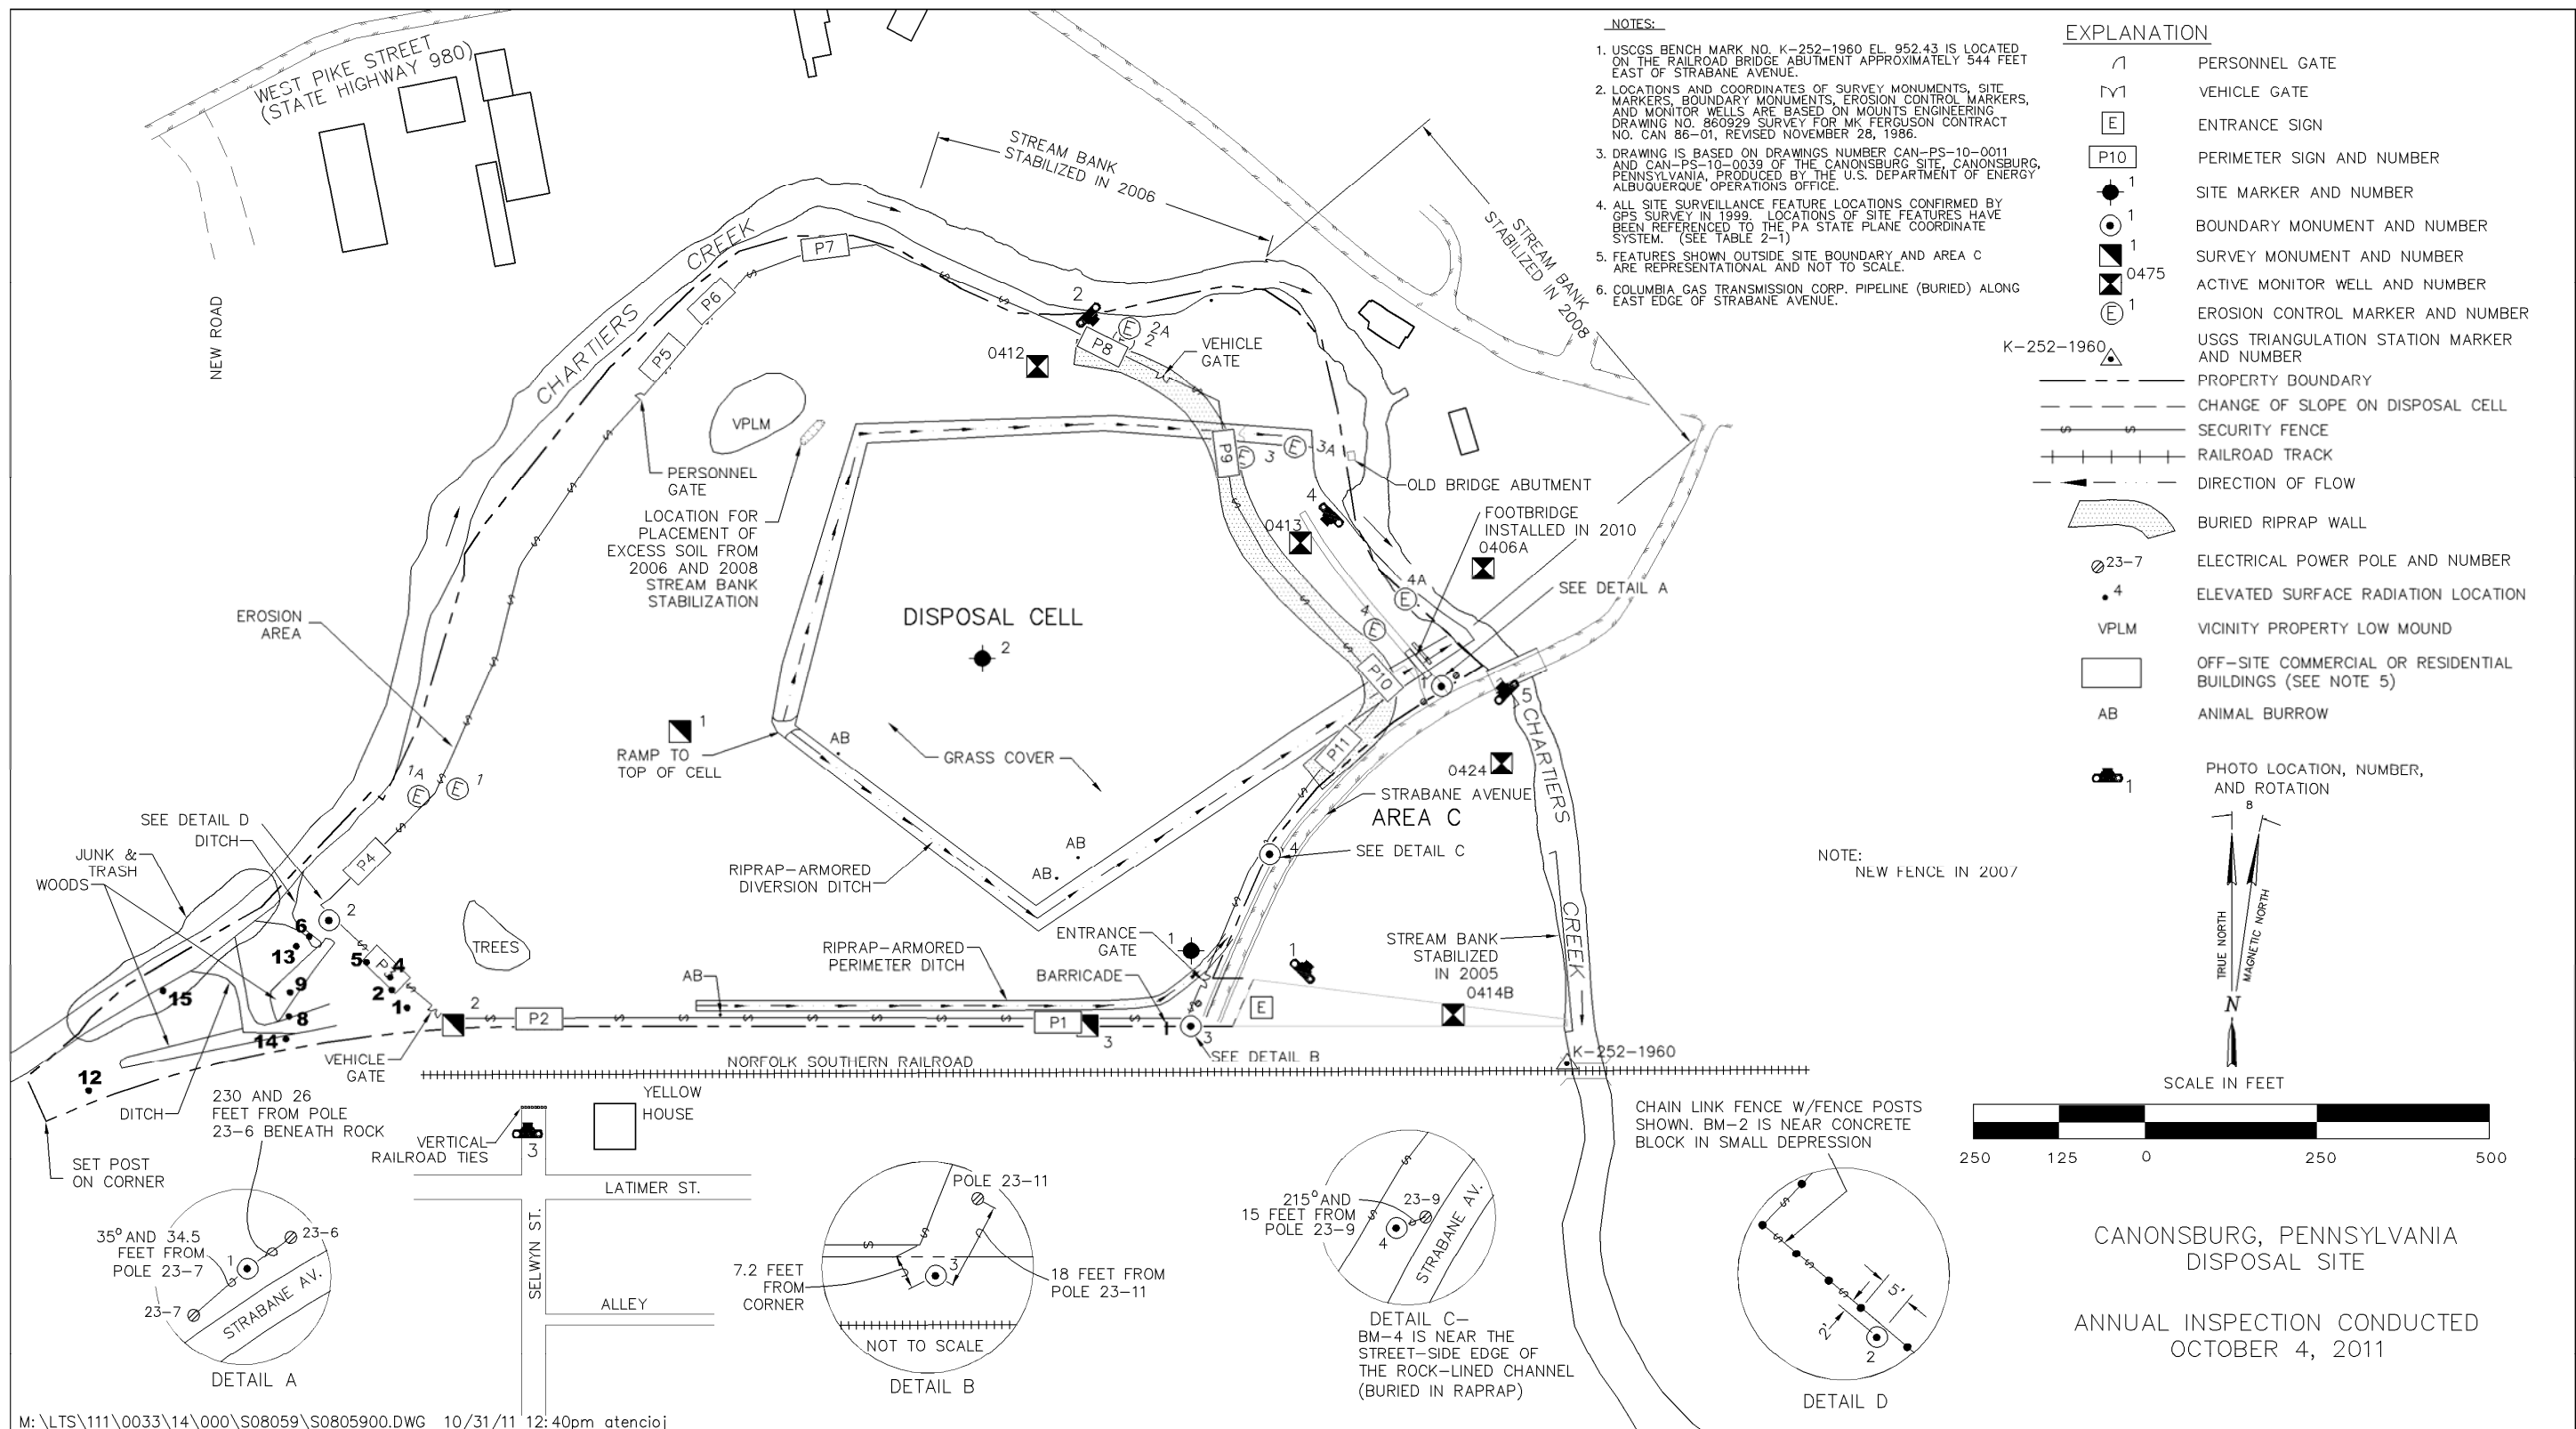
Figure 3-1. 2011 Annual Compliance Drawing for the Canonsburg Disposal Site

Access, Gates, Fence, and Signs—Access to the site is directly from Strabane Avenue, a public right-of-way within the Borough of Canonsburg in Washington County, Pennsylvania. The security fence and all four site gates were in excellent condition. A vegetation-free buffer zone is being maintained around the entire site security fence (PL–2). The entrance sign and 11 perimeter signs were in good condition.

A small footbridge was installed north of the disposal cell in 2010, improving access to an unfenced portion of the site. The footbridge provides a safer way for the public to cross a riprap-lined diversion ditch. The footbridge was in excellent condition.

All site markers and monuments are in excellent condition. Erosion control marker EC-4A was replaced just prior to this year's inspection. The original monument was lost several years ago to flooding along Chartiers Creek. Installation of a replacement marker was delayed to coincide with the completion of several stream bank stabilization projects in the area of the monument, including revegetation associated with those projects.

All of the monitoring wells were in excellent condition. Monitoring well 0410 (a background well that was no longer used) was safely plugged and abandoned on September 12, 2011, in accordance with the Pennsylvania Water Well Drillers License Act (Act 610). The site of the abandoned well was in excellent condition (PL-3).

3A Disposal Cell—The grass-covered disposal cell surface was in excellent condition. There was no evidence of slumping, settling, erosion, or other modifying processes. The grass was mowed in accordance with the LTSP. Noxious and invasive weeds continue to be successfully controlled through a combination of mowing and spot-spraying.

Animal burrows continue to be observed on the cell cover. Because a 36-inch-thick clay layer (radon barrier), an 18-inch-thick rock layer, and a 12-inch-thick topsoil layer overlie the buried tailings at this site, biointrusion into the tailings is unlikely, and such burrows should not pose a risk to the disposal cell's integrity or the public's health. The location, level of activity, and significance of burrows on the cell cover will continue to be monitored.

Diversion Channels and Perimeter Ditch—Diversion channels around the disposal cell and the perimeter ditch along the south side of the site are armored with riprap and were in good condition. No indications of diminished rock durability were noted. Woody vegetation in the diversion ditches continues to be controlled by cutting and spraying.

- Drain holes were installed in the protective casings of wells 0406A, 0412, and 0413.
- A brass identification tag was installed on well 0413.
- A concrete pad and protective bollards were installed at well 0413 (PL-4).
- Protective bollards were repaired or installed at wells 0414B and 0424.
