3.0 Canonsburg, Pennsylvania, Disposal Site

3.1 Compliance Summary

The Canonsburg, Pennsylvania, Uranium Mill Tailings Radiation Control Act (UMTRCA) Title I Disposal Site was inspected on October 20, 2010. The disposal cell and all associated surface water diversion and drainage structures were in excellent condition and functioning as designed. No other maintenance needs or cause for a follow-up or contingency inspection was identified.

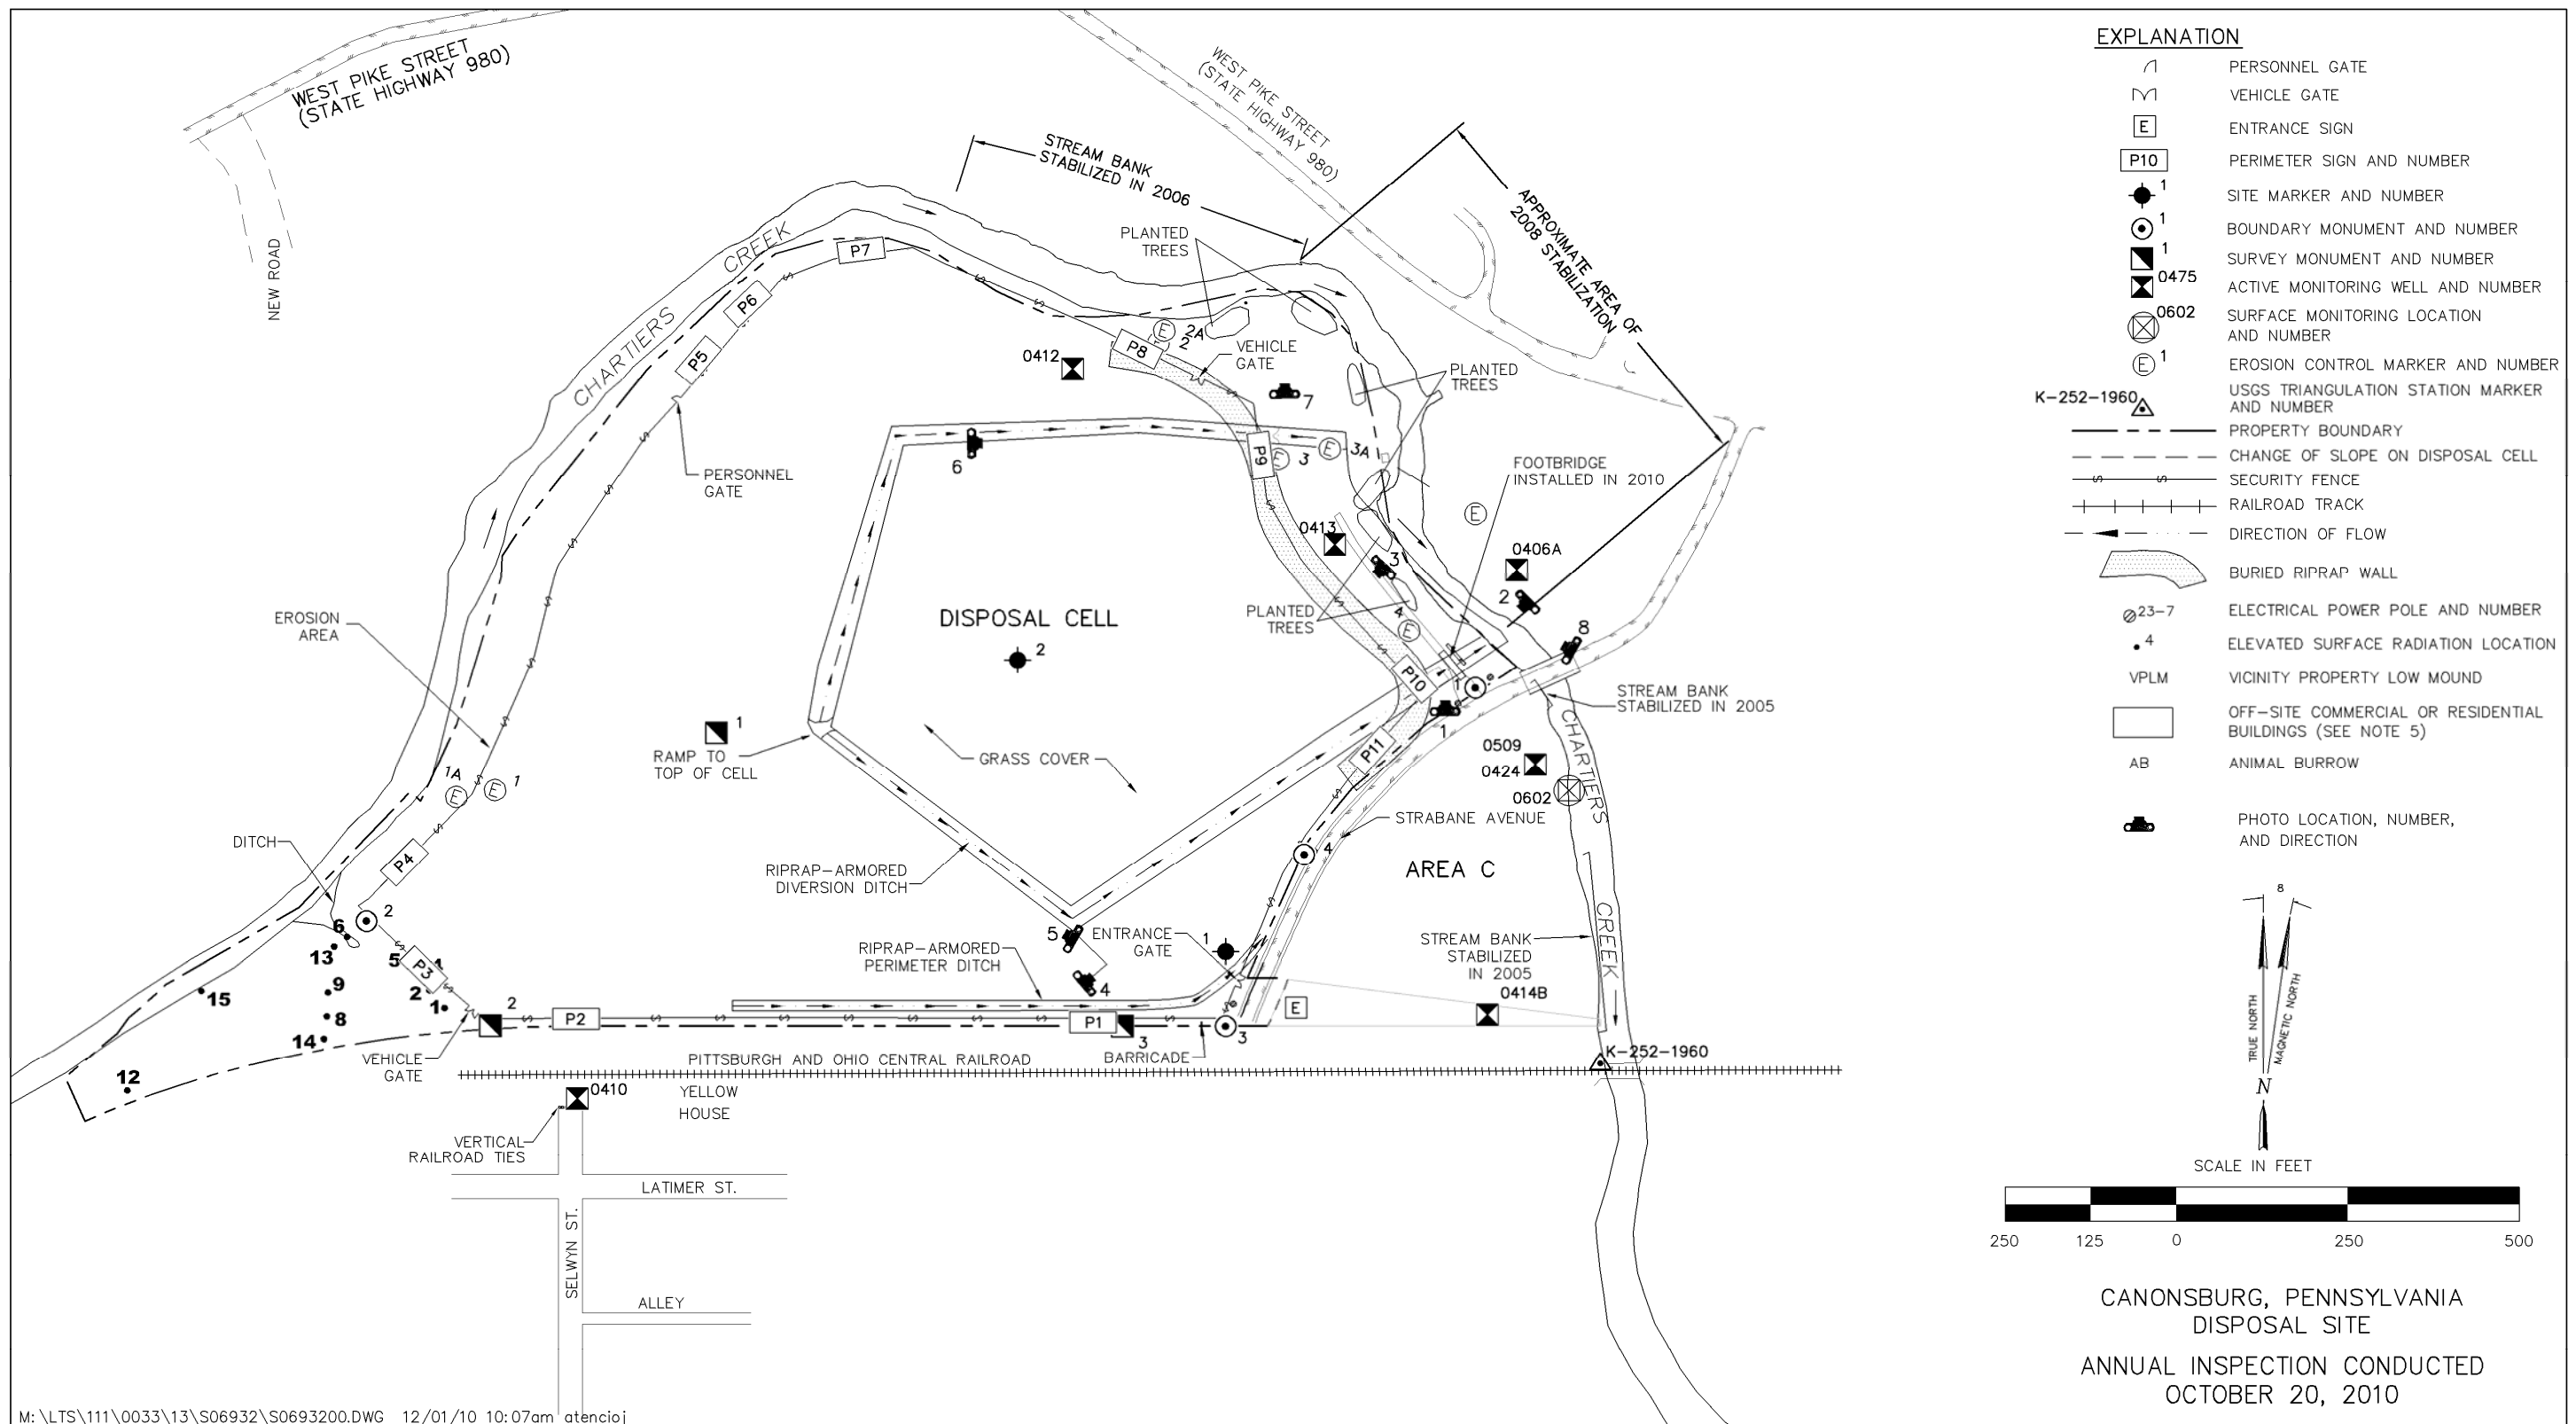
Figure 3-1. 2010 Annual Compliance Drawing for the Canonsburg Disposal Site

Both site markers are in excellent condition. Four pairs of erosion control markers were initially installed along the bank of Chartiers Creek. Three pairs are in excellent condition, and the fourth pair requires a replacement. Erosion control marker EC–4A was lost to erosion in 1997. Now

- 3A that Stream Bank Stabilization in the area is complete, the marker will be replaced. This work will be coordinated with similar work at the Burrell, Pennsylvania, Disposal Site to improve efficiency and reduce costs.
