3.0 Canonsburg, Pennsylvania, Disposal Site

3.1 Compliance Summary

The Canonsburg, Pennsylvania, Uranium Mill Tailings Radiation Control Act (UMTRCA) Title I Disposal Site was inspected on October 21, 2009. The disposal cell and all associated surface water diversion and drainage structures were in excellent condition and functioning as designed.

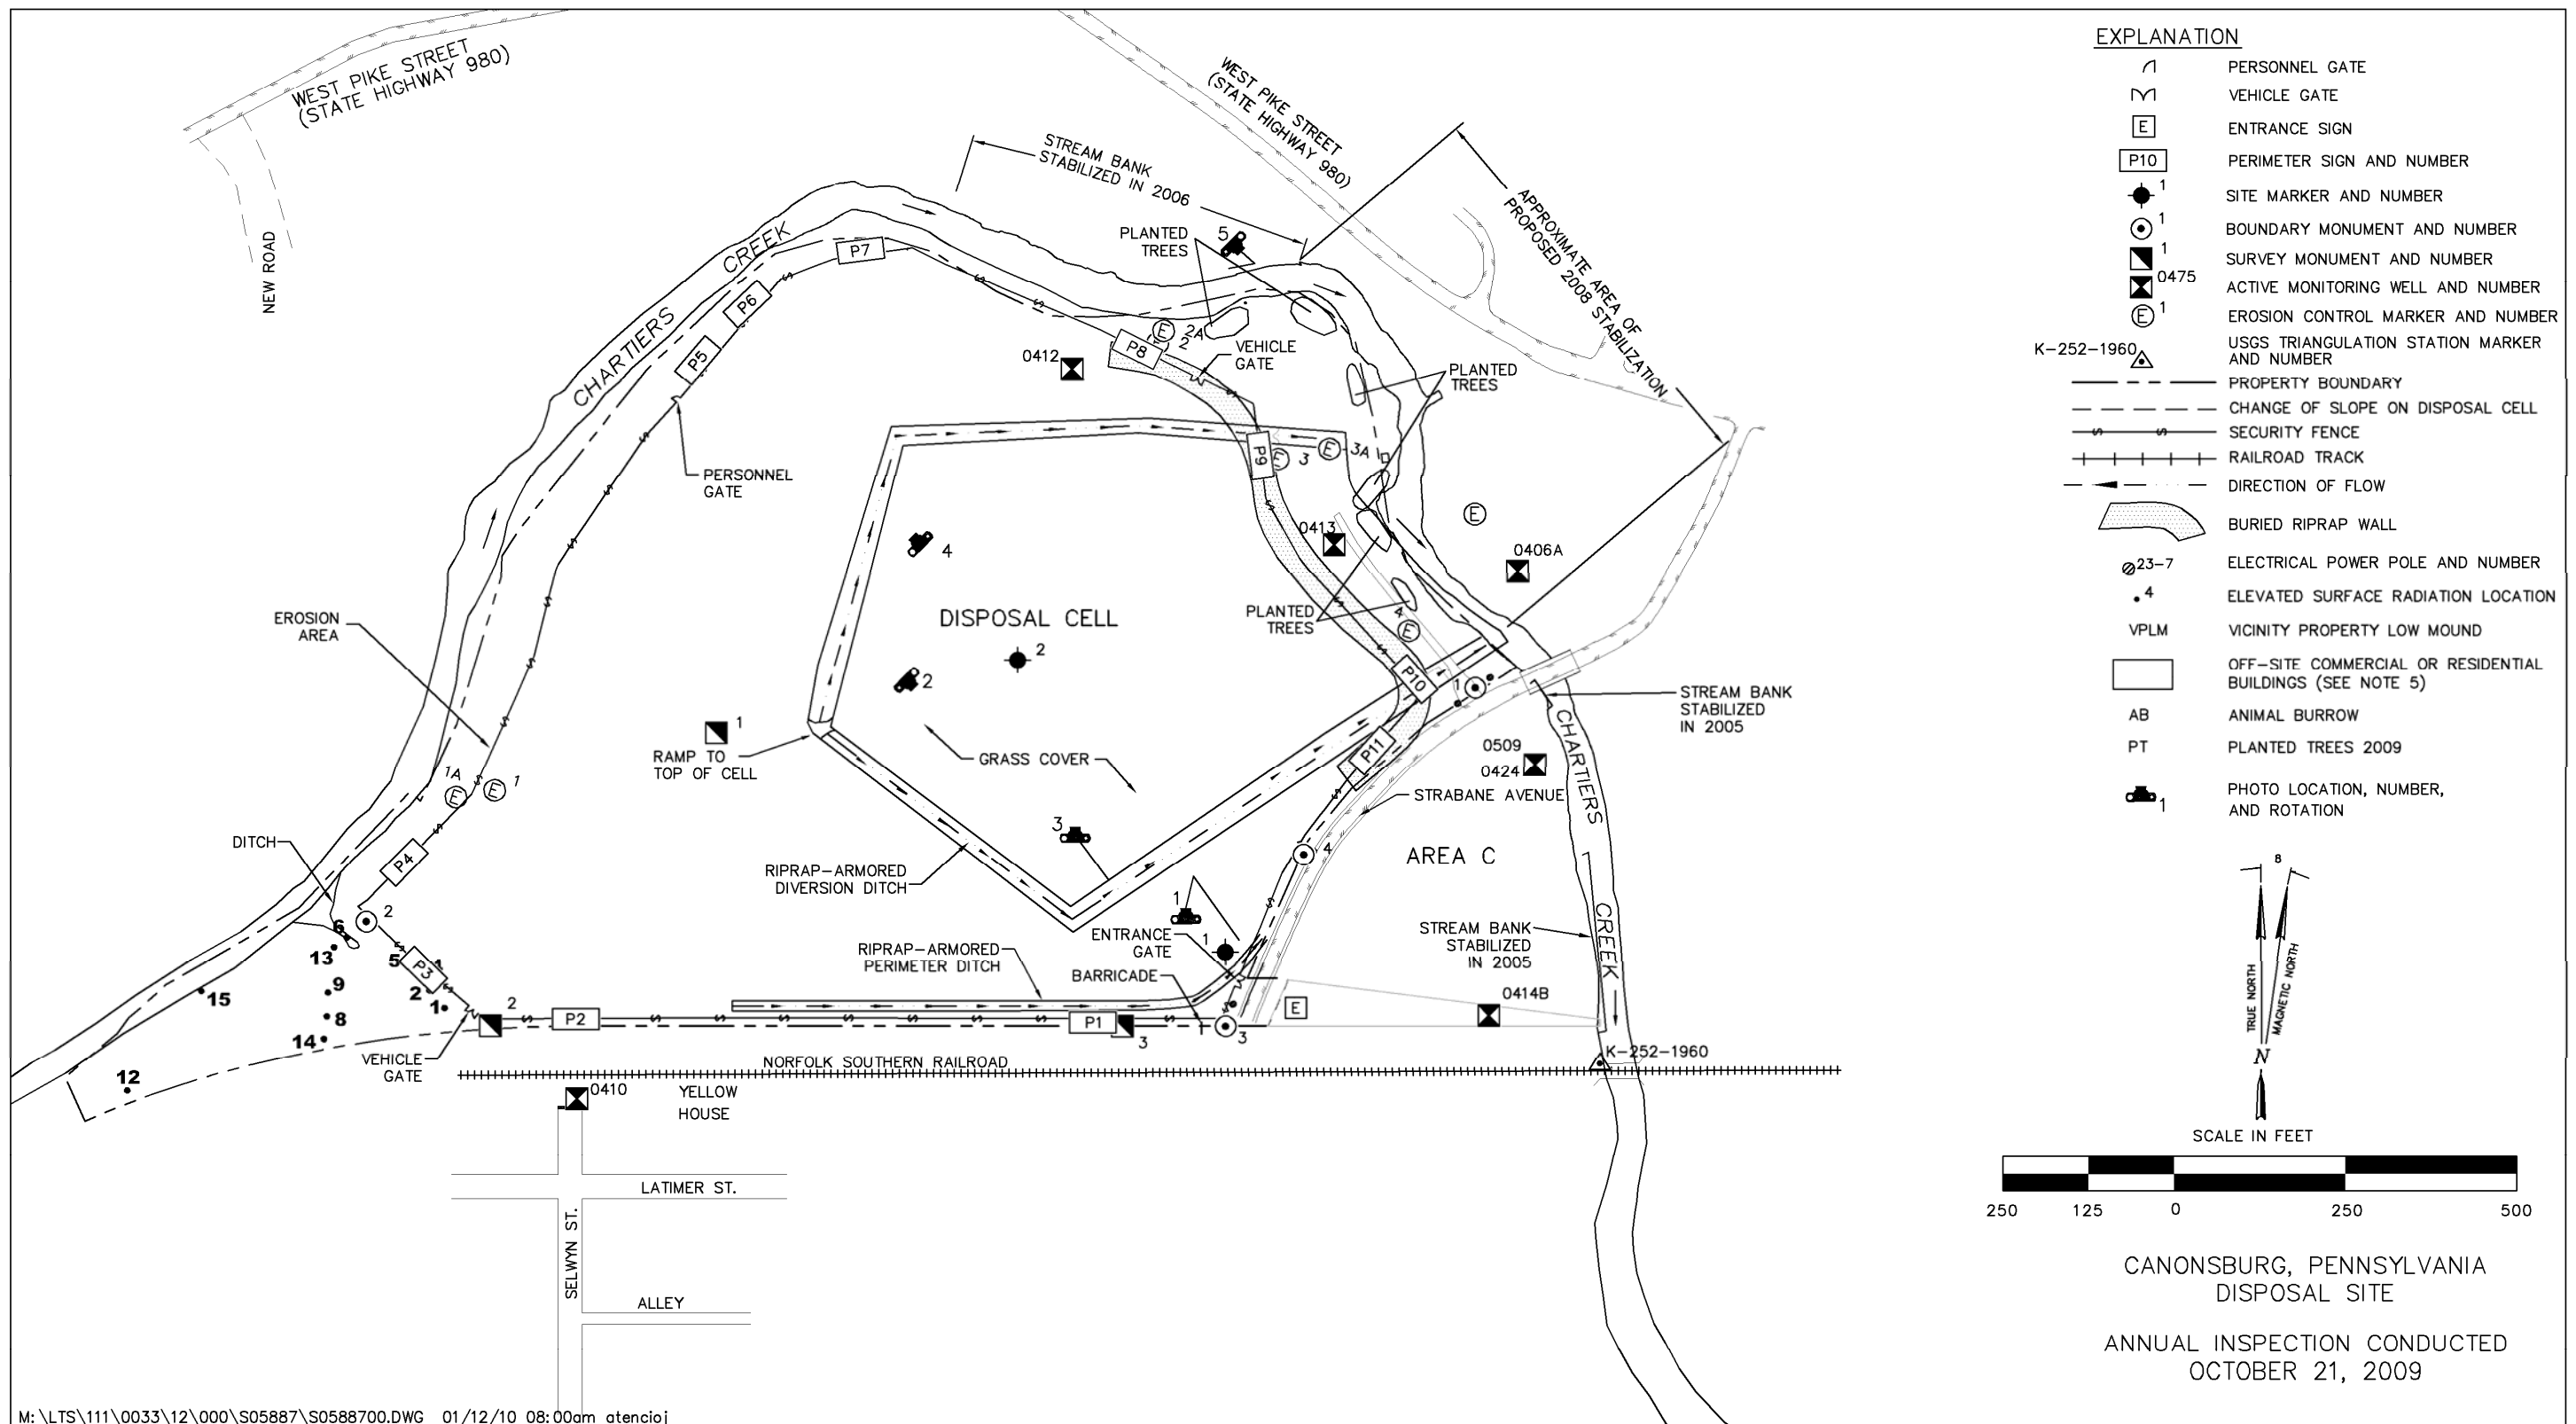
Figure 3-1. 2009 Annual Compliance Drawing for the Canonsburg Disposal Site

Access, Gates, Fence, and Signs—Access to the site is directly from Strabane Avenue, a public right-of-way within the borough of Canonsburg in Washington County, Pennsylvania. The security fence and all four site gates were in excellent condition. A vegetation-free buffer zone is being maintained around the entire site security fence. The entrance sign and 11 perimeter signs were in good condition.

Both site markers are in excellent condition (PL–1). Four pairs of erosion control markers were initially installed along the bank of Chartiers Creek. One of these markers, ECM–4A, was lost to erosion in 1997; erosion control marker ECM–4 has been used for reference. Stream bank stabilization work is complete, and erosion control marker ECM–4A will be replaced. All remaining erosion control markers were in excellent condition.

The three survey monuments and four boundary monuments were located and in excellent condition.

Monitoring wells—All five monitoring wells that constitute the groundwater monitoring network (MW–0406A, MW–0412, MW–0413, MW–0414B, and MW–0424) were in excellent condition. The revised LTSP (issued in 2008) no longer requires that well MW–0410 be monitored. However, the well will not be abandoned at this time and will remain secured with a lock and inspected.
