## 3.0 Canonsburg, Pennsylvania, Disposal Site

### 3.1 Compliance Summary

The Canonsburg, Pennsylvania, Uranium Mill Tailings Radiation Control Act (UMTRCA) Title I Disposal Site (site) was inspected on October 11, 2018. No changes were observed on the disposal cell or in the associated drainage features. Inspectors identified several minor maintenance needs.

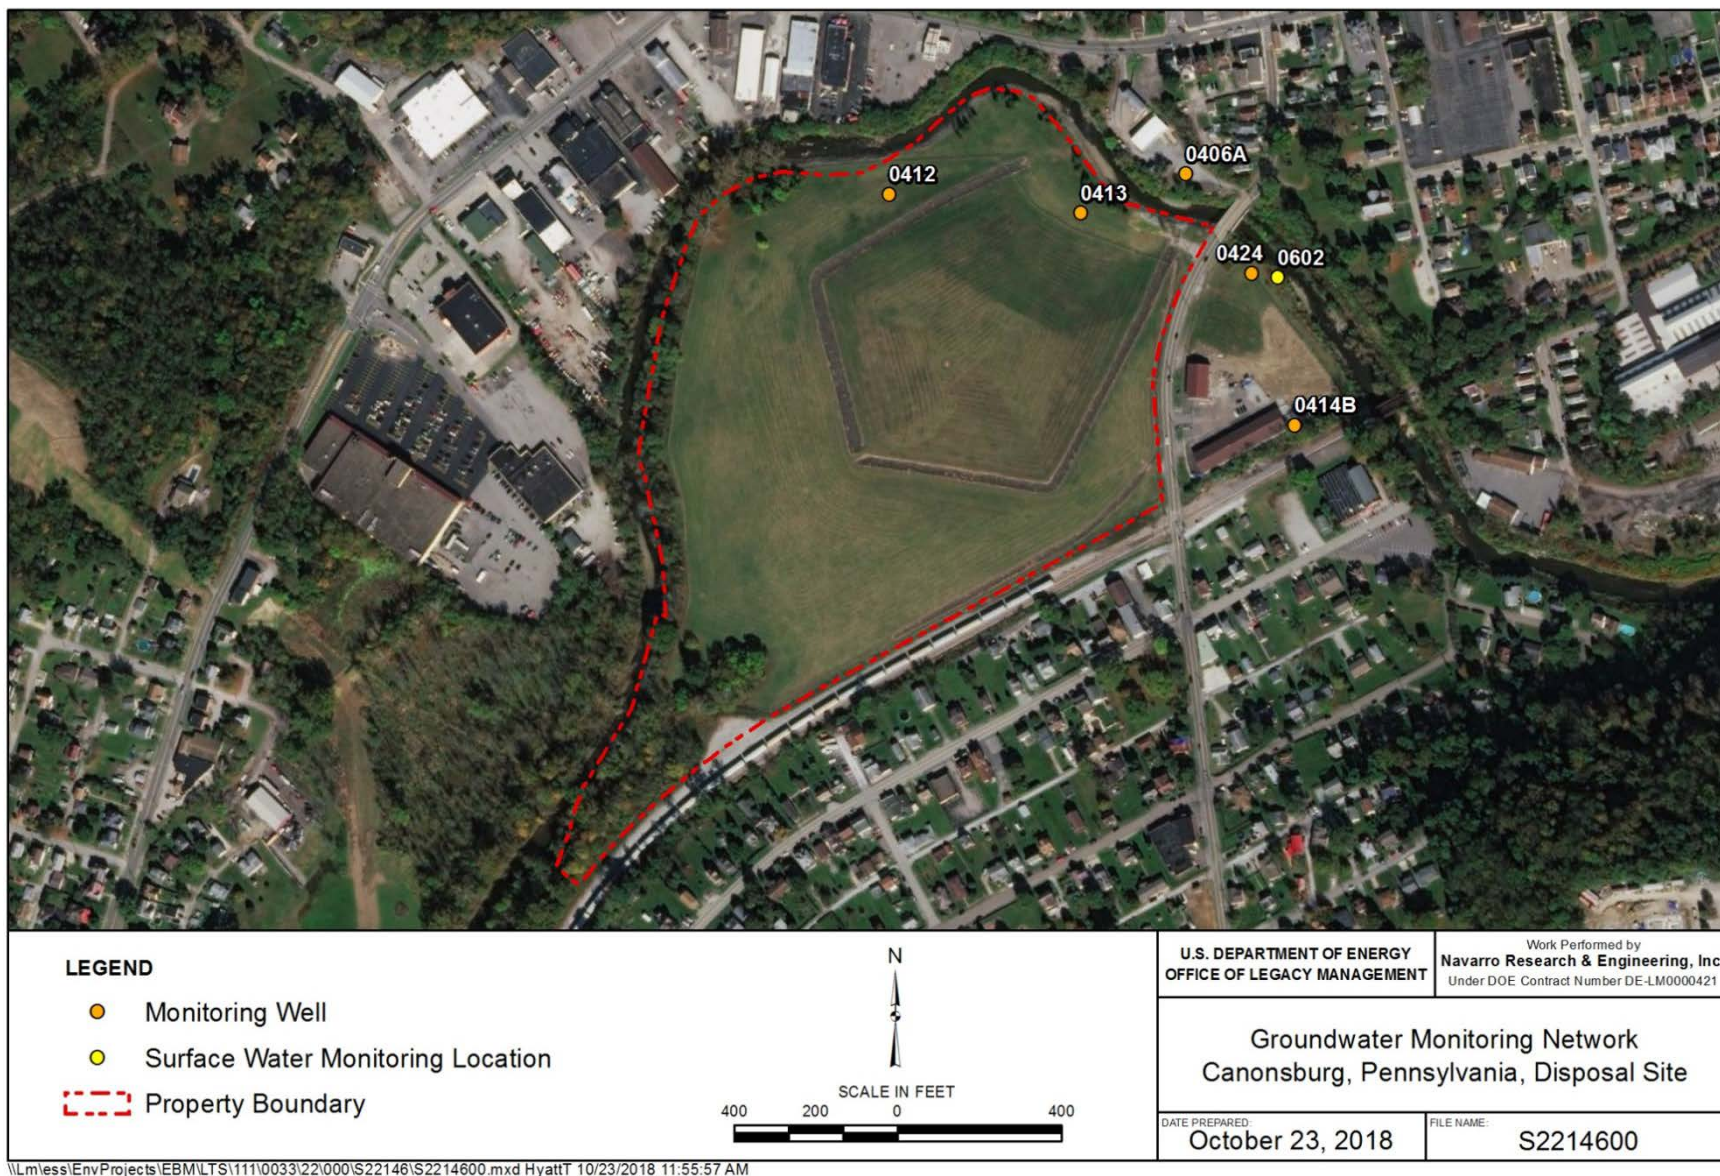
Figure 3-2. Groundwater Monitoring Network for the Canonsburg, Pennsylvania, Disposal Site

The groundwater monitoring network consists of five monitoring wells, including three POC wells and two best management practice wells (Table 3-2 and Figure 3-2). All monitoring wells are completed in the uppermost aquifer (shallow unconsolidated materials). Groundwater is sampled for the constituent of concern, uranium. The ACL is 1.0 milligrams per liter (mg/L) at the POC wells. All groundwater monitoring results for the site are reported and published on the LM Geospatial Environmental Mapping System website (<http://gems.lm.doe.gov/#site=CAN>).

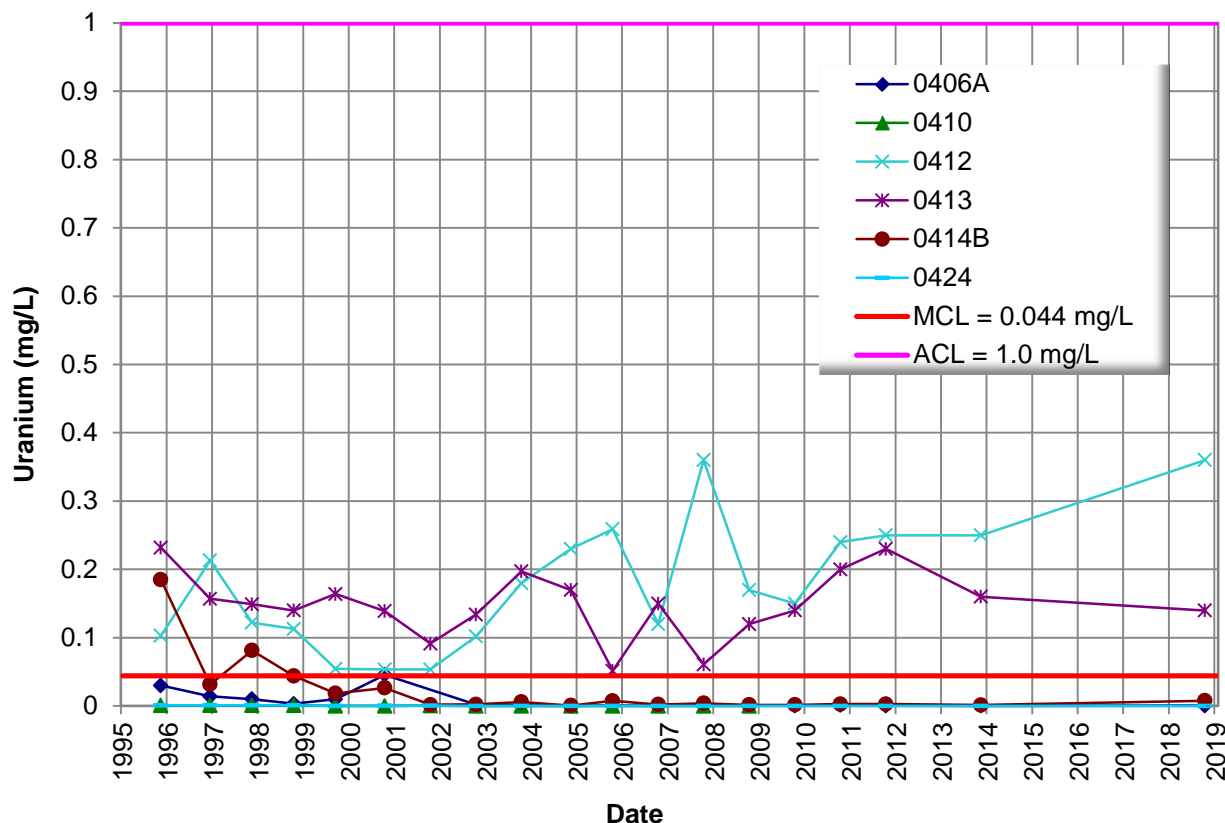
Figure 3-3. Uranium in Groundwater at the Canonsburg, Pennsylvania, Disposal Site

Uranium concentrations in 2018 were below the established ACL (Figure 3-3). With the exception of monitoring wells 0412 and 0413, uranium concentrations in 2018 were also below the MCL of 0.044 mg/L.

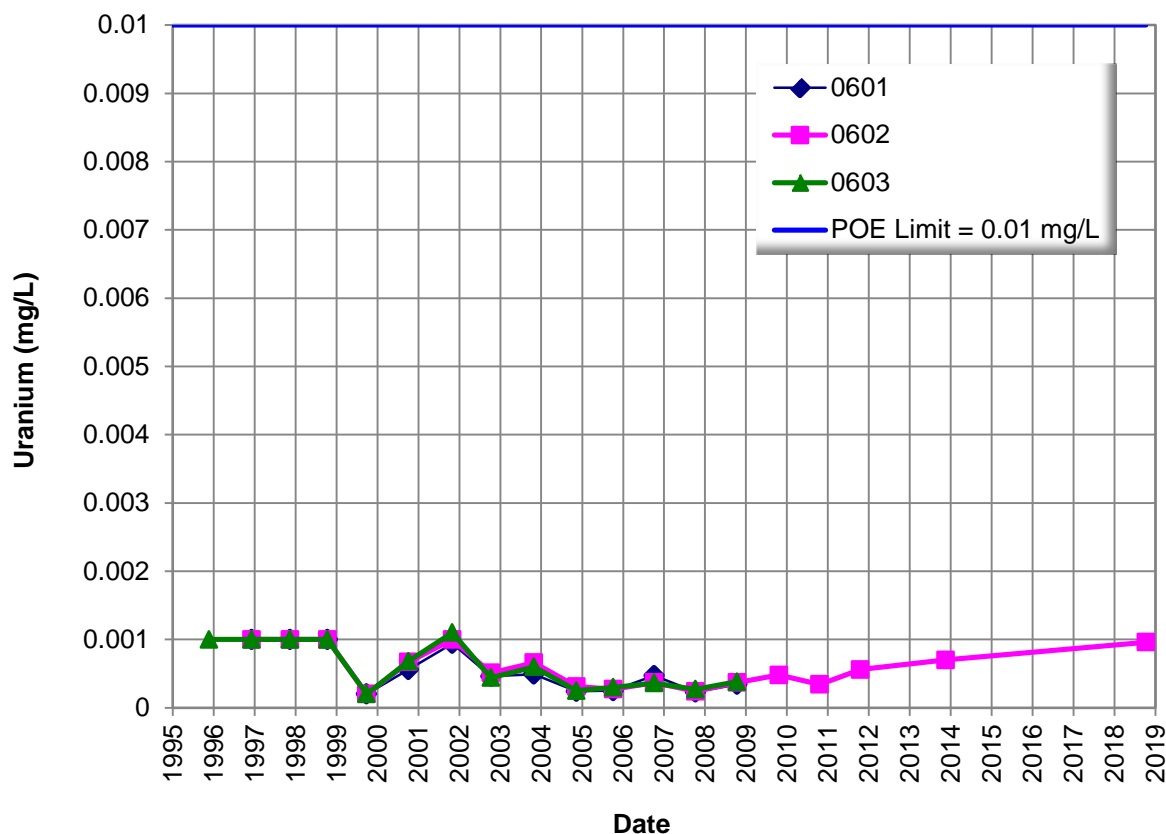
Figure 3-4. Uranium in Surface Water at the Canonsburg, Pennsylvania, Disposal Site

All surface water monitoring results for the site are reported and published on the LM Geospatial Environmental Mapping System website (<http://gems.lm.doe.gov/#site=CAN>). The 2018 uranium concentration of surface water at location 0602 remained significantly below the established concentration limit of 0.01 mg/L (Figure 3-4).
