5.0 Falls City, Texas, Disposal Site

5.1 Compliance Summary

The Falls City, Texas, Uranium Mill Tailings Radiation Control Act (UMTRCA) Title I Disposal Site, was inspected on January 15, 2008. The disposal cell and all associated surface water diversion and drainage structures were in excellent condition and functioning as designed. Control of deep-rooted woody vegetation on the top and side slopes of the disposal cell continues. Grass continues to be cut and baled on site, including on the disposal cell cover. Minor fence repair were performed and one missing perimeter sign was replaced. Groundwater monitoring was performed; generally, historical trends continue, although the uranium concentration in well MW-0880 decreased significantly. NRC concurrence in the revised LTSP was received after the annual inspection was conducted; however, changes to the monitoring program were implemented. No maintenance needs or cause for a follow-up or contingency inspection was identified.

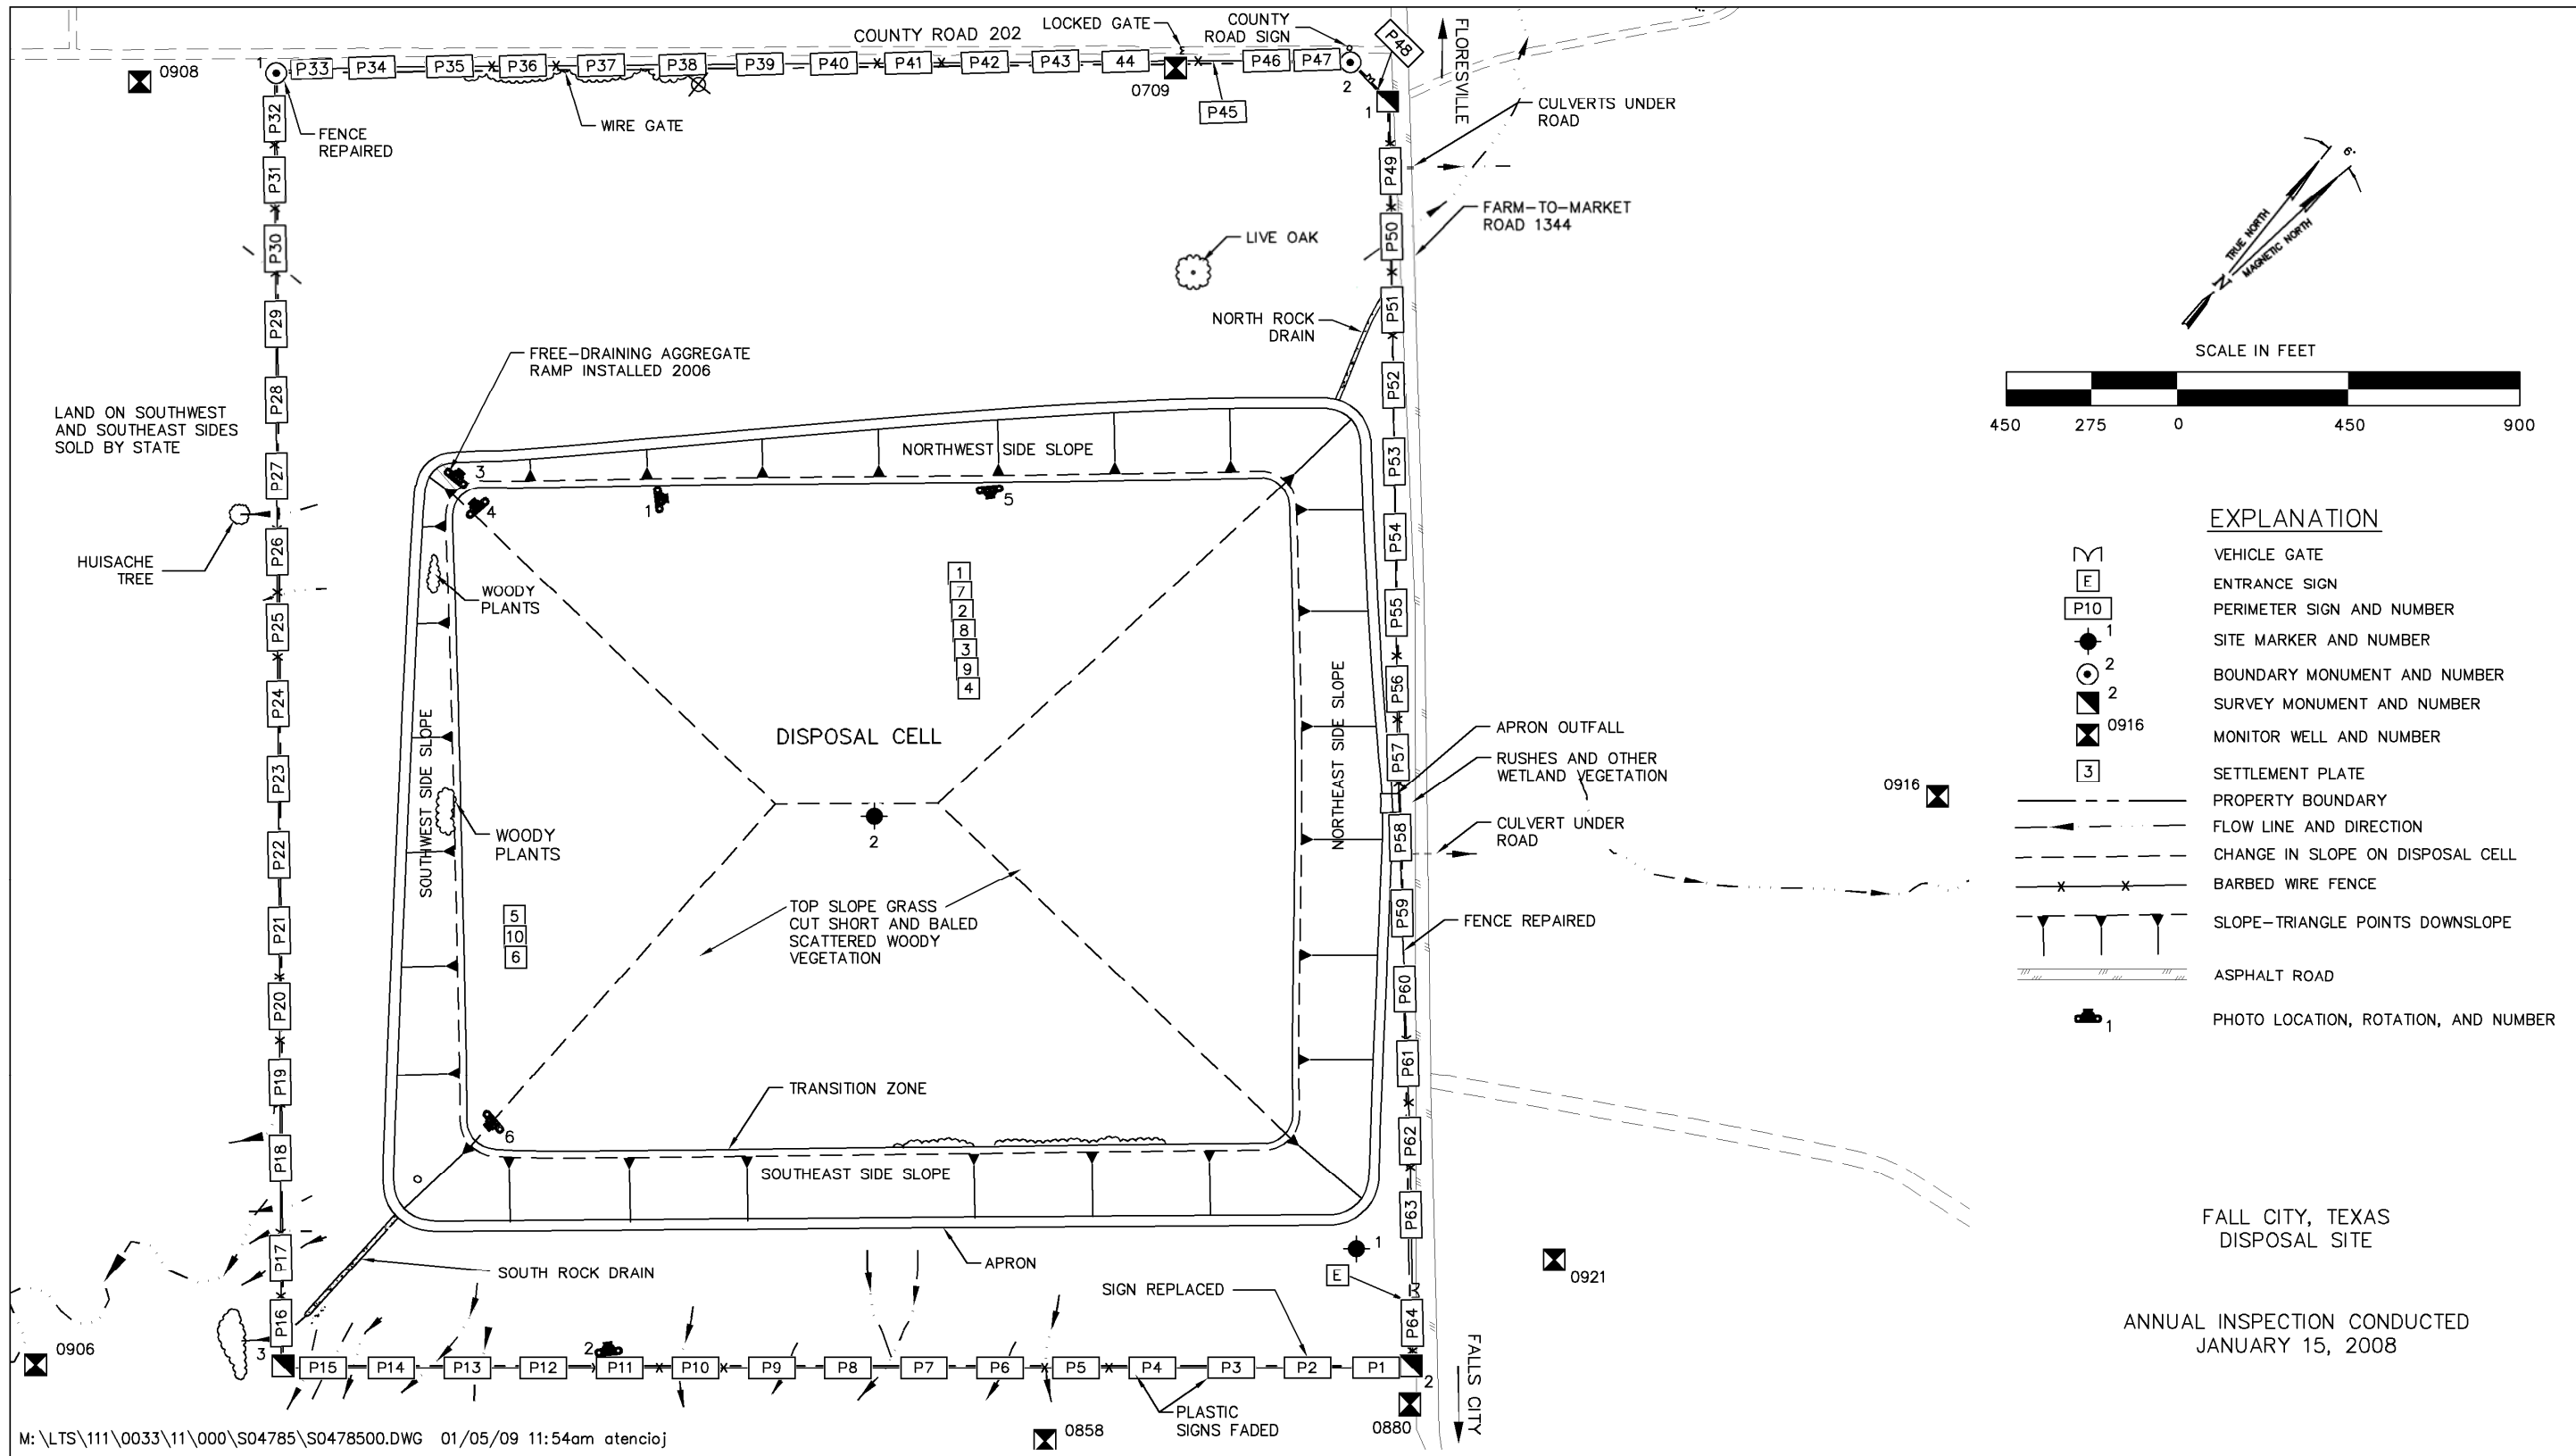
Figure 5-1. 2008 Annual Compliance Drawing for the Falls City Disposal Site

The site, located east of Falls City, Texas, was inspected on January 15, 2008. Results of the inspection are described below. Features and photograph locations (PLs) mentioned in this report are shown on Figure 5-1. Numbers in the left margin of this report refer to items summarized in the “Executive Summary” table.

Top and Side Slopes of the Disposal Cell—The top of the disposal cell is covered with well-established grass and was in good condition; there was no indication of settlement, rock degradation, erosion, or other sign of instability. A local rancher cuts and bales hay each year from the disposal site, including the top of the cell (PL-1). The grass on the cell top had been cut short to control the risk of fire. Deep-rooted vegetation that encroaches on the disposal cell is controlled in accordance with the LTSP. Deep-rooted vegetation is of concern because it can penetrate the radon barrier. There was a minor amount of deep-rooted vegetation found on top of the disposal cell at the time of the inspection.

The side slopes are covered with riprap and are in good condition (PL-2). As noted during previous inspections, minor amounts of fractured riprap were observed along the side slopes. The fractured riprap apparently is an artifact of the quarrying and placement of the rock. Monitoring locations were established with T-posts, and reference photos will be taken during inspections (PL-3). This monitoring is not a requirement of the LTSP, but it is being conducted to demonstrate that the riprap is not deteriorating. During the 2008 inspection, no evidence was found to suggest that the riprap is degrading.

An access ramp was installed at the west corner of the side slope. No changes in the access ramp or the side slope were observed (PL-4).

No water was observed flowing in the north or south rock drains, and the drains appeared to be functioning as designed (PL-6). Grass growing in both drains (as noted in previous inspections) is not sufficient to impede the flow of water draining from the cell apron. The apron outfall, midway along the northeast side slope, is not yet affected by grass encroachment. Grass in the rock drains may actually assist in dissipating the energy of site runoff, and may, therefore, be a desirable feature. No willows were noted this year in the drainage ditch running from the south corner of the disposal cell (PL-6). Vegetation needs to be removed from the culvert northeast of perimeter sign P50.

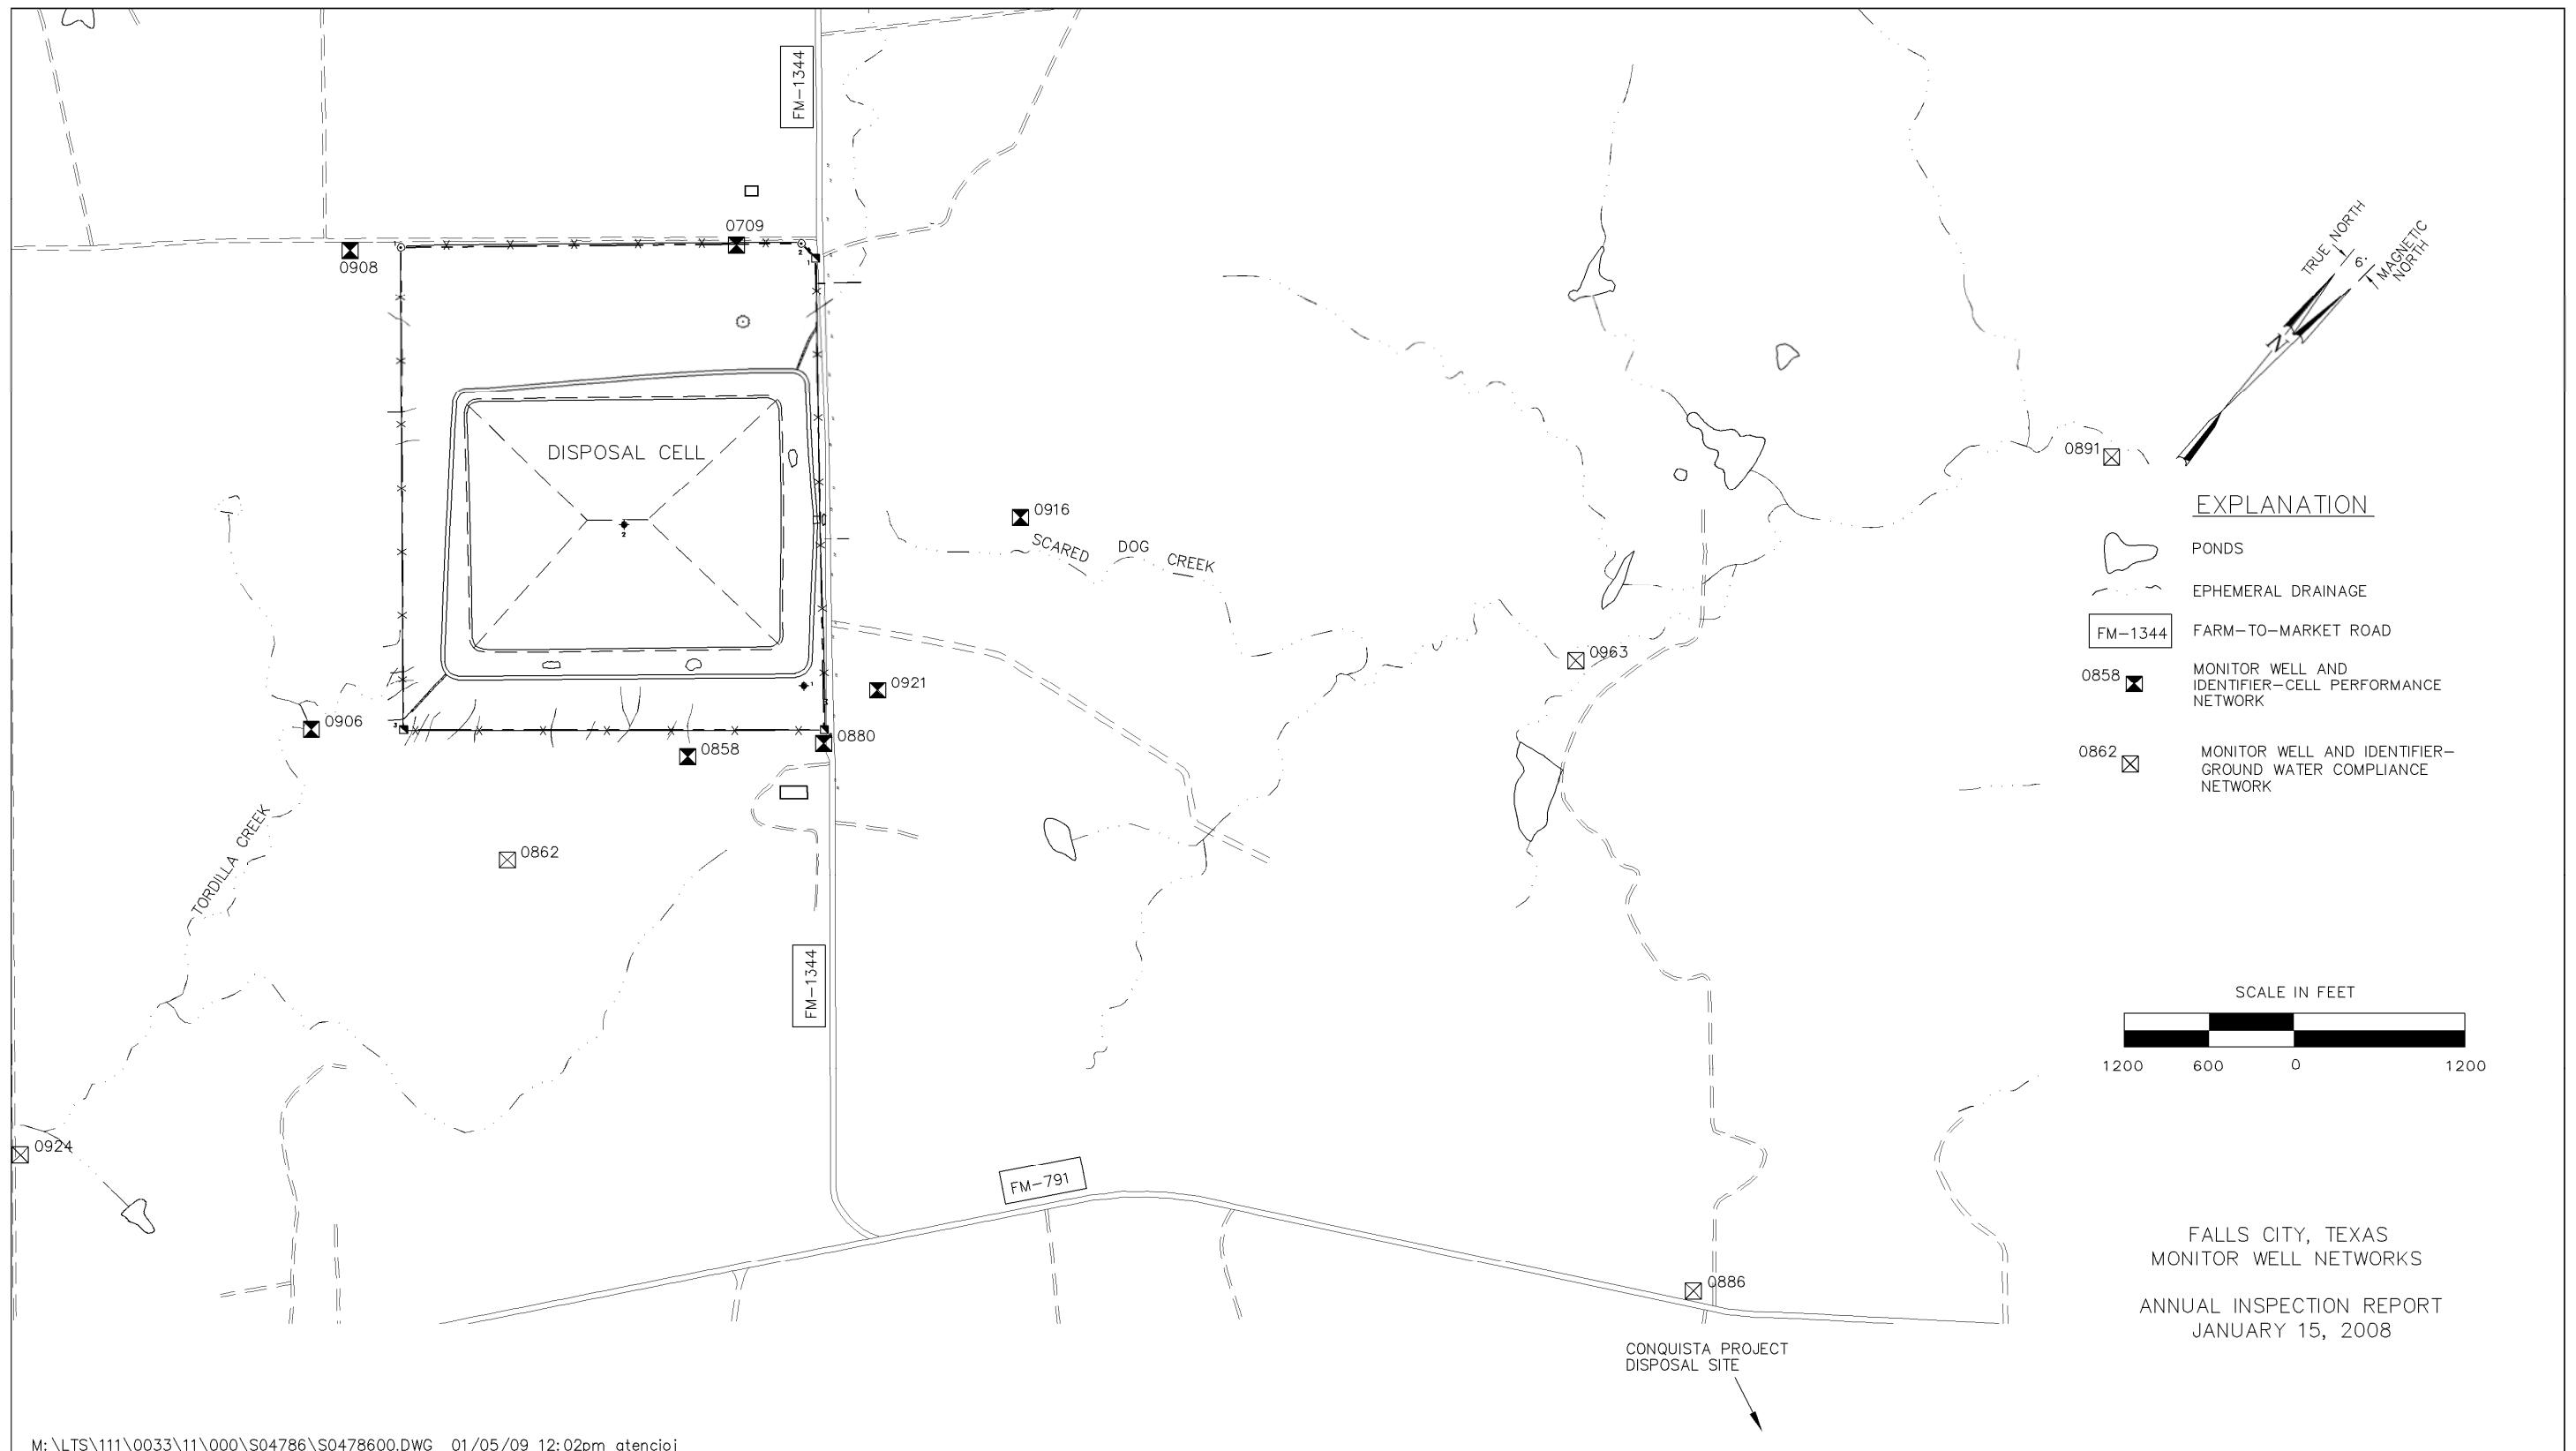
Figure 5-2. Combined Monitor Well Network at the Falls City Disposal Site

The disposal cell performance monitoring network consists of five monitor wells (MW-0709, MW-0858, MW-0880, MW-0906, and MW-0921) that are completed in the uppermost aquifer and sampled as specified in the revised LTSP (March 2008). Two additional cell performance wells (MW-0908 and MW-0916), also completed in the uppermost aquifer, are designated for water-level measurements only.

The groundwater compliance monitoring network consists of five monitor wells (MW-0862, MW-0886, MW-0891, MW-0924, and MW-0963) that are completed in the uppermost aquifer and sampled annually as specified in the GCAP and the revised LTSP. The monitor well networks are shown on Figure 5-2.
