**2014 Annual Land-Use Covenant  
Inspection Report  
for DOE Areas at the Laboratory  
for Energy-Related Health  
Research/Old Campus Landfill  
Superfund Site  
University of California, Davis**

**January 2015**

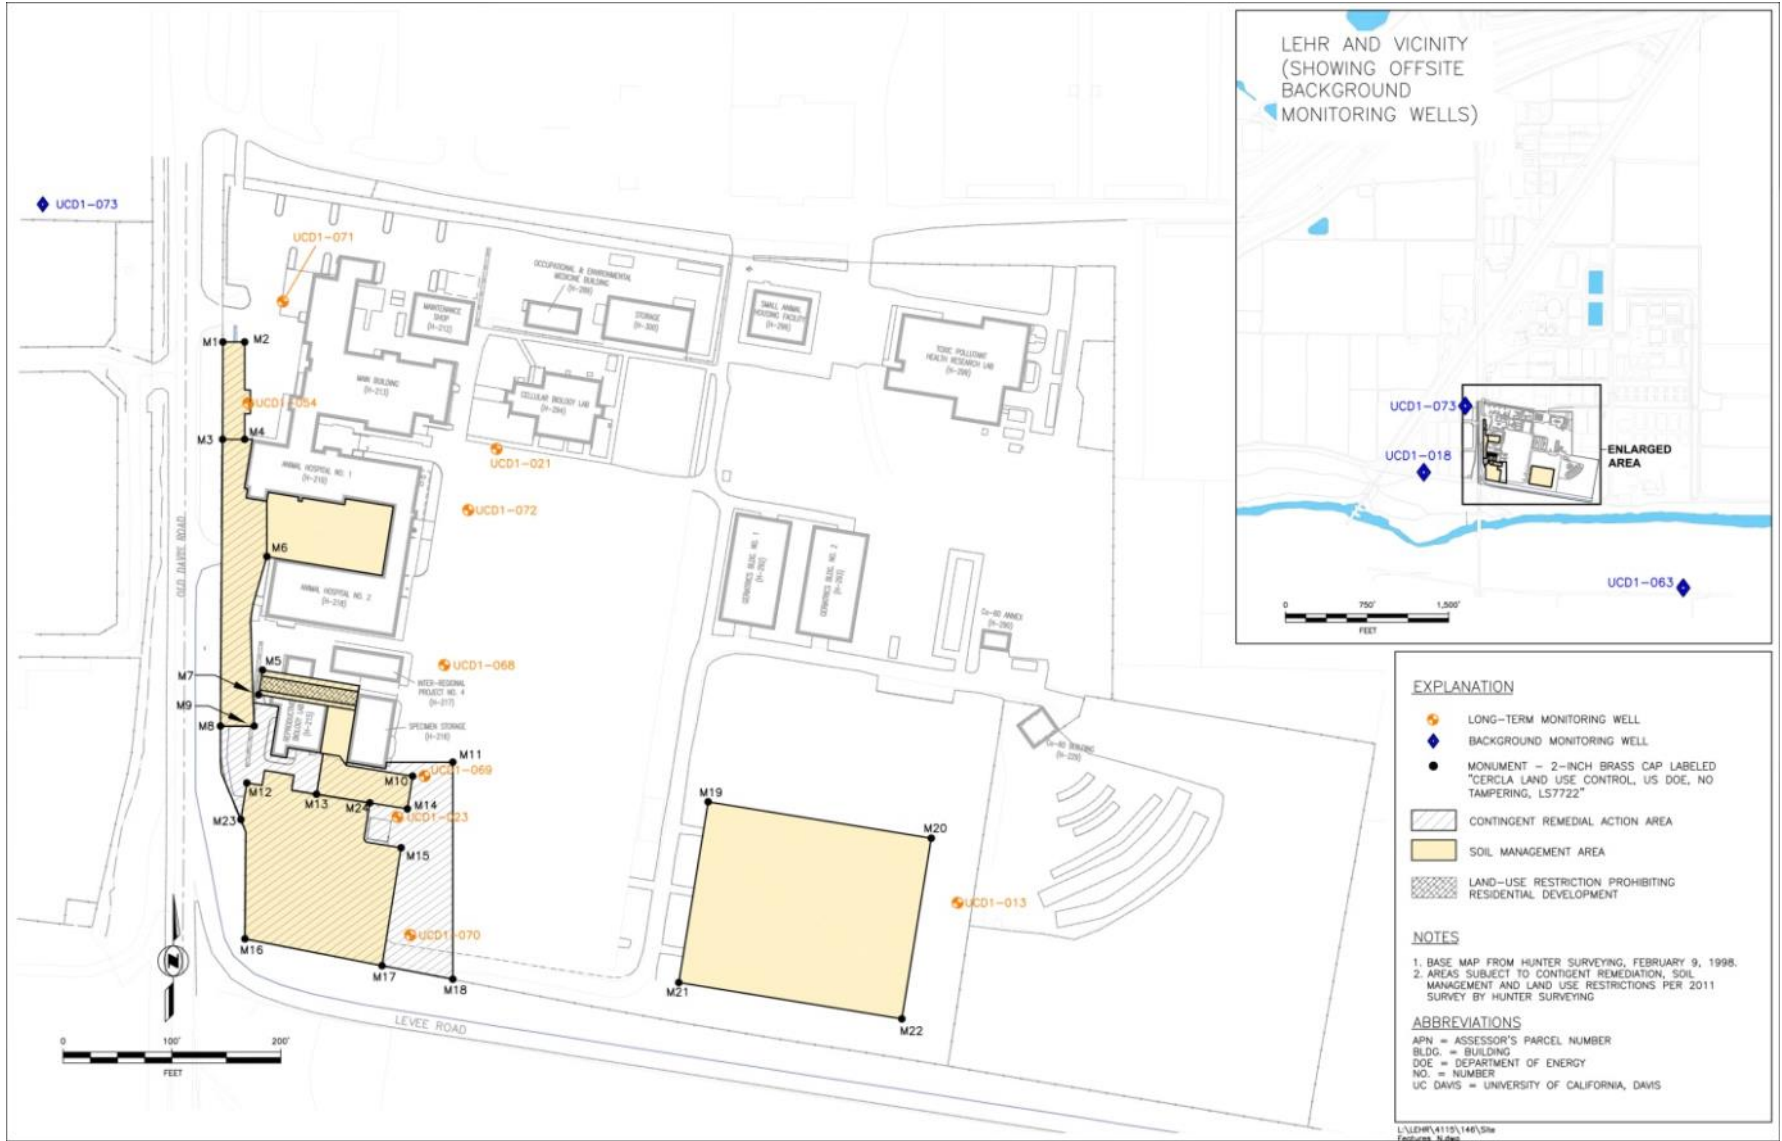
Figure 3. Monitoring Wells and Corner Point Monuments at the LEHR Superfund Site

On November 6, 2014, between 11:20 a.m. and 5:00 p.m., Tim Utterback of Weiss performed a walk-through inspection of groundwater monitoring wells UCD1-013, UCD1-018, UCD1-021, UCD1-023, UCD1-054, UCD1-063, and wells UCD1-068 through UCD1-073 (Figure 3). None of the wells showed evidence of tampering. Wells with standpipe completions (UCD1-013, UCD1-018, UCD1-063, UCD1-070, and UCD1-073) were observed to be secured with functioning padlocks. Wells UCD1-054, UCD1-068, UCD1-069, UCD1-071 and UCD1-072 have surface completions and were observed to be secured with bolts. Wells UCD1-021 and UCD1-023 have surface completions and screw-on lids. All well completions were structurally sound, and the wells were in good condition.

Well UCD1-021 has surface cracks and chips in the cement pad, but the underlying structural cement around the vault appears to be sound. The cement pad at the base of the standpipe at well UCD1-070 has a crack but the standpipe is sound. Cement pads at the remainder of the DOE areas wells and at the background wells were structurally sound with no surface damage.

Some minor well maintenance issues were noted during the November 6, 2014, inspection:

- Vault lid bolts were difficult to fasten to the anchorage threads at wells UCD1-068 and UCD1-071.
- The casing cap in well UCD1-069 was missing a stopper in the water level measurement port.

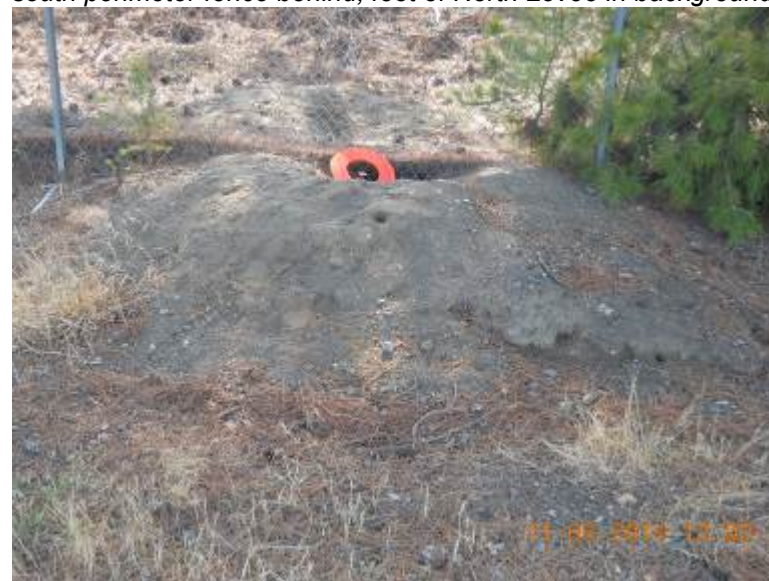
On November 6, 2014, between 10:59 a.m. and 2:03 p.m., Tim Utterback of Weiss Associates (Weiss) performed a walk-through inspection of monuments that define the areas subject to land-use restrictions (Figure 3). All 24 monuments were in good condition. Evidence of minor soil disturbance from a burrowing animal was observed at monument M18. The burrow penetrates into the foot of the levee south of the perimeter fence and outside of the LEHR site boundary. Soil cast from the burrow by animal activity is mounded north of the perimeter fence in the Eastern Remediation Support Area. This burrowing activity does not present a risk of bringing contaminated soil from DOE areas to the surface because the burrow is located more than 50 feet from the nearest DOE area containing residual soil contamination (SWT Area). Appendix A provides the completed inspection checklist; Appendix B provides photographs of the monuments.

*View south: Monument 18, within orange ring; foot of North Levee in background; burrow mound in foreground.*
