3.0 Canonsburg, Pennsylvania, Disposal Site

3.1 Compliance Summary

The Canonsburg, Pennsylvania, Uranium Mill Tailings Radiation Control Act (UMTRCA) Title I Disposal Site was inspected on November 2, 2021. No changes were observed on the disposal cell or in the associated drainage features. Evidence of site trespassing was noted beneath the west fence at an erosional area under the fence. Metal slats preventing entry had been removed, allowing a trespasser to crawl under the fence. Inspectors replaced the slats. No cause for a follow-up inspection was identified.

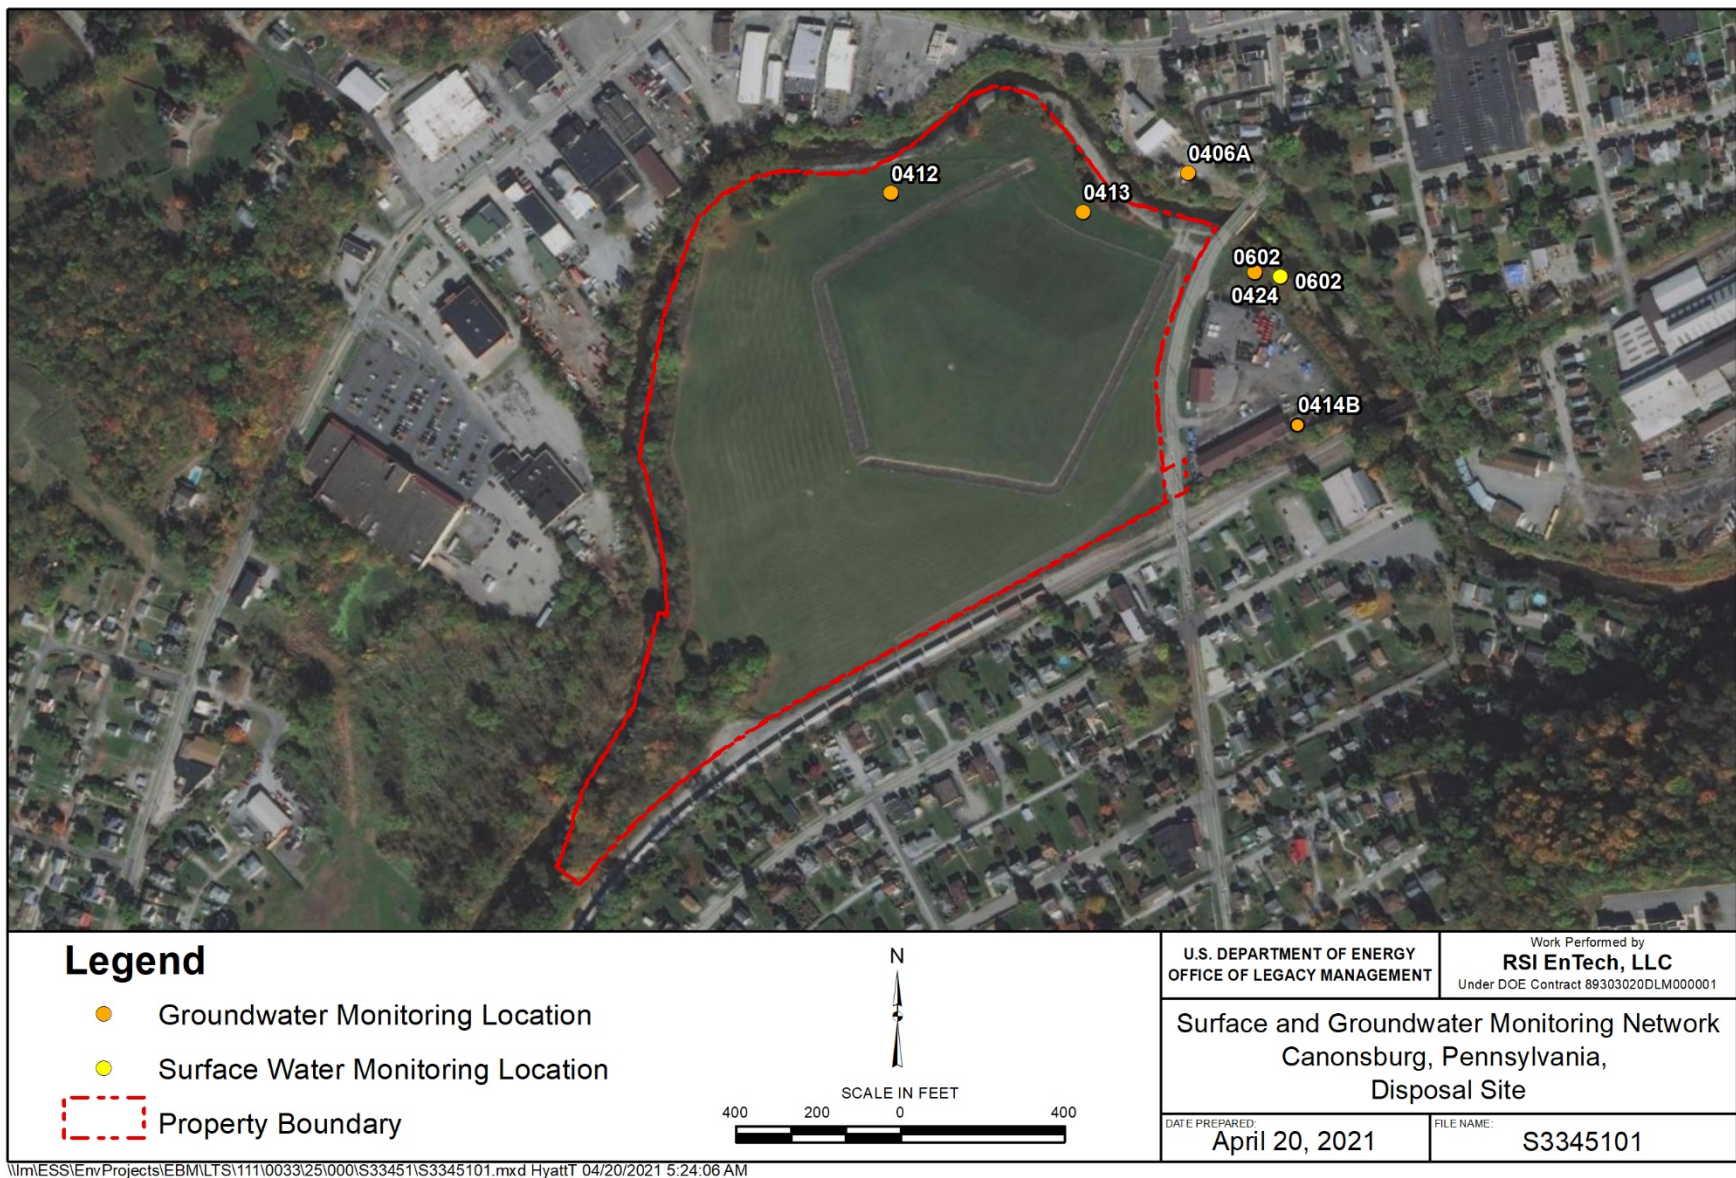
Figure 3-2. Groundwater and Surface Water Monitoring Network for the Canonsburg, Pennsylvania, Disposal Site

The groundwater monitoring network consists of five monitoring wells—three POC wells and two best management practice wells (Table 3-2 and Figure 3-2). All monitoring wells are
