3.0 Canonsburg, Pennsylvania, Disposal Site

3.1 Compliance Summary

Figure 3-1. 2022 Annual Inspection Drawing for the Canonsburg, Pennsylvania, Disposal Site

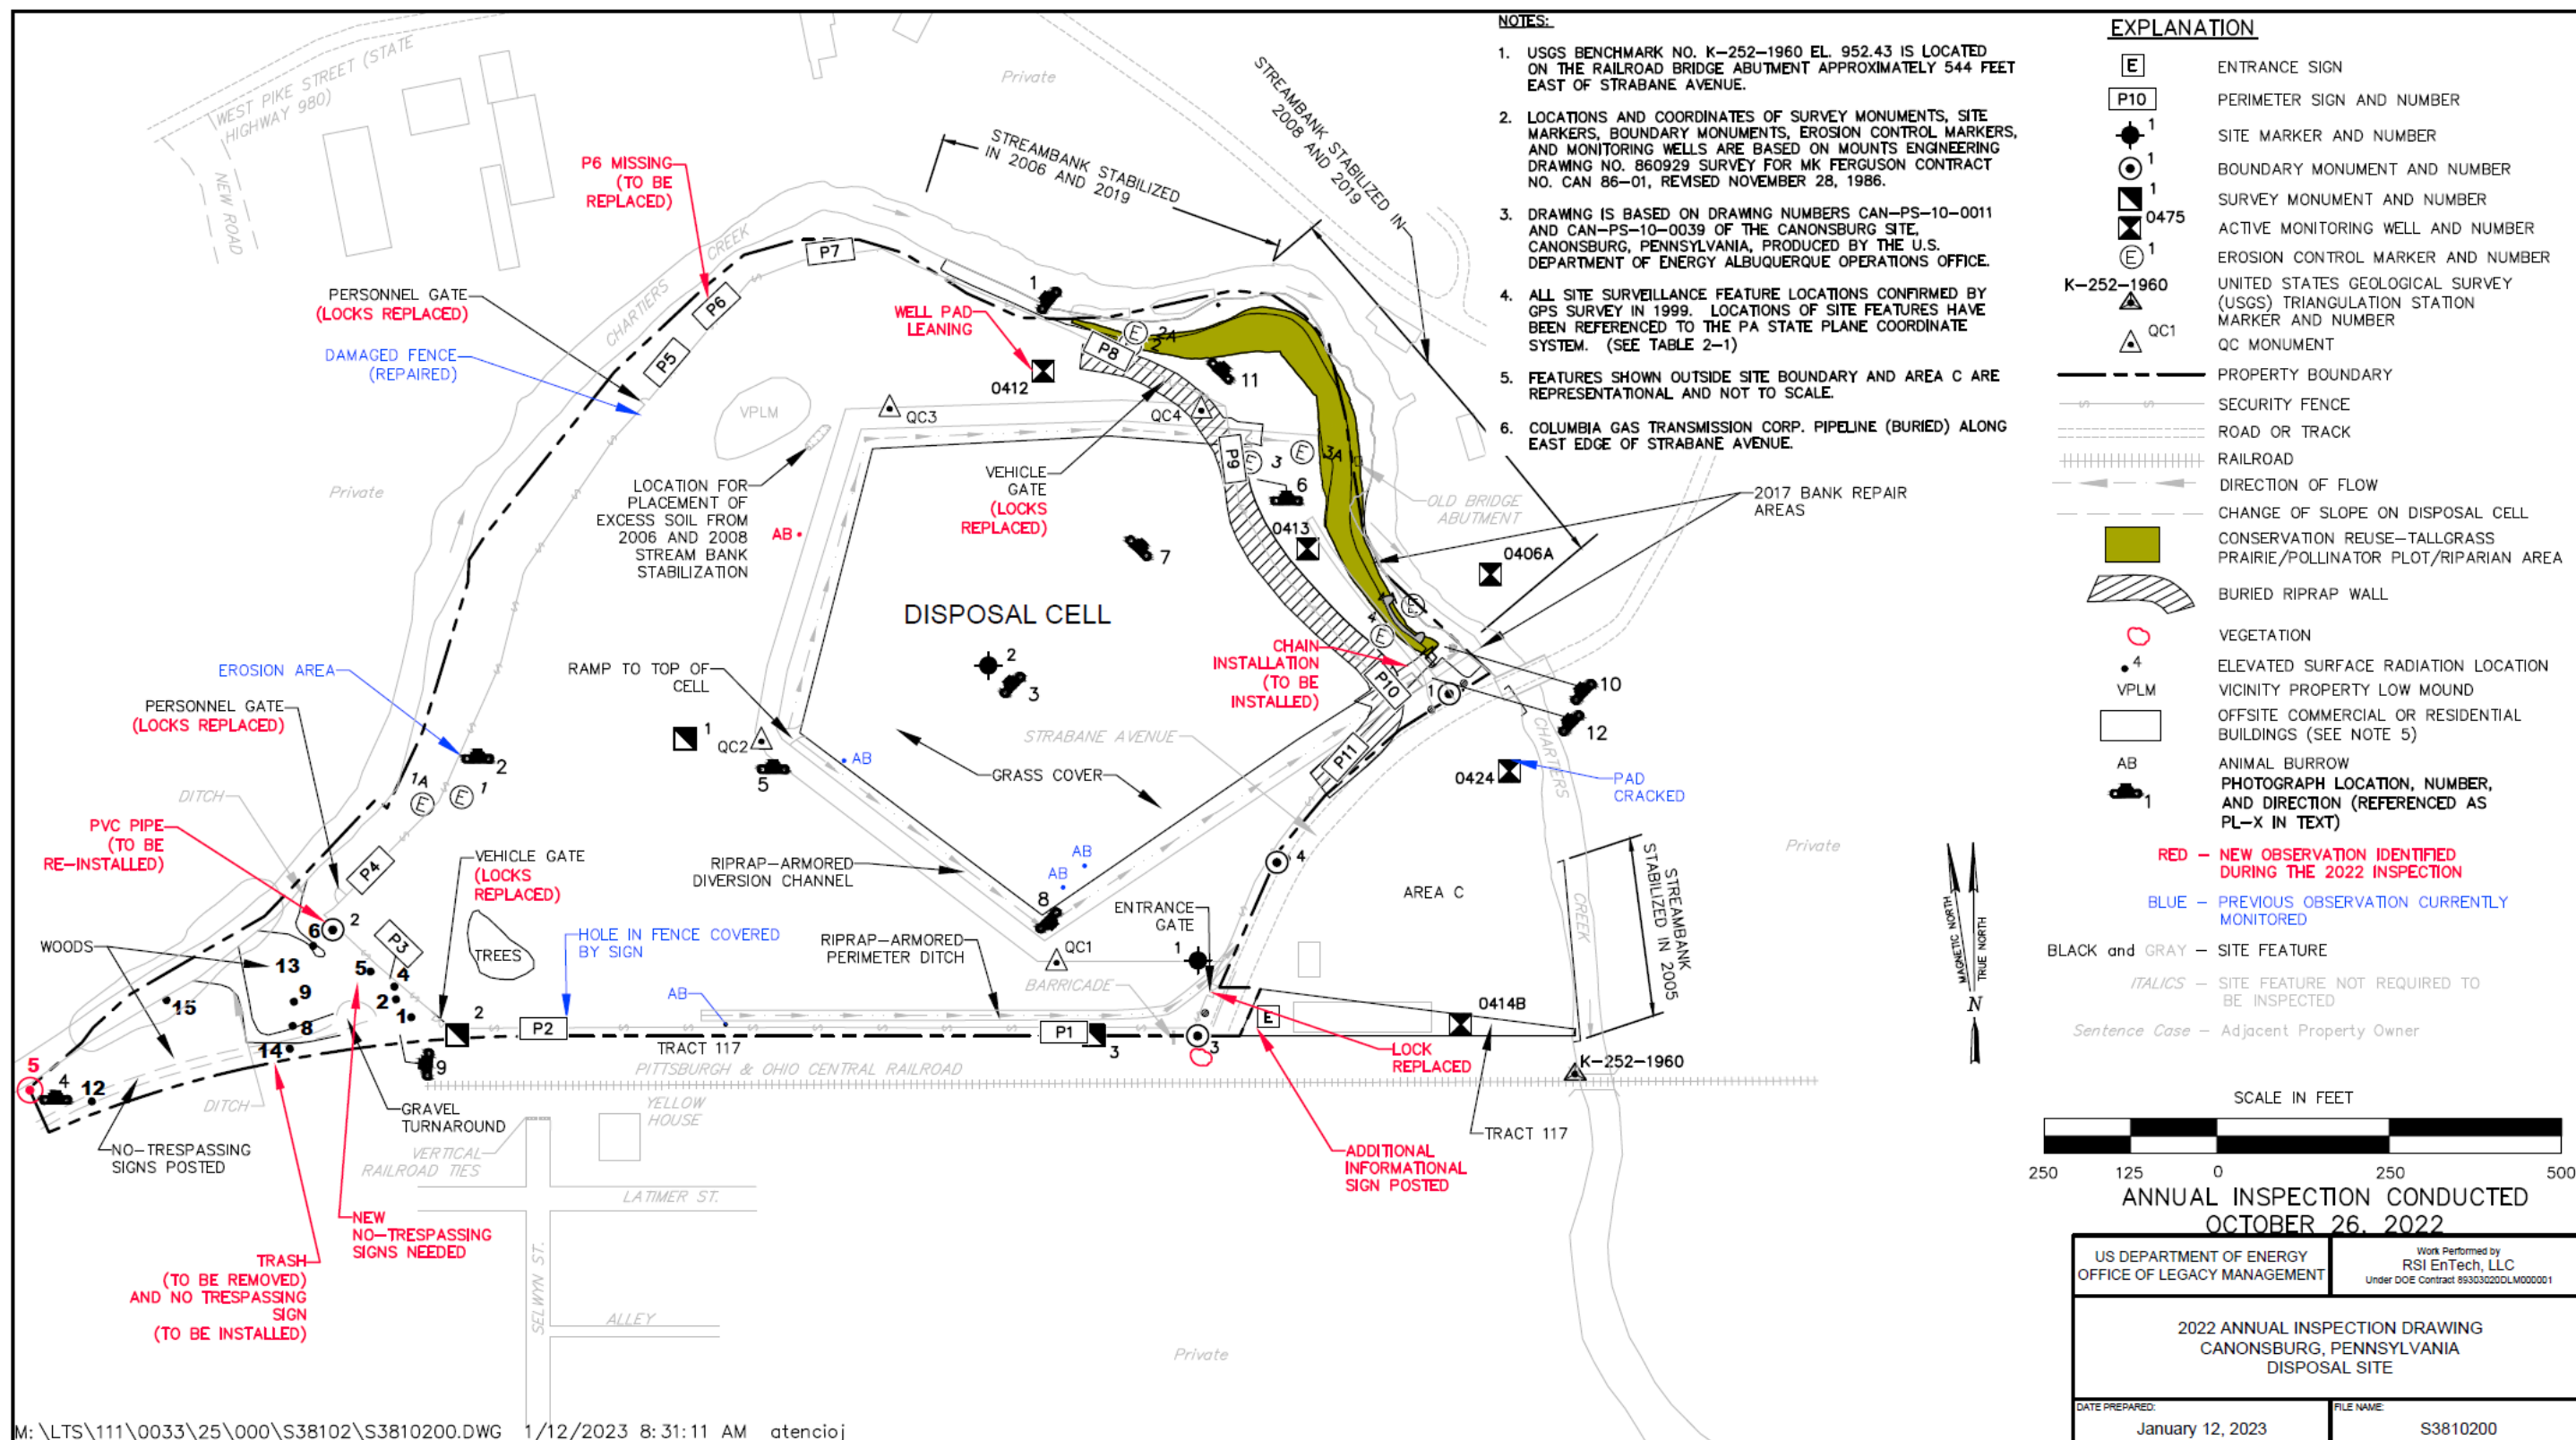
Figure 3-1 shows the locations of site features, including site surveillance features and inspection areas, in black and gray font. Some site features that are present but not required to be inspected are shown in italic font. Observations from previous inspections that are currently monitored are shown in blue, and new observations identified during the 2022 annual inspection are shown in red. Inspection results and recommended maintenance activities associated with site surveillance features are described in the following subsections. Photographs to support specific observations are noted in the text and in Figure 3-1 by photograph location (PL) numbers. The photographs and photograph log are presented in Section 3.10.

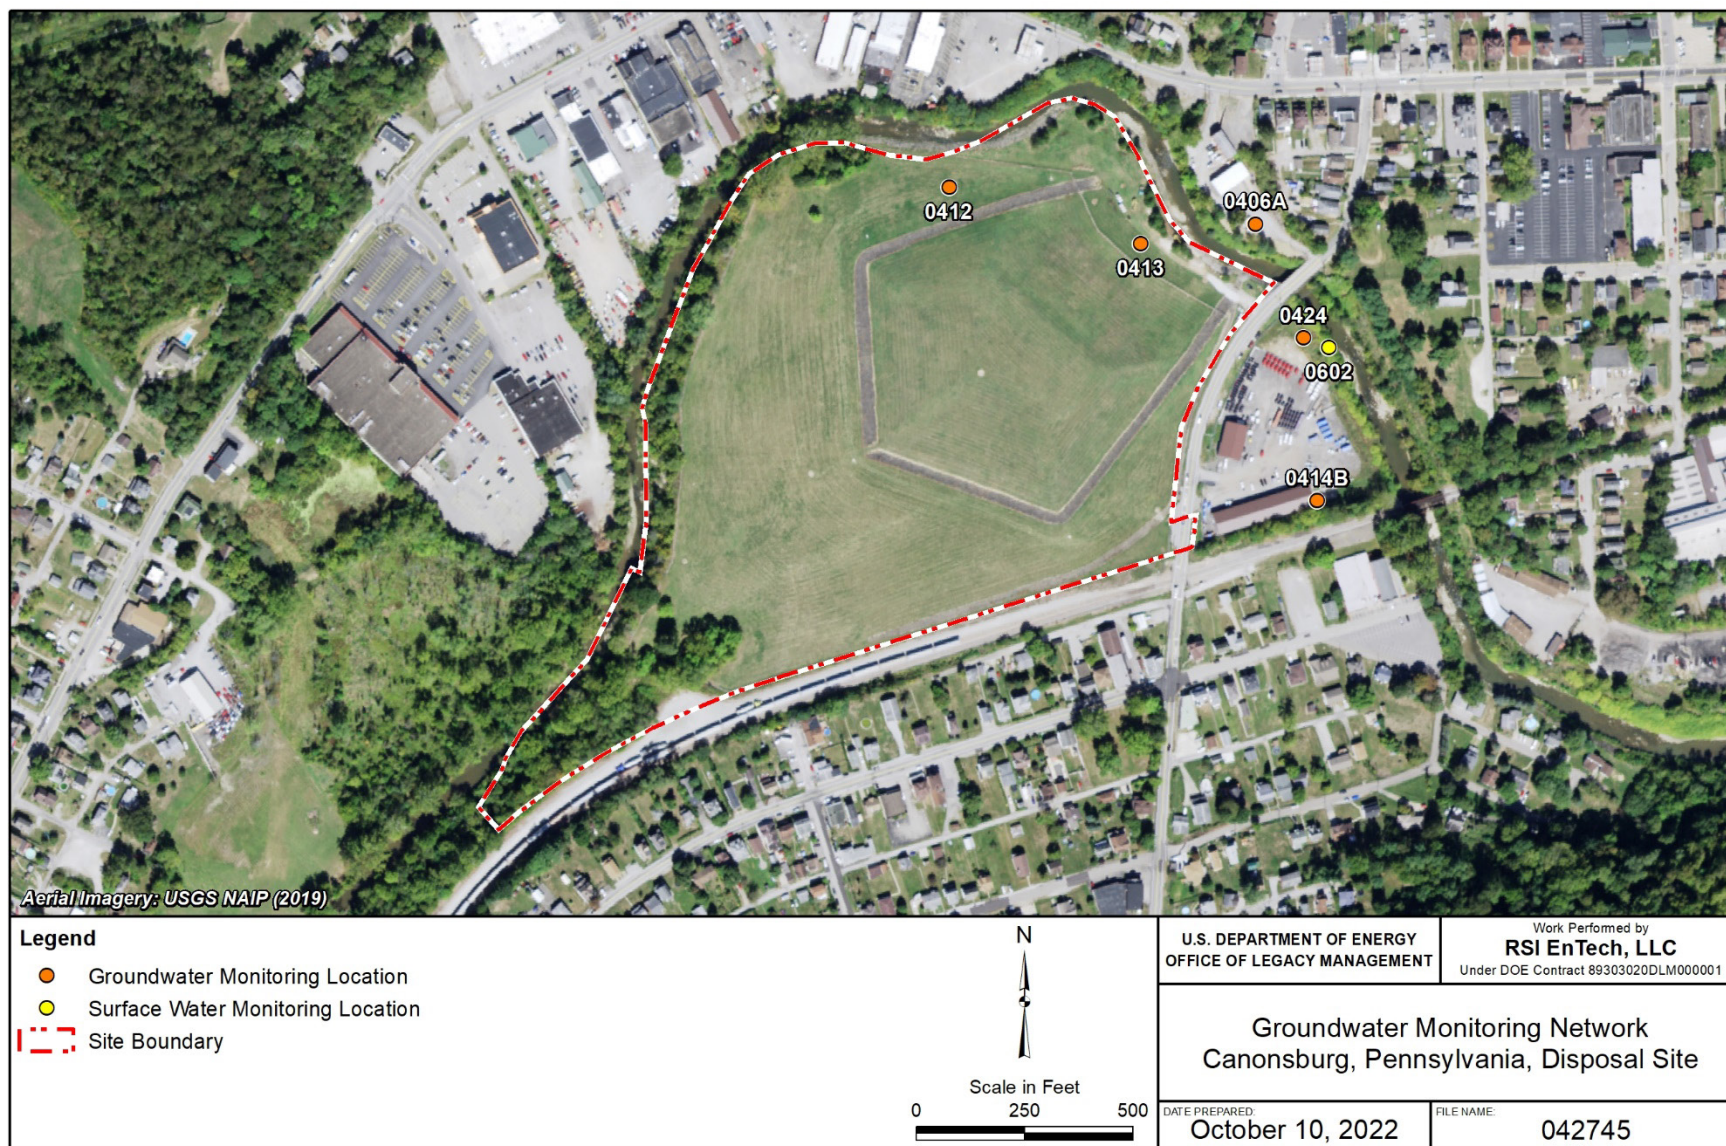
Figure 3-2. Groundwater and Surface Water Monitoring Network for the Canonsburg, Pennsylvania, Disposal Site

The groundwater monitoring network consists of five monitoring wells—three POC wells and two best management practice wells (Table 3-2 and Figure 3-2). All monitoring wells are completed in the uppermost aquifer (shallow, unconsolidated materials). Groundwater is sampled and analyzed for the one constituent of concern—uranium. The ACL is 1 milligram per liter (mg/L) for groundwater at the POC wells. With the exception of monitoring wells 0412 and 0413, uranium concentrations in 2018 were also below the UMTRCA maximum concentration limit (MCL) of 0.044 mg/L.
