3.0 Canonsburg, Pennsylvania, Disposal Site

3.1 Compliance Summary

The Canonsburg, Pennsylvania, Uranium Mill Tailings Radiation Control Act (UMTRCA) Title I Disposal Site was inspected on October 30, 2024. No changes were observed on the disposal cell or in the associated drainage features. No evidence of site trespassing was observed. A tree was down on the perimeter fence, the result of a recent windstorm. The integrity of the fence appears to be functional but will need to be assessed further once the tree is removed. A few minor maintenance items were identified. No cause for a follow-up inspection was identified.

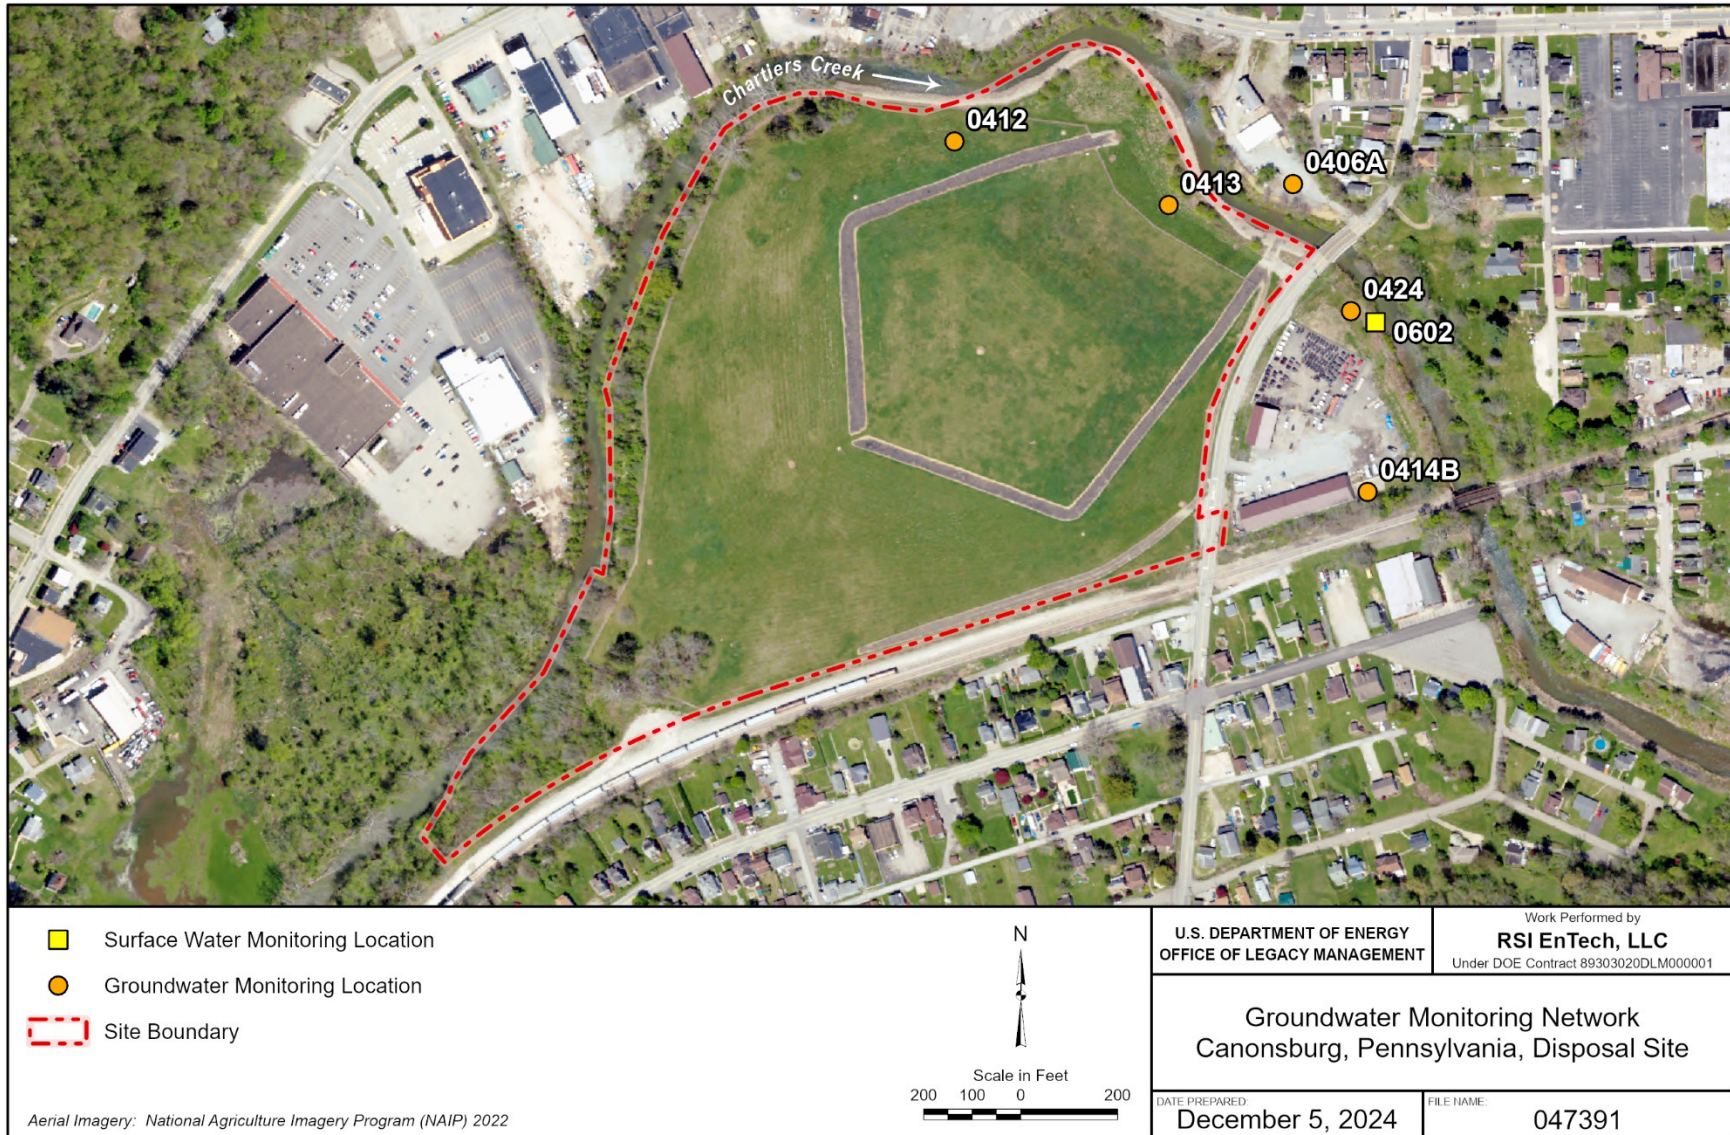
Figure 3-2. Groundwater and Surface Water Monitoring Network for the Canonsburg, Pennsylvania, Disposal Site

The groundwater monitoring network consists of five monitoring wells: three POC wells and two best management practice wells (Figure 3-2 and Table 3-2). All monitoring wells are completed in the uppermost aquifer consisting of unconsolidated materials overlying the bedrock of the Casselman Formation.

Only one location, 0602 (Figure 3-2), is currently sampled in Chartiers Creek; the most recent sampling event occurred in October 2023. This location is considered a POE for the site and is sampled for uranium, to which an ACL of 0.01 mg/L is applied (DOE 2013).

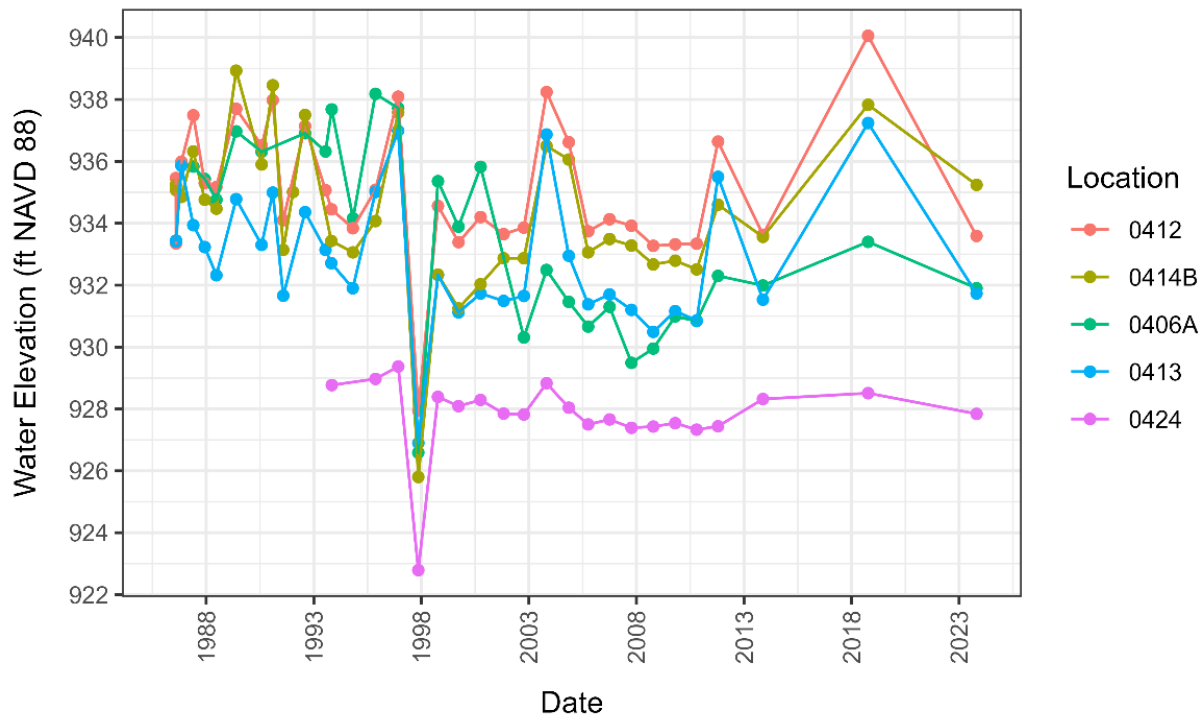
Figure 3-3. Temporal Trends of Water Elevations in Canonsburg Disposal Site Monitoring Wells

Manual water level measurements since 1986 (most taken in the fall) indicate that water elevations, though fluctuating, have usually been within the historical range of water elevations measured at the site (Figure 3-3). Exceptions have occurred in 1997, with the lowest recorded water elevations, and most recently in 2018, when maximum groundwater elevations were recorded for all wells except well 0424.

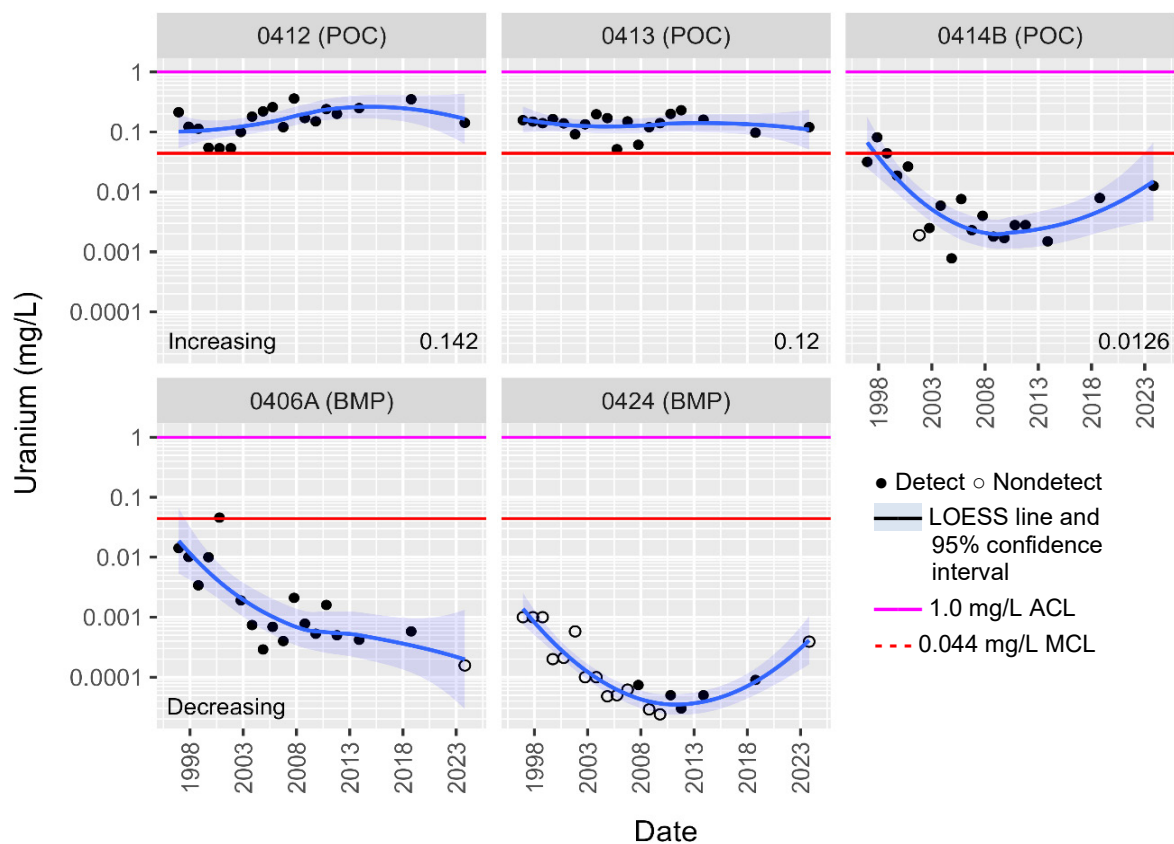
Figure 3-4. Uranium Concentrations in Groundwater at the Canonsburg, Pennsylvania, Disposal Site

Groundwater is sampled and analyzed for uranium, the only remaining constituent of concern since the GCAP was issued in 2000. The ACL established in the LTSP for uranium in groundwater (applied to POC wells) is 1.0 mg/L (DOE 2013). Figure 3-4 plots historical data for the POC and best management practice wells for 1996–2023. MCL concentrations are shown on each plot as a red line. ACL concentrations are shown on the plot as a magenta line. As shown in Figure 3-4, uranium concentrations in all wells have been consistently below the ACL.

A statistical trend analysis applied to the 1996–2023 dataset indicates a statistically significant increasing trend in uranium concentrations for well 0412.¹ Despite observed increases between 2000 and 2018 (accounting for the significant trend), uranium results for well 0412 have often fluctuated. Between 2018 and 2023, the result decreased from 0.35 to 0.14 mg/L.

Although no significant trend was found for POC well 0414B, uranium concentrations in this well have increased since 2013 and are approaching levels measured from 1996–2000, as well as the maximum concentration limit (MCL) of 0.044 mg/L (Figure 3-4). Uranium concentrations in the two best management practice monitoring wells, 0406A and 0424, have historically been well below the MCL of 0.044 mg/L. A statistically significant decreasing trend was found for well 0406A. The most recent (2023) results in both wells were below detectable levels (≤ 0.0004 mg/L).

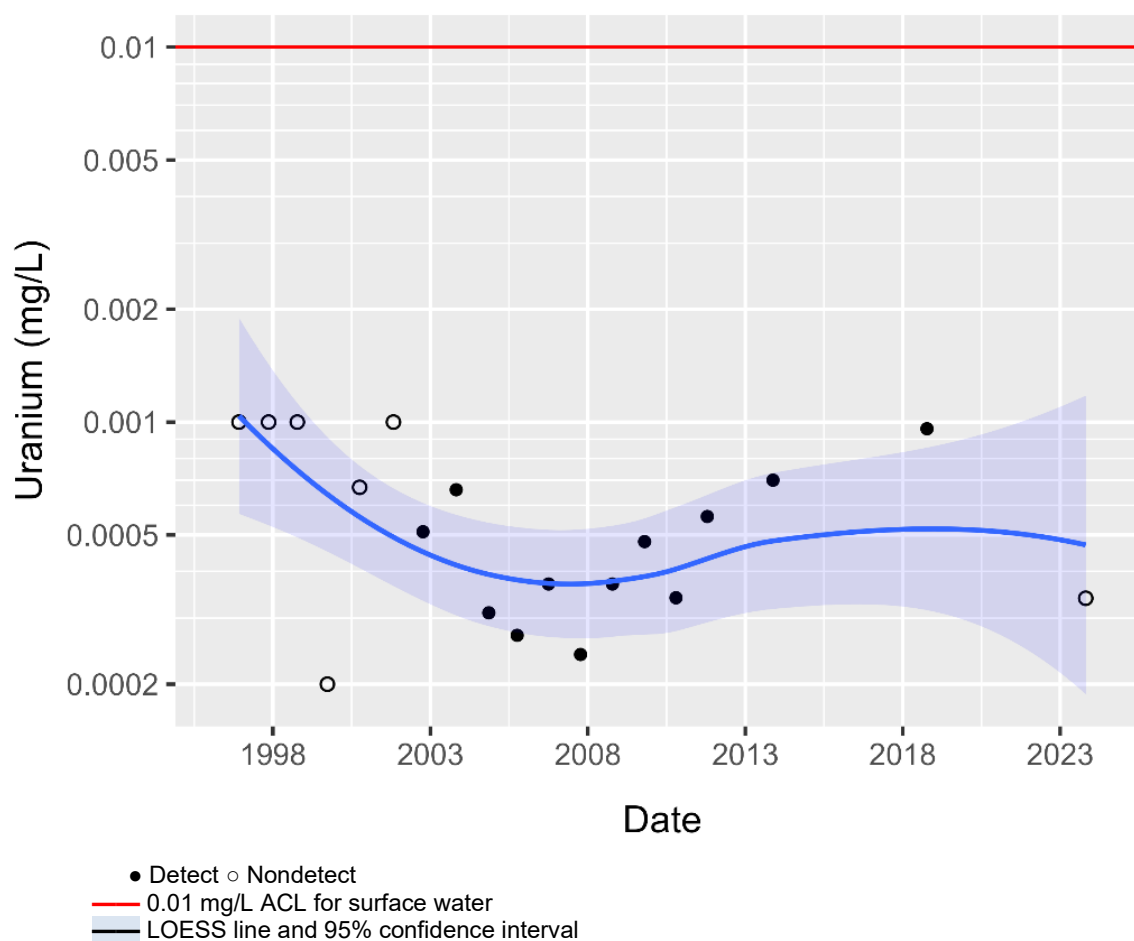
Figure 3-5. Uranium Concentrations at POE Location 0602 (Chartiers Creek)
Canonsburg, Pennsylvania, Disposal Site

In 2023, the uranium result for surface water location 0602 was below detectable levels (<0.00034 mg/L), well below the established ACL of 0.01 mg/L (Figure 3-5).
