# 7.0 Green River, Utah, Disposal Site

# 7.1 Compliance Summary

The Green River, Utah, Uranium Mill Tailings Radiation Control Act (UMTRCA) Title I Disposal Site, was inspected on March 26, 2008. The disposal cell and all associated surface water diversion and drainage structures were in excellent condition and functioning as designed. Three damaged perimeter signs were replaced. Groundwater monitoring continued for the purpose of evaluating cell performance; no constituents of concern exceeded their respective proposed alternate concentration limits (ACLs), although current standards continued to be exceeded for uranium, nitrate, and selenium. No additional maintenance needs or cause for a follow-up or contingency inspection were identified.

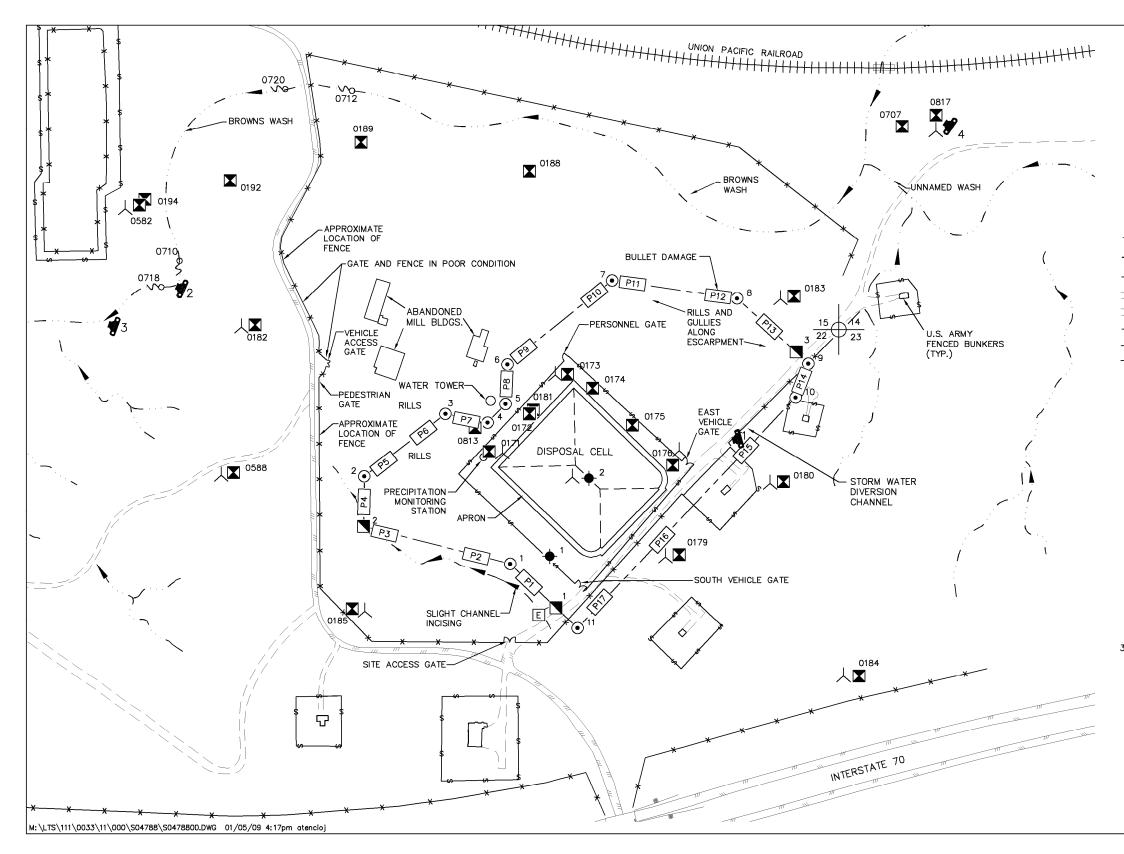
Figure 7–1. 2008 Annual Compliance Drawing for the Green River Disposal Site

**Disposal Cell and Adjacent Area Inside the Security Fence**—The 6-acre disposal cell was completed in 1989. The slopes of the disposal cell cover are armored with basalt rock. The cell cover was in excellent condition (PL–1). The riprap-filled apron trench along the base of the disposal cell on all sides was in excellent condition.

**Site Perimeter Between the Security Fence and the Site Boundary**—Rills and gullies are present on the west side of the property but do not pose a threat to the integrity of the cell and currently are not impacting any site-surveillance features. Rills and gullies are also present along the escarpment northeast of the disposal cell in the area between boundary monument BM–7 and survey monument SM–3. Maximum gully depth in this area is approximately 3 feet. The rill and gully erosion poses no threat to the integrity of the disposal cell but could eventually damage perimeter signs and boundary monuments. Rills and gullies on site will continue to be monitored.

A barbed-wire stock fence on the surrounding State-owned property is in poor condition, and an access gate through the fence to abandoned mill buildings northwest of DOE property was broken off of its hinges. Tracks indicate that vehicles enter the gate and cross DOE property to access areas northeast of the site. However, there was no evidence of vandalism to site-surveillance features. Because DOE is not responsible for maintaining the barbed-wire fence and gate, trespassing onto DOE property is difficult to control. DOE will continue to monitor for evidence of vandalism at the site.

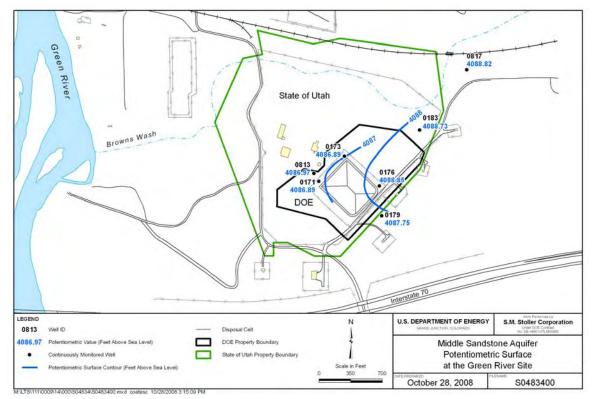
Figure 7–7. Potentiometric Surface of the Middle Sandstone Aquifer at the Green River Disposal Site (9/1/08 Measurements)

Water-level hydrographs of the POC wells, completed in the middle sandstone aquifer, indicate that an overall decrease in the groundwater elevation of approximately 3 feet occurred from 1998 through 2004, followed by an increase of approximately 8 feet since then (Figure 7–6). This rapid increase in groundwater elevation, which appears to be leveling off, may be the result of local and regional aquifer recharge through fractures in the Cedar Mountain Formation and nearby outcrops located southeast of the site, as numerous heavy rainfall events have occurred at the site since 2004. Erroneous manual measurements, likely due to equipment problems, occurred on several occasions (continuous measurements indicated essentially no change at those times); these measurements are not shown on Figure 7–6.
