15.0 Salt Lake City, Utah, Disposal Site

15.1 Compliance Summary

The Salt Lake City, Utah, Uranium Mill Tailings Radiation Control Act (UMTRCA) Title I Disposal Site was inspected on April 2, 2008. The disposal cell and all associated surface water diversion and drainage structures were in excellent condition and functioning as designed. No change was observed in the three slight depressions found on the disposal cell top; monitoring for settlement will continue. The area that flooded with potentially contaminated non-contact storm water in June 2007—from a breach in the containment berm for the adjacent EnergySolutions Incorporated (EnergySolutions) low-level radioactive waste (LLRW) container pad—was in good condition; no contamination from the release was reported, and the berm had been repaired. No waste debris or indication of windblown or spillover contamination from EnergySolutions adjacent radioactive waste disposal operations was noted. Disposal operations by EnergySolutions adjacent to the Disposal site resulted in damage to the site perimeter fence and the covering of a boundary monument. EnergySolutions subsequently remedied both conditions. No other maintenance needs

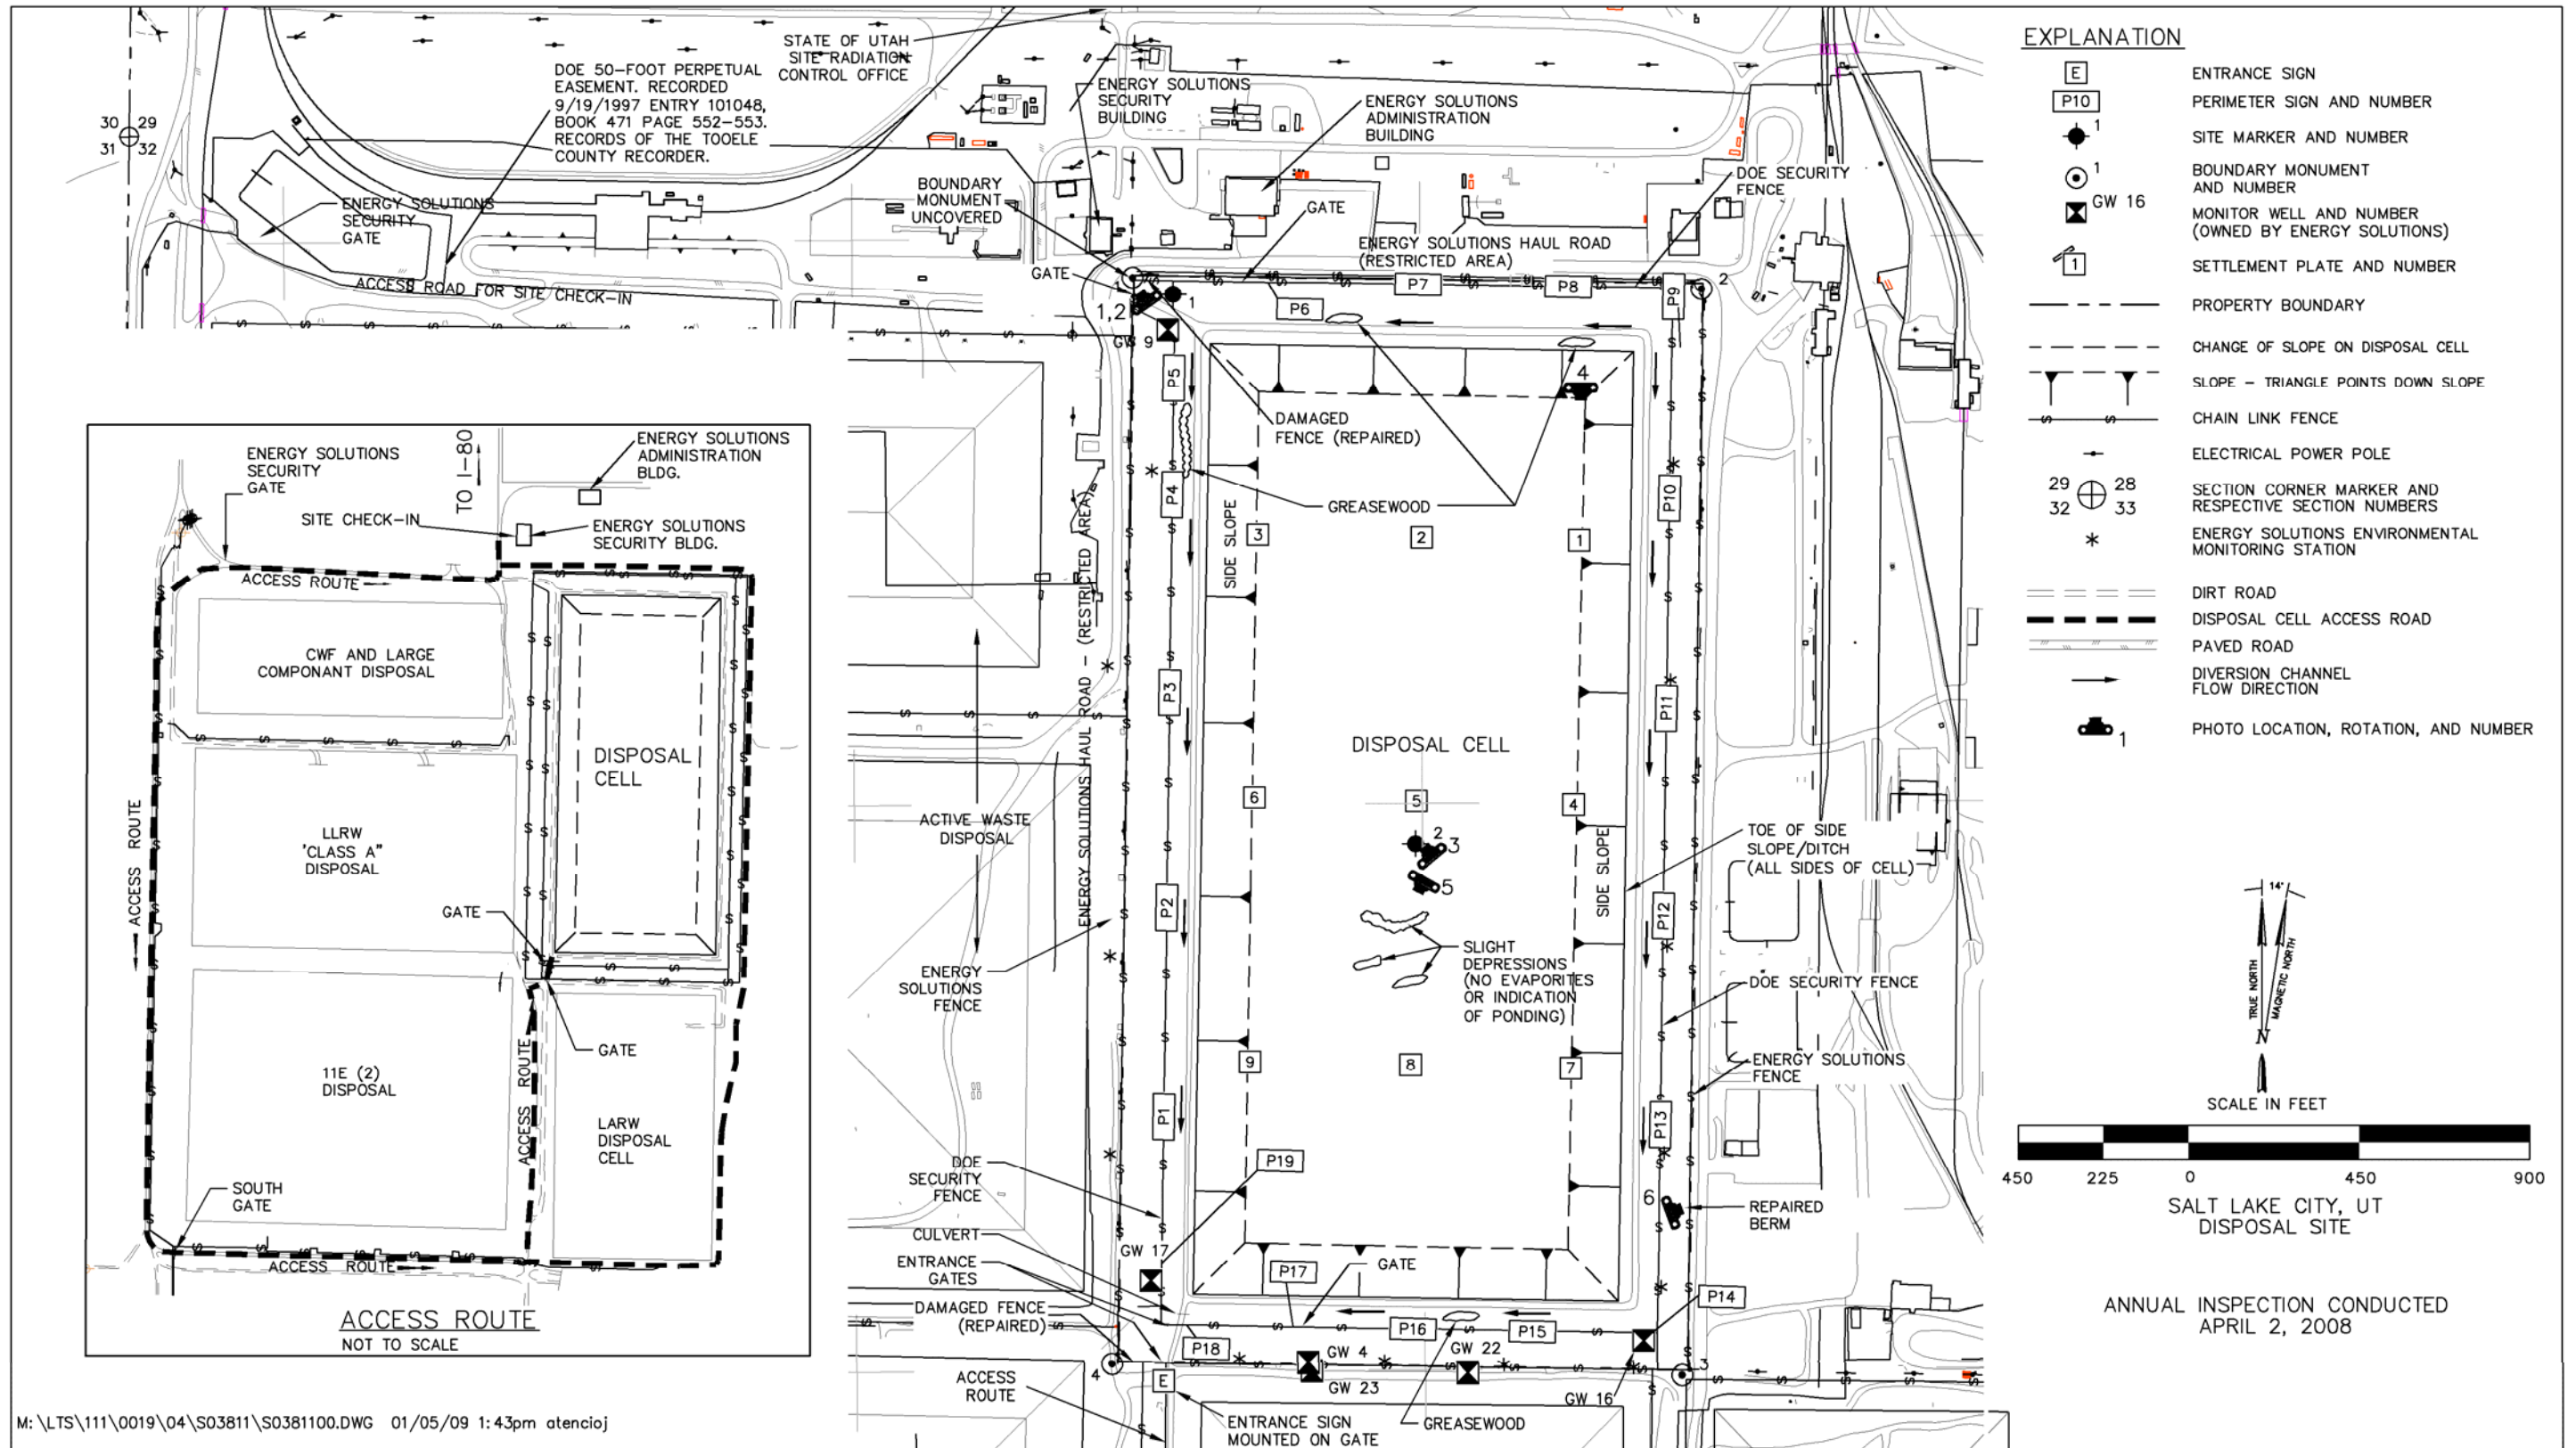
Figure 15-1. 2008 Annual Compliance Drawing for the Salt Lake City Disposal Site

15B In 2008, fence damage caused by EnergySolutions’ adjacent waste disposal operations was observed in both the southwest and northwest corners (PL–1) of the site. EnergySolutions repaired the fence (PL–2). The remaining portions of the fence were in good condition.

Site Markers and Monuments—Two granite site markers are placed at the site. Site marker SMK-1 is located at the site entrance in the northwest corner, and SMK-2 is located on the disposal cell top (PL-3); both were in excellent condition. Four boundary monuments are located on the property, one in each corner of the site. All were in good condition, except boundary monument BM-1, which was buried by EnergySolutions' adjacent waste-haul-road grade work. Subsequent to the inspection, EnergySolutions uncovered the boundary monument (PL-2).

Top and Side Slopes of the Disposal Cell—The top and side slopes of the disposal cell are armored with riprap (PL-3 and PL-4). The riprap was in excellent condition, and no evidence of settling, slumping, or instability was noted on the top or side slopes of the disposal cell during the inspection. No deep-rooted plants were growing on the disposal cell cover.

Three minor depressions first noted in 2006 on the cell top were inspected; no change was observed (PL-5). These slight depressions are likely from irregularities in the surface grading that occurred during the construction of the disposal cell, rather than from settling. They currently do not present a problem and will continue to be monitored. There was no evidence of surface water ponding in any of the depressions and no evaporates were observed.

In June 2007, DOE was notified that EnergySolutions implemented their Emergency Response Plan to address a breach in a containment berm west of its LLRW container pad. The breach, caused by a significant precipitation event, allowed an estimated 500 gallons of potentially contaminated non-contact storm water to flow onto the disposal site. The non-contact storm water flowed into an estimated 84,000-gallon pool of standing surface water (approximately 25 feet wide by 450 feet long by 1 foot deep) that was located on the east side of DOE's property between the security fence and the perimeter fence, also caused by the precipitation event. EnergySolutions collected samples of the ponded storm water. Results reported background levels for all radiological parameters measured. EnergySolutions pumped the storm water from the disposal site and gave DOE a copy of follow-up correspondence with the Utah Division of Radiation Control to document the event. In 2008, this area was inspected, and no adverse conditions were noted; the berm was intact, and no standing water was present (PL-6).
