4.0 Durango, Colorado, Disposal Site

The U.S. Department of Energy (DOE) Office of Legacy Management (LM) conducted the Durango, Colorado, Uranium Mill Tailings Radiation Control Act (UMTRCA) Title I Disposal Site annual inspection on May 15, 2024, and the annual groundwater monitoring event in June 2024. No cause for a follow-up inspection was identified.

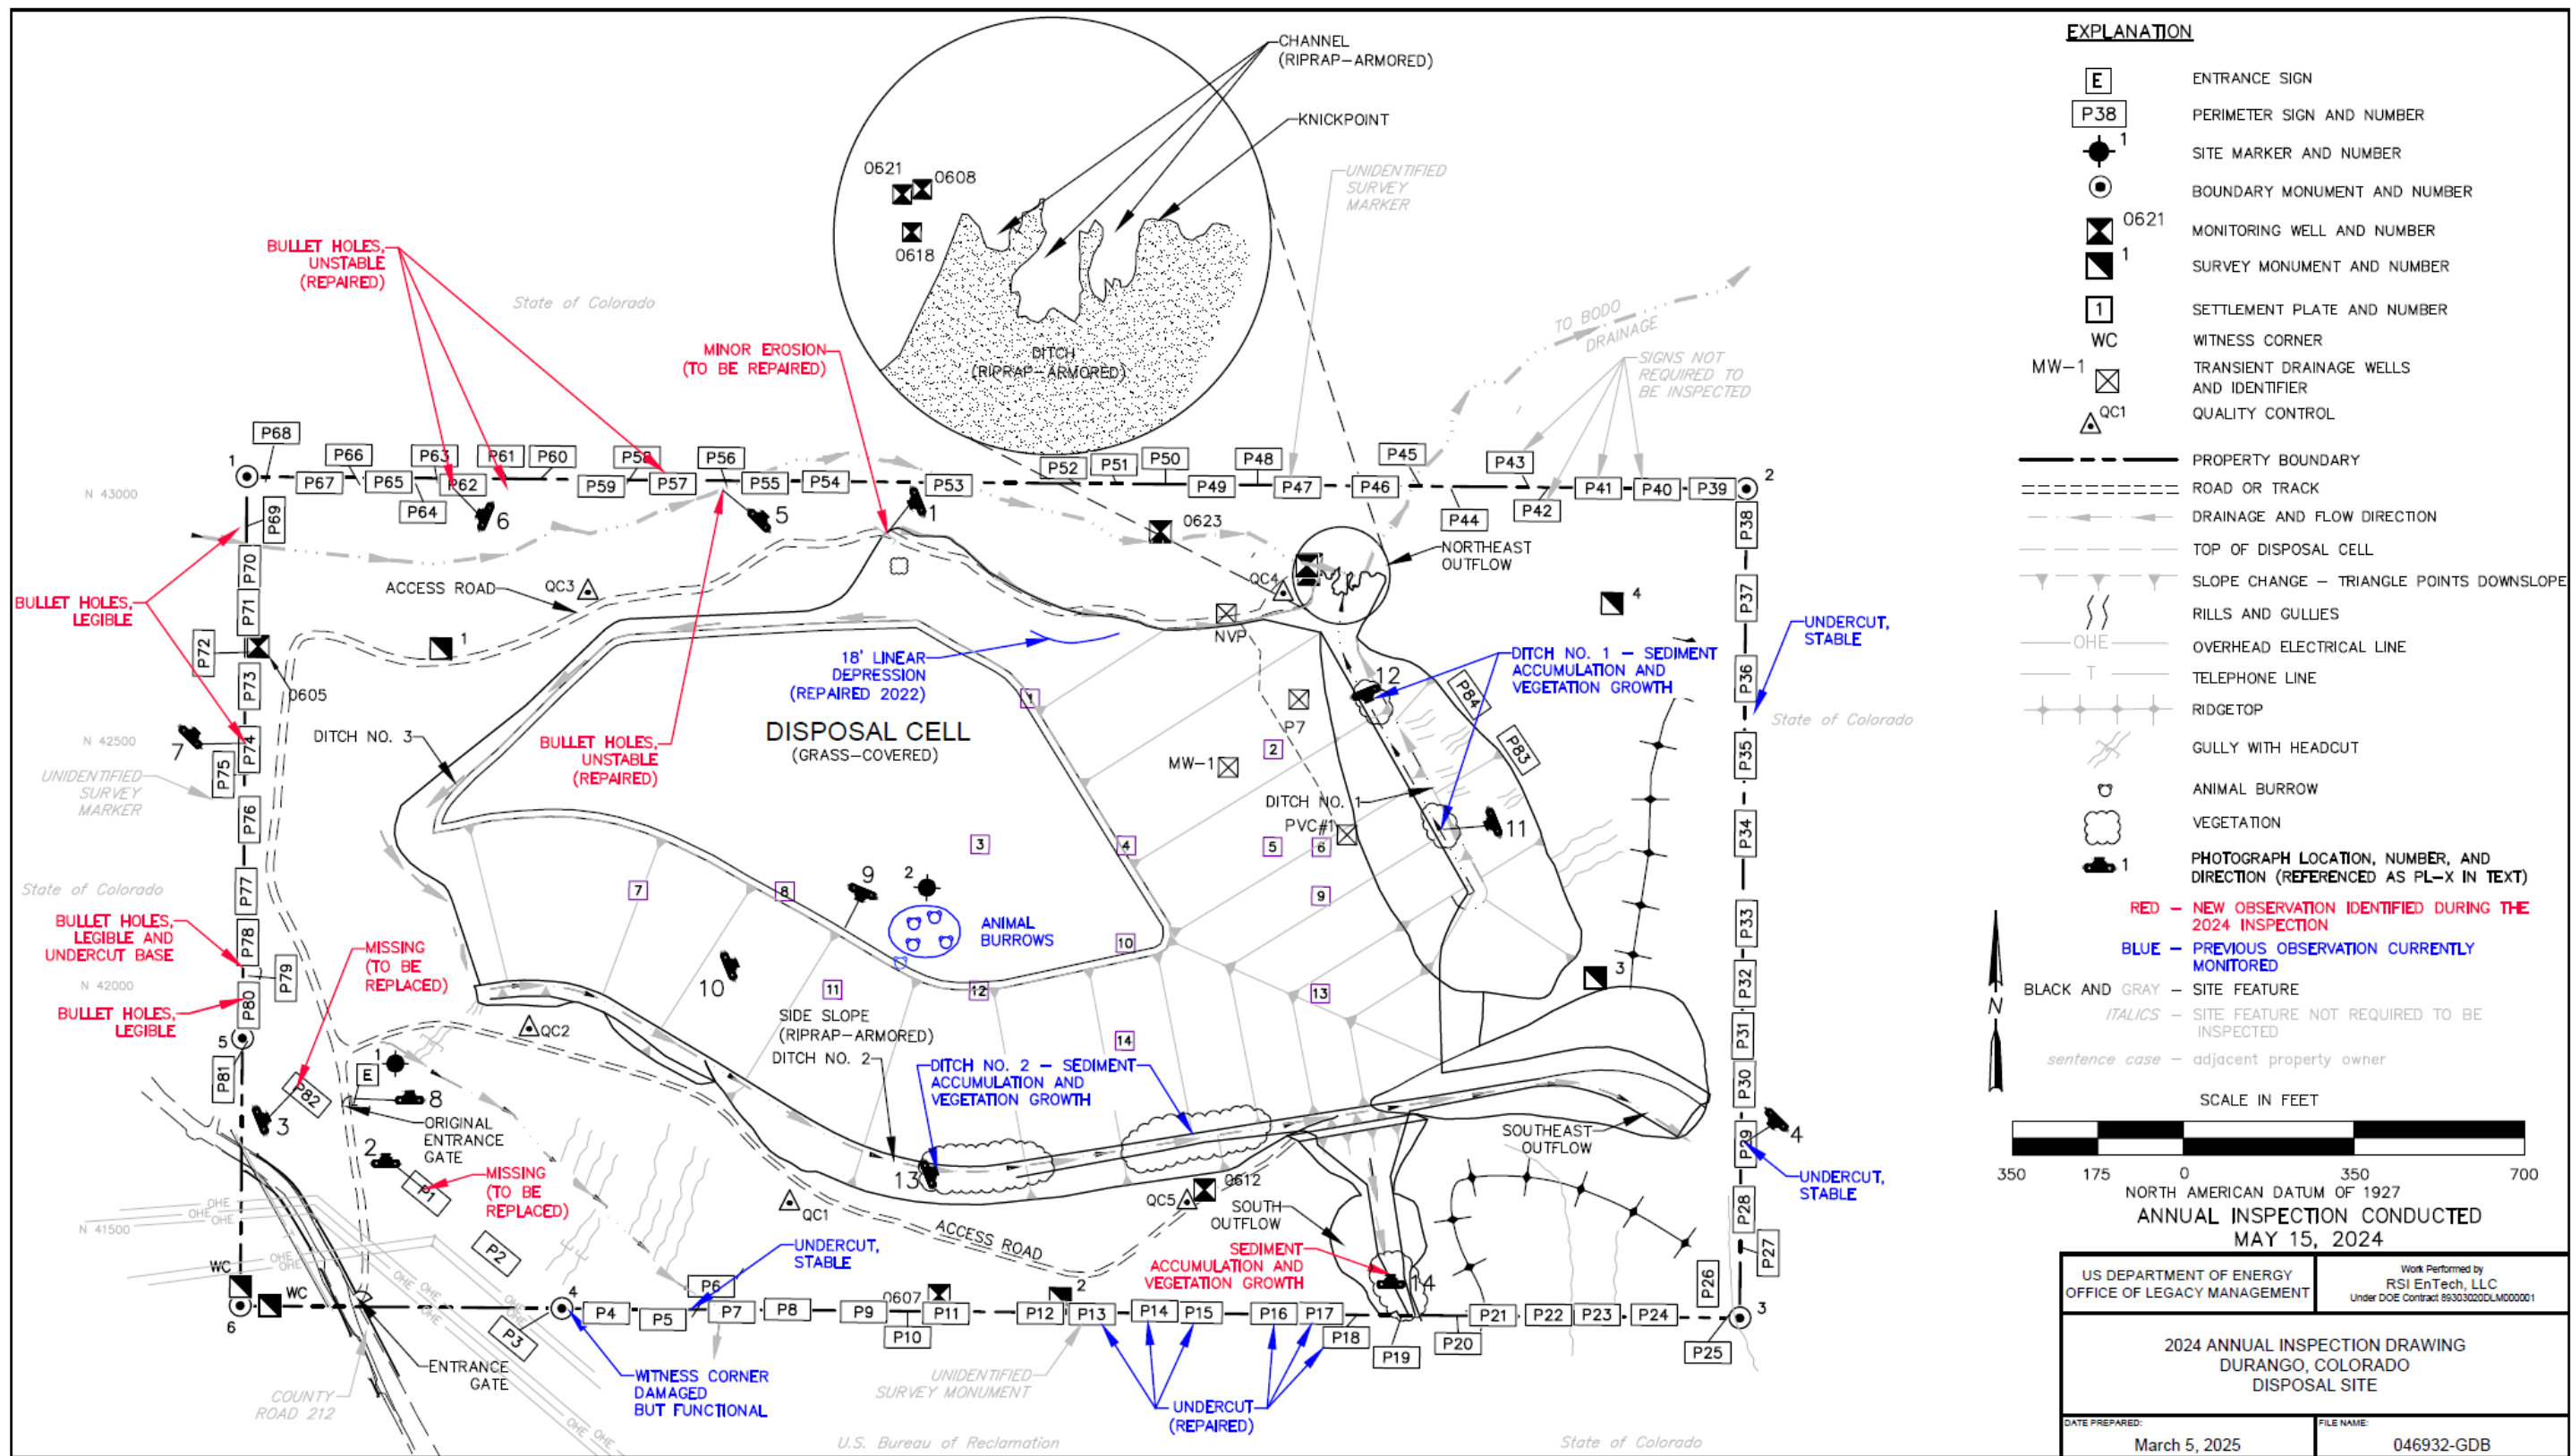
Figure 4-1. 2024 Annual Inspection Drawing for the Durango, Colorado, Disposal Site

Figure 4-1 shows the locations of site features, including site surveillance features and inspection areas, in black and gray font. Some site features that are present but not required to be inspected are shown in italic font. Observations from previous inspections that are currently monitored are shown in blue, and new observations identified during the 2024 annual inspection are shown in red. Inspection results and recommended maintenance activities associated with site surveillance features are described in the following subsections. Photographs to support specific observations are noted in the text and in Figure 4-1 by photograph location (PL) numbers. The photographs and photograph log are presented in Section 4.11.

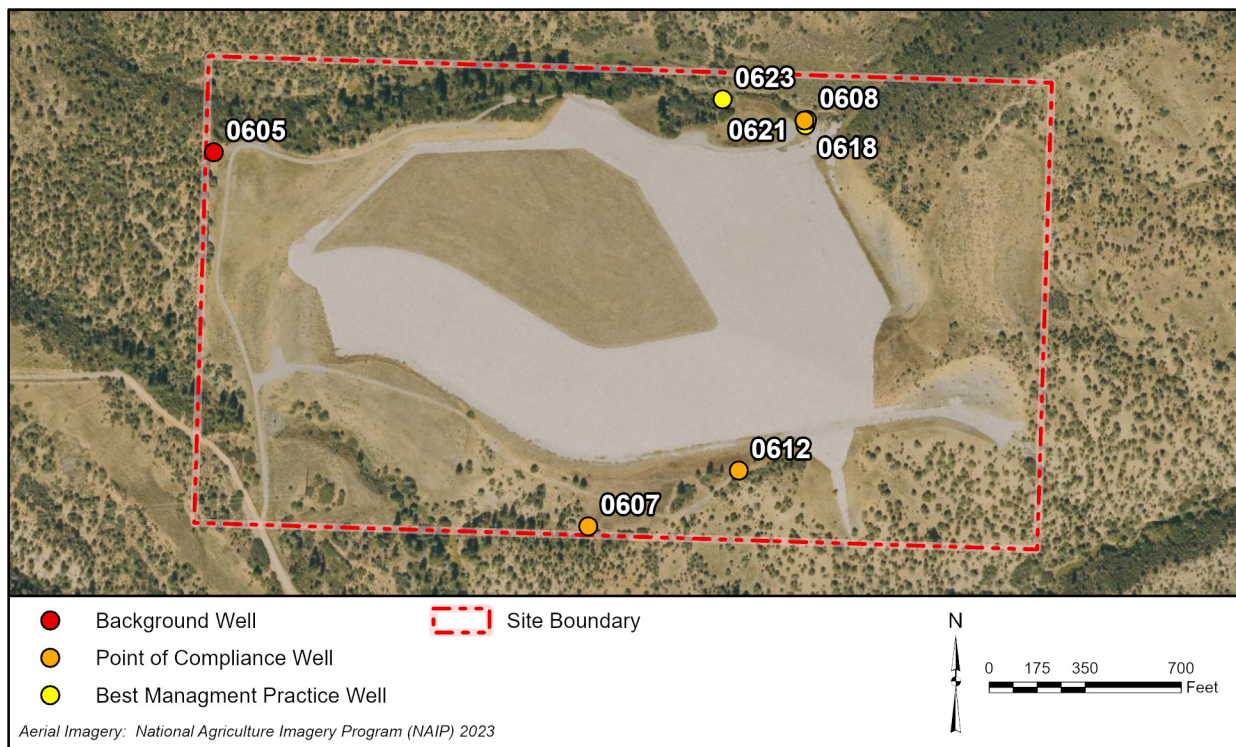
Figure 4-2. Groundwater Monitoring Network for the Durango, Colorado, Disposal Site

LM conducts annual groundwater sampling and analysis to monitor disposal cell performance. The monitoring network consists of seven wells, including three POC wells, three wells monitored as a best management practice, and one background well (Figure 4-2). The most recent annual sampling event occurred at the site in June 2024.

The LTSP (DOE 2019) establishes three POC wells at the site: wells 0607, 0612, and 0621. These wells are completed in the uppermost aquifer (bedrock of the Cliff House Sandstone and the Menefee Formation) because of the limited extent of saturated alluvium underlying the site. A background well (well 0605) is also completed in the uppermost bedrock aquifer. Monitoring wells 0608, 0618, and 0623 are completed in the overlying alluvium.

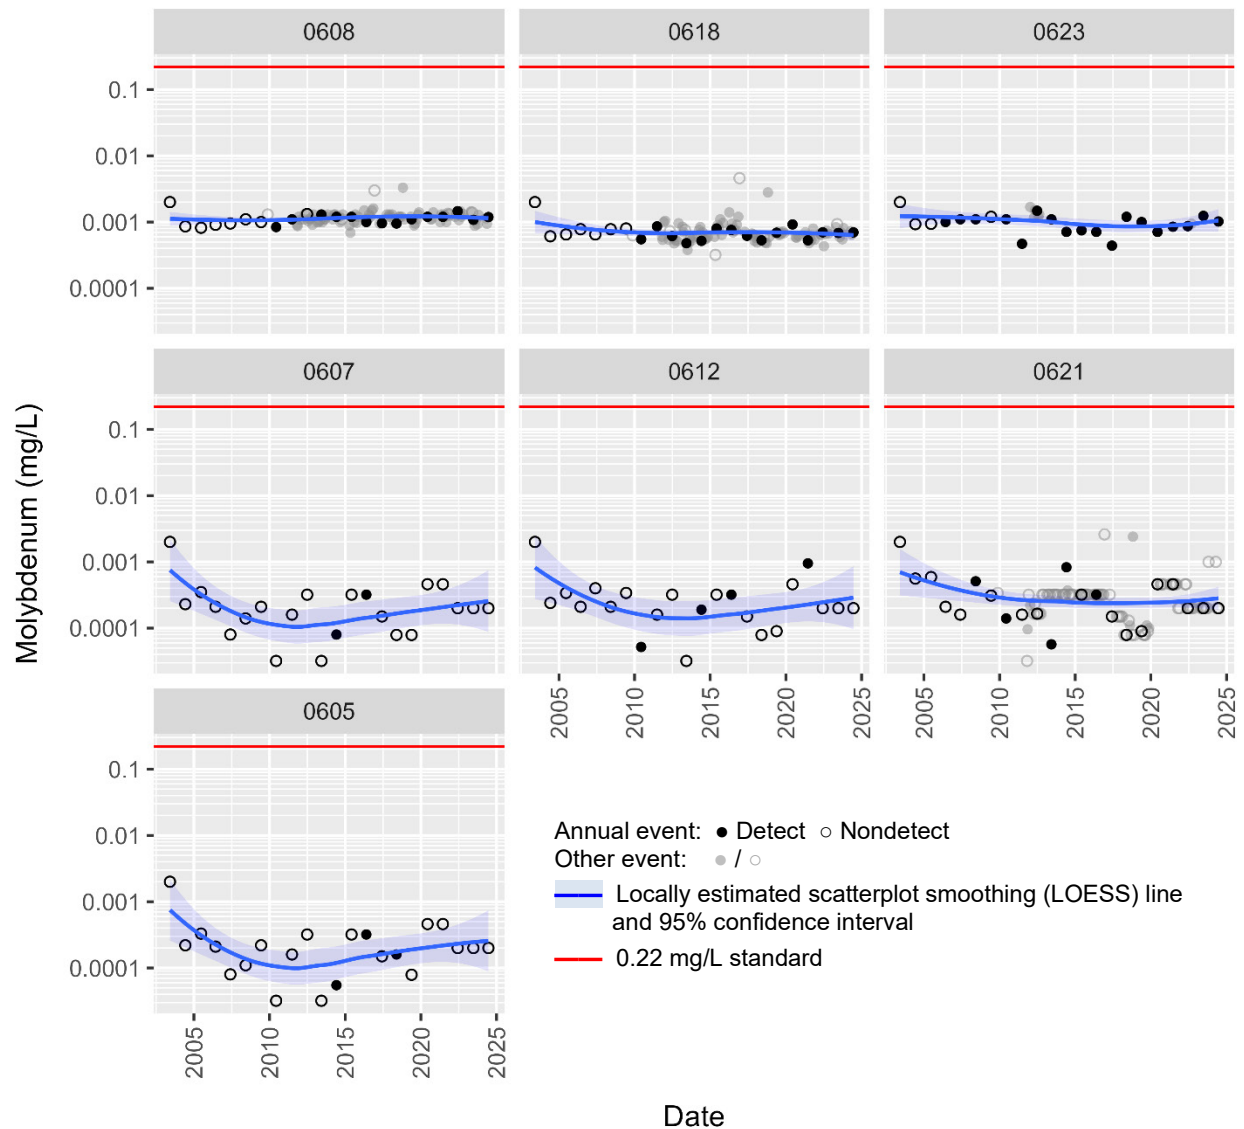
Figure 4-3. Molybdenum Concentrations in Groundwater at the Durango, Colorado, Disposal Site, 2003–2024

As shown in Figure 4-3 through Figure 4-5, concentrations of indicator parameters (molybdenum, selenium, and uranium) in POC wells 0607, 0612, and 0621 in the uppermost aquifer continue to be below respective standards. Uranium concentrations in well 0618 have consistently been variable and typically higher than concentrations in the other onsite wells.

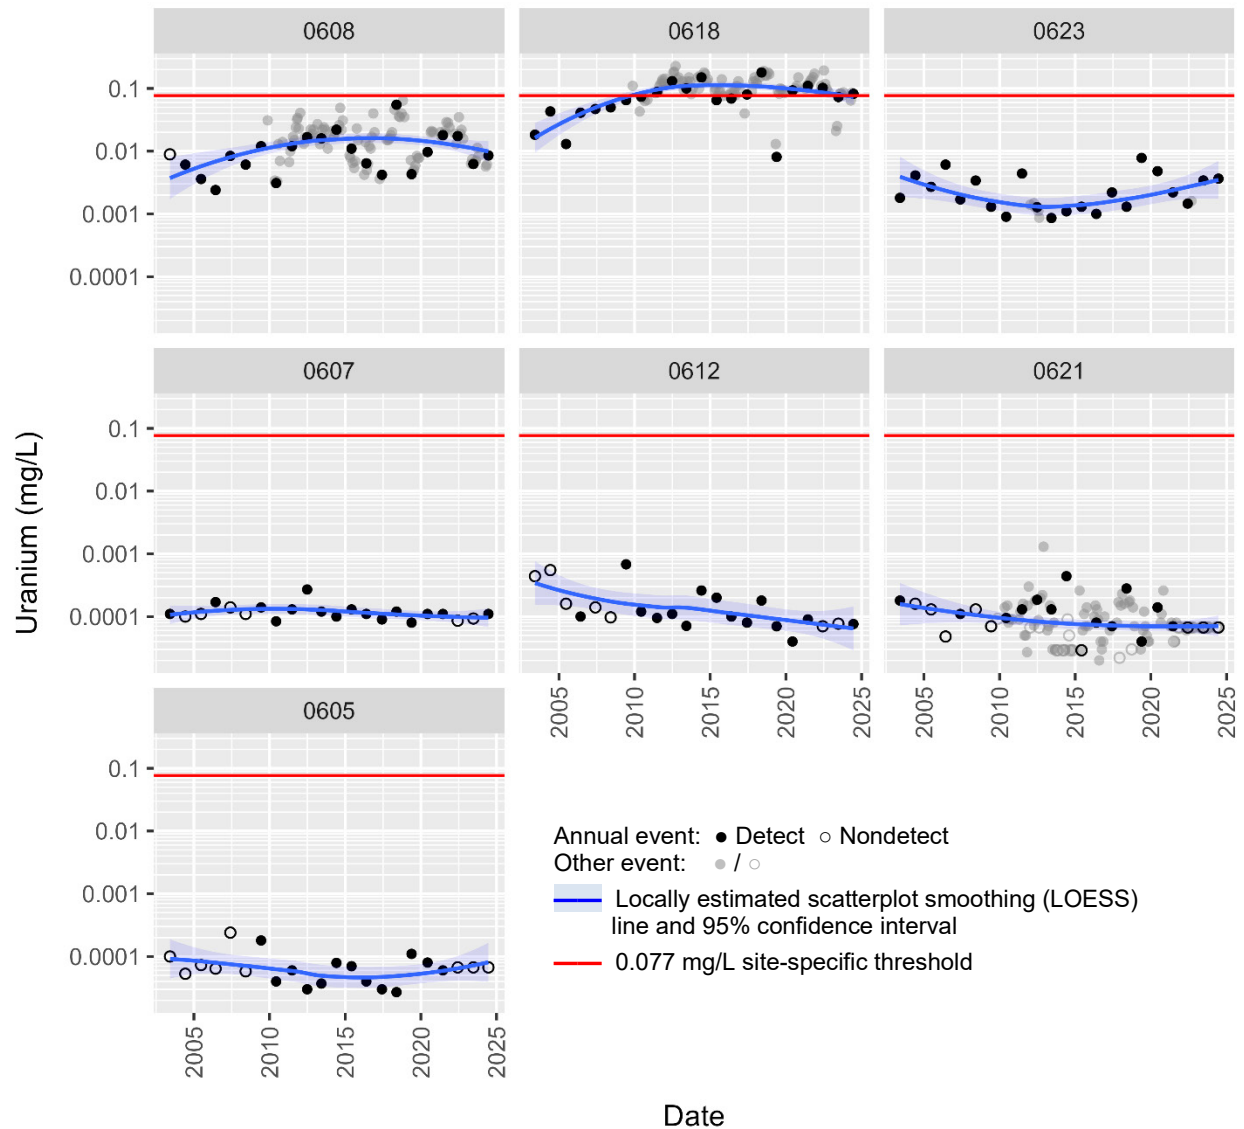
Figure 4-5. Uranium Concentrations in Groundwater at the Durango, Colorado, Disposal Site, 2003–2024

In addition to the annual sampling event and as a best management practice, LM samples monitoring wells 0608 and 0618 and POC well 0621 on a monthly basis (weather permitting) to monitor variable uranium concentrations in well 0618 that are typically above site-specific thresholds. Table 4-2 presents the current groundwater monitoring network.
