**2022 Annual Land-Use Covenant
Inspection Report
for DOE Areas at the
Laboratory for Energy-Related
Health Research/Old Campus
Landfill Superfund Site
University of California, Davis**

January 2023

U.S. DEPARTMENT OF
ENERGY

Legacy
Management

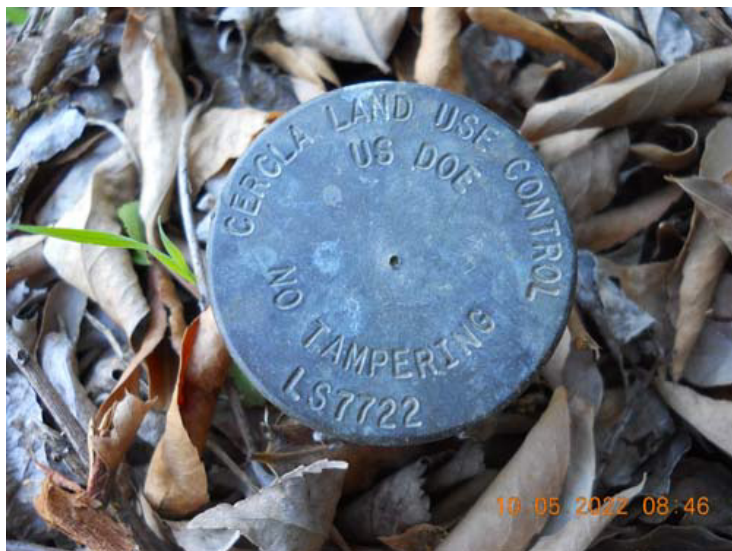
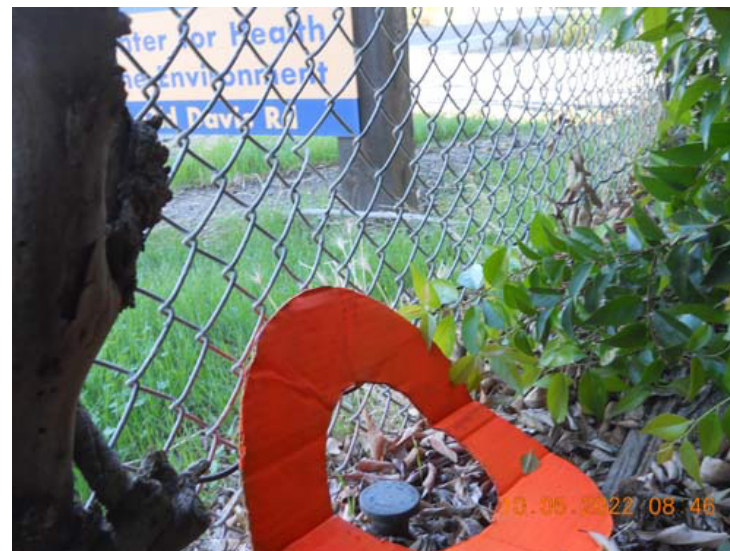
*Survey Monument 1: Northwest Corner of Dry Wells A–E Area
(Photo No. 4696)*

*View Northwest: Survey Monument 1 Within Orange Ring
(outside diameter, 14 inches); West Perimeter Fence and Center
for Health and the Environment Entrance Sign in Background
(Photo No. 4695)*

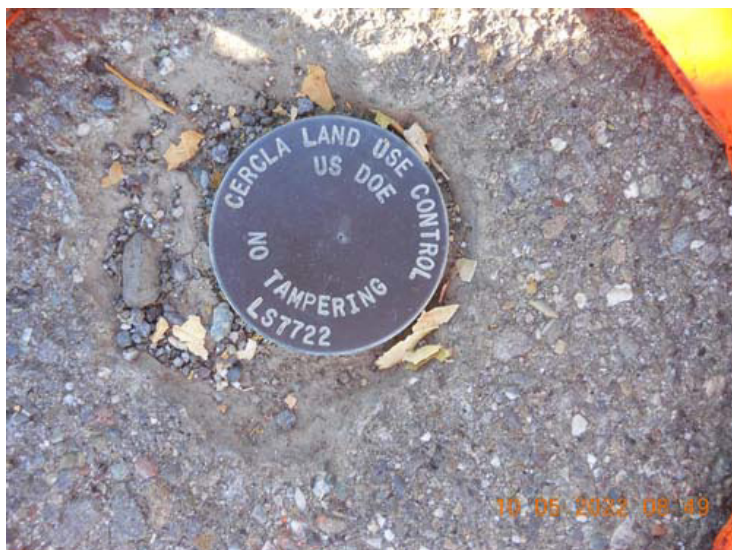
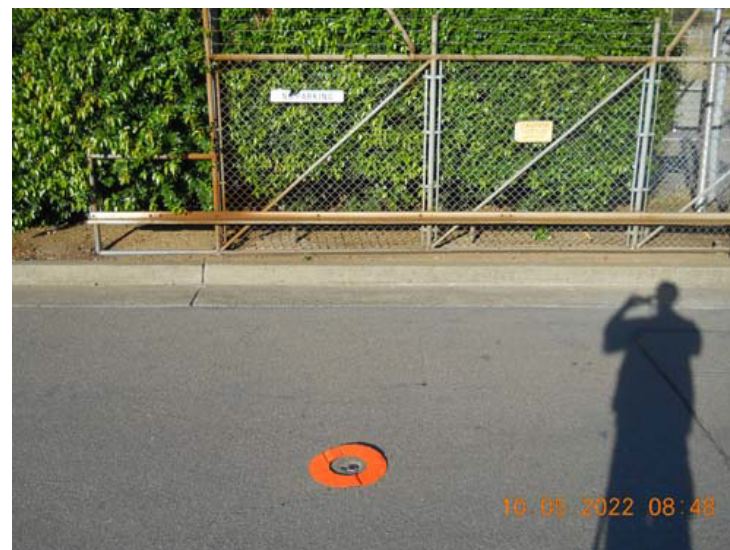
*Survey Monument 2: Northeast Corner of Dry Wells A–E Area
(Photo No. 4698)*

*View West: Survey Monument 2 Within Orange Ring; Retracted
Entrance Gate in Background (Photo No. 4697)*

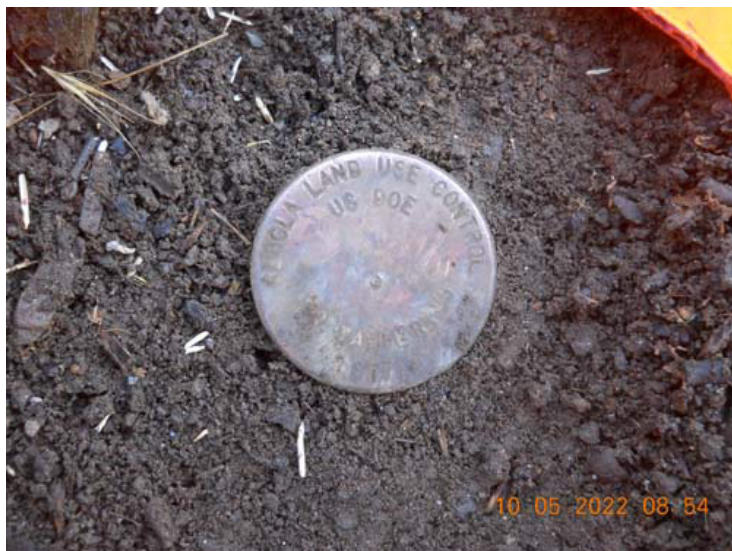
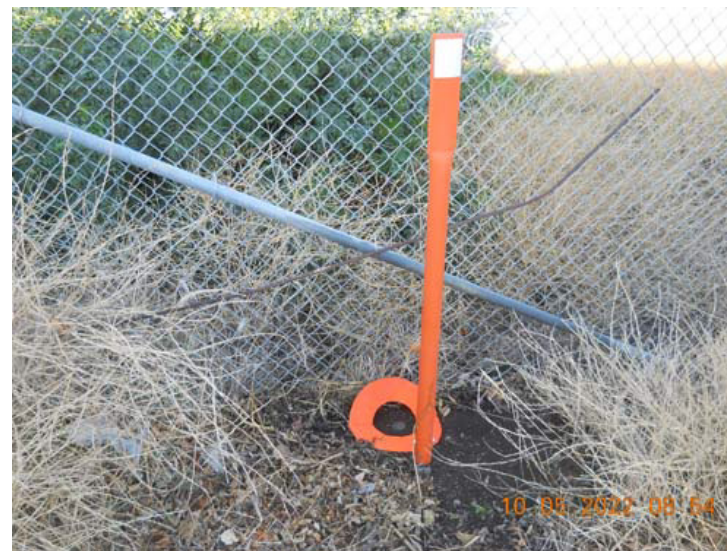
*Survey Monument 3: Southwest Corner of Dry Wells A-E Area
(Photo No. 4701)*

*View Southwest: Survey Monument 3 Within Orange Ring; West
Perimeter Fence Behind Survey Monument; Orange Delineator
Right of Survey Monument (Photo No. 4700)*

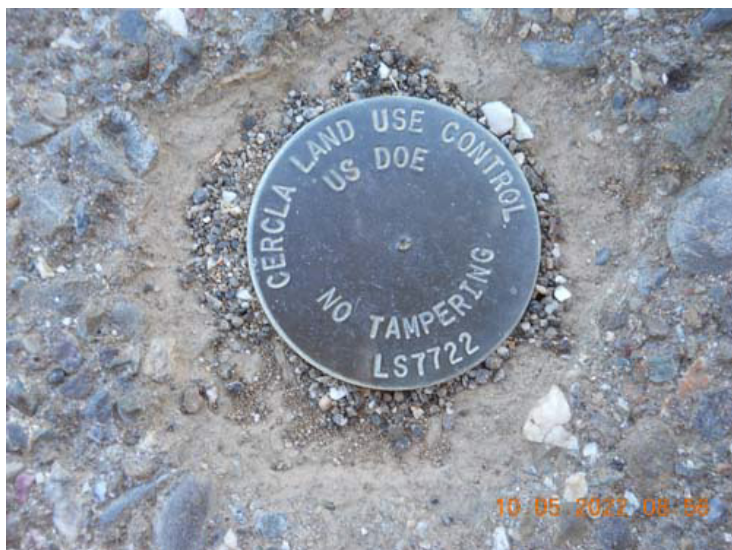
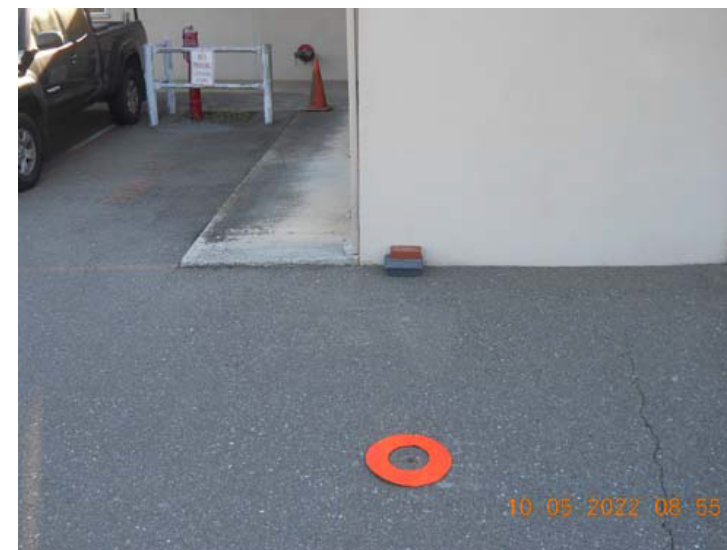
*Survey Monument 4: Southeast Corner of Dry Wells A-E Area
(Photo No. 4703)*

*View East: Survey Monument 4 Within Orange Ring;
Building H-219 in Background (Photo No. 4702)*

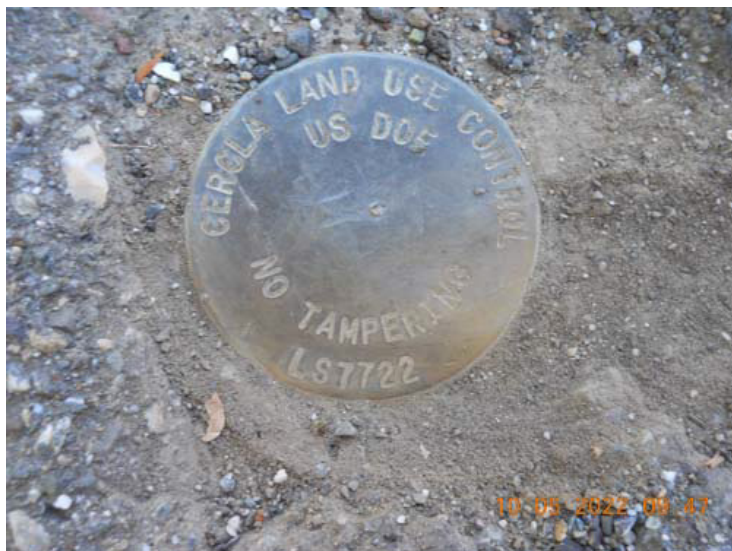
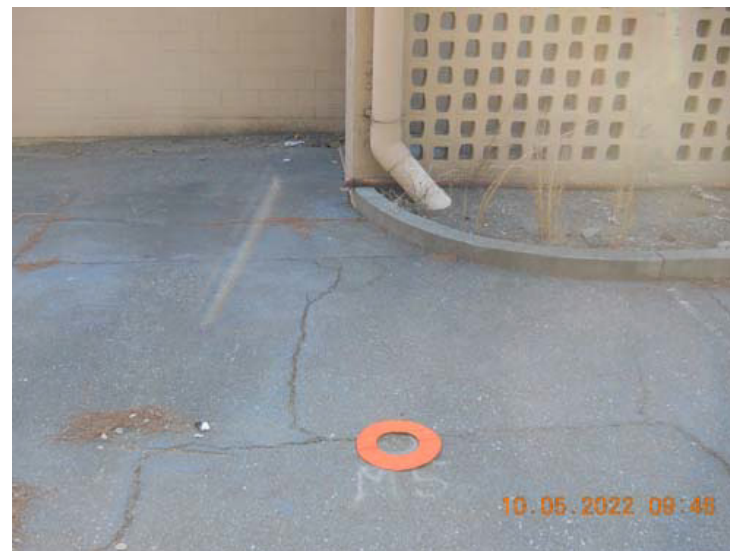
*Survey Monument 5: Northwest Corner of DSS 4 Area
(Photo No. 4721)*

*View East: Survey Monument 5 Within Orange Ring;
Building H-215 in Background (Photo No. 4720)*

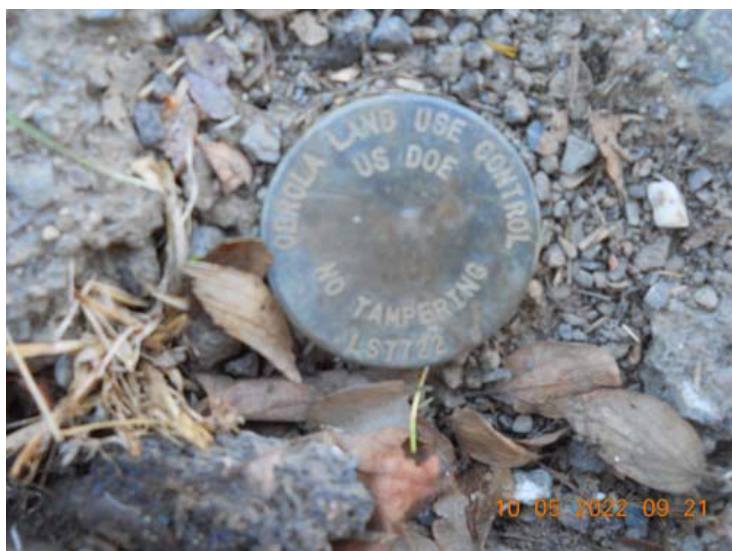
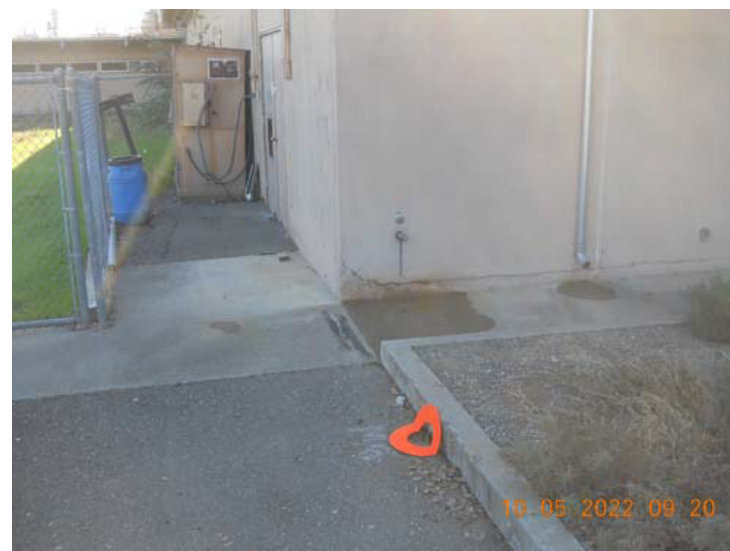
*Survey Monument 6: Adjacent to Northwest Corner of Building H-218;
Ra/Sr Treatment Systems Area (Photo No. 4712)*

*View East: Survey Monument 6 Within Orange Ring; Corner of
Building H-218 in Background (Photo No. 4711)*

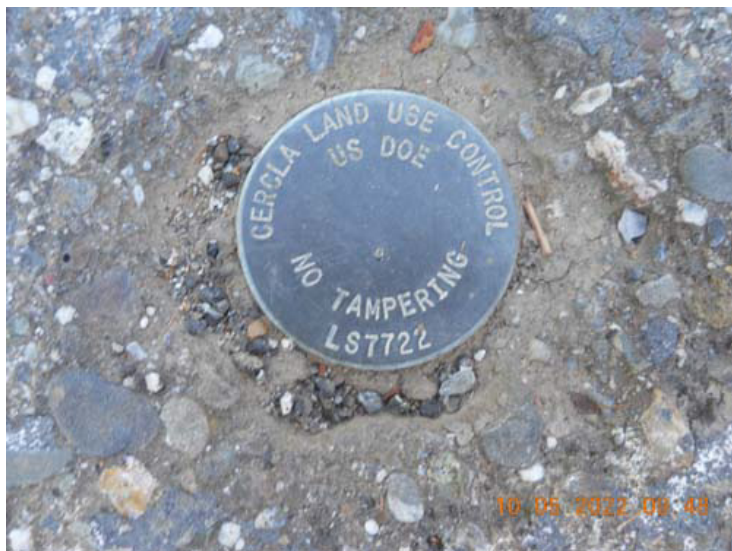
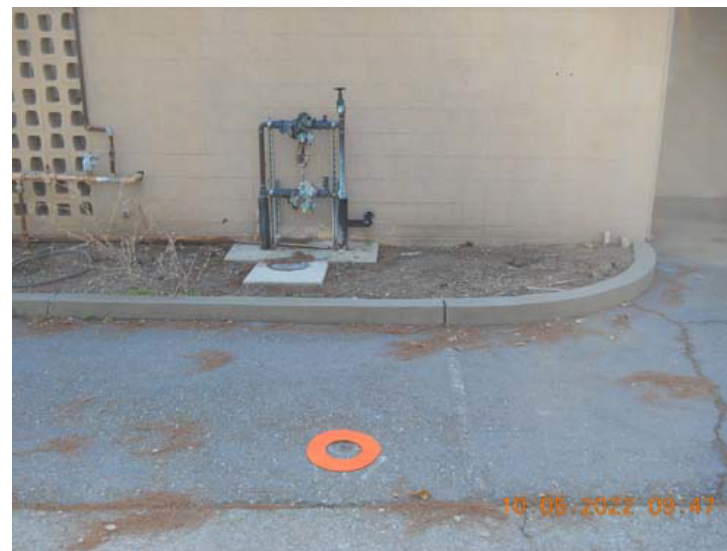
*Survey Monument 7: Southwest Corner of DSS 4 Area
(Photo No. 4723)*

*View East: Survey Monument 7 Within Orange Ring;
Building H-215 in Background (Photo No. 4722)*

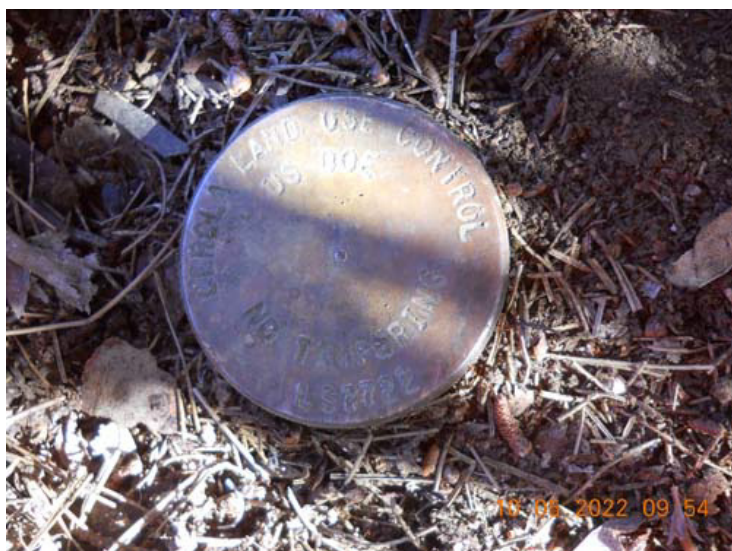
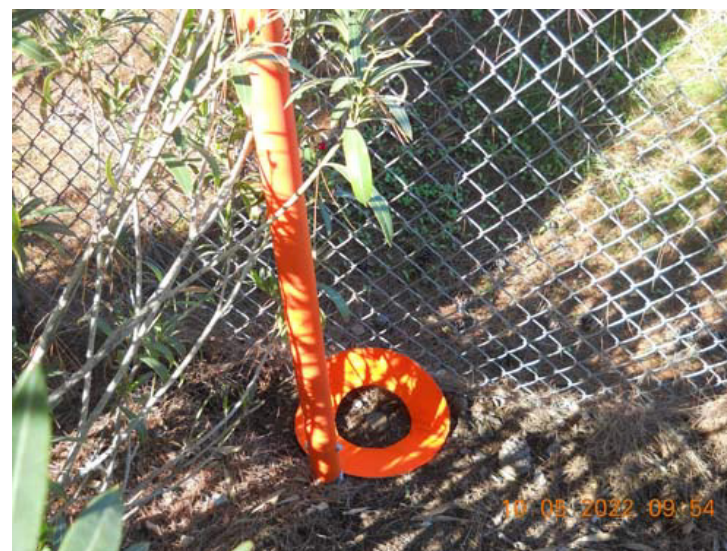
*Survey Monument 8: Southwest Corner of Radium-226
Leach Trench; Ra/Sr Treatment Systems Area (Photo No. 4726)*

*View Southwest: Survey Monument 8 Within Orange Ring;
West Perimeter Fence Behind Survey Monument;
Orange Delineator Left of Survey Monument (Photo No. 4725)*

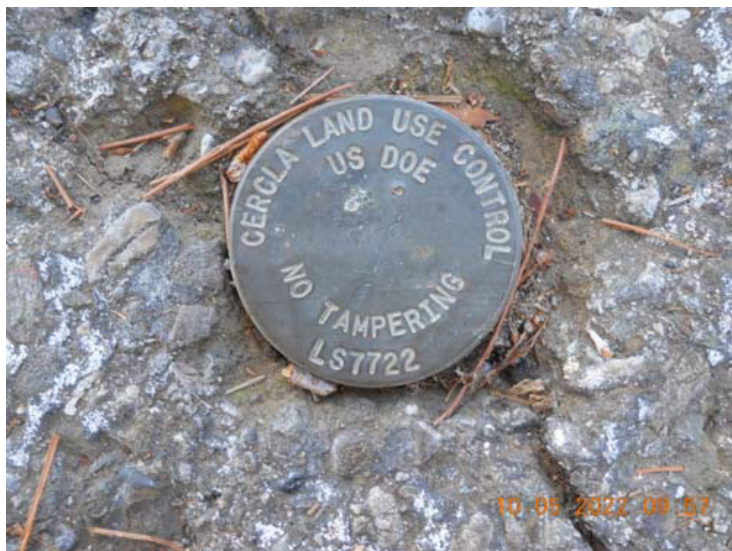
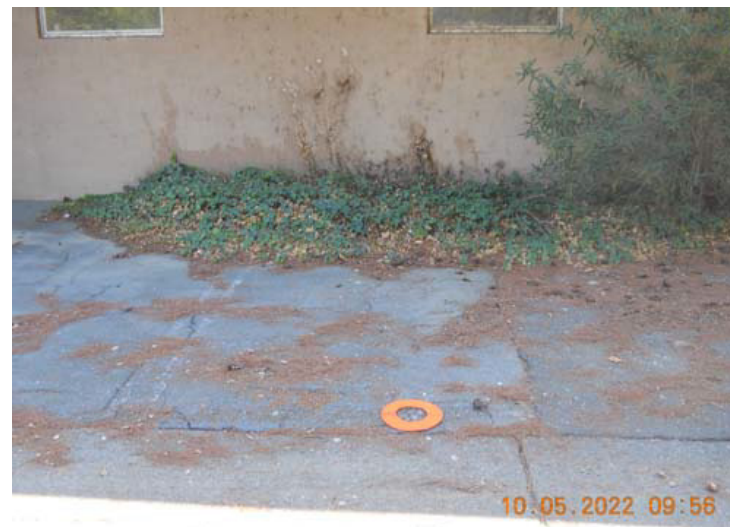
*Survey Monument 9: Southeast Corner of Radium-226 Leach Trench;
Ra/Sr Treatment Systems Area (Photo No. 4729)*

*View East: Survey Monument 9 Within Orange Ring;
Building H-215 in Background (Photo No. 4728)*

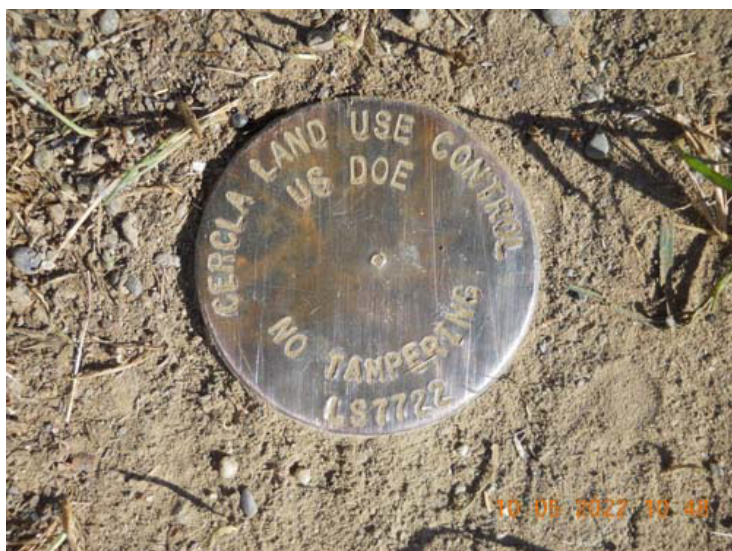
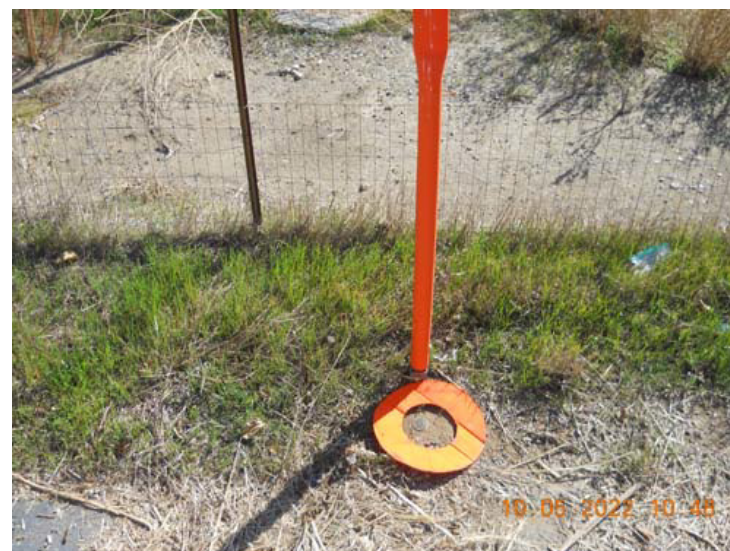
*Survey Monument 10: Northeast Corner of Former Leach Field
in DSS 3 Area (Photo No. 4749)*

*View East: Survey Monument 10 Within Orange Ring;
Delineator Behind Survey Monument (Photo No. 4748)*

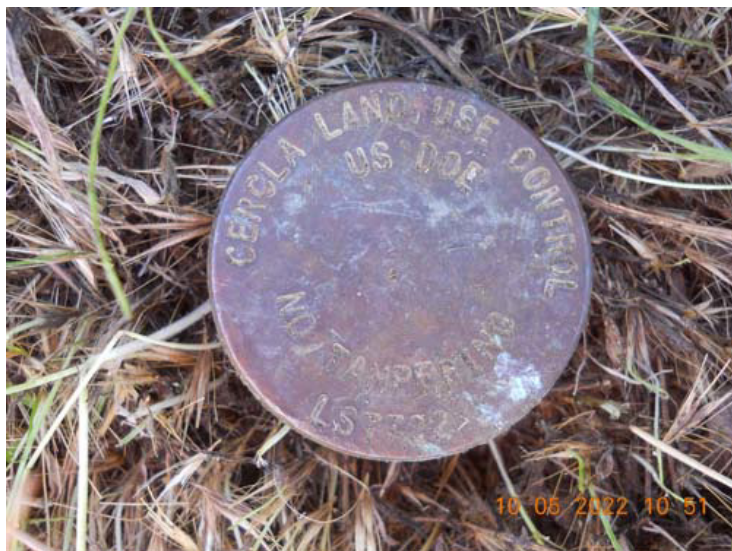
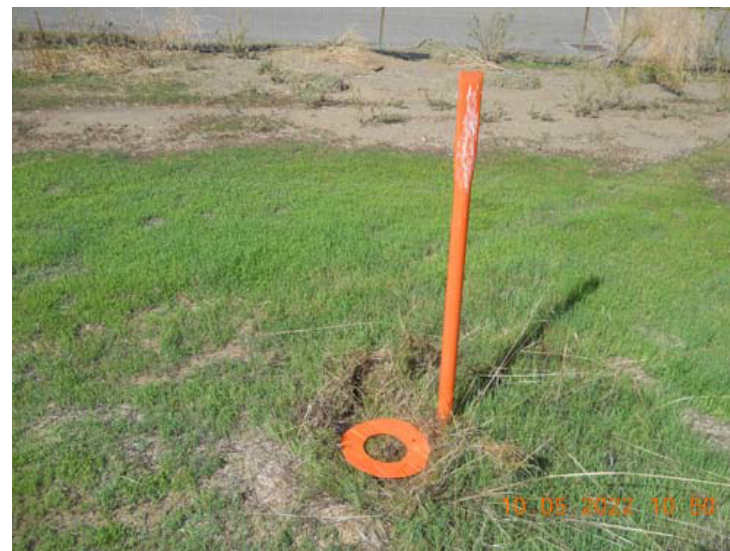
Survey Monument 11: Northeast Corner of Eastern Remediation Support Area (Photo No. 4751)

View North: Survey Monument 11 Within Orange Ring; Delineator Right of Survey Monument (Photo No. 4750)

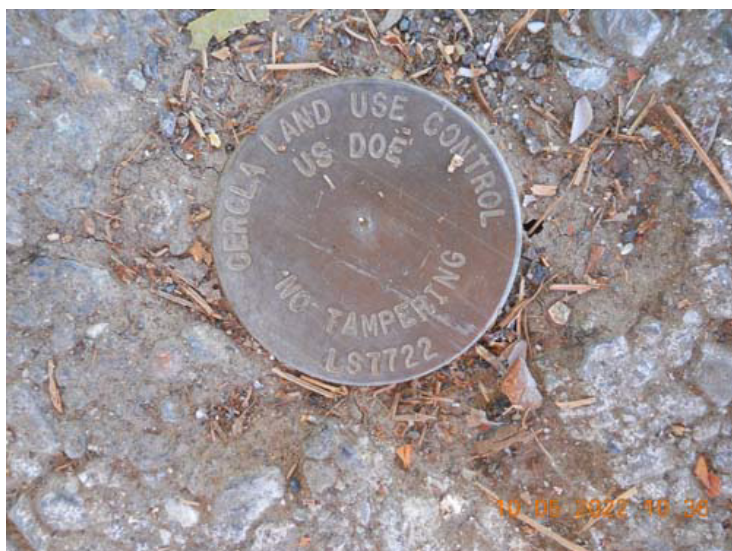
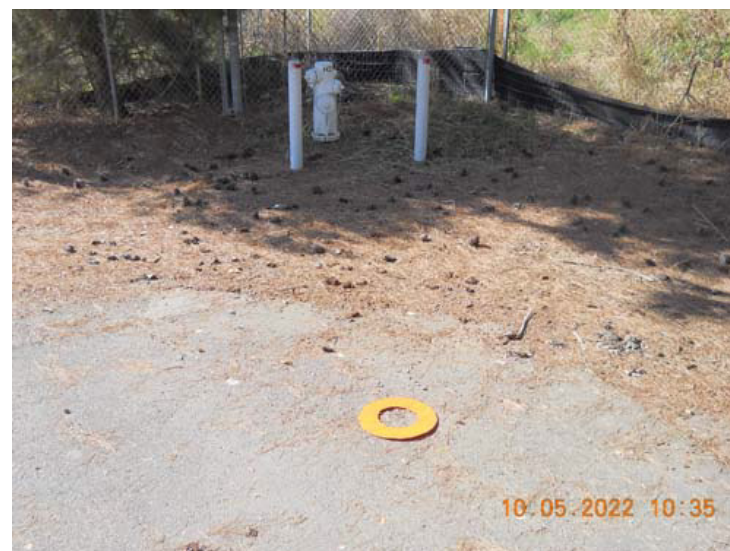
Survey Monument 12: Northwest Corner of SWT Area (Photo No. 4743)

View South: Survey Monument 12 Within Orange Ring in Foreground; Water Hydrant in Background (Photo No. 4742)

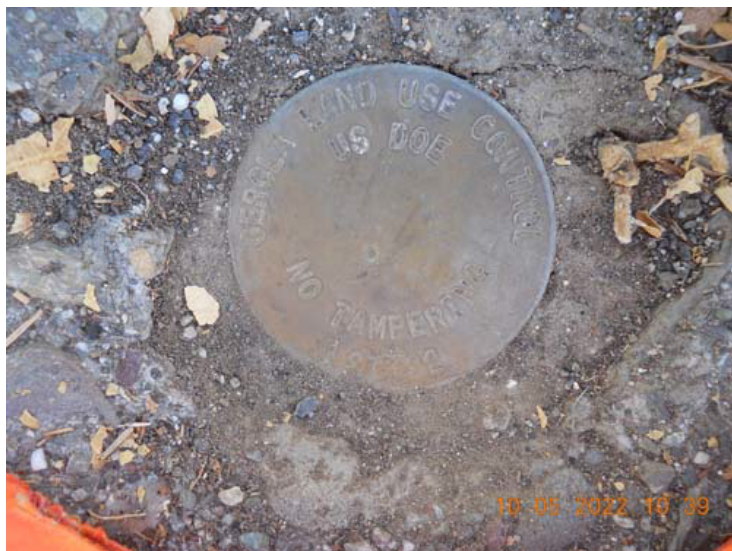
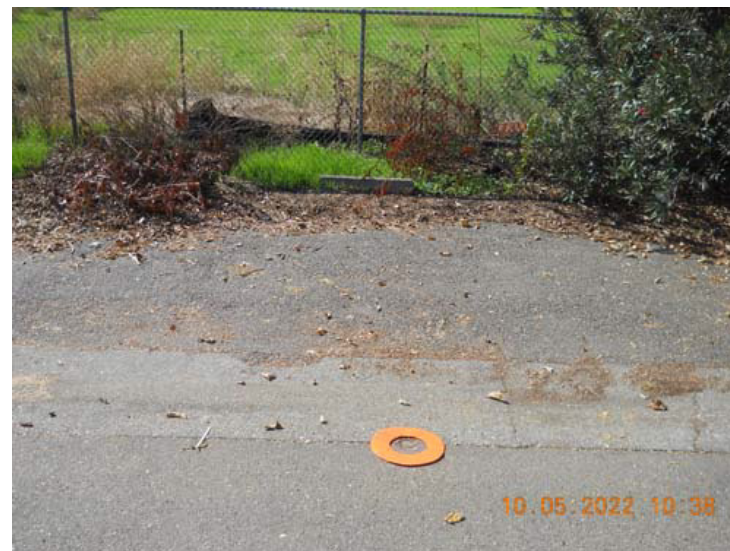
*Survey Monument 13: Southwest Corner of DSS 3 Area
(Photo No. 4746a)*

*View South: Survey Monument 13 Within Orange Ring at
Edge of Concrete Swale; Northern Perimeter of Southwest
Trenches Area in Background (Photo No. 4745a)*

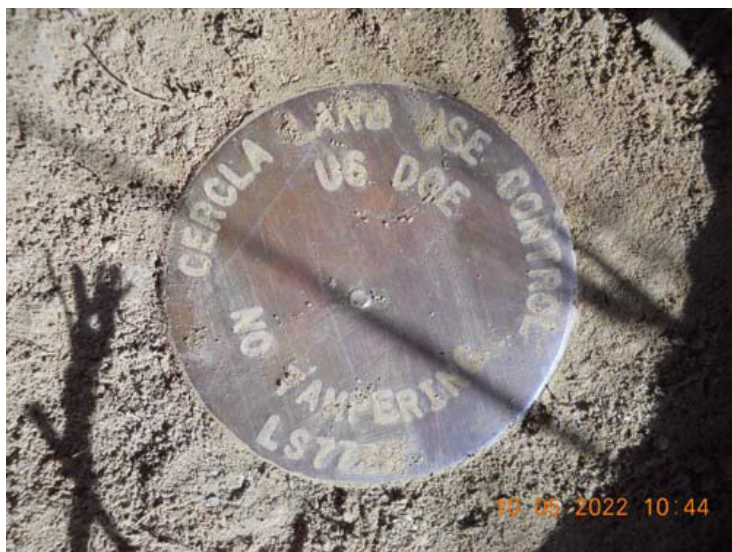
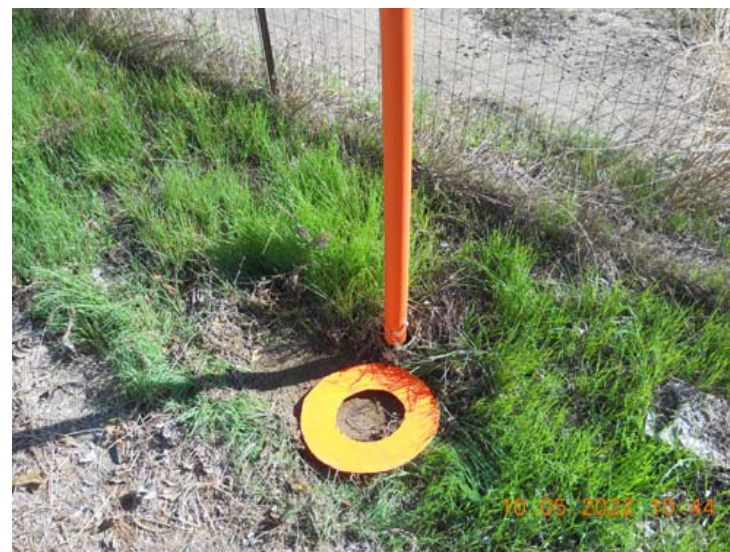
*Survey Monument 14: Southeast Corner of DSS 3 Area
(Photo No. 4745b)*

*View Northeast: Survey Monument 14 Within Orange Ring;
Delineator Behind Survey Monument (Photo No. 4744)*

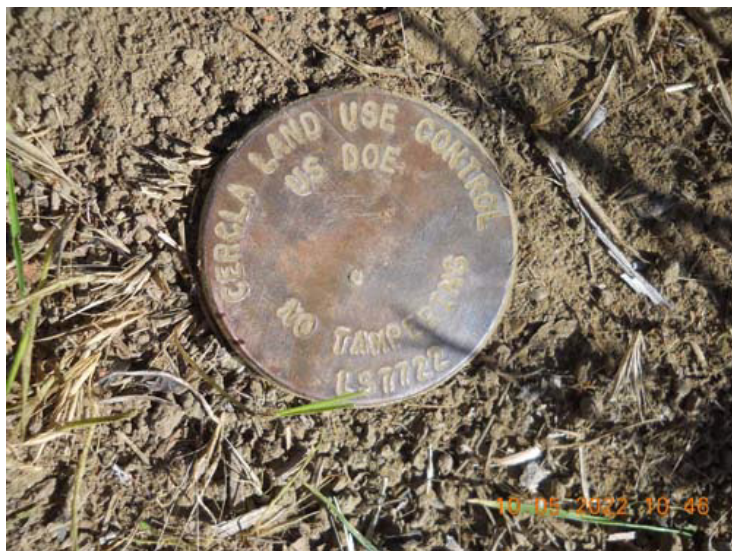
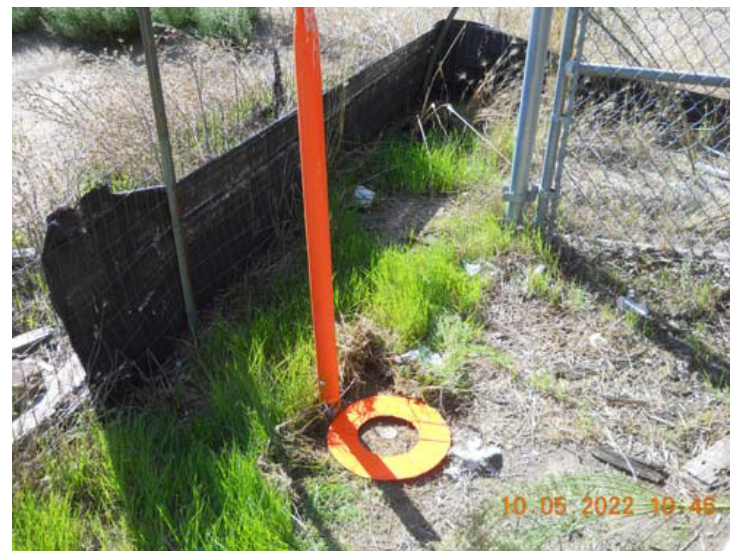
*Survey Monument 15: Eastern Corner of SWT Area
(Photo No. 4747b)*

*View Southeast: Survey Monument 15 Within Orange Ring;
Delineator Left of Survey Monument (Photo No. 4746b)*

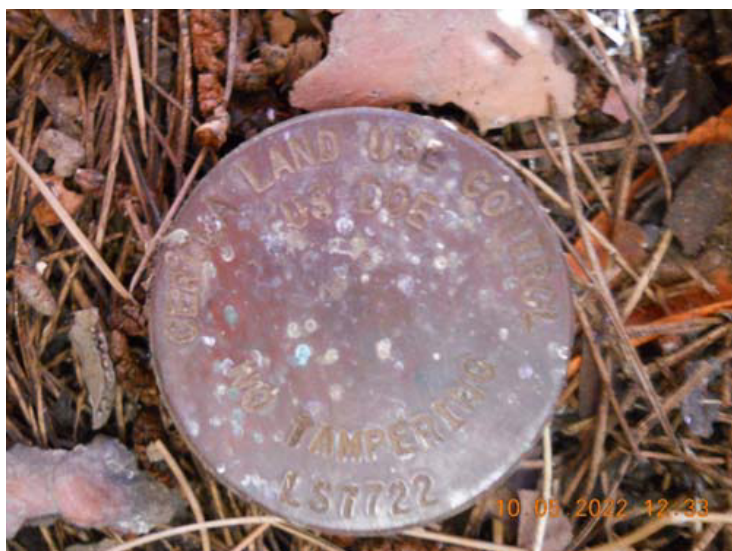
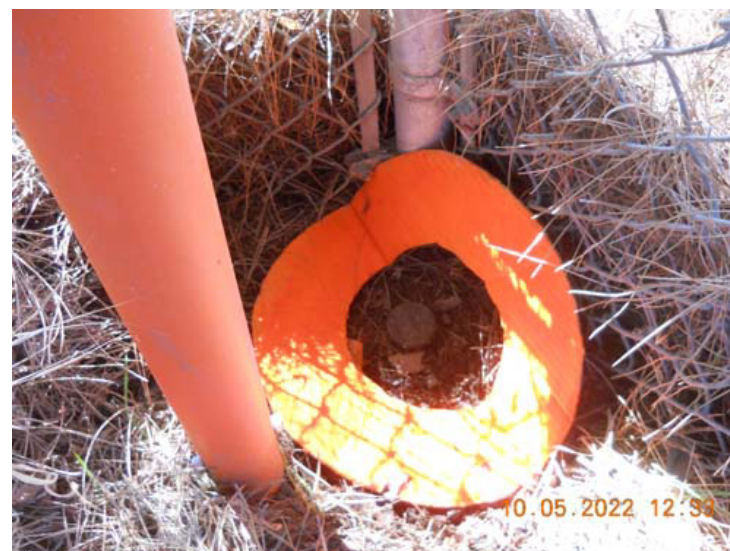
*Survey Monument 16: Southwest Corner of SWT Area
(Photo No. 4773)*

*View Southwest: Survey Monument 16 Within Orange Ring;
Delineator Left of Survey Monument; Southwest Corner Post of
Perimeter Fence Behind Survey Monument (Photo No. 4772)*

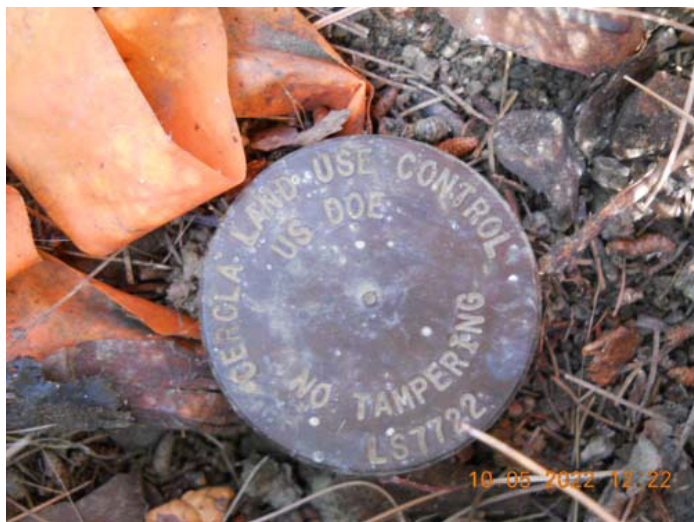
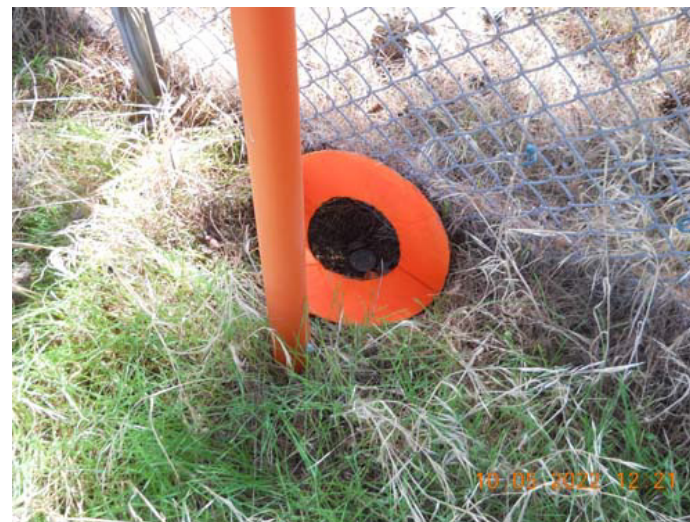
*Survey Monument 17: Southeast Corner of SWT Area
(Photo No. 4761)*

*View Southeast: Survey Monument 17 Within Orange Ring;
Delineator Left of Survey Monument; South Perimeter Fence
Behind Survey Monument; Foot of North Levee in Background
(Photo No. 4760)*

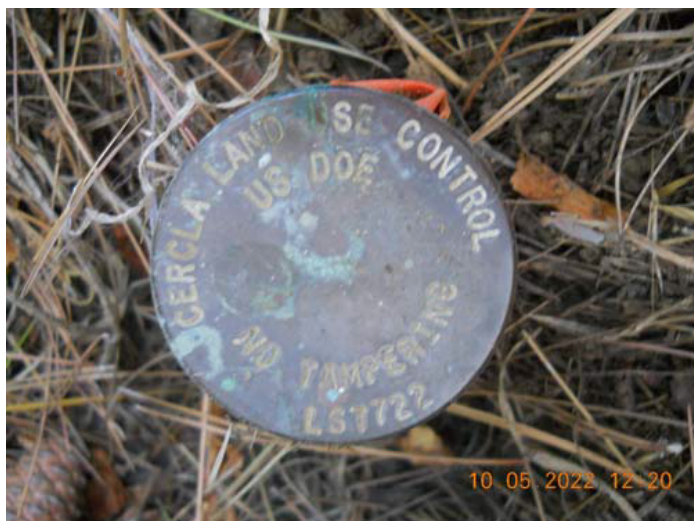
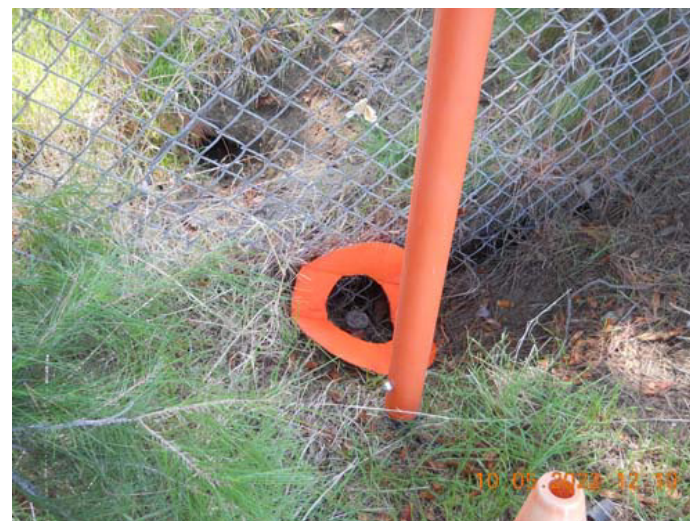
*Survey Monument 18: Southeast Corner of
Eastern Remediation Support Area (Photo No. 4759)*

*View South: Survey Monument 18 Within Orange Ring;
Delineator Right of Survey Monument; South Perimeter Fence
Behind Survey Monument; Foot of North Levee in Background
(Photo No. 4758)*

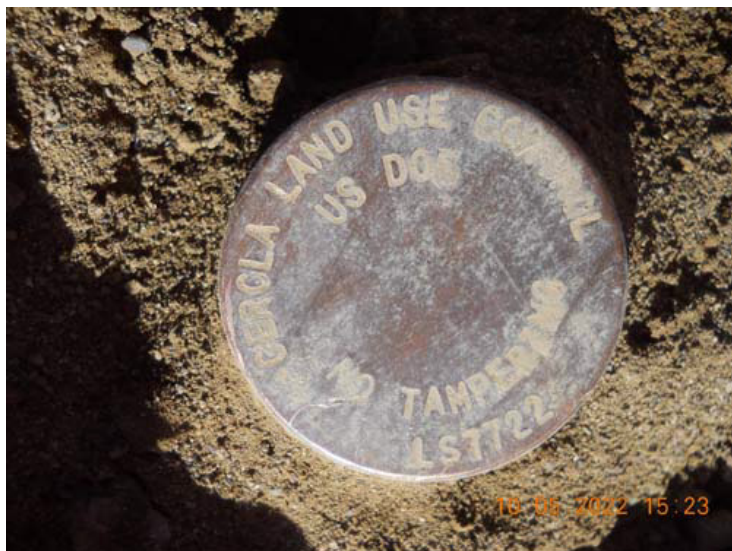
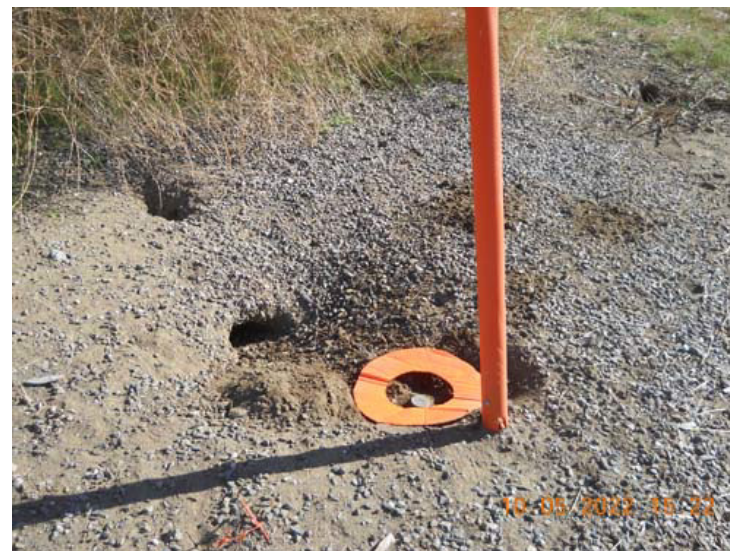
*Survey Monument 19: Northwest Corner of EDPs Area
(Photo No. 4782)*

*View Southeast: Survey Monument 19 Within Orange Ring;
Delineator Right of Survey Monument (Photo No. 4781)*

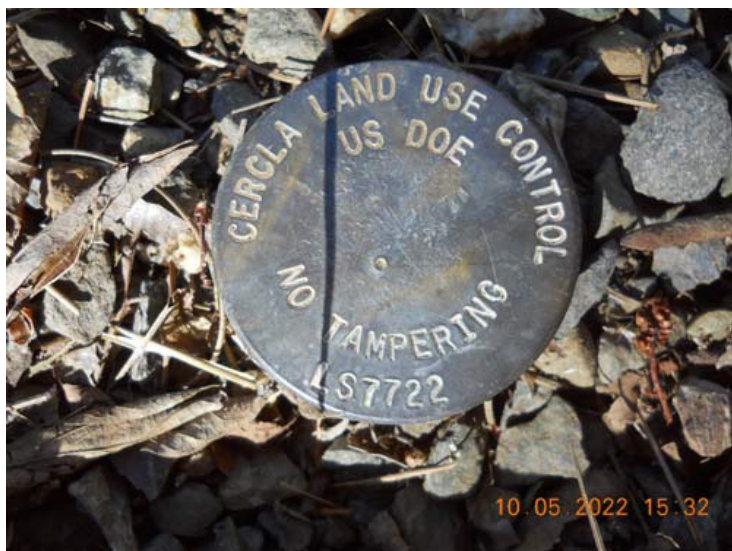
*Survey Monument 20: Northeast Corner of EDPs Area
(Photo No. 4786)*

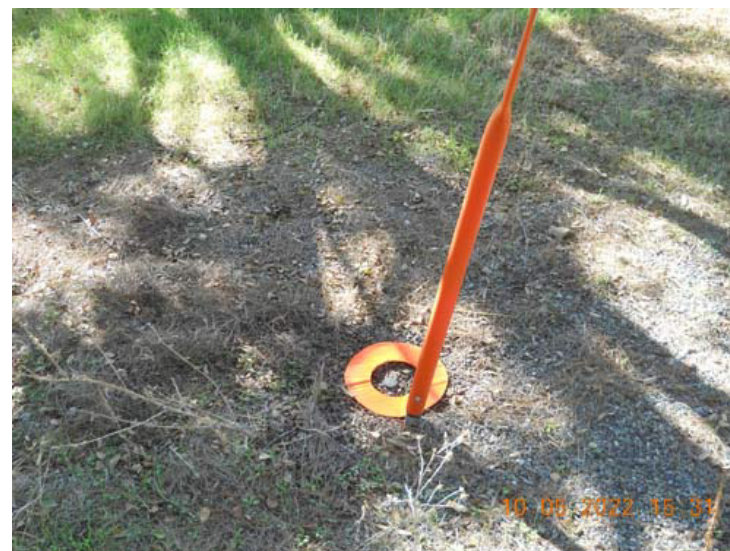
*View Southwest: Survey Monument 20 Within Orange Ring;
Delineator Right of Survey Monument (Photo No. 4785)*

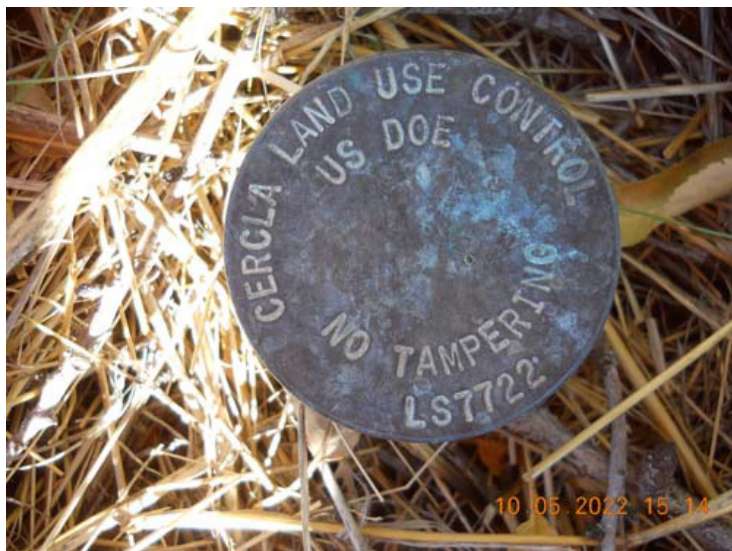
*Survey Monument 21: Southwest Corner of EDPs Area
(Photo No. 4778)*

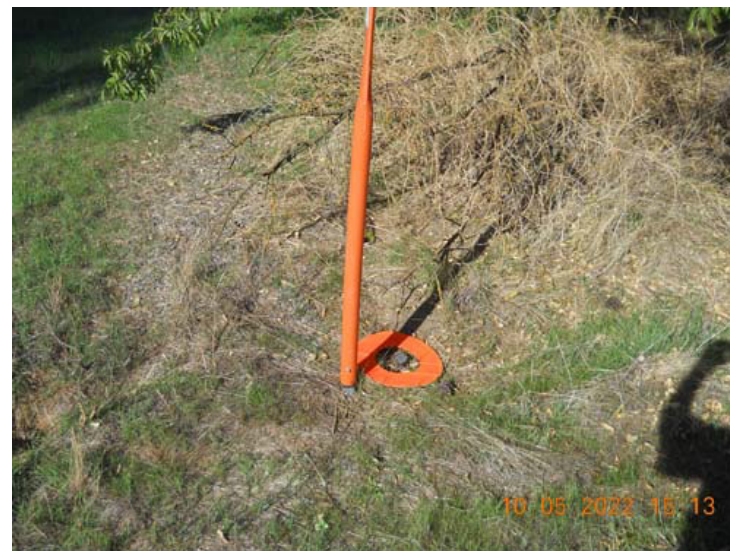
*View Northeast: Survey Monument 21 Within Orange Ring;
Delineator Left of Survey Monument (Photo No. 4777)*

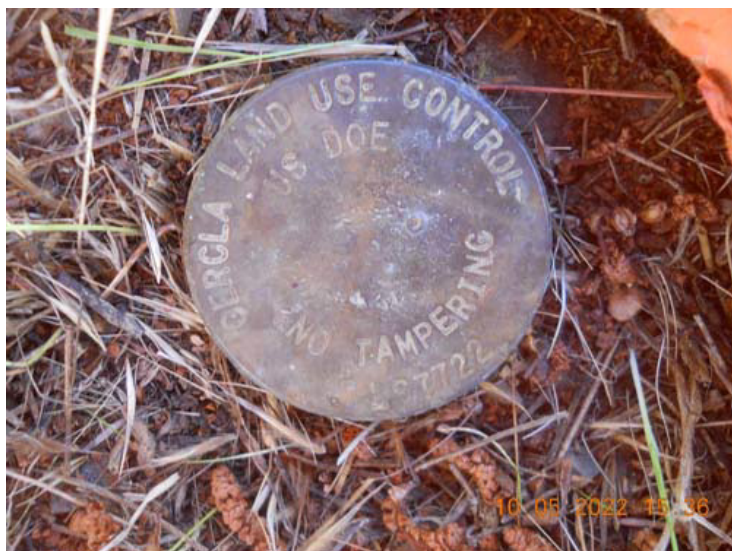
*Survey Monument 22: Southeast Corner of EDPs Area
(Photo No. 4789)*

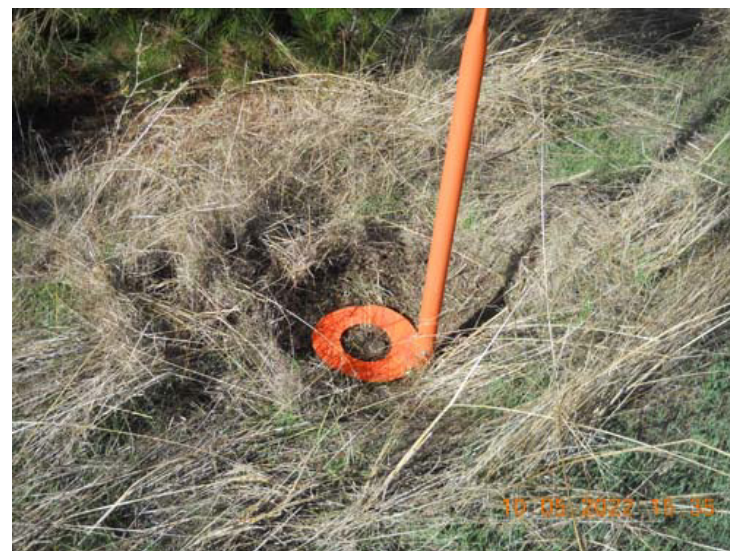
*View Northwest: Survey Monument 22 Within Orange Ring;
Delineator Right of Survey Monument (Photo No. 4788)*

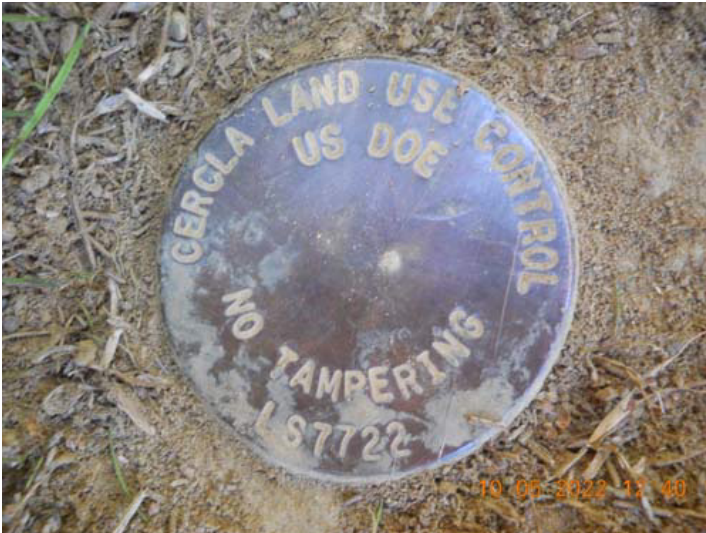
Survey Monument 23: Western Perimeter Point of SWT Area
(Photo No. 4775)

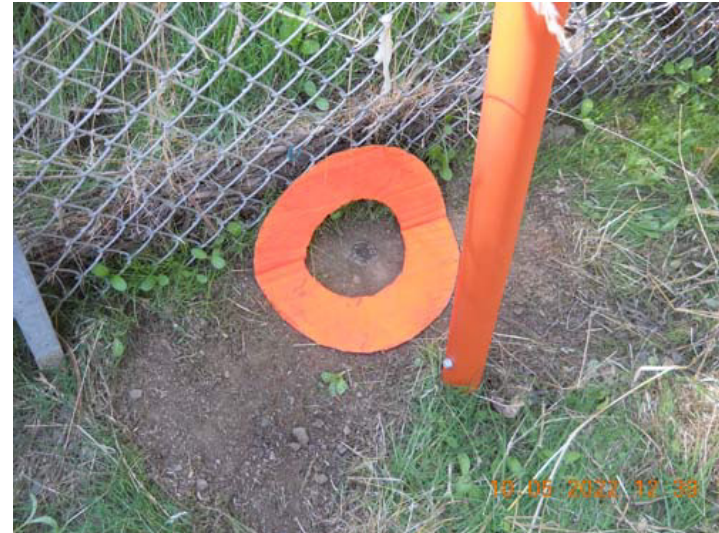
View Northwest: Survey Monument 23 Within Orange Ring;
Delineator Right of Survey Monument; West Perimeter Fence
Behind Survey Monument (Photo No. 4774)

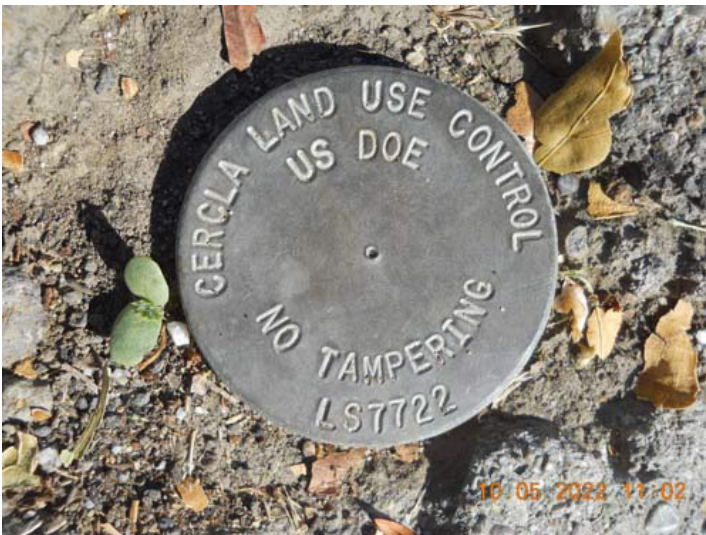
Survey Monument 24: Northeast Corner of SWT Area at
Southern Perimeter of DSS 3 Area (Photo No. 4752)

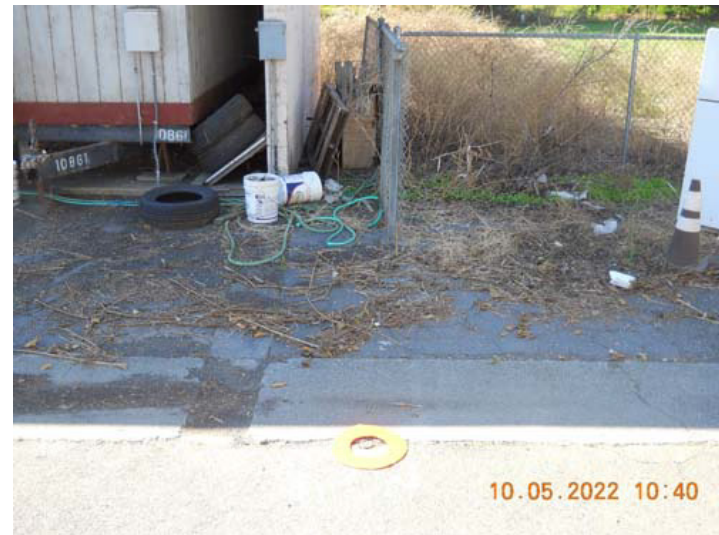
View South: Survey Monument 24 Within Orange Ring on
Edge of Concrete Swale; Former Washdown Pad in Upper Left
(Photo No. 4747a)

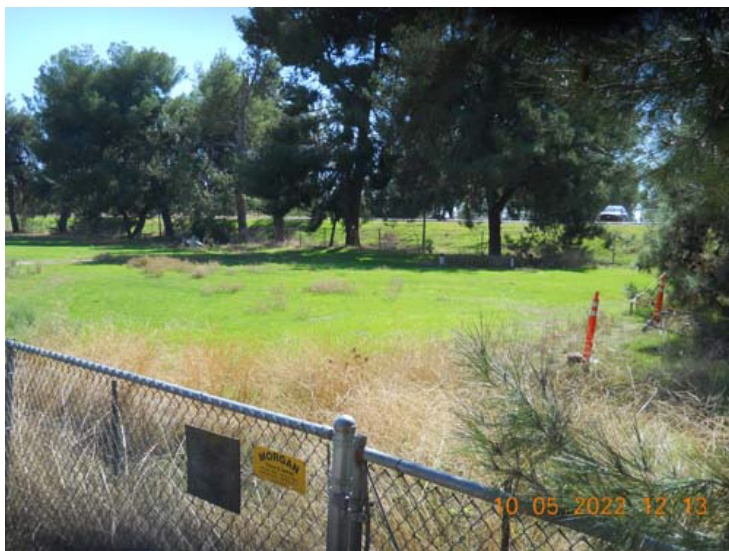
View Southeast of SWT Area: North Levee of the South Fork of Putah Creek in Background (Photo No. 4753)

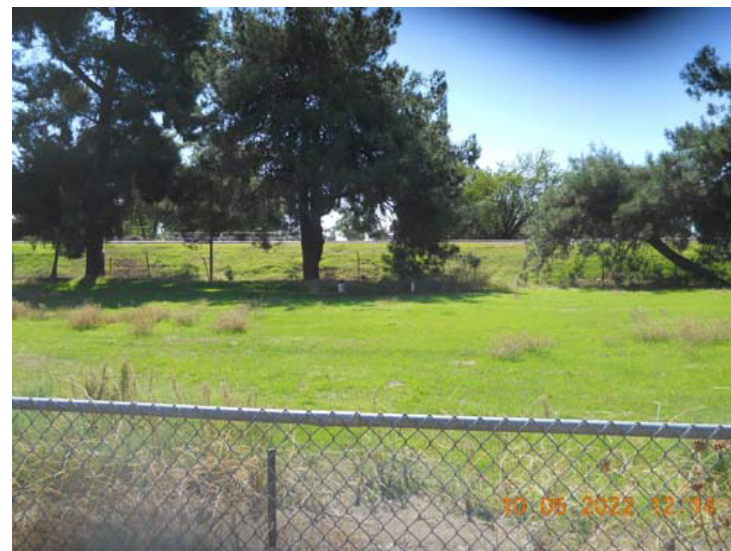
View South of SWT Area: North Levee of the South Fork of Putah Creek in Background (Photo No. 4754)

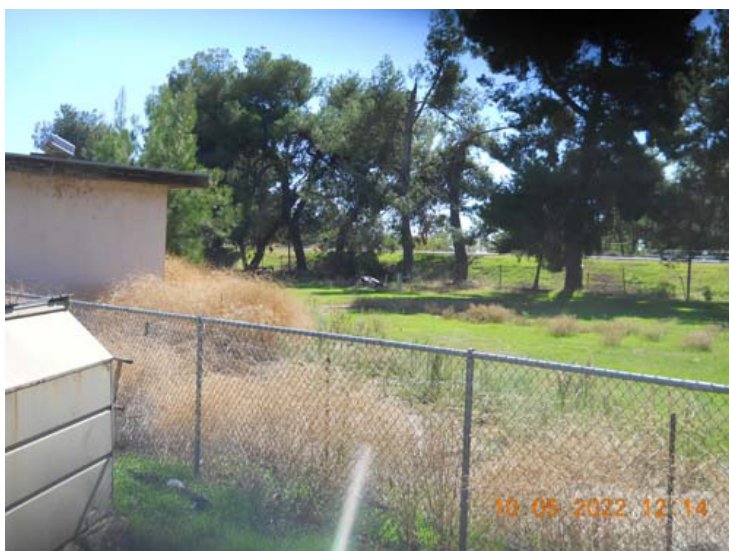
View Southeast of SWT Area: Former Washdown Pad in Left (Photo No. 4756)

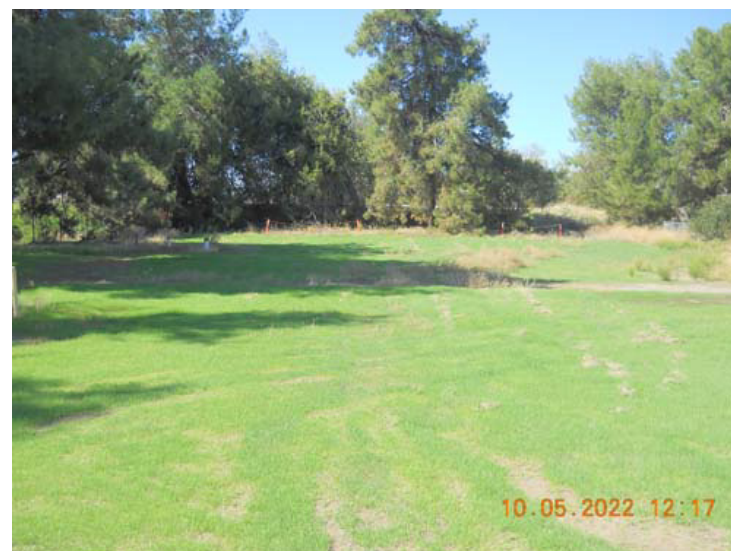
View West of SWT Area: Shoulder of Old Davis Road in Background (Photo No. 4757)

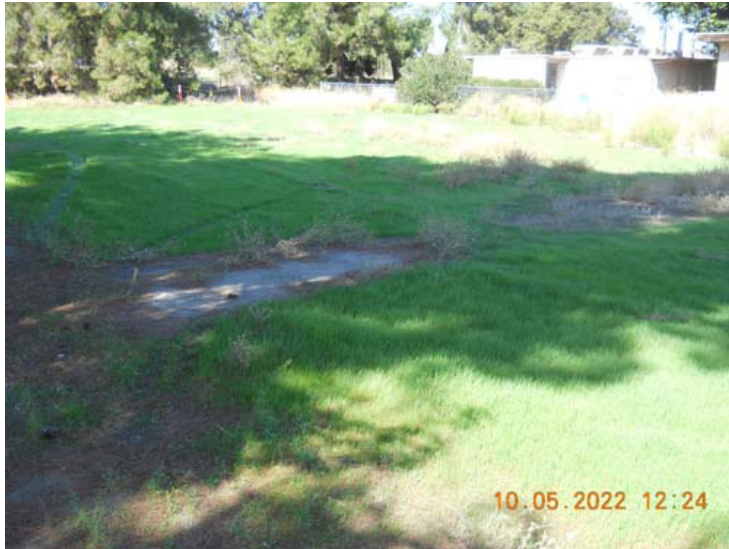
View Northwest of SWT Area (Photo No. 4762)

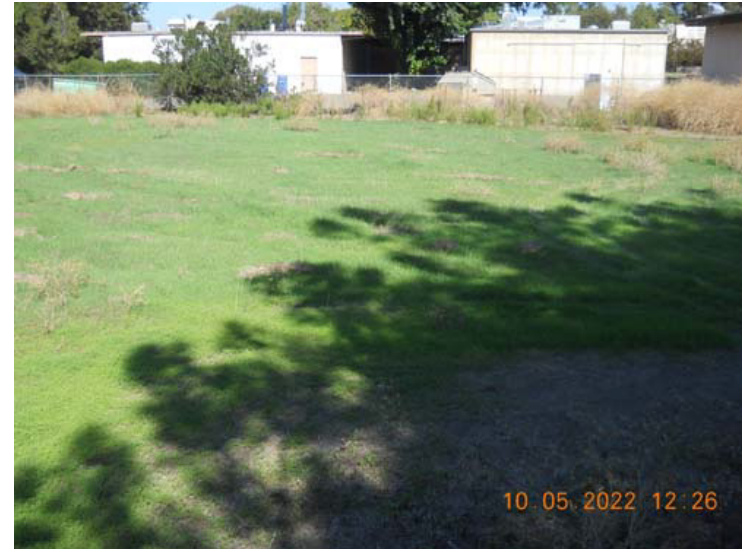
View North of SWT Area: Buildings H-215 and H-216 in Background (Photo No. 4763)
