**2022 Annual Land-Use Covenant
Inspection Report
for DOE Areas at the
Laboratory for Energy-Related
Health Research/Old Campus
Landfill Superfund Site
University of California, Davis**

January 2023

U.S. DEPARTMENT OF
ENERGY

Legacy
Management

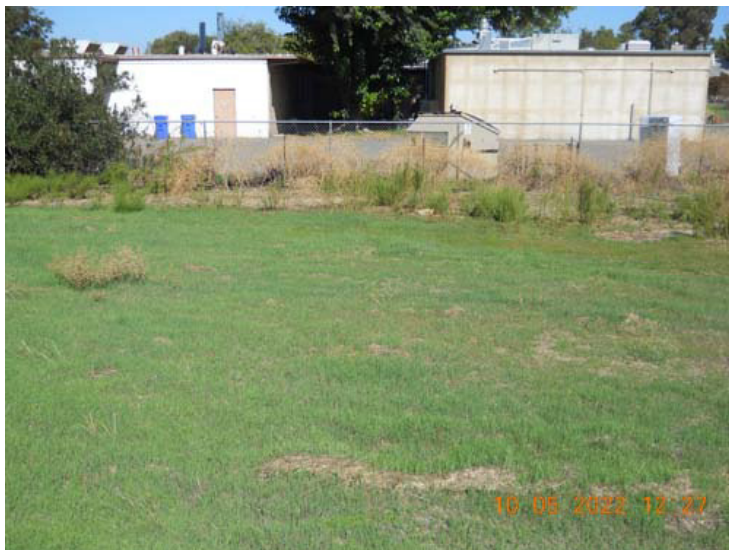
View North from Center of SWT Area: Buildings H-215 and H-216 in Background (Photo No. 4764)

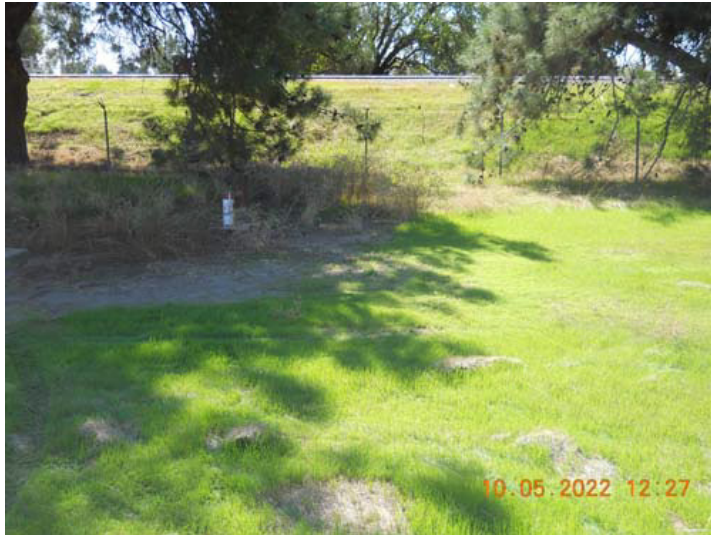
View South from Center of SWT Area (Photo No. 4766)

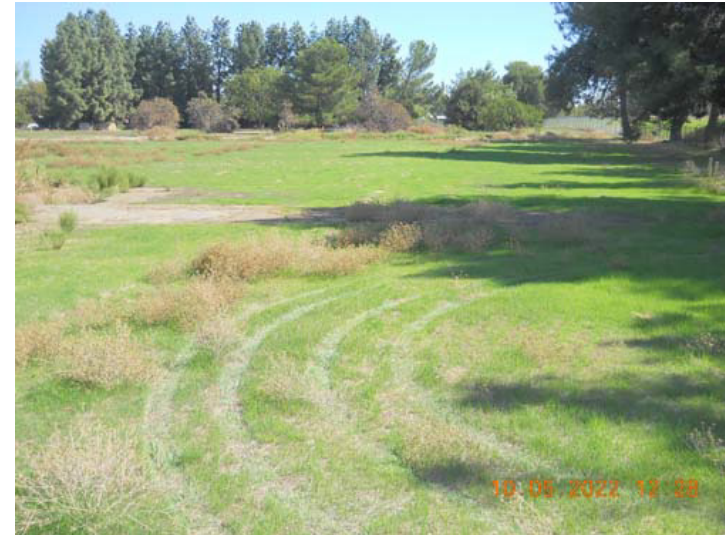
View East from Center of SWT Area: Western Dog Pens Area and UC Davis Southern Trenches Area in Background (Photo No. 4767)

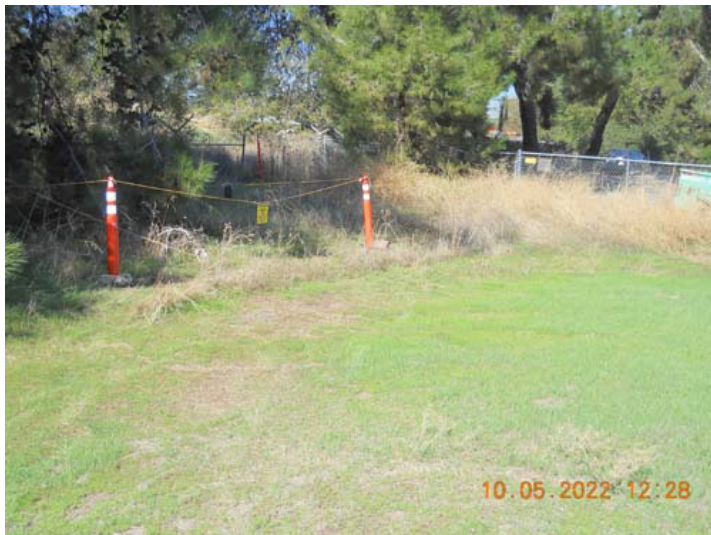
View North of Northwest Corner of SWT Area; Tree 16219 Fallen Limb Behind Stanchions, Posting, and Rope in Upper Left of Photo (Photo No. 4768)

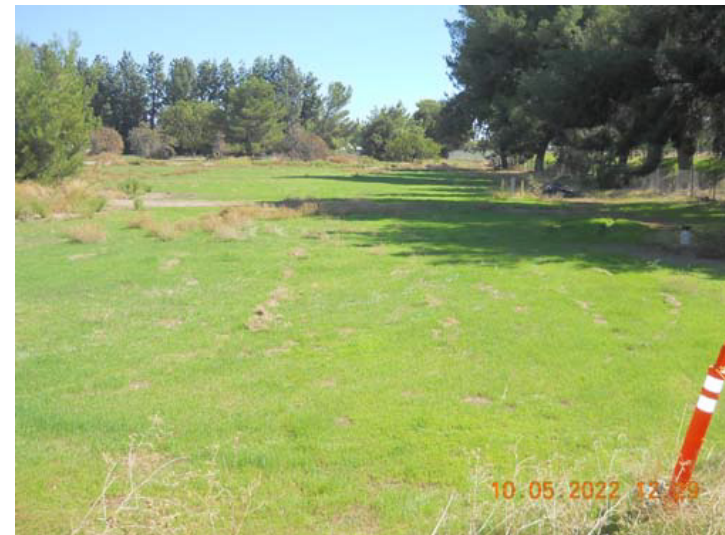
View East of SWT Area: Western Dog Pens Area and UC Davis Southern Trenches Area in Background (Photo No. 4769)

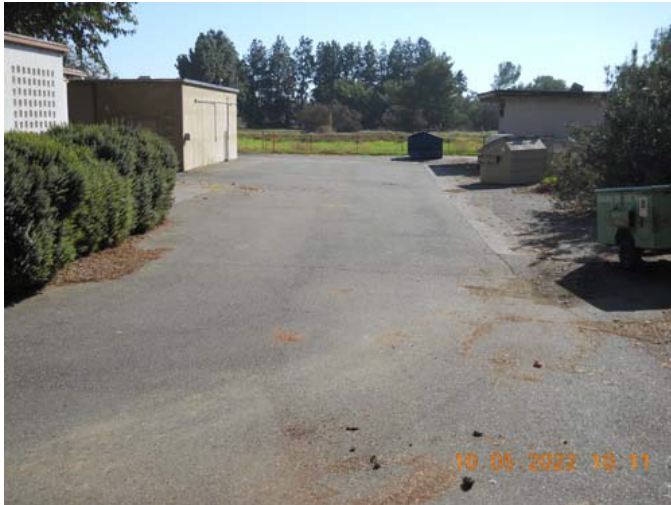
*View East Over Former Leach Field Part of DSS 3 Area:
Buildings H-215 and H-216 in Upper Left; Former Washdown
Pad in Upper Right; Western Dog Pens Area in Background
(Photo No. 4734)*

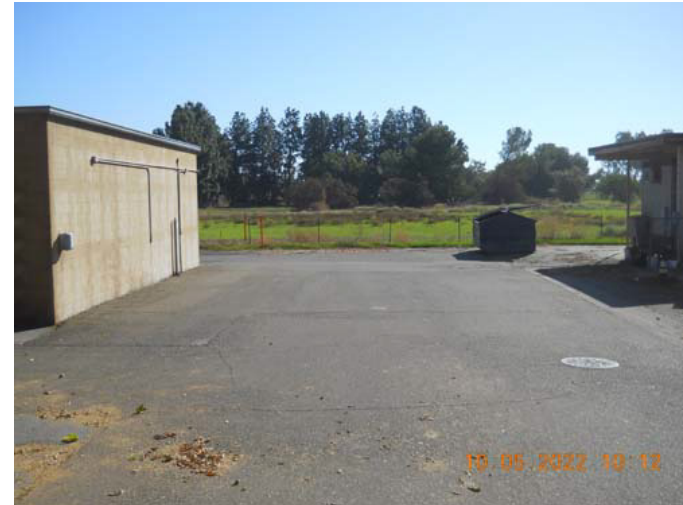
*View East of Eastern Half of DSS 3 Area
(Photo No. 4735)*

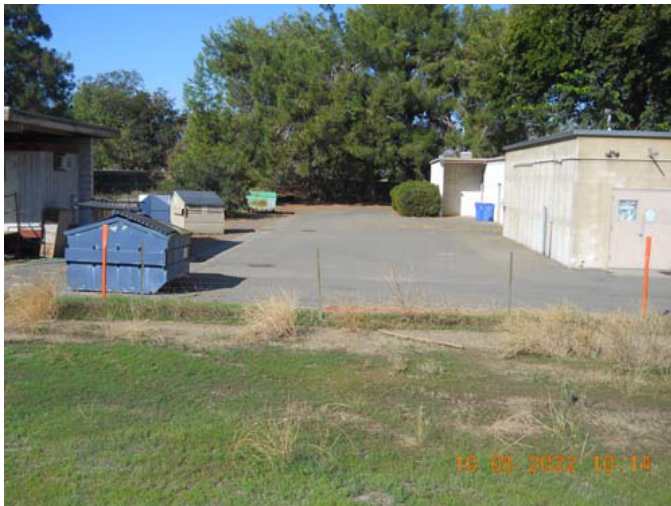
*View West of Former Leach Field Part of DSS 3:
Buildings H-215 and H-216 to Right; Former Washdown Pad to Left;
Old Davis Road Obscured by Tree in Background (Photo No. 4736)*

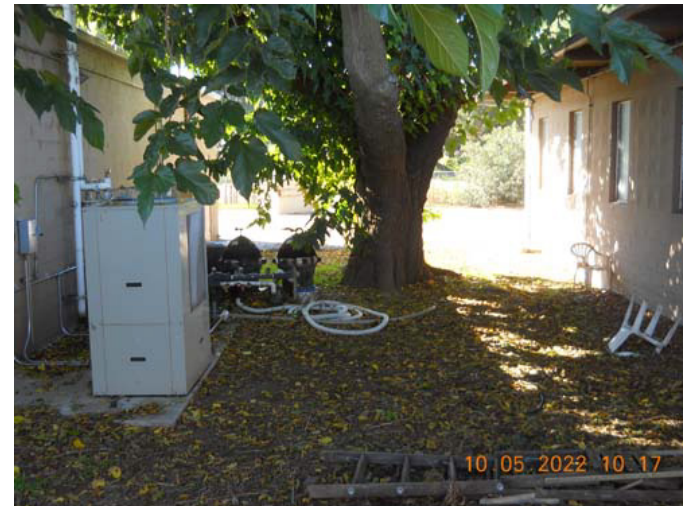
*View South of Septic Tank Part of DSS 3 Area:
Building H-216 to Left; Building H-215 to Right
(Photo No. 4739)*

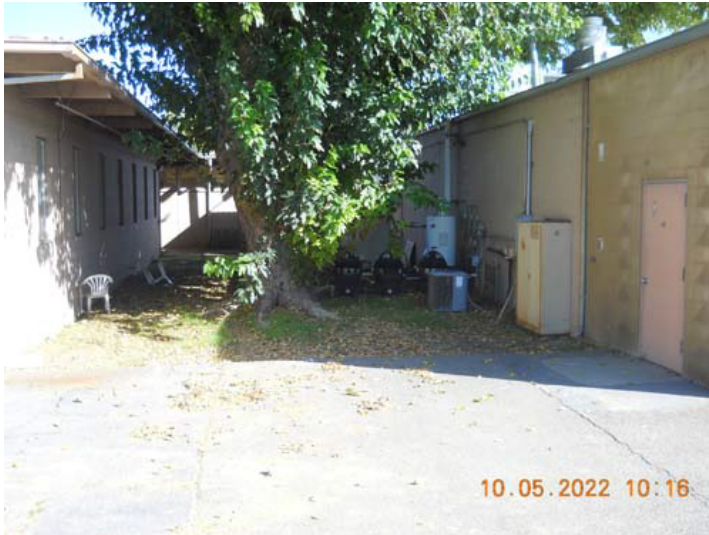
*View North of Portions of DSS 3 and 4 Areas:
Building H-215 to Left; Building H-216 to Right; DSS 4 Area in
Background (Photo No. 4738)*

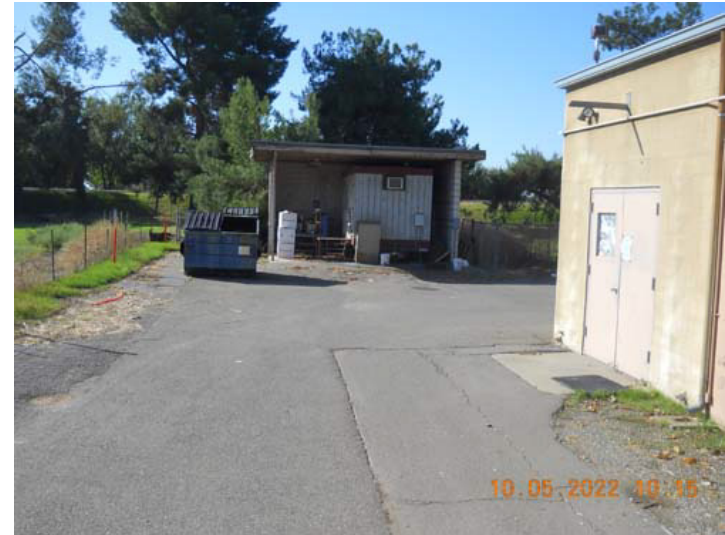
*View South of East End of DSS 3 Area Leach Field:
Building H-215 to Right; Former Washdown Pad in
Background (Photo No. 4737)*

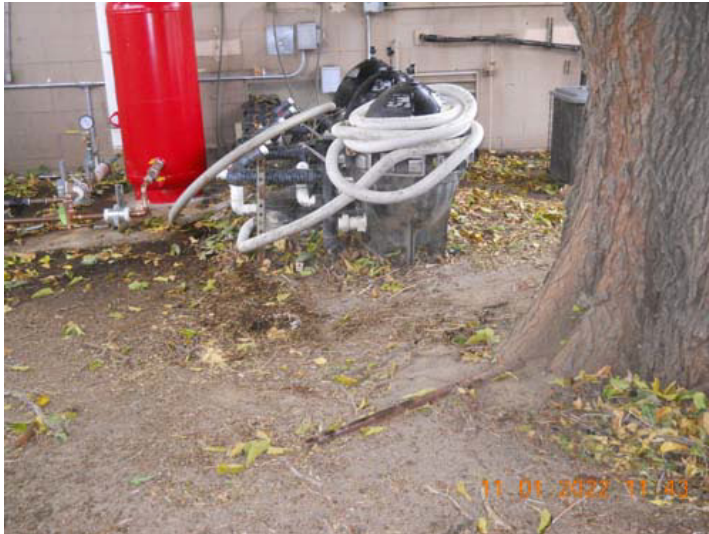
*View East of DSS 3 Area: Out-of-Service Filter Cannisters
in Center; Building H-216 in Background, Standing North and
Left of Tree (Photo No. 4911)*

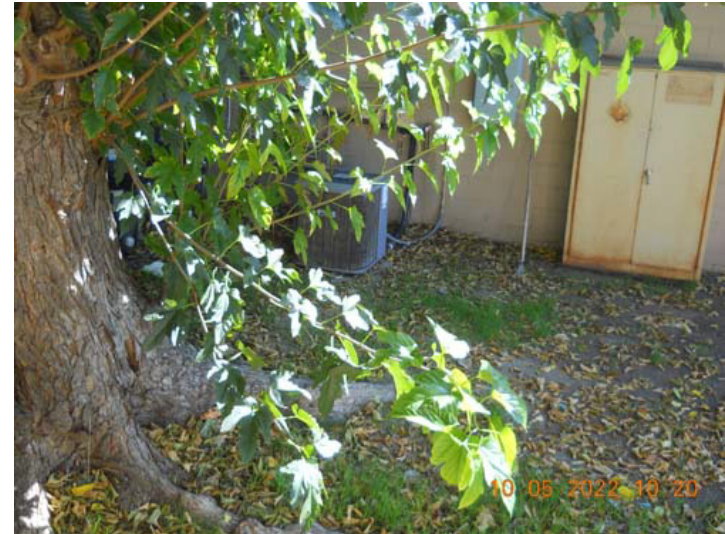
*View East of DSS 3 Area: Building H-216 in Background,
Standing South and Right of Tree
(Photo No. 4741)*

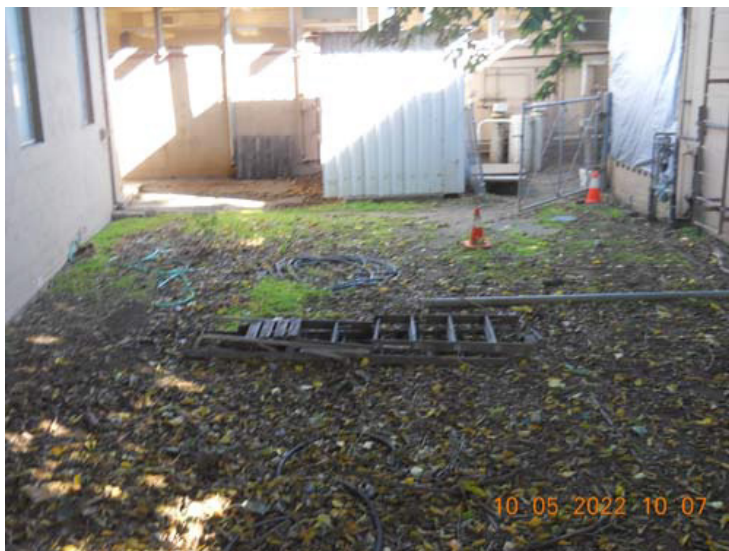
View North of DSS 4 Area Septic Tank Location and East End of Leach Field: Building H-215 to Left; Building H-216 to Right; Building H-217 in Background (Photo No. 4733)

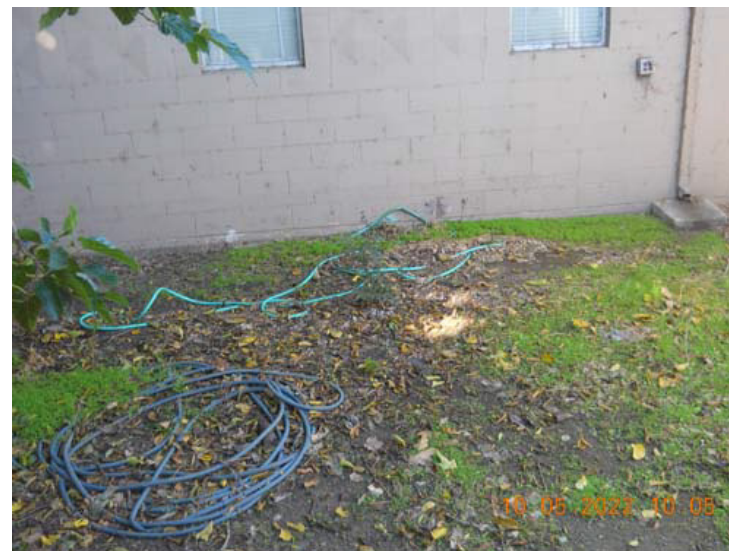
View West of East End of DSS 4 Area Leach Field; Building H-215 in Background (Photo No. 4731)

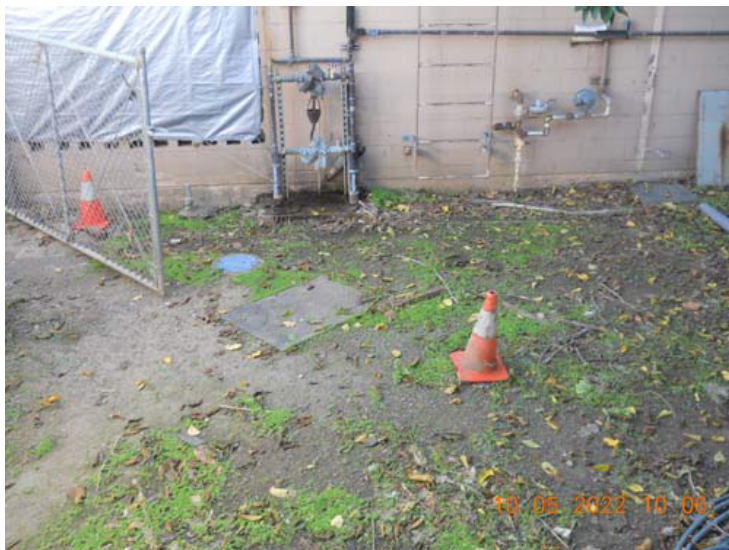
View East of DSS 4 Area Septic Tank Location: Building H-216 in Background (Photo No. 4732)

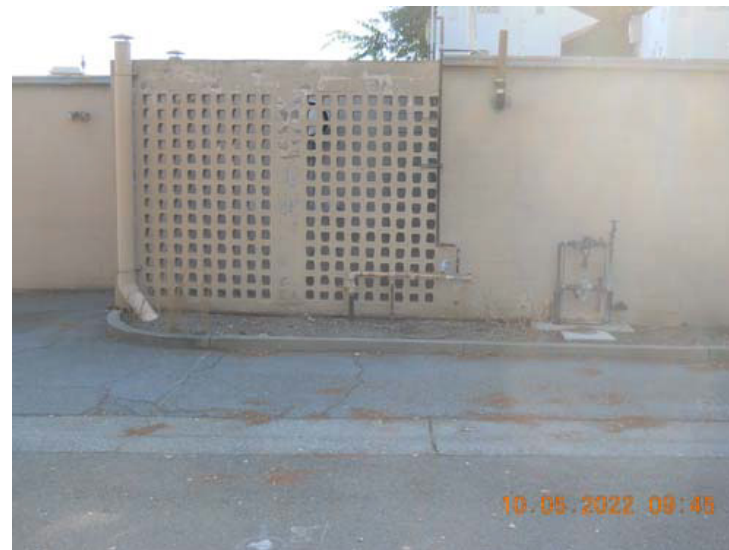
View East of Western Portion of DSS 4 Area: Building H-215 in Background, Center (Photo No. 4719)

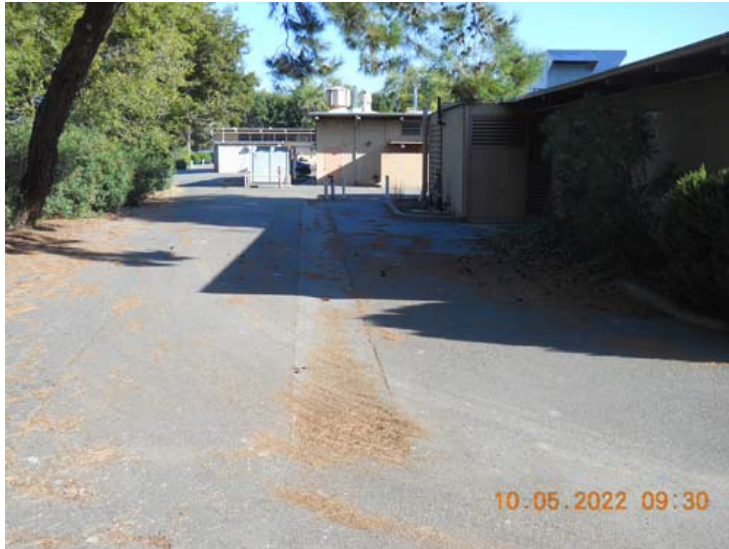
View North of Southern Portion of Ra/St Treatment Systems Area: Building H-215 to Right; Buildings H-218 and H-219 in Background (Photo No. 4718)

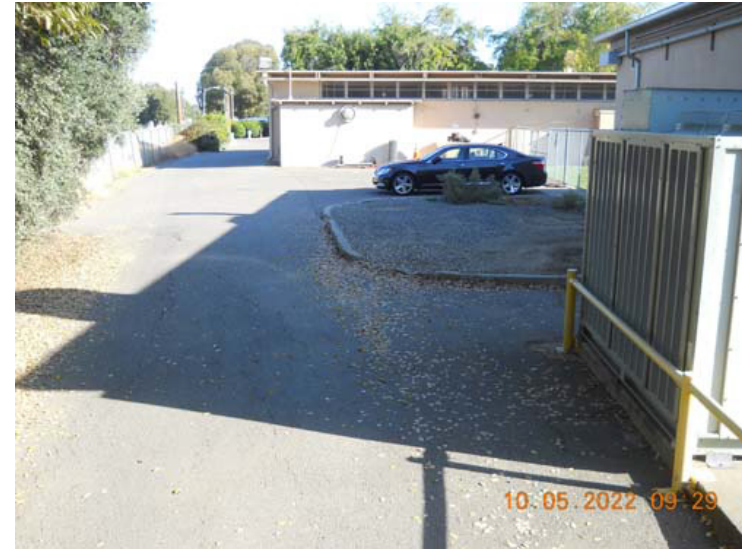
View North of Middle Portion of Ra/Sr Treatment Systems Area: Building Cooling Unit and Building H-218 Corner in Right Top Portion of Photo; Building H-219 in Background (Photo No. 4717)

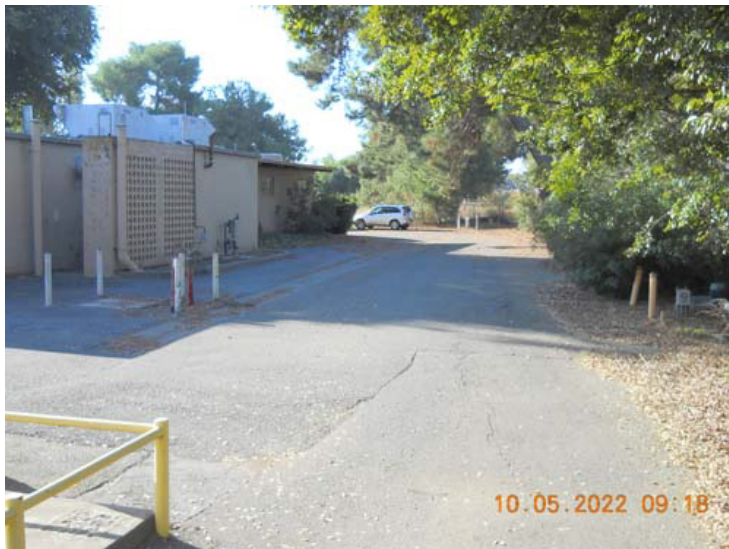
View South of Southern Portion of Ra/Sr Treatment Systems Area: Building H-215 to Left (Photo No. 4710)

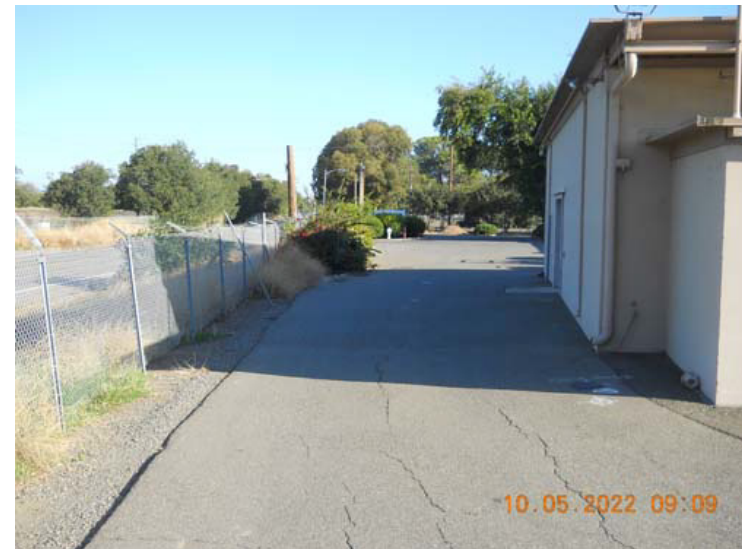
View North of Northern Portion of Ra/Sr Treatment Systems Area: Building H-219 to Right (Photo No. 4704)

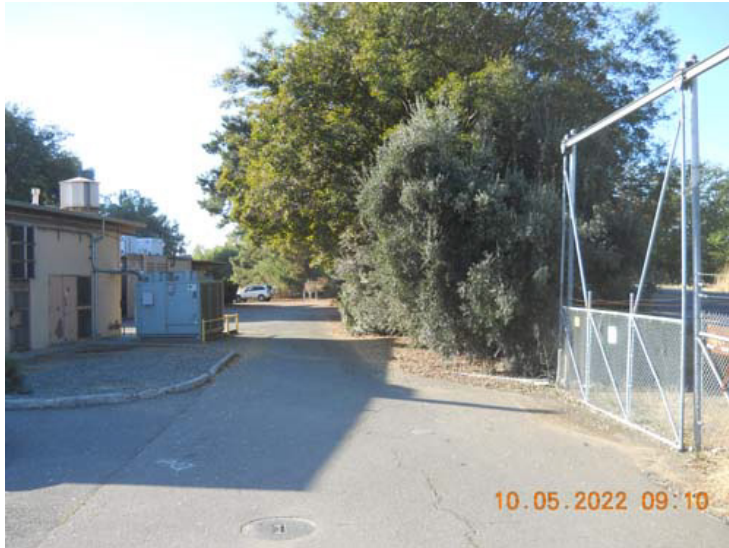
View South of Middle-South Portion of Ra/Sr Treatment Systems Area: Building H-218 to Left; West Perimeter Gate and Fence to Right (Photo No. 4706)

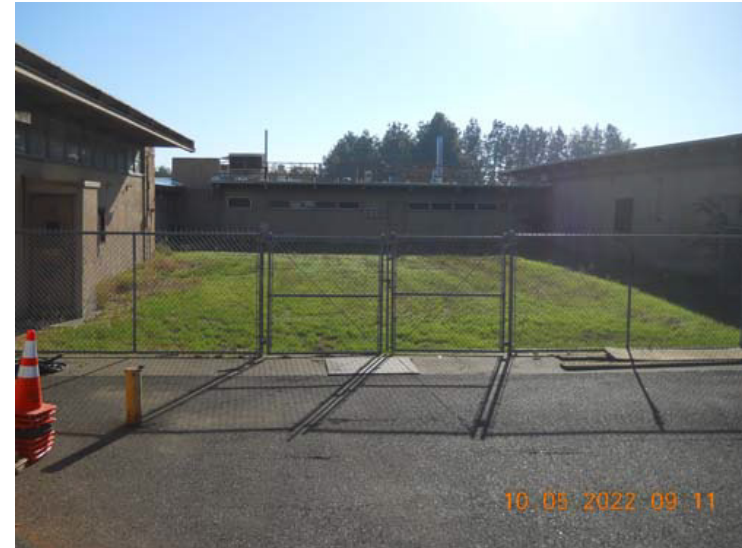
View East of Central Portion of Ra/Sr Treatment Systems Area: Building H-218 to Right; Building H-219 to Left (Photo No. 4707)

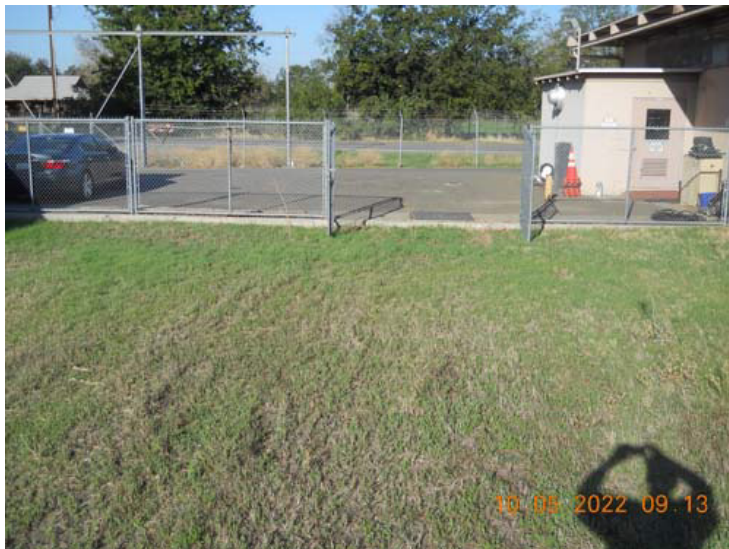
View West of DSS 2 Area Within Middle-West Portion of Ra/Sr Treatment Systems Area (Photo No. 4708)

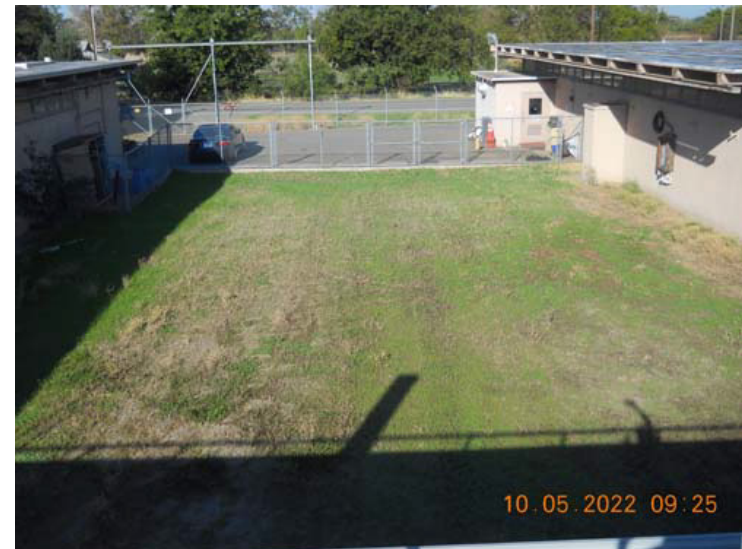
Roof-Level View West of Central Portion of Ra/Sr Treatment Systems Area: Building H-219 to Right; Building H-218 to Left (Photo No. 4714)

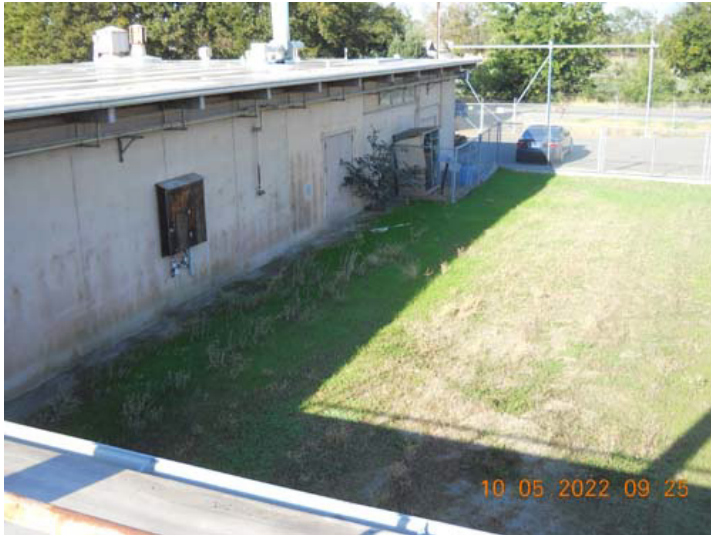
Roof-Level View Southwest of Central Portion of Ra/Sr Treatment Systems Area: Building H-218 in Background, Left (Photo No. 4715)

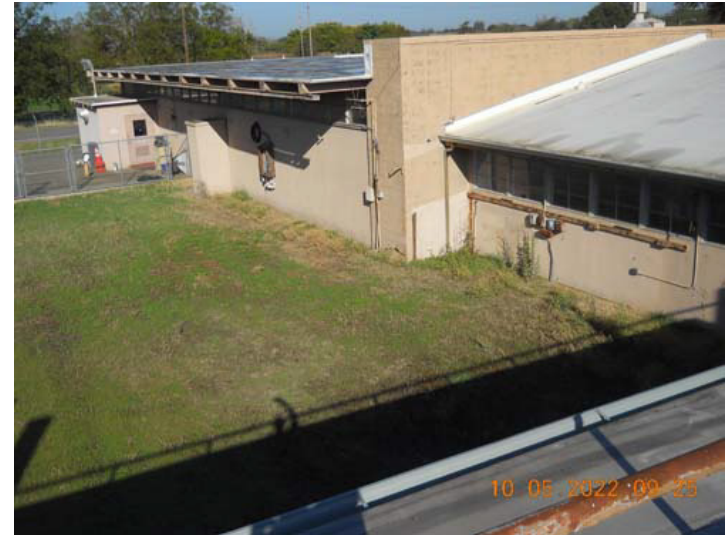
Roof-Level View Northwest of Central Portion of Ra/Sr Treatment Systems Area: Building H-219 in Background (Photo No. 4716)

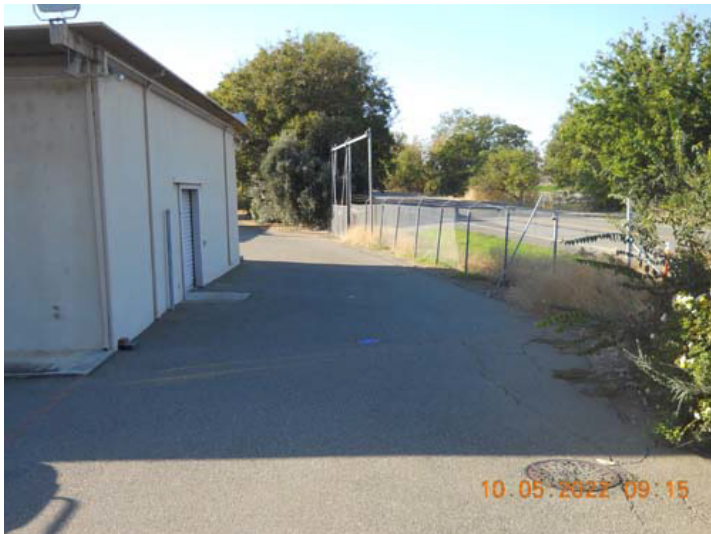
View South over Northern Portion of Ra/Sr Treatment Systems Area: Building H-219 to Left; West Perimeter Fence and Old Davis Road to Right (Photo No. 4709)

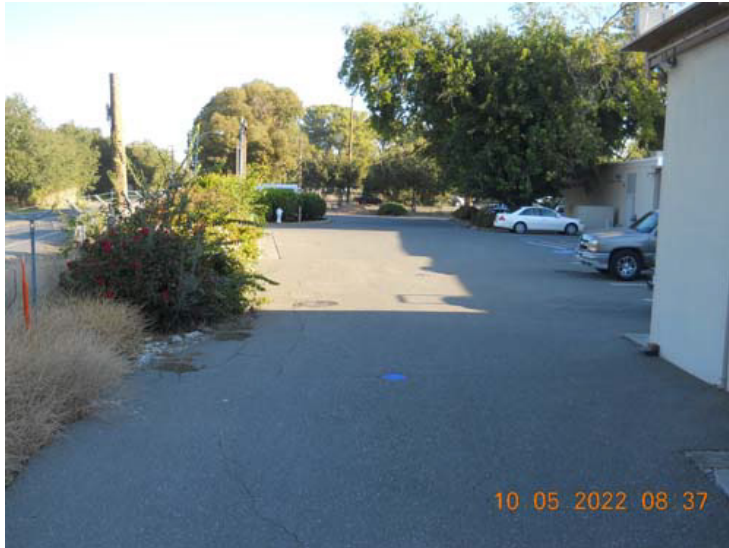
View North of Dry Wells A-E Area: Old Davis Road to Left; Corner of Building H-219 to Right (Photo No. 4694)

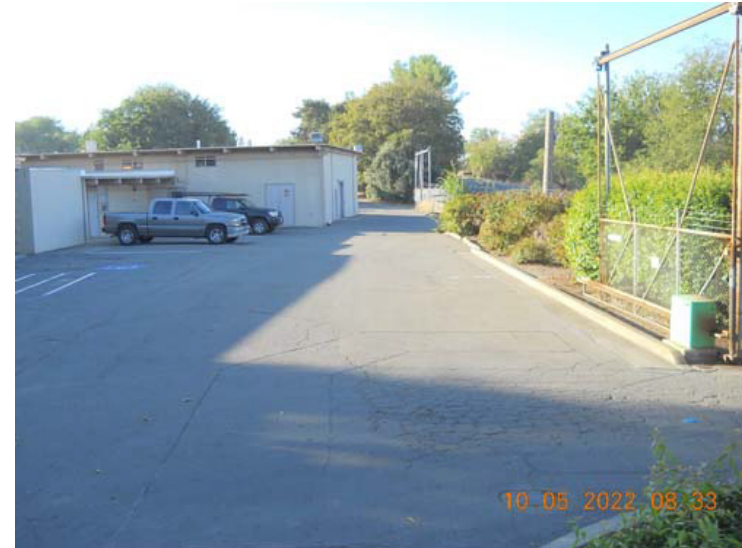
View South of Dry Wells A-E Area: Building H-219 in Background, Left (Photo No. 4691)

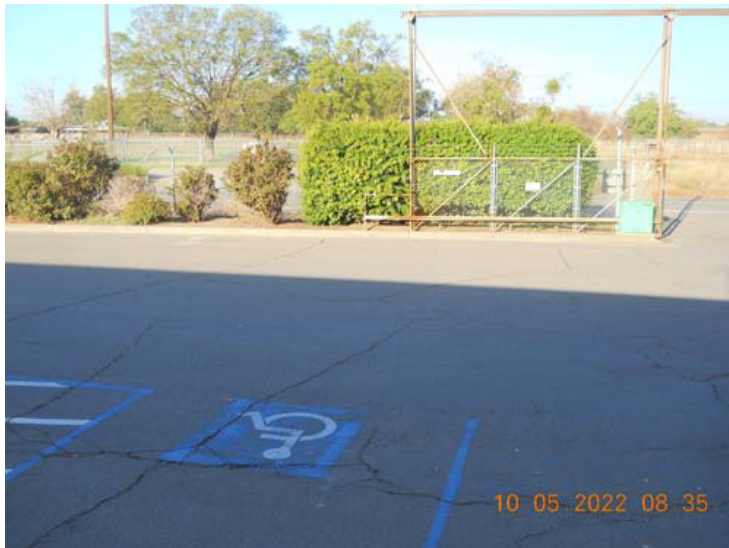
View West of Dry Wells A-E Area and Main Gate; Old Davis Road in Background (Photo No. 4692)

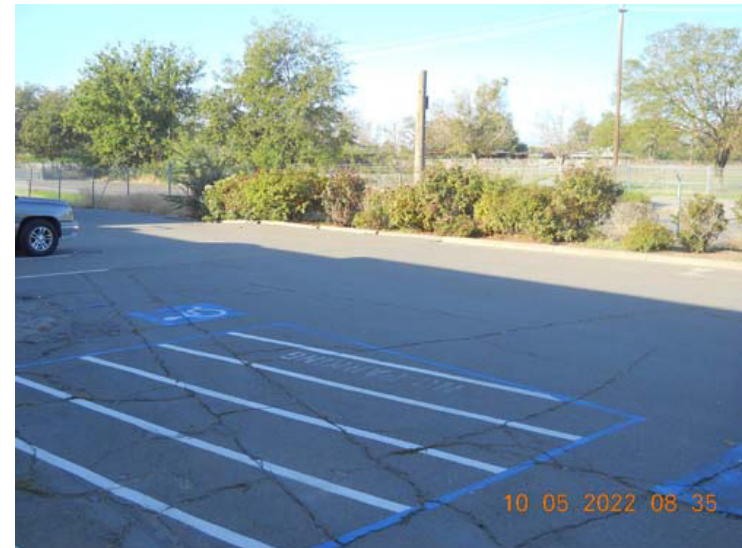
View Southwest of Dry Wells A-E Area (Photo No. 4693)

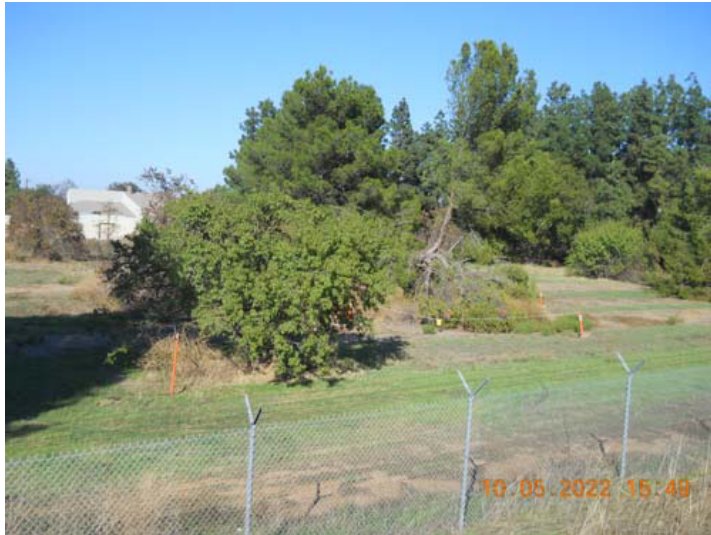
View Northeast of EDPs Area from North Levee of South Fork Putah Creek with Orange Delineator Showing Southwest Corner Monument Location in Lower Left (Photo No. 4790)

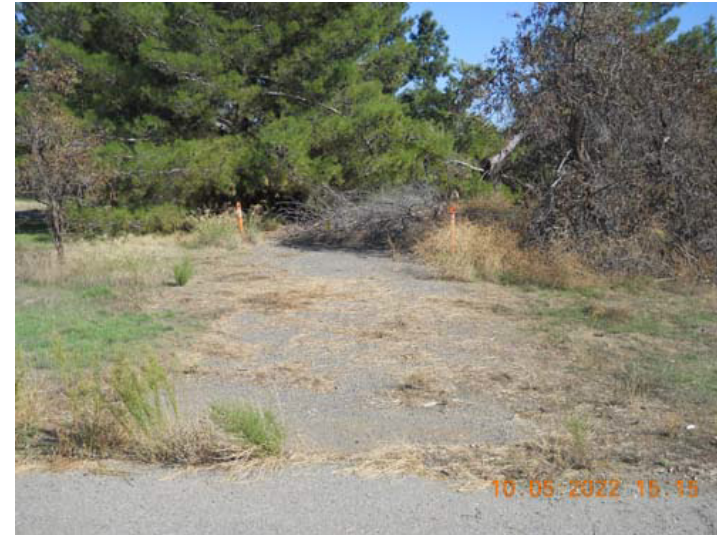
View East of EDPs Area; Tree 16236 Fallen Limb in Center, Behind Stanchions and Rope (Photo No. 4779)

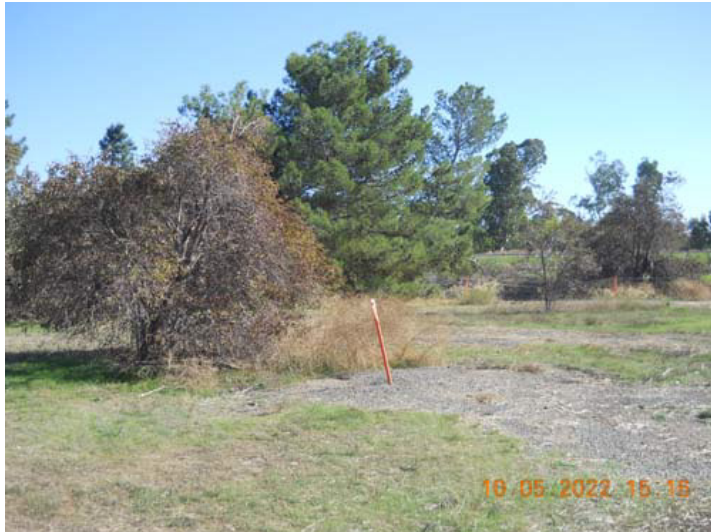
View Southeast of EDPs Area from Northwest Corner Showing Northwest Corner Monument Location (Photo No. 4780)

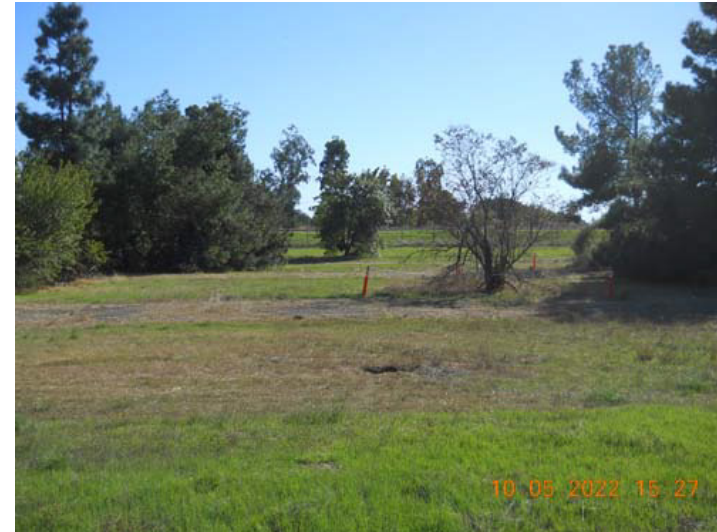
View South of EDPs Area; Shrub 16233 with Small Fallen Limbs in Center, Left of Photo Behind Stanchions and Rope (Photo No. 4783)

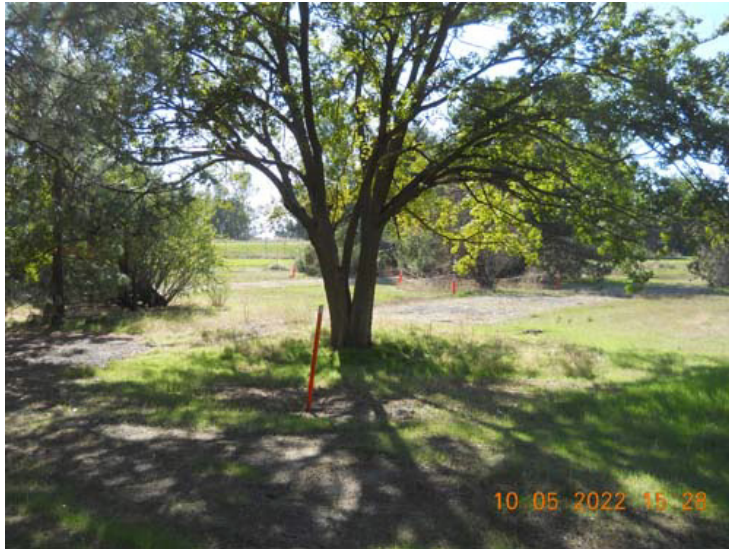
View Southwest of EDPs Area from Northeast Corner Showing Location of Northeast Corner Monument (Photo No. 4784)

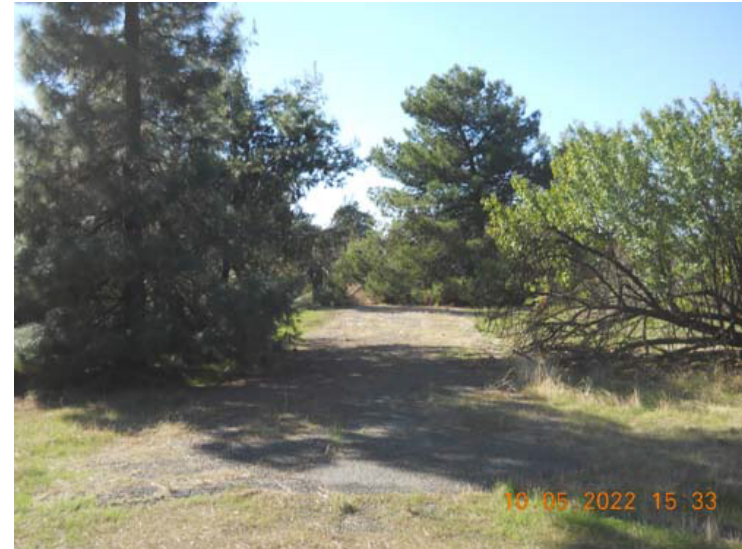
View West of EDPs Area (Photo No. 4787)

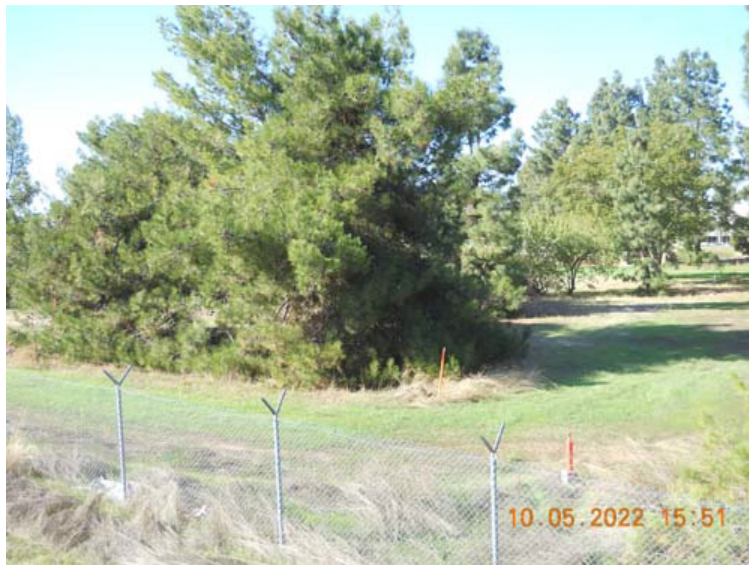
View Northwest into EDPs Area from North Levee of the South Fork of Putah Creek Showing Location of Southeast Corner Monument (Photo No. 4792)

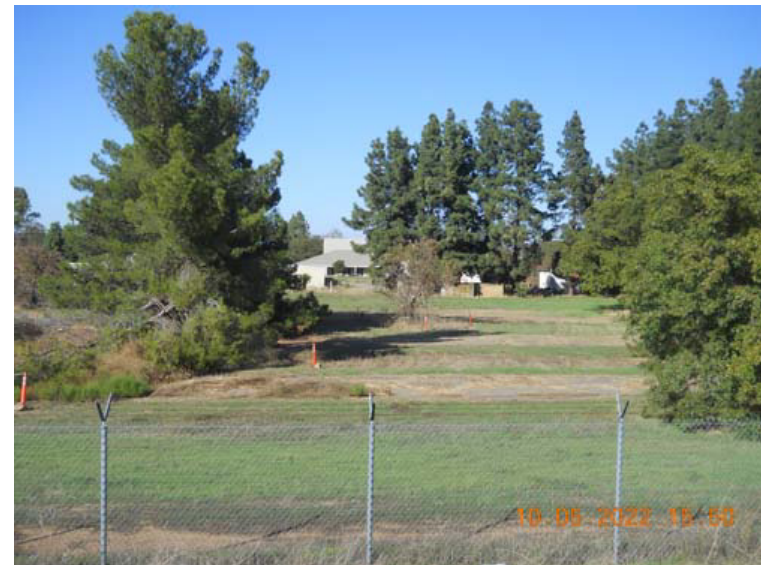
View North over EDPs Area from North Levee of the South Fork of Putah Creek (Photo No. 4791)

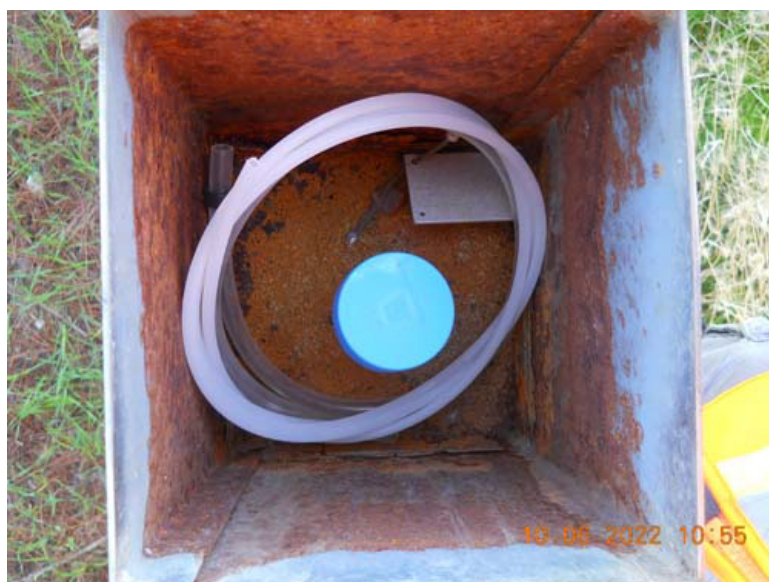
UCD1-070 Interior (Photo No. 4848)

Well UCD1-070: Pump Manufacturer's Waterproof Cap Installed (Photo No. 4848)

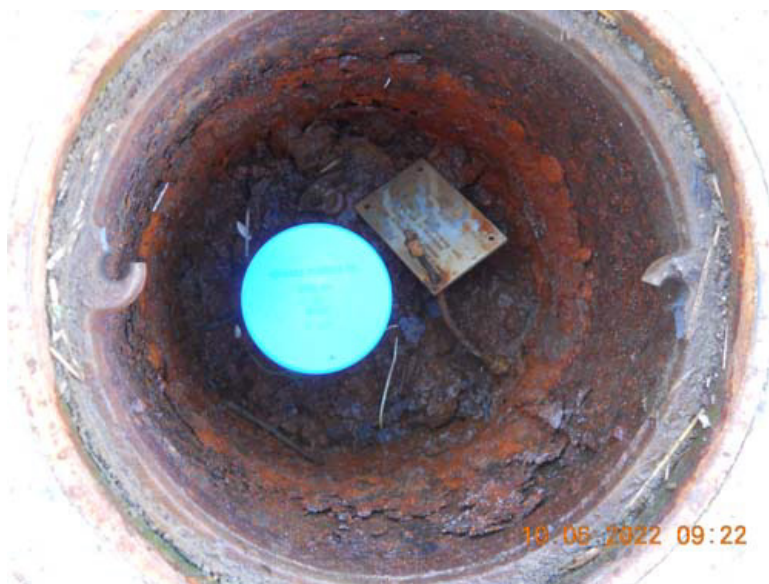
UCD1-072 Interior (Photo No. 4832)

Well UCD1-072: Pump Manufacturer's Waterproof Cap Installed (Photo No. 4832)
