1.0 Ambrosia Lake, New Mexico, Disposal Site

1.1 Compliance Summary

The Ambrosia Lake, New Mexico, Uranium Mill Tailings Radiation Control Act (UMTRCA) Title I Disposal Site was inspected on August 27, 2008. The disposal cell and all associated surface water diversion and drainage structures were in excellent condition and functioning as designed. The site access road, owned by Rio Algom Mining LLC (Rio Algom), was temporarily realigned in 2006 to allow for construction of a waste haul road; waste hauling operations are complete, and the site access road is scheduled for restoration in 2009. Slight settlement may be recurring at a location on the cell cover that was repaired in 2005; this location will continue to be monitored. No maintenance needs or cause for a follow-up or contingency inspection were identified.

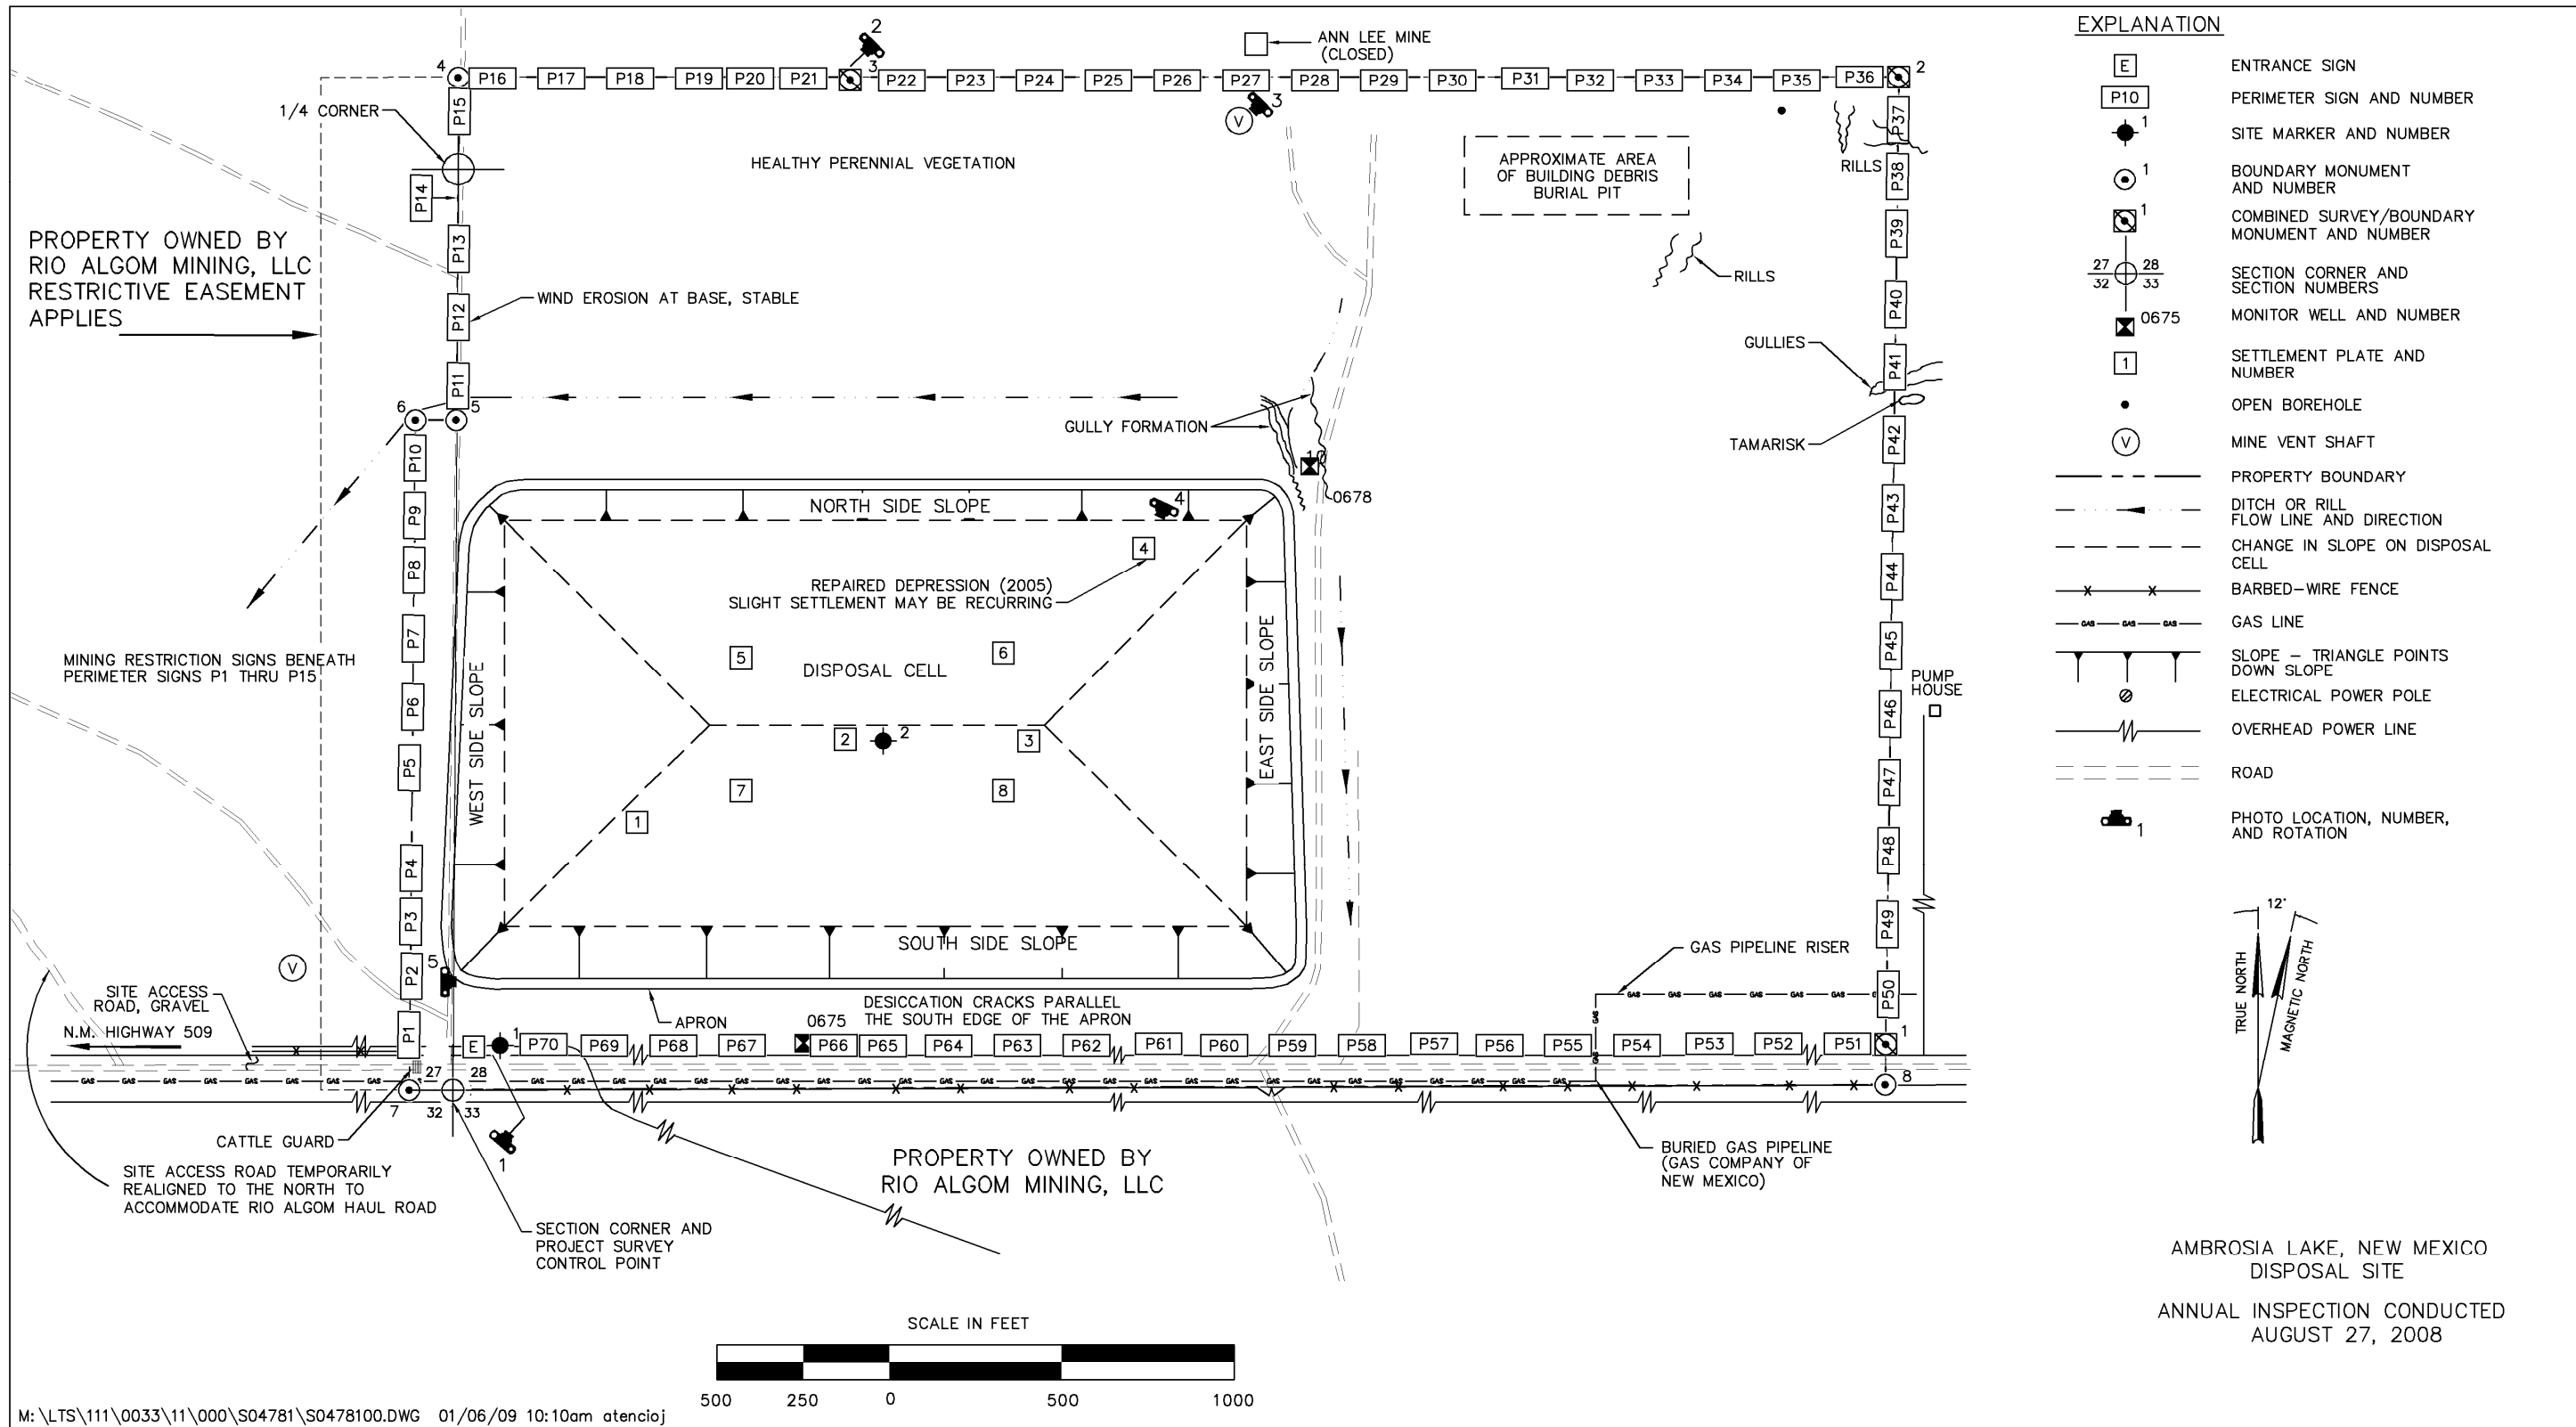
Figure 1-1. 2008 Annual Compliance Drawing for the Ambrosia Lake Disposal Site

The entrance sign and all perimeter signs were in good condition. Posts for perimeter signs P1 through P15 include mining restriction-area warning signs.

Site Markers, and Survey and Boundary Monuments—The two granite site markers (PL–1), three combined survey and boundary monuments (PL–2), and five additional boundary monuments were all undisturbed and in excellent condition.

Monitor Wells—Two monitor wells (MW–0675 and MW–0678) are present on the site and were in good condition. Gully formation adjacent to monitor well MW–0678 appears to be stabilizing.

1A Top of Disposal Cell—The 91-acre disposal cell was completed in 1994. The basalt riprap-covered top of the disposal cell was in good condition. There was no evidence of cracking, slumping, or erosion. In August 2005, repairs were made to a shallow depression in the cell cover around settlement plate SP-4. Surveys of the settlement plates in 2005, 2006, and 2007 indicated no change in the surface elevations. However, visual observations during the 2008 inspection indicated that slight settlement may be recurring at SP-4 (PL-4). This location will continue to be visually monitored.

Side Slopes and Apron—The basalt riprap-covered side slopes and apron were in excellent condition and showed no evidence of cracking, settling, slumping, or erosion (PL-5). Desiccation cracks occur in the clay-rich backfill soil parallel to the apron along the south side of the cell. The cracks do not pose a threat to the disposal cell.
