# **Rocky Flats Site, Colorado, Quarterly Report of Site Surveillance and Maintenance Activities, First Quarter, Calendar Year 2023**

**July 2023**

**U.S. DEPARTMENT OF  
ENERGY**

Legacy  
Management

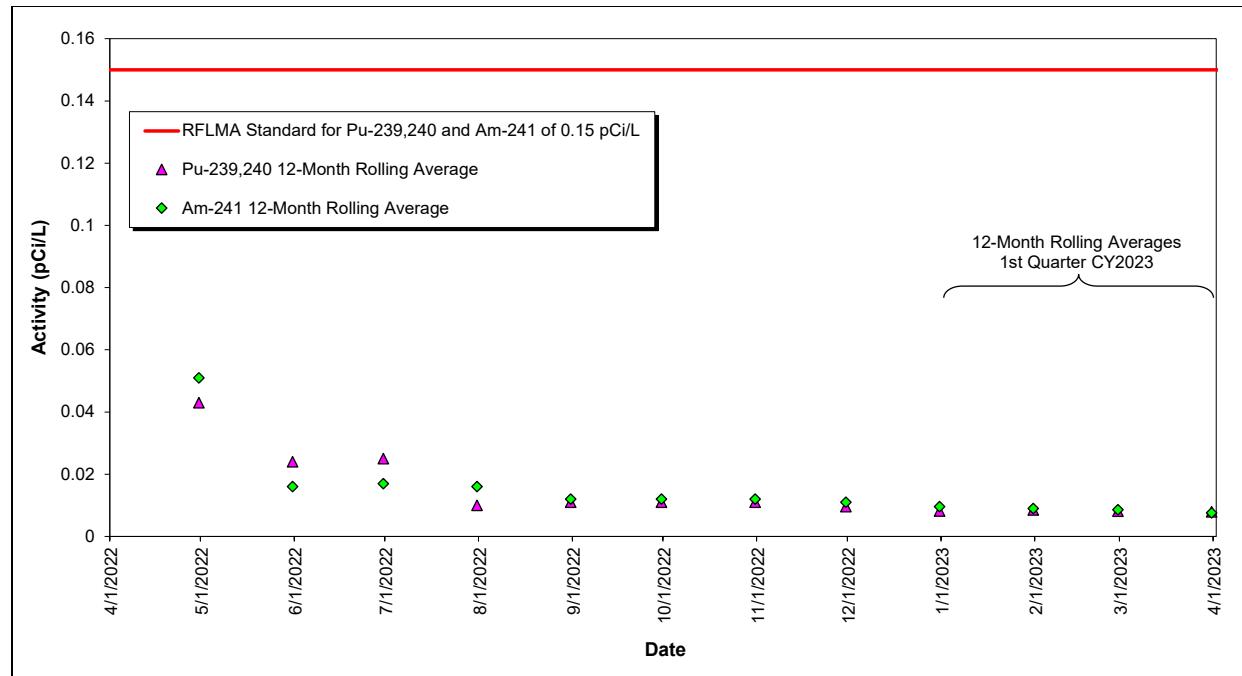
Monitoring location GS10 is on South Walnut Creek just upstream of the B-Series ponds. Figure 12 shows no occurrences of a reportable condition for Am or Pu. The method for calculating the 12-month rolling averages is detailed in the annual report.

Figure 12. Volume-Weighted 12-Month Rolling Average Plutonium and Americium Activities at GS10: Year Ending First Quarter 2023

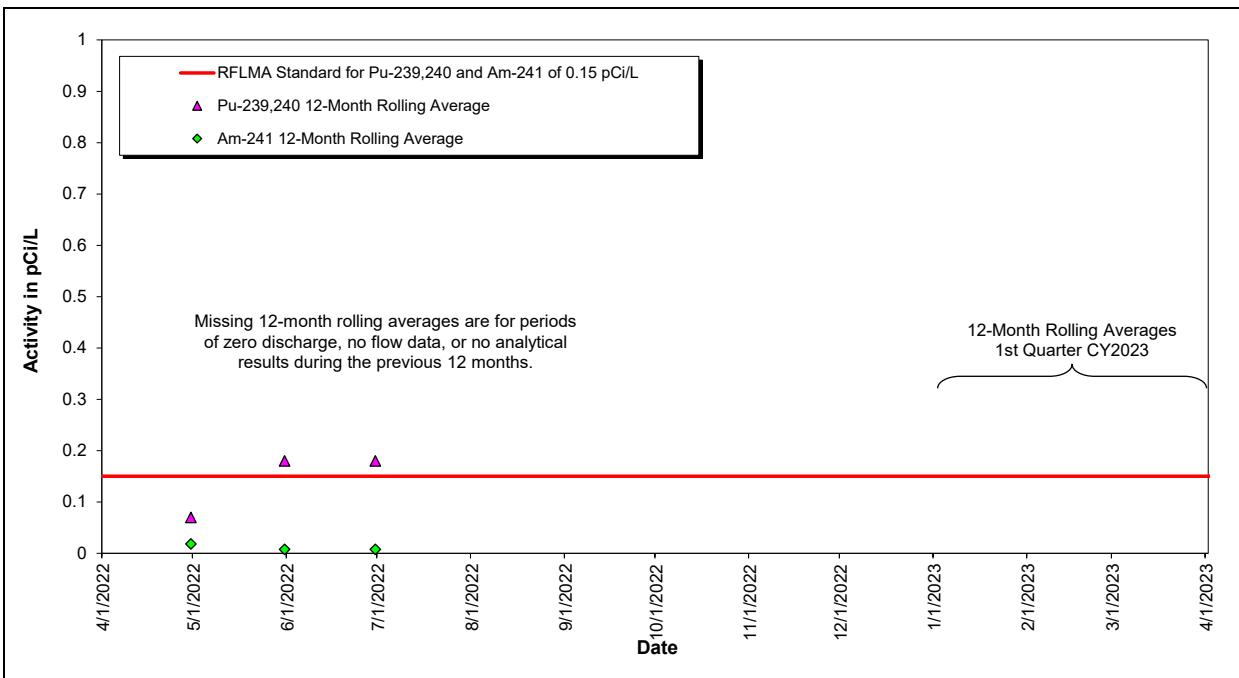
Figure 14 and Figure 15 show the averages for the 12 months ending March 31, 2023; no reportable conditions are triggered by Am and uranium concentrations. The 2022 reportable condition for Pu (Figure 14) is essentially a continuation of the 2021 reportable condition since both were caused by data collected in 2021. CR 2022-04 addresses the 2022 reportable condition for Pu; the 2021 reportable condition is addressed in CR 2021-03.

As of July 31, 2022, no flow had occurred at SW027 for more than 12 months, and no flow or analytical data were available. Therefore, with the absence of average values after July 31, 2022, Pu is no longer reportable at SW027. Regardless, response actions associated with CR 2021-03 have been implemented or are ongoing.

**Note:** There has been no flow at SW027 since early July 2021. Therefore, there are no 12-month rolling averages after June 30, 2022.

*Figure 14. Volume-Weighted 12-Month Rolling Average Plutonium and Americium Activities at SW027: Year Ending First Quarter 2023*

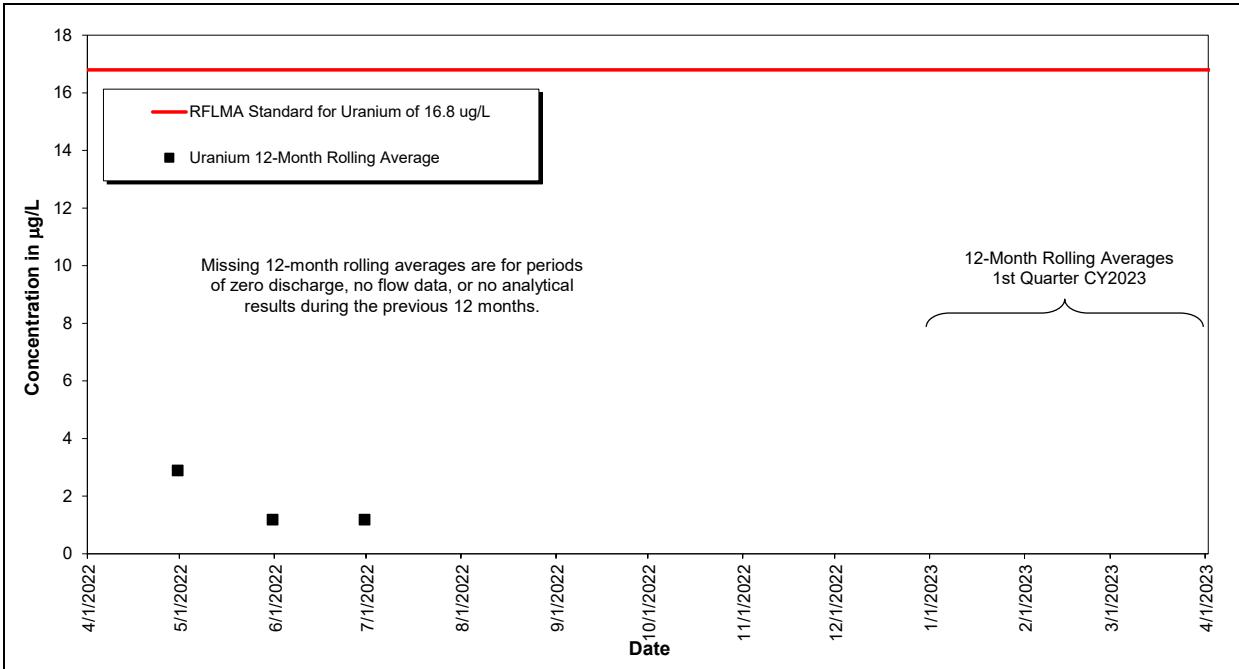
**Note:** There has been no flow at SW027 since early July 2021. Therefore, there are no 12-month rolling averages after June 30, 2022.

*Figure 15. Volume-Weighted 12-Month Rolling Average Uranium Concentrations at SW027: Year Ending First Quarter 2023*

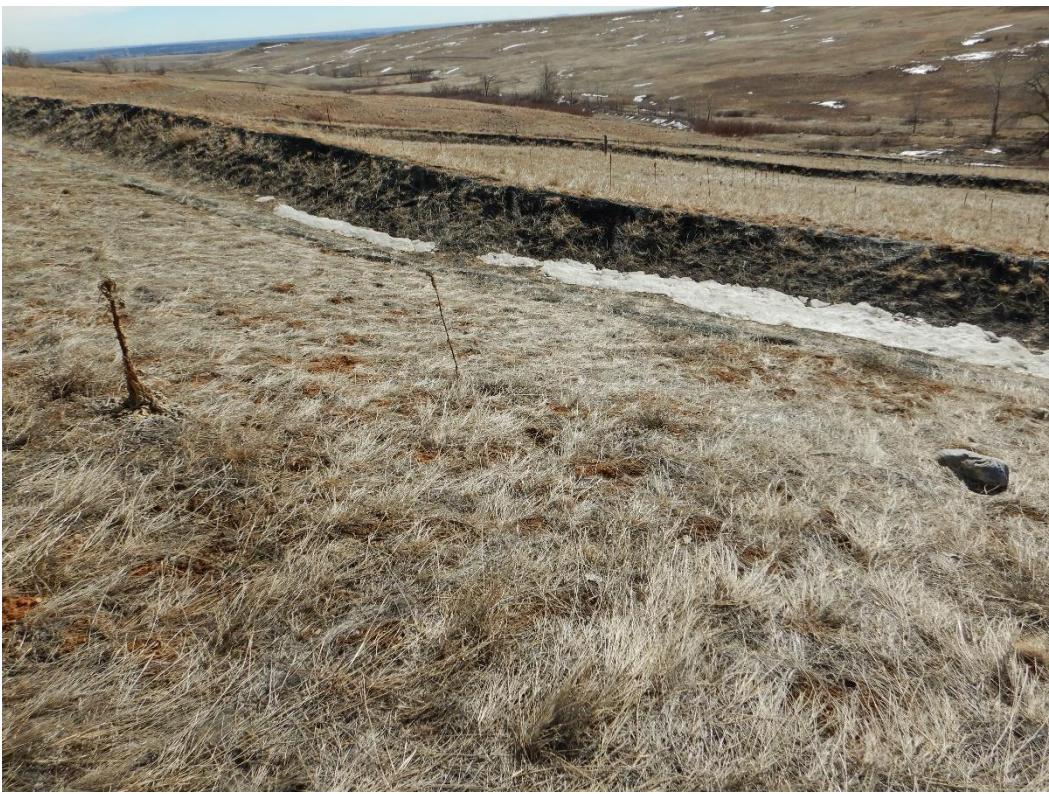
No issues were noted during the inspection. Spots of less than an inch of snow remained in channels and shaded areas from past precipitation. Berms 1–3 (**Figure 2**) and Berms 4–7 (**Figure 3**) were in good condition. The East Perimeter Channel (EPC) was in good condition (**Figure 4**). The West Perimeter Channel (WPC) was in good condition (**Figure 5**).

*Figure 2. Looking Southeast at Berms 1–3, Which Were in Good Condition*

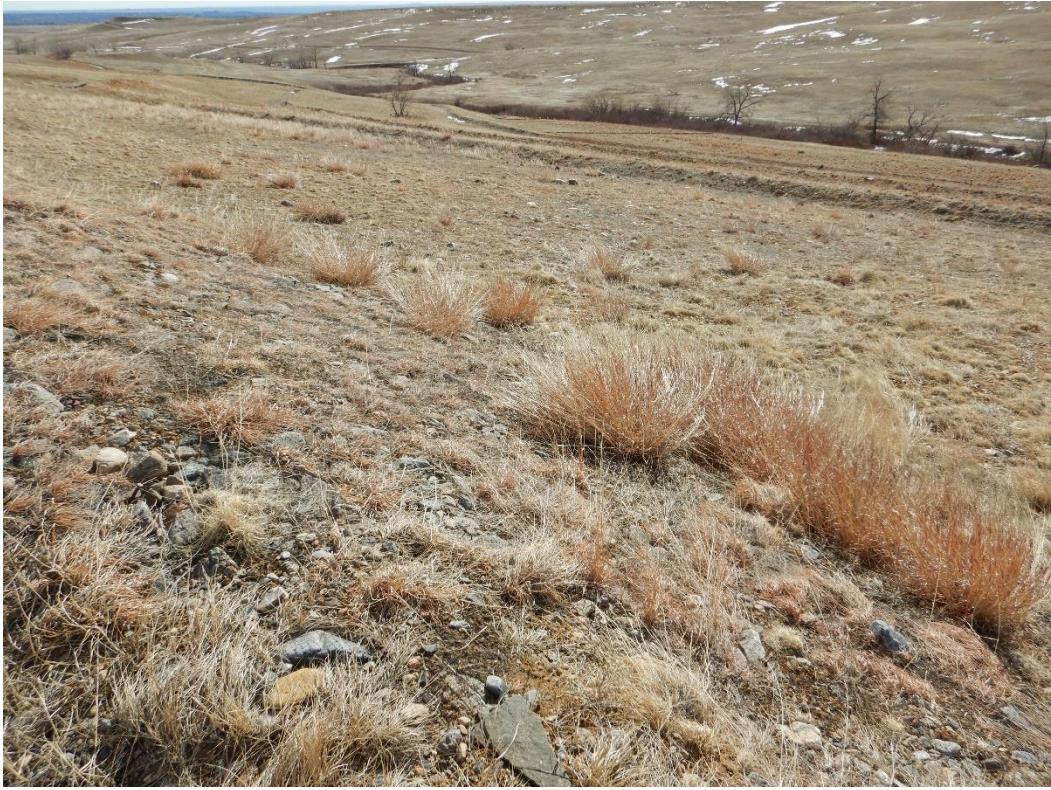
*Figure 3. Looking Southeast at Berms 4–7, Which Were in Good Condition*

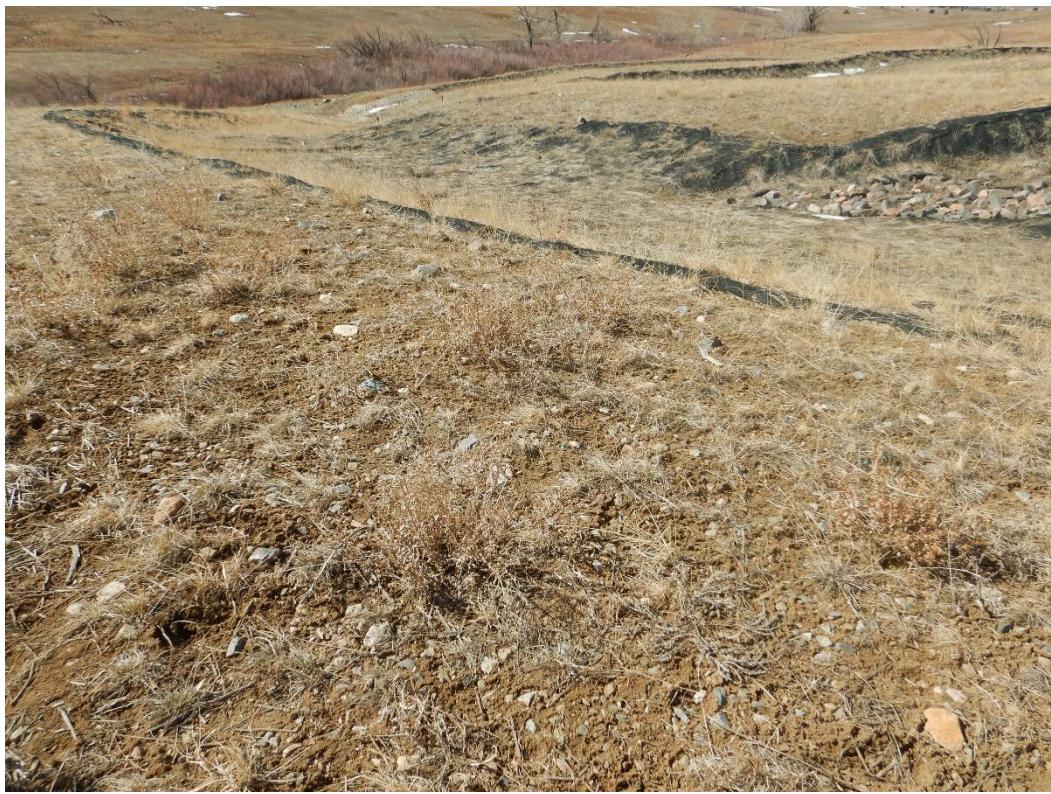
*Figure 4. Looking Southwest at the EPC, Which Was in Good Condition*

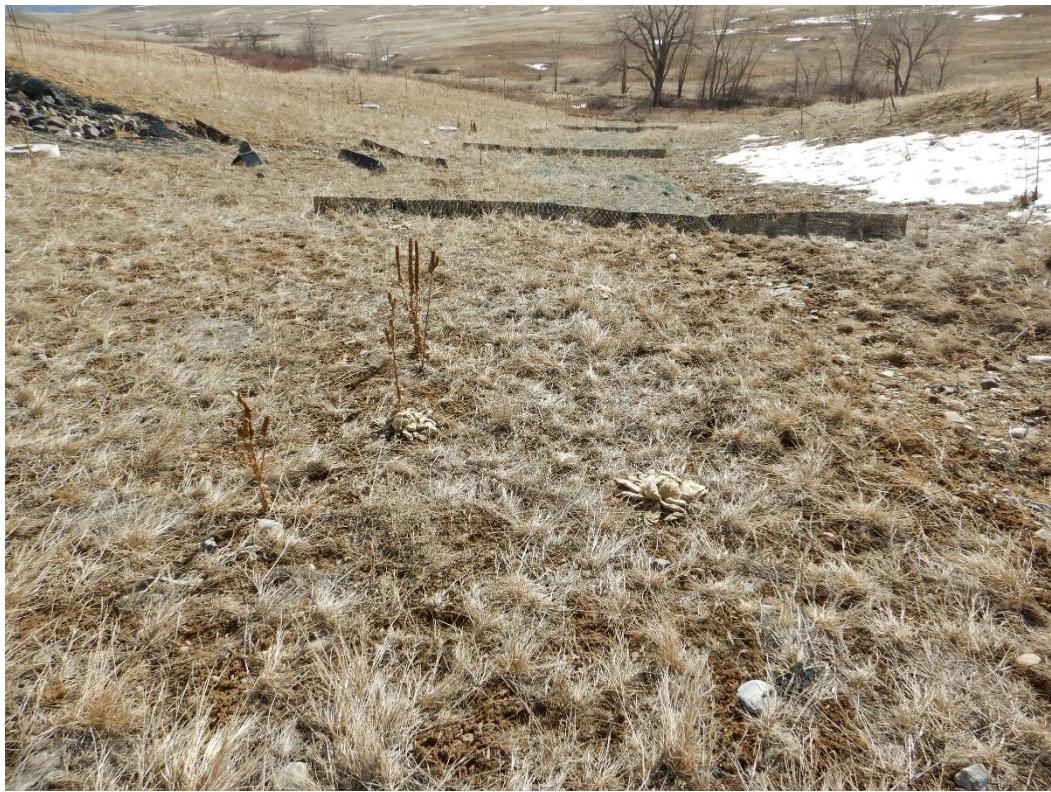
*Figure 5. Looking South-Southeast at the WPC, Which Was in Good Condition*

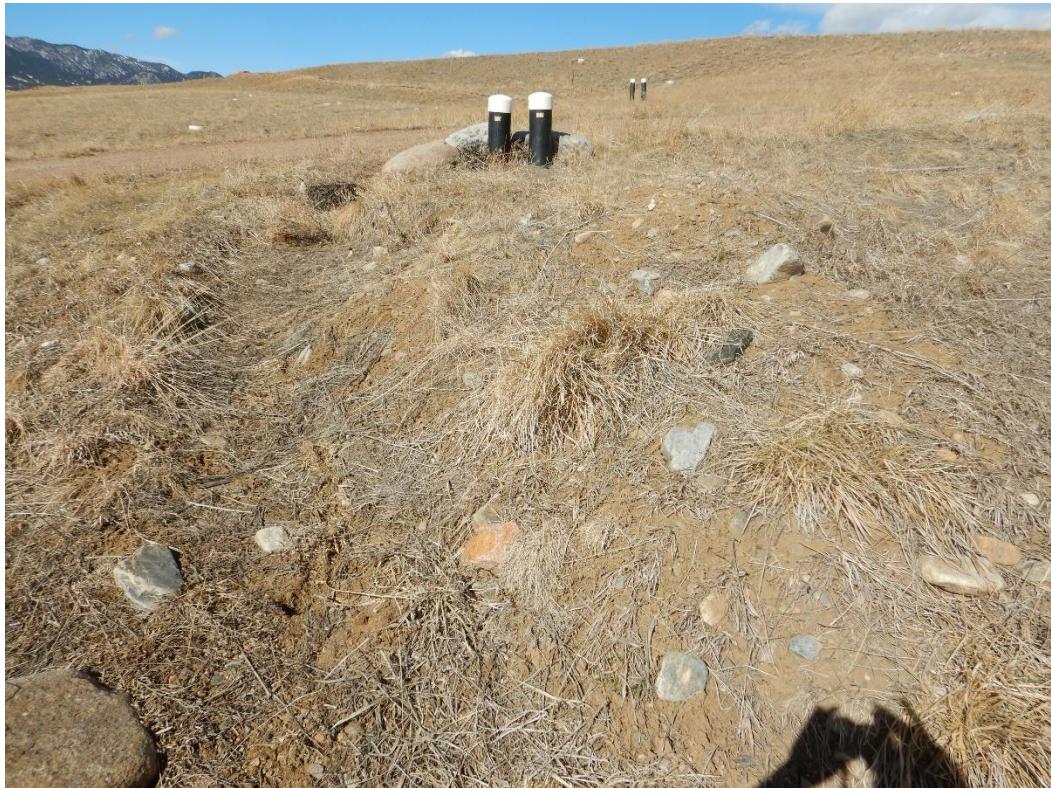
No issues were noted with the East Subsurface Drain (ESSD) (**Figure 7**), which had no flow during the inspection. No issues were noted with the South Interceptor Ditch (SID) (**Figure 8**), which receives groundwater from the ESSD outfall and an interceptor drain on the eastern hillside which had a flow of less than 1 gpm during the inspection.

*Figure 7. Looking West-Northwest at the ESSD (Cleanouts) and the Surrounding Area, Which Was in Good Condition*

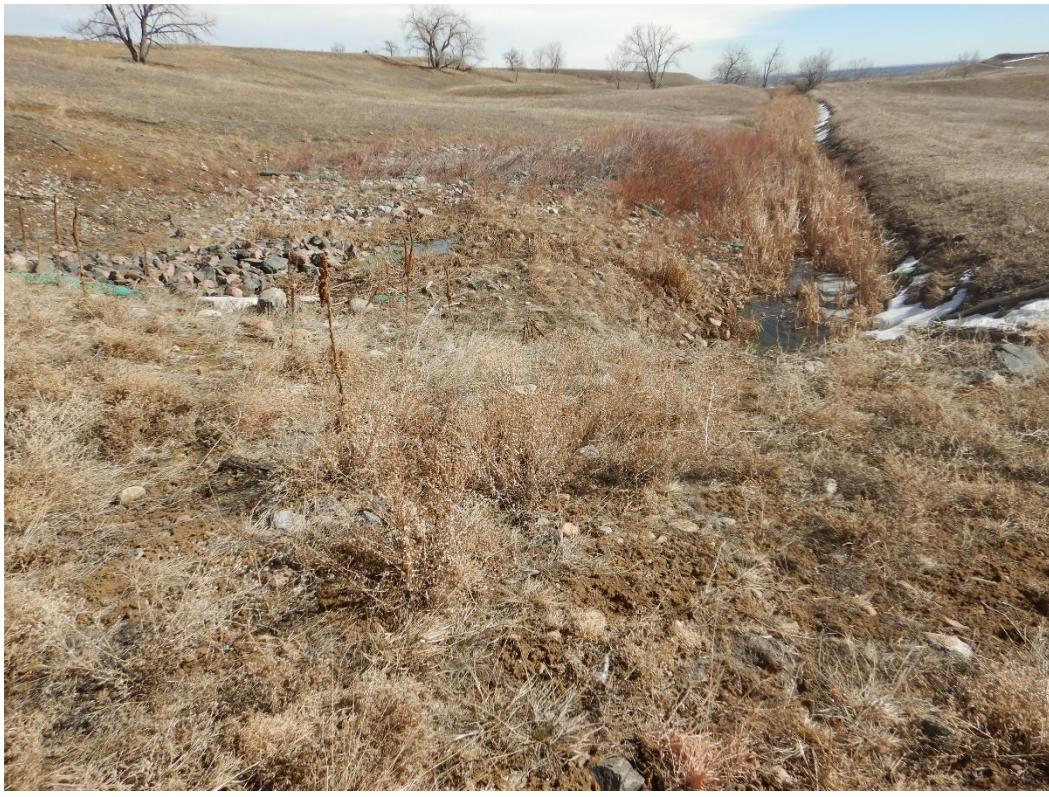
*Figure 8. Looking East-Northeast at the SID, Which Receives Groundwater from the ESSD Outfall and an Interceptor Drain on the Eastern Hillside*

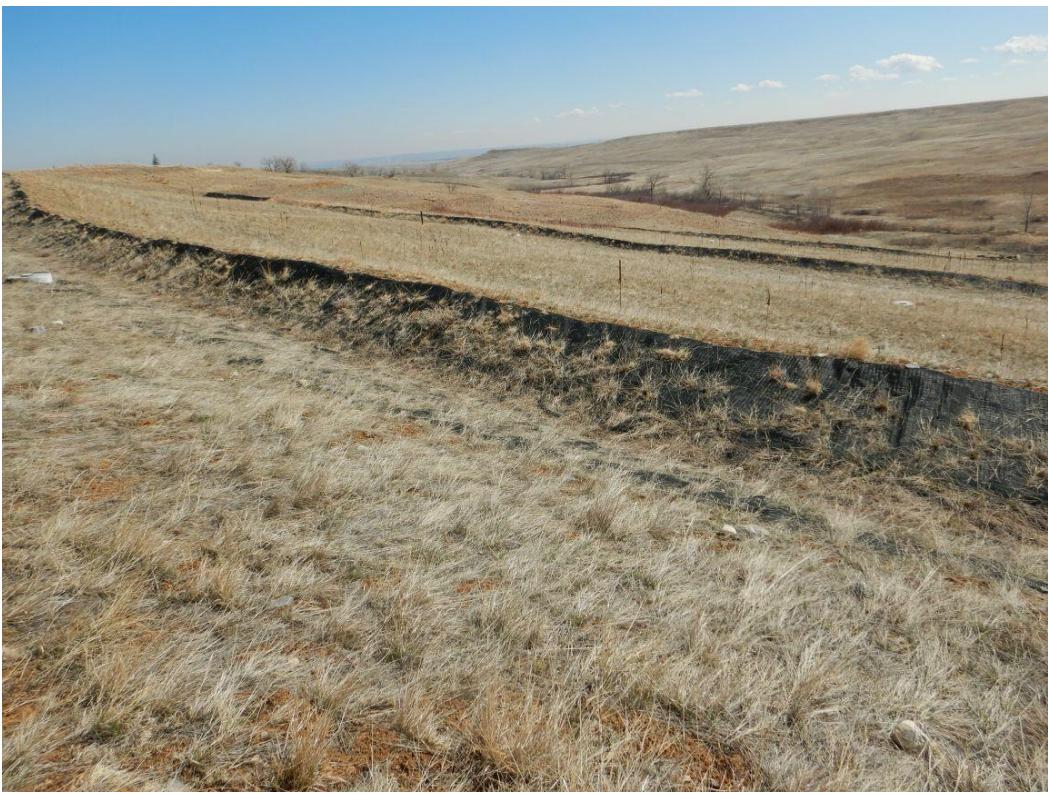
No issues were noted during the inspection. Berms 1–3 (**Figure 2**) and Berms 4–7 (**Figure 3**) were in good condition. Erosion control blankets along eastern Berm 2 (**Figure 4**) were displaced by elk passing through the area in early March. The blankets were restaked in late March and early April. Erosion control blankets along Berm 4 (**Figure 5**) have remained in good condition. Erosion controls installed in 2021 on the western end of Berm 3 have remained in good condition (**Figure 6**). The East Perimeter Channel (EPC) was in good condition (**Figure 7**). The West Perimeter Channel (WPC) was in good condition (**Figure 8**).

*Figure 2. Looking East-Southeast at Berms 1–3, Which Were in Good Condition*

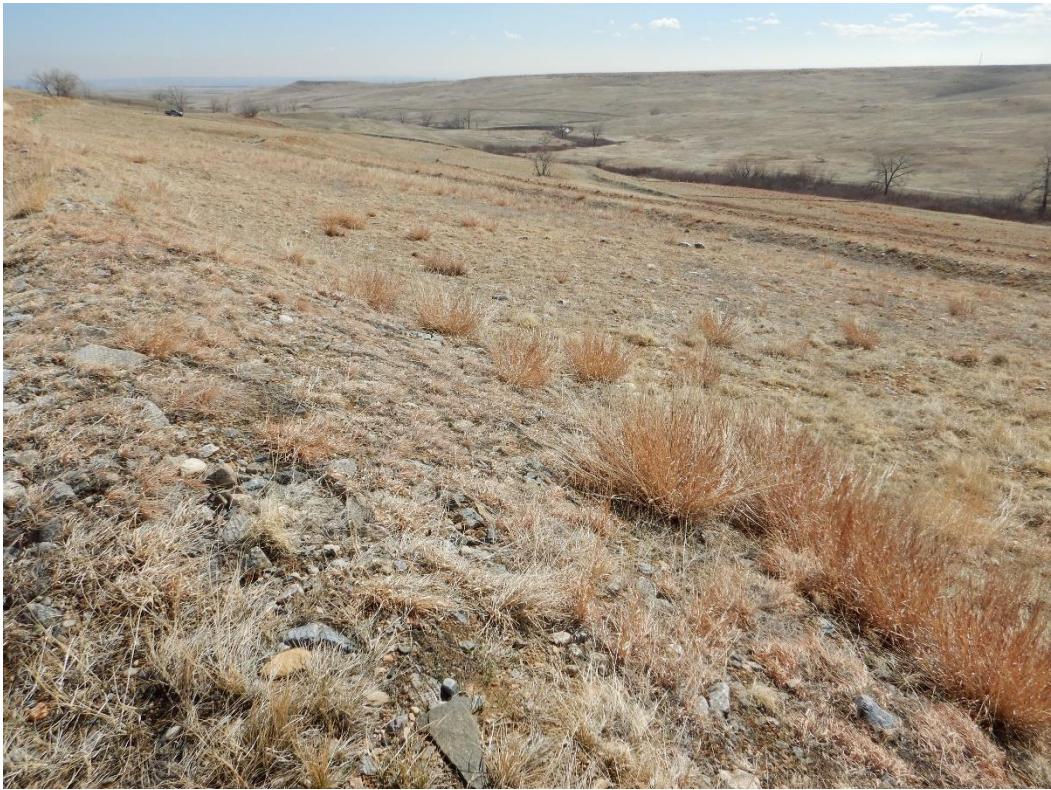
*Figure 3. Looking Southeast at Berms 4–7, Which Were in Good Condition*

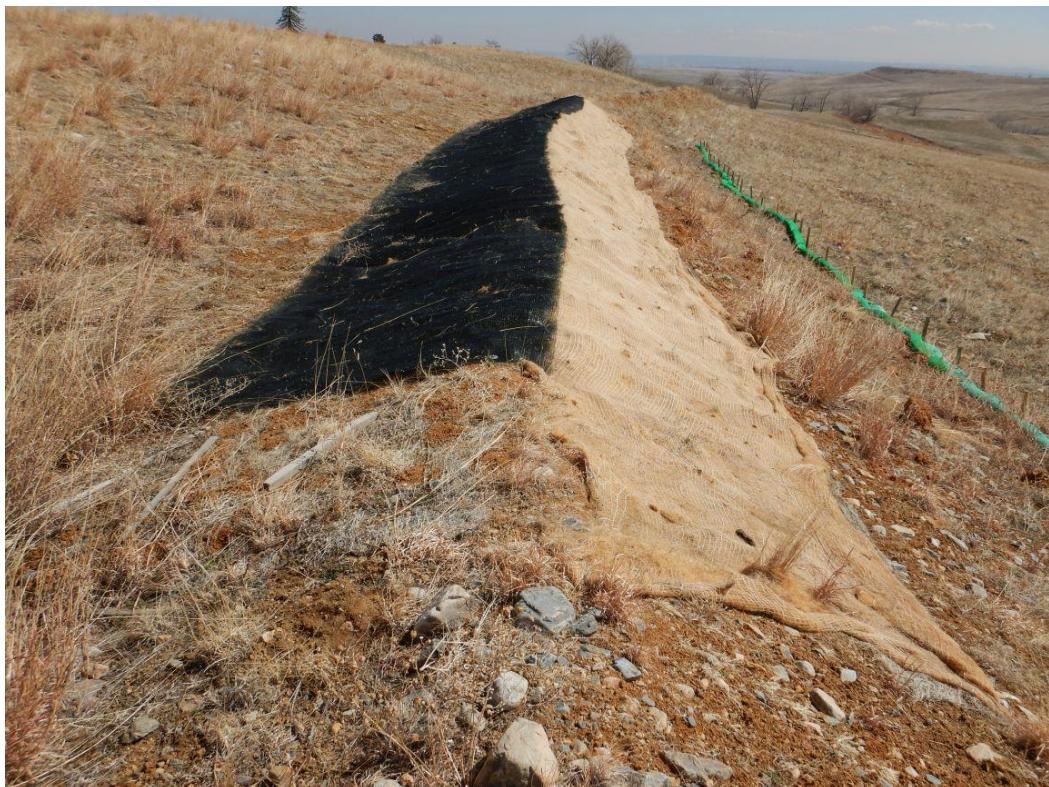
*Figure 5. Looking East-Northeast at Erosion Control Blankets Along the Center of Berm 4, Which Were in Good Condition*

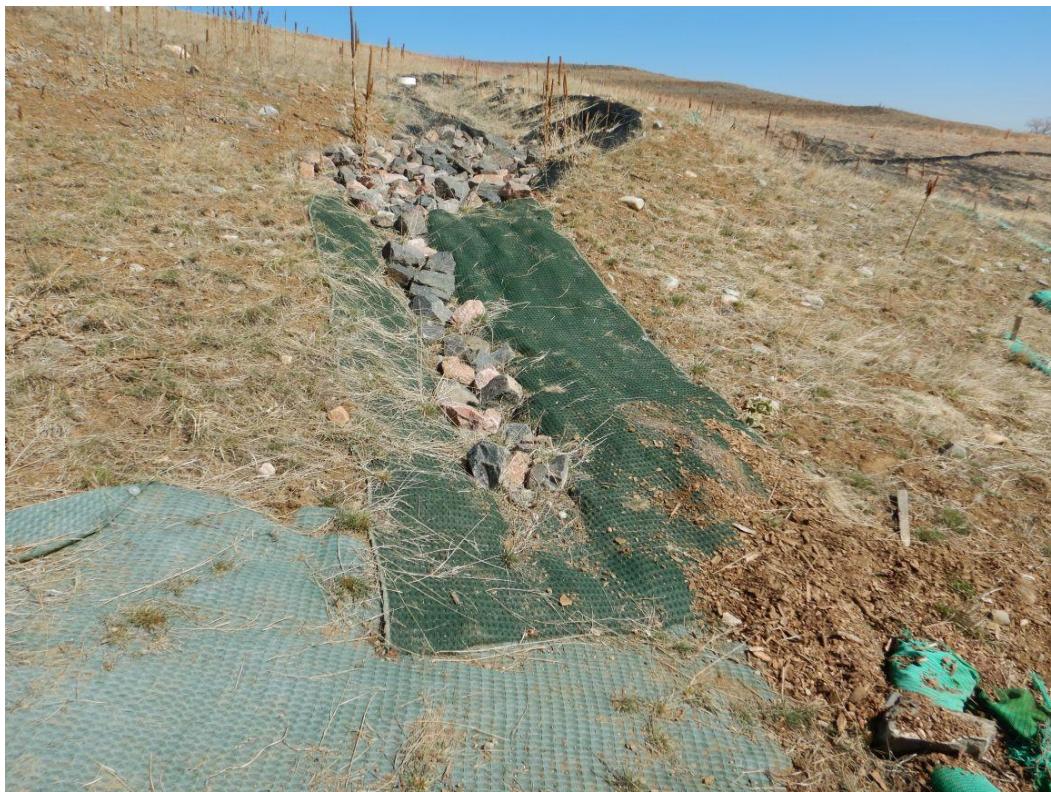
*Figure 6. Looking North-Northeast at Erosion Controls Installed in 2021 on the Western End of Berm 3, Which Have Remained in Good Condition*

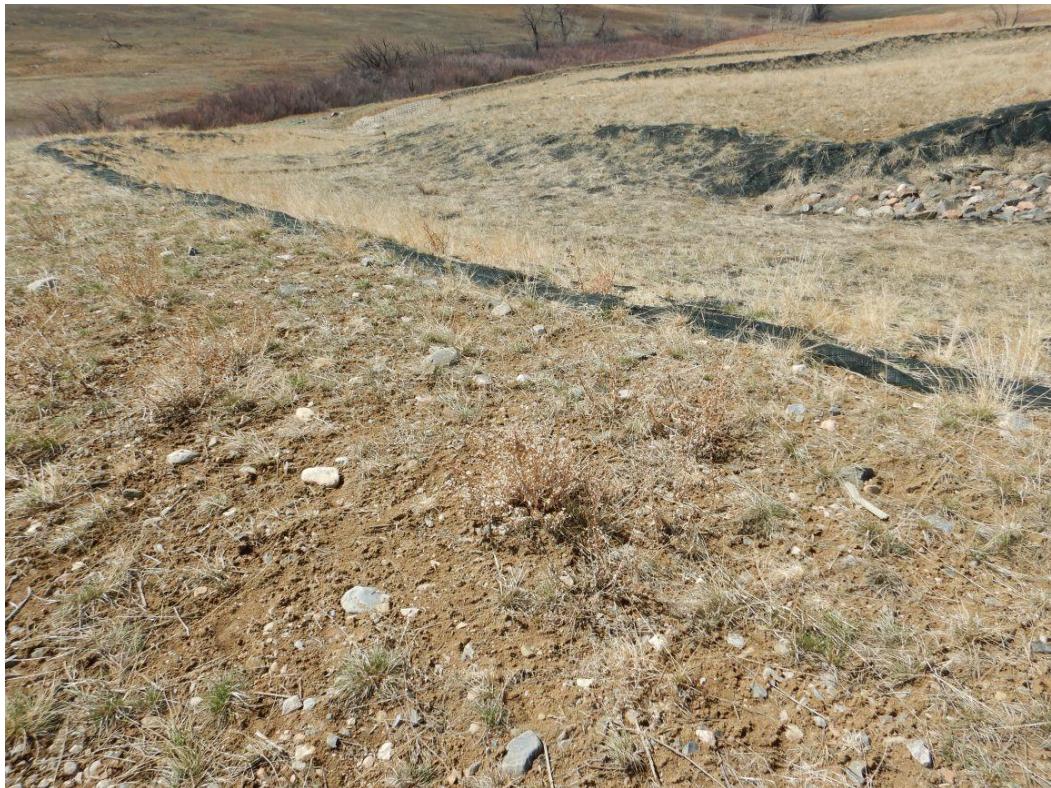
*Figure 7. Looking Southwest at the EPC, Which Was in Good Condition*

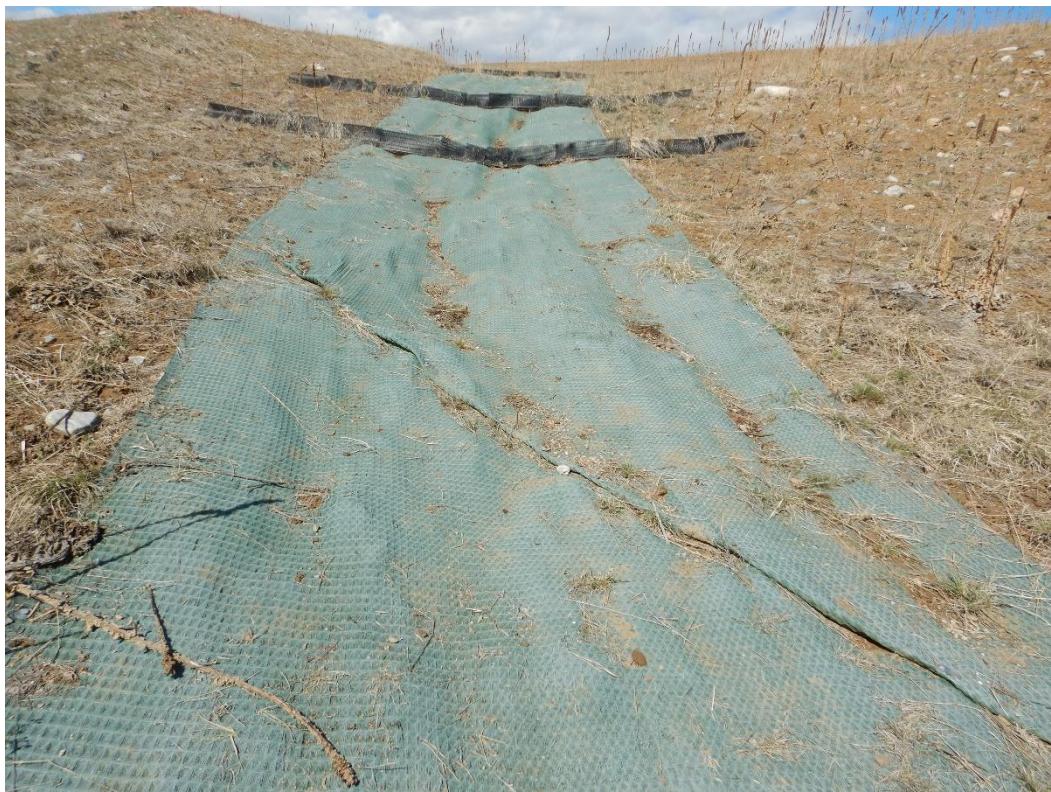
*Figure 8. Looking Northwest at the WPC, Which Was in Good Condition*

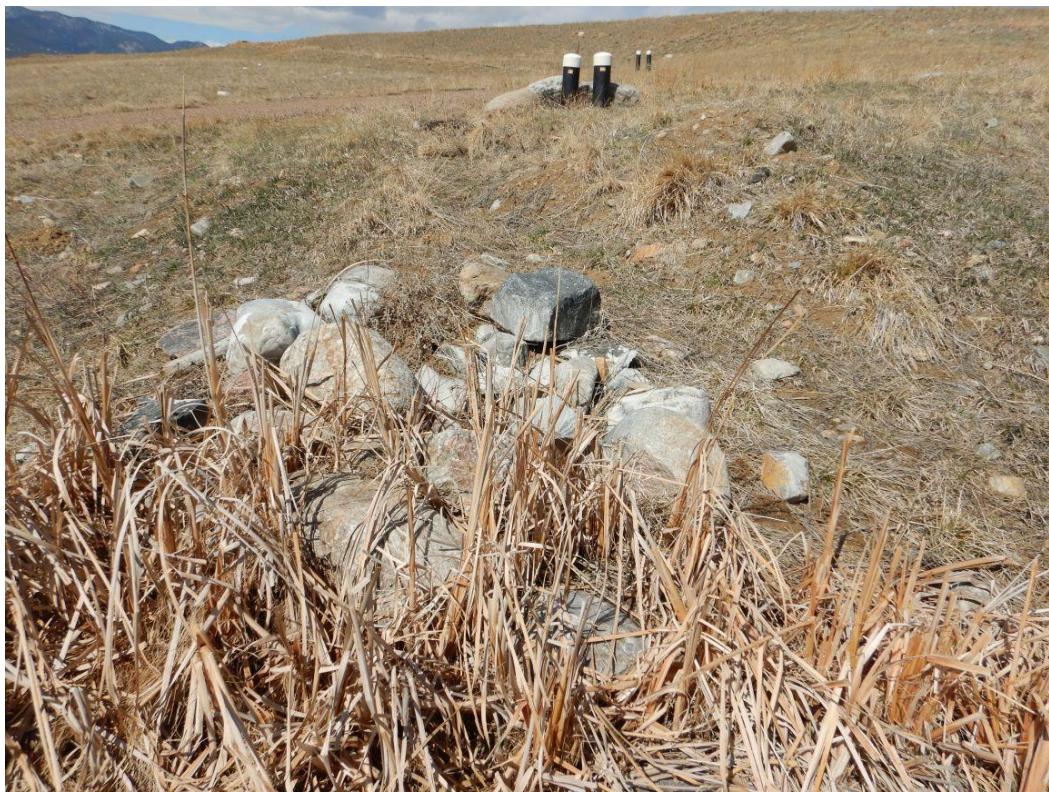
No issues were noted with the East Subsurface Drain (ESSD) (**Figure 10**), which had no flow during the inspection. No issues were noted with the South Interceptor Ditch (SID) (**Figure 11**), which receives groundwater from the ESSD outfall and an interceptor drain on the eastern hillside, which had a flow of less than 1 gpm during the inspection.

Figure 10. Looking West-Northwest at the ESSD (Cleanouts) and the Surrounding Area, Which Was in Good Condition

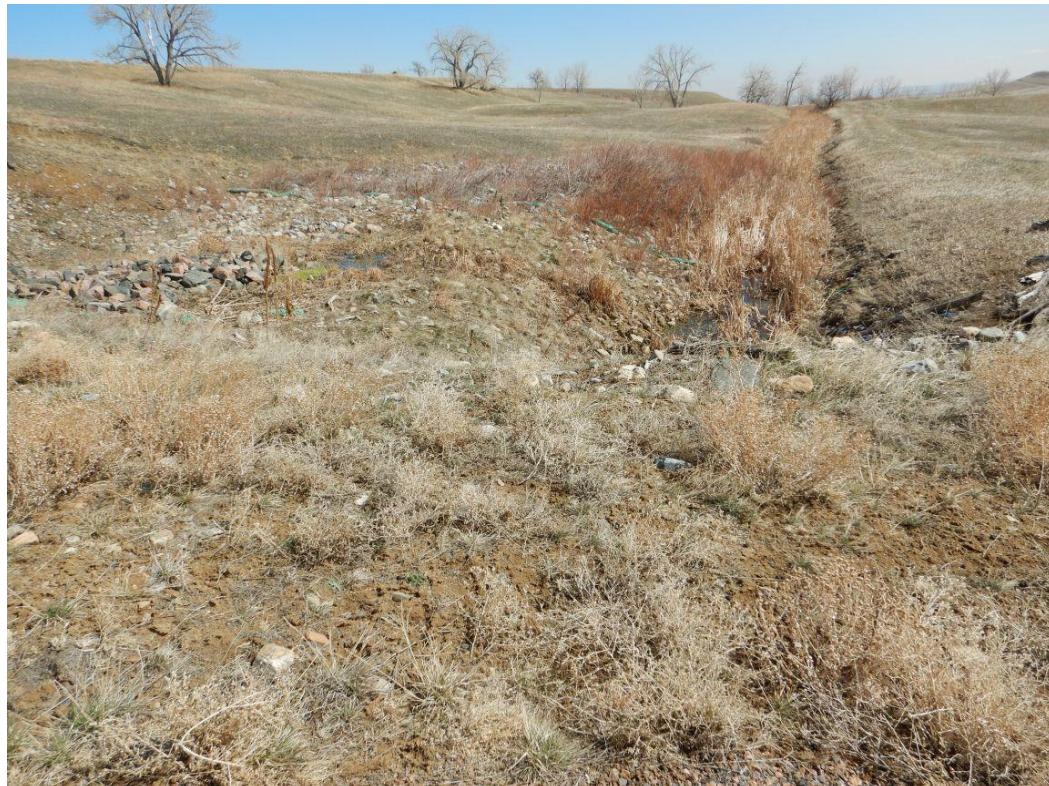
Figure 11. Looking East-Northeast at the SID, Which Receives Groundwater from the ESSD Outfall and an Interceptor Drain on the Eastern Hillslope

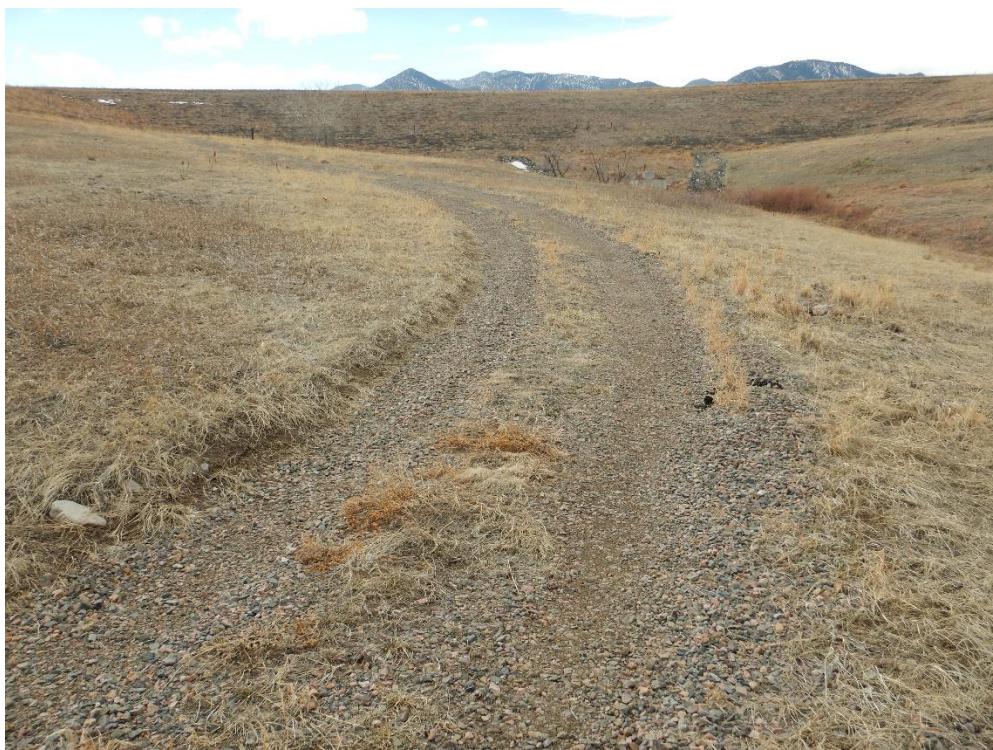
*Figure 2. Looking West at the East Face Slope, Which Was in Good Condition.*

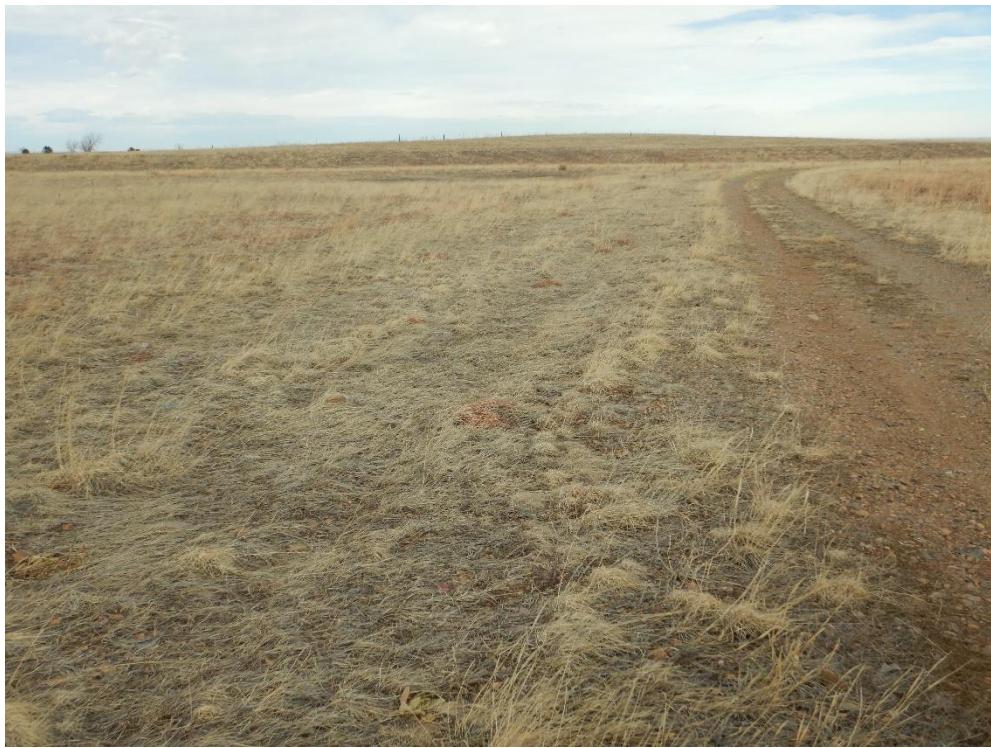
*Figure 3. Looking Northeast at the landfill's top cover, Which Was in Good Condition.*

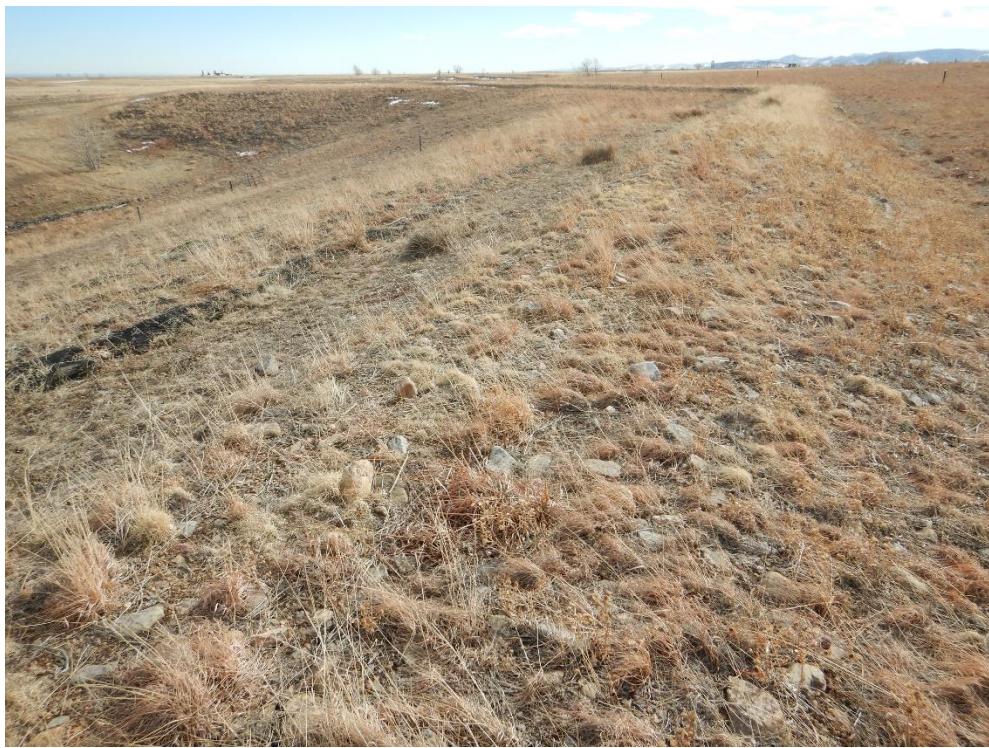
*Figure 5. Looking South at the Diversion Berm Located Between the East Face Slope and the Top of the Landfill Cover, Which Was in Good Condition.*
