16.0 Shiprock, New Mexico, Disposal Site

16.1 Compliance Summary

The Shiprock, New Mexico, Uranium Mill Tailings Radiation Control Act (UMTRCA) Title I Disposal Site was inspected on June 1, 2011. The disposal cell and all associated surface water diversion and drainage structures remain in good condition and were functioning as designed.

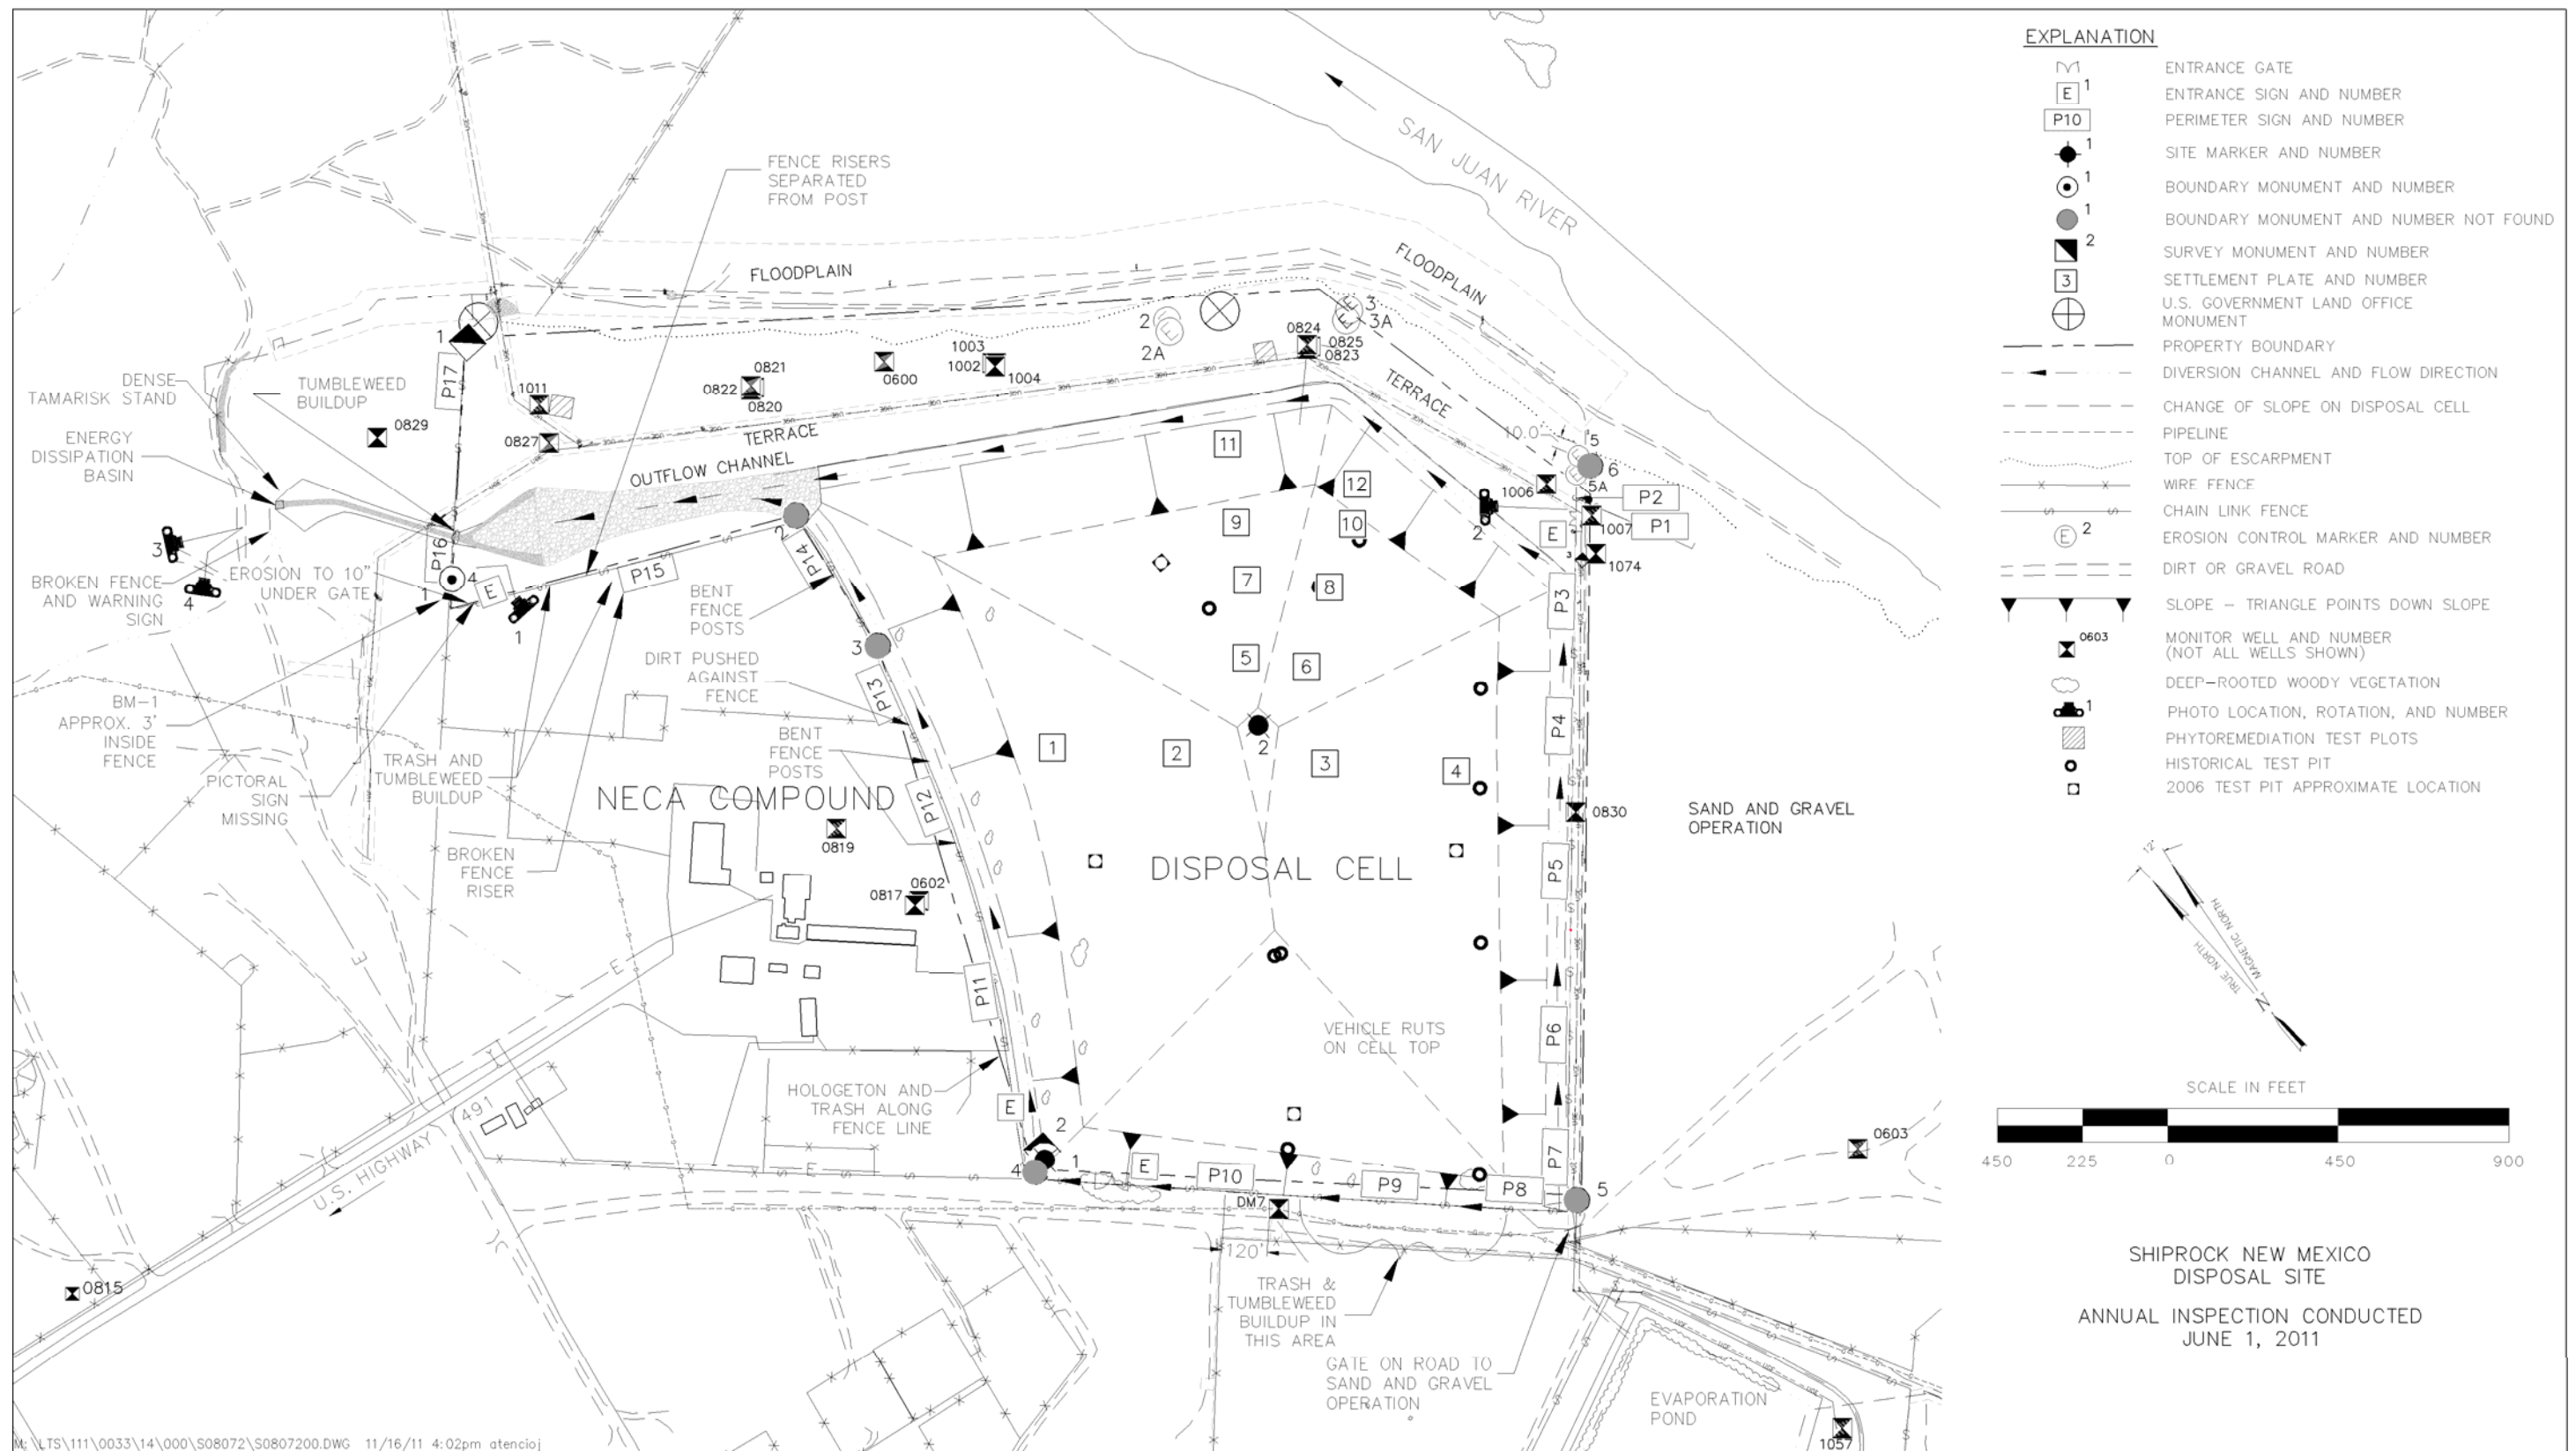
Figure 16-1. 2011 Annual Compliance Drawing for the Shiprock Disposal Site

Erosion Control Markers—The four sets of erosion control markers along the edge of the terrace escarpment were in good condition except for the marker near the east entrance gate (ECM–5A on Figure 16–1). This marker was previously damaged by a vehicle, but the marker is still functional and does not require repair at this time.
