16.0 Shiprock, New Mexico, Disposal Site

16.1 Compliance Summary

16.4 Inspection Results

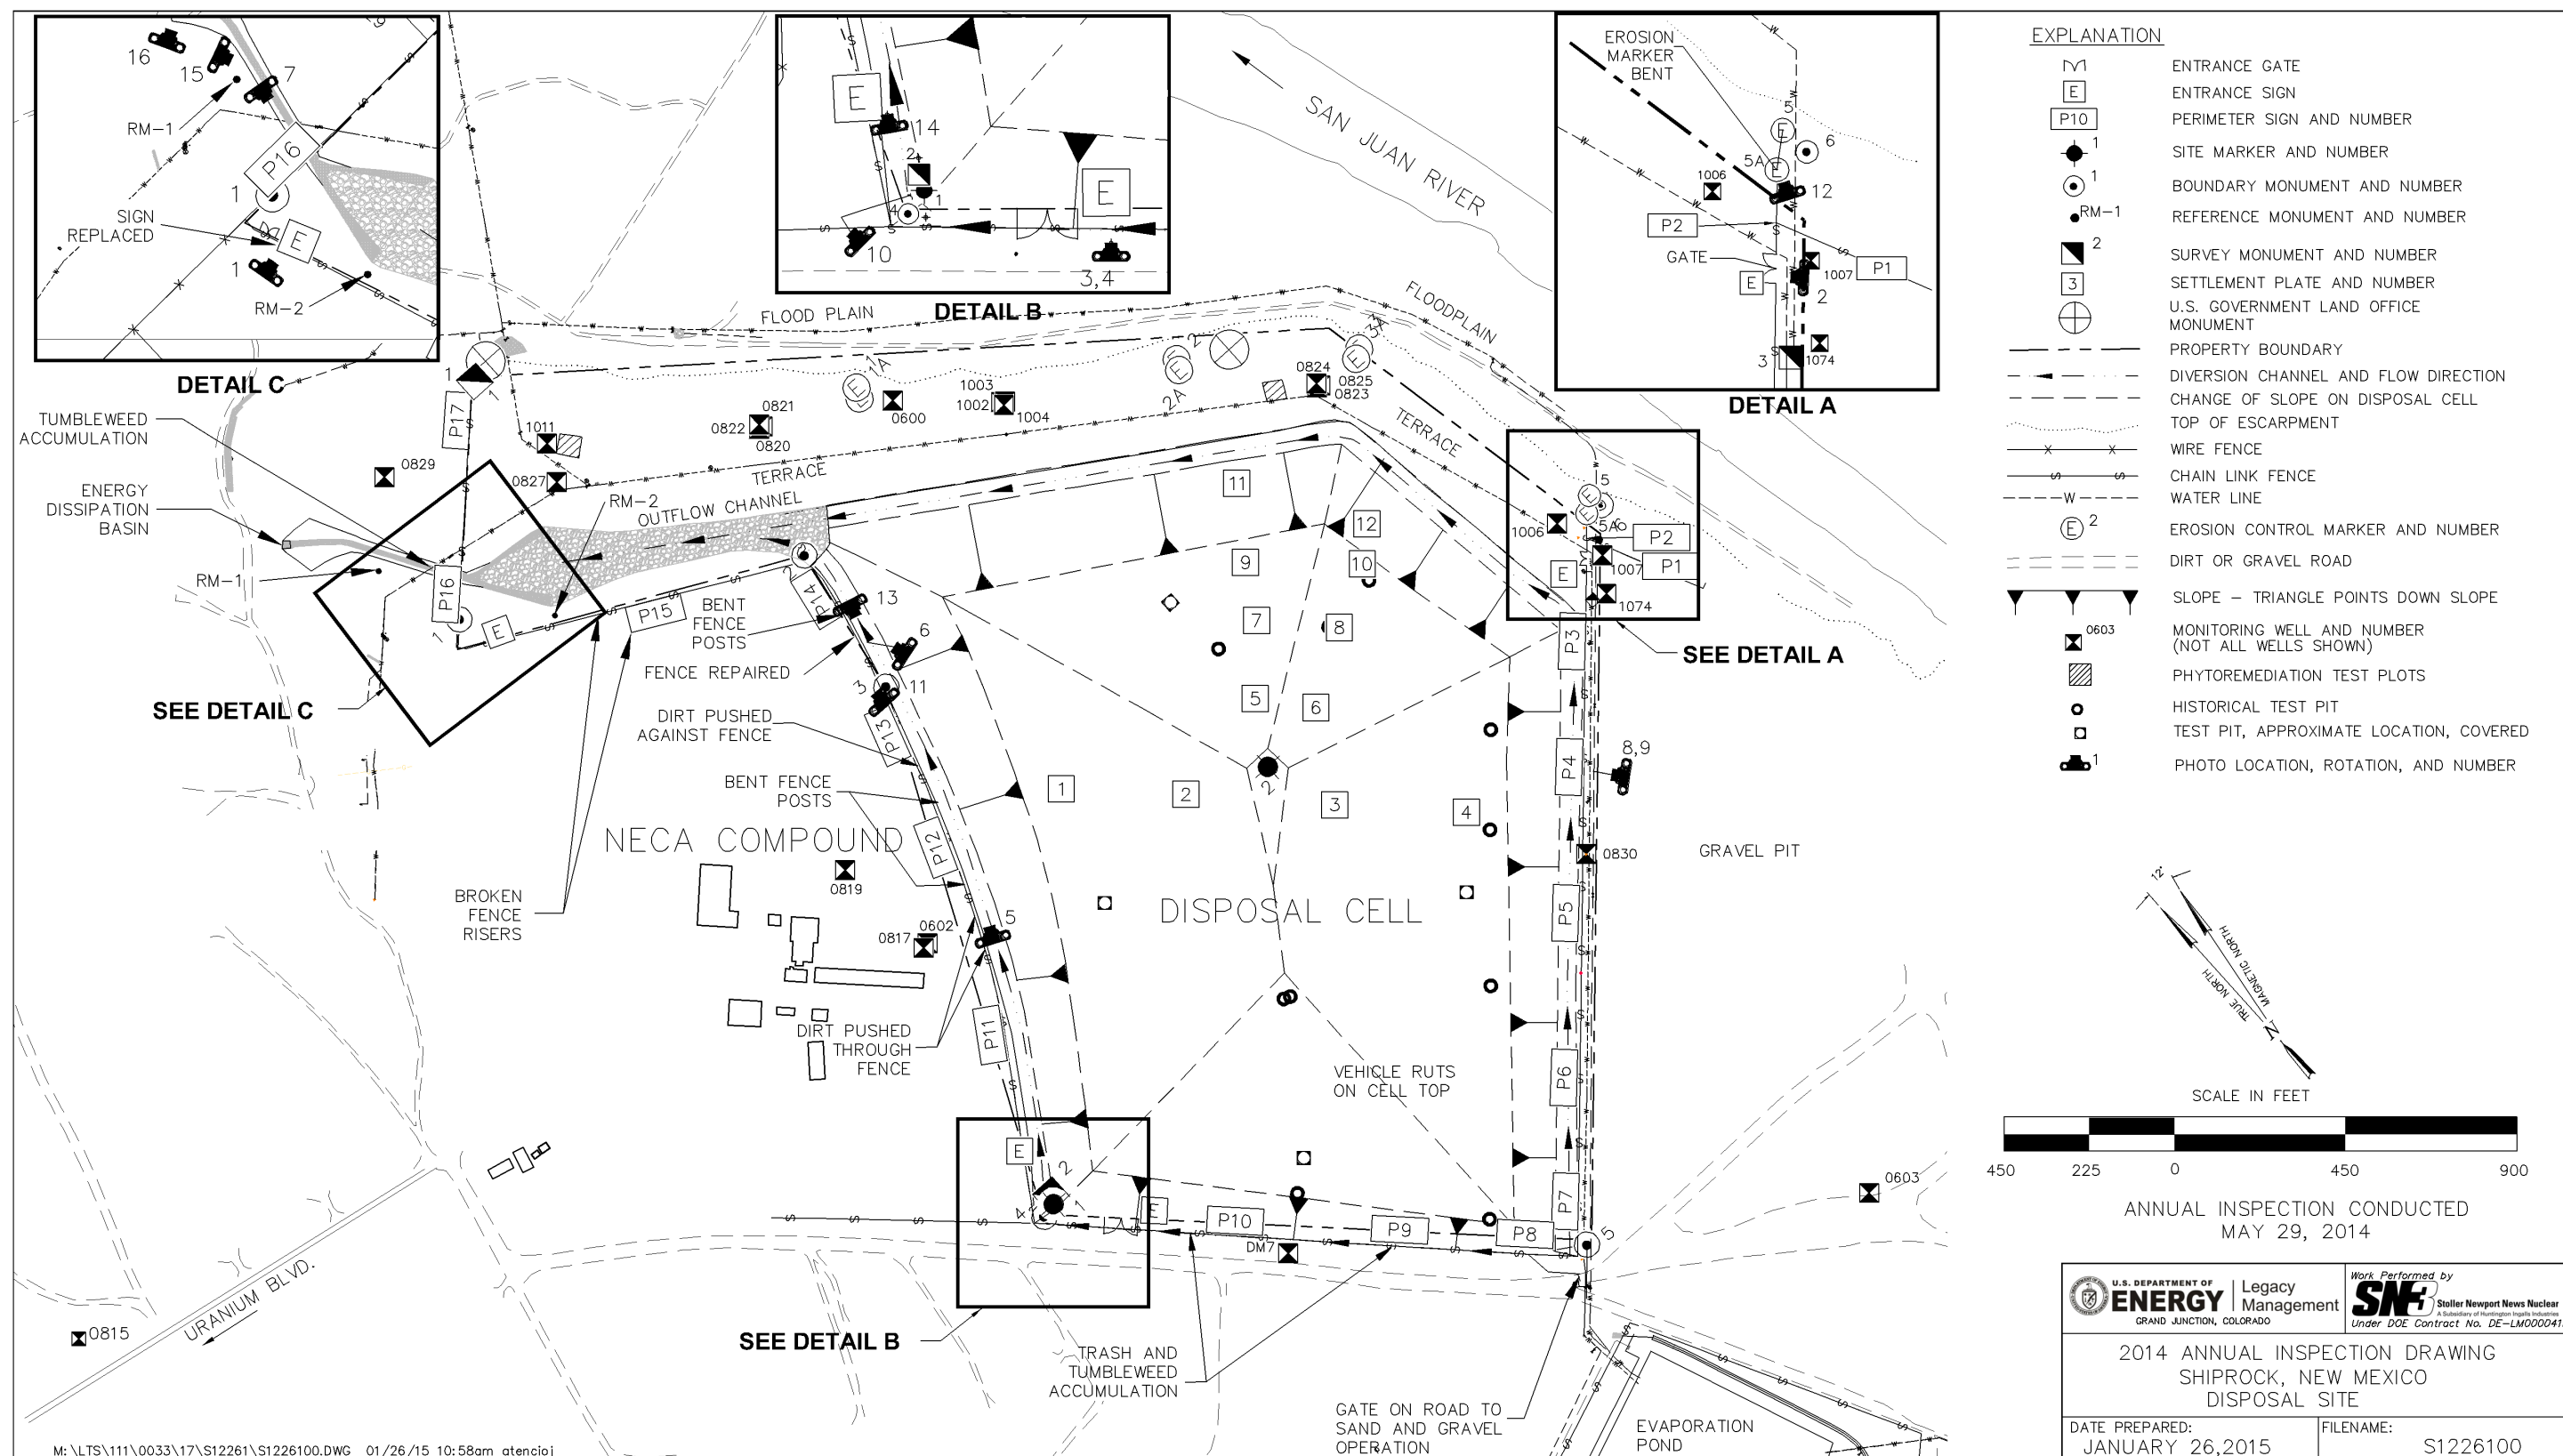
Figure 16-1. Annual Inspection Drawing for the Shiprock Disposal Site

Figure 16-1 shows the locations of site surveillance features. Inspection results and recommended maintenance activities associated with site surveillance features are included in the following subsections. Photographs to support specific observations are identified in the text and on Figure 16-1 by photograph location (PL) numbers.
