16.0 Shiprock, New Mexico, Disposal Site

16.1 Compliance Summary

16.4 Inspection Results

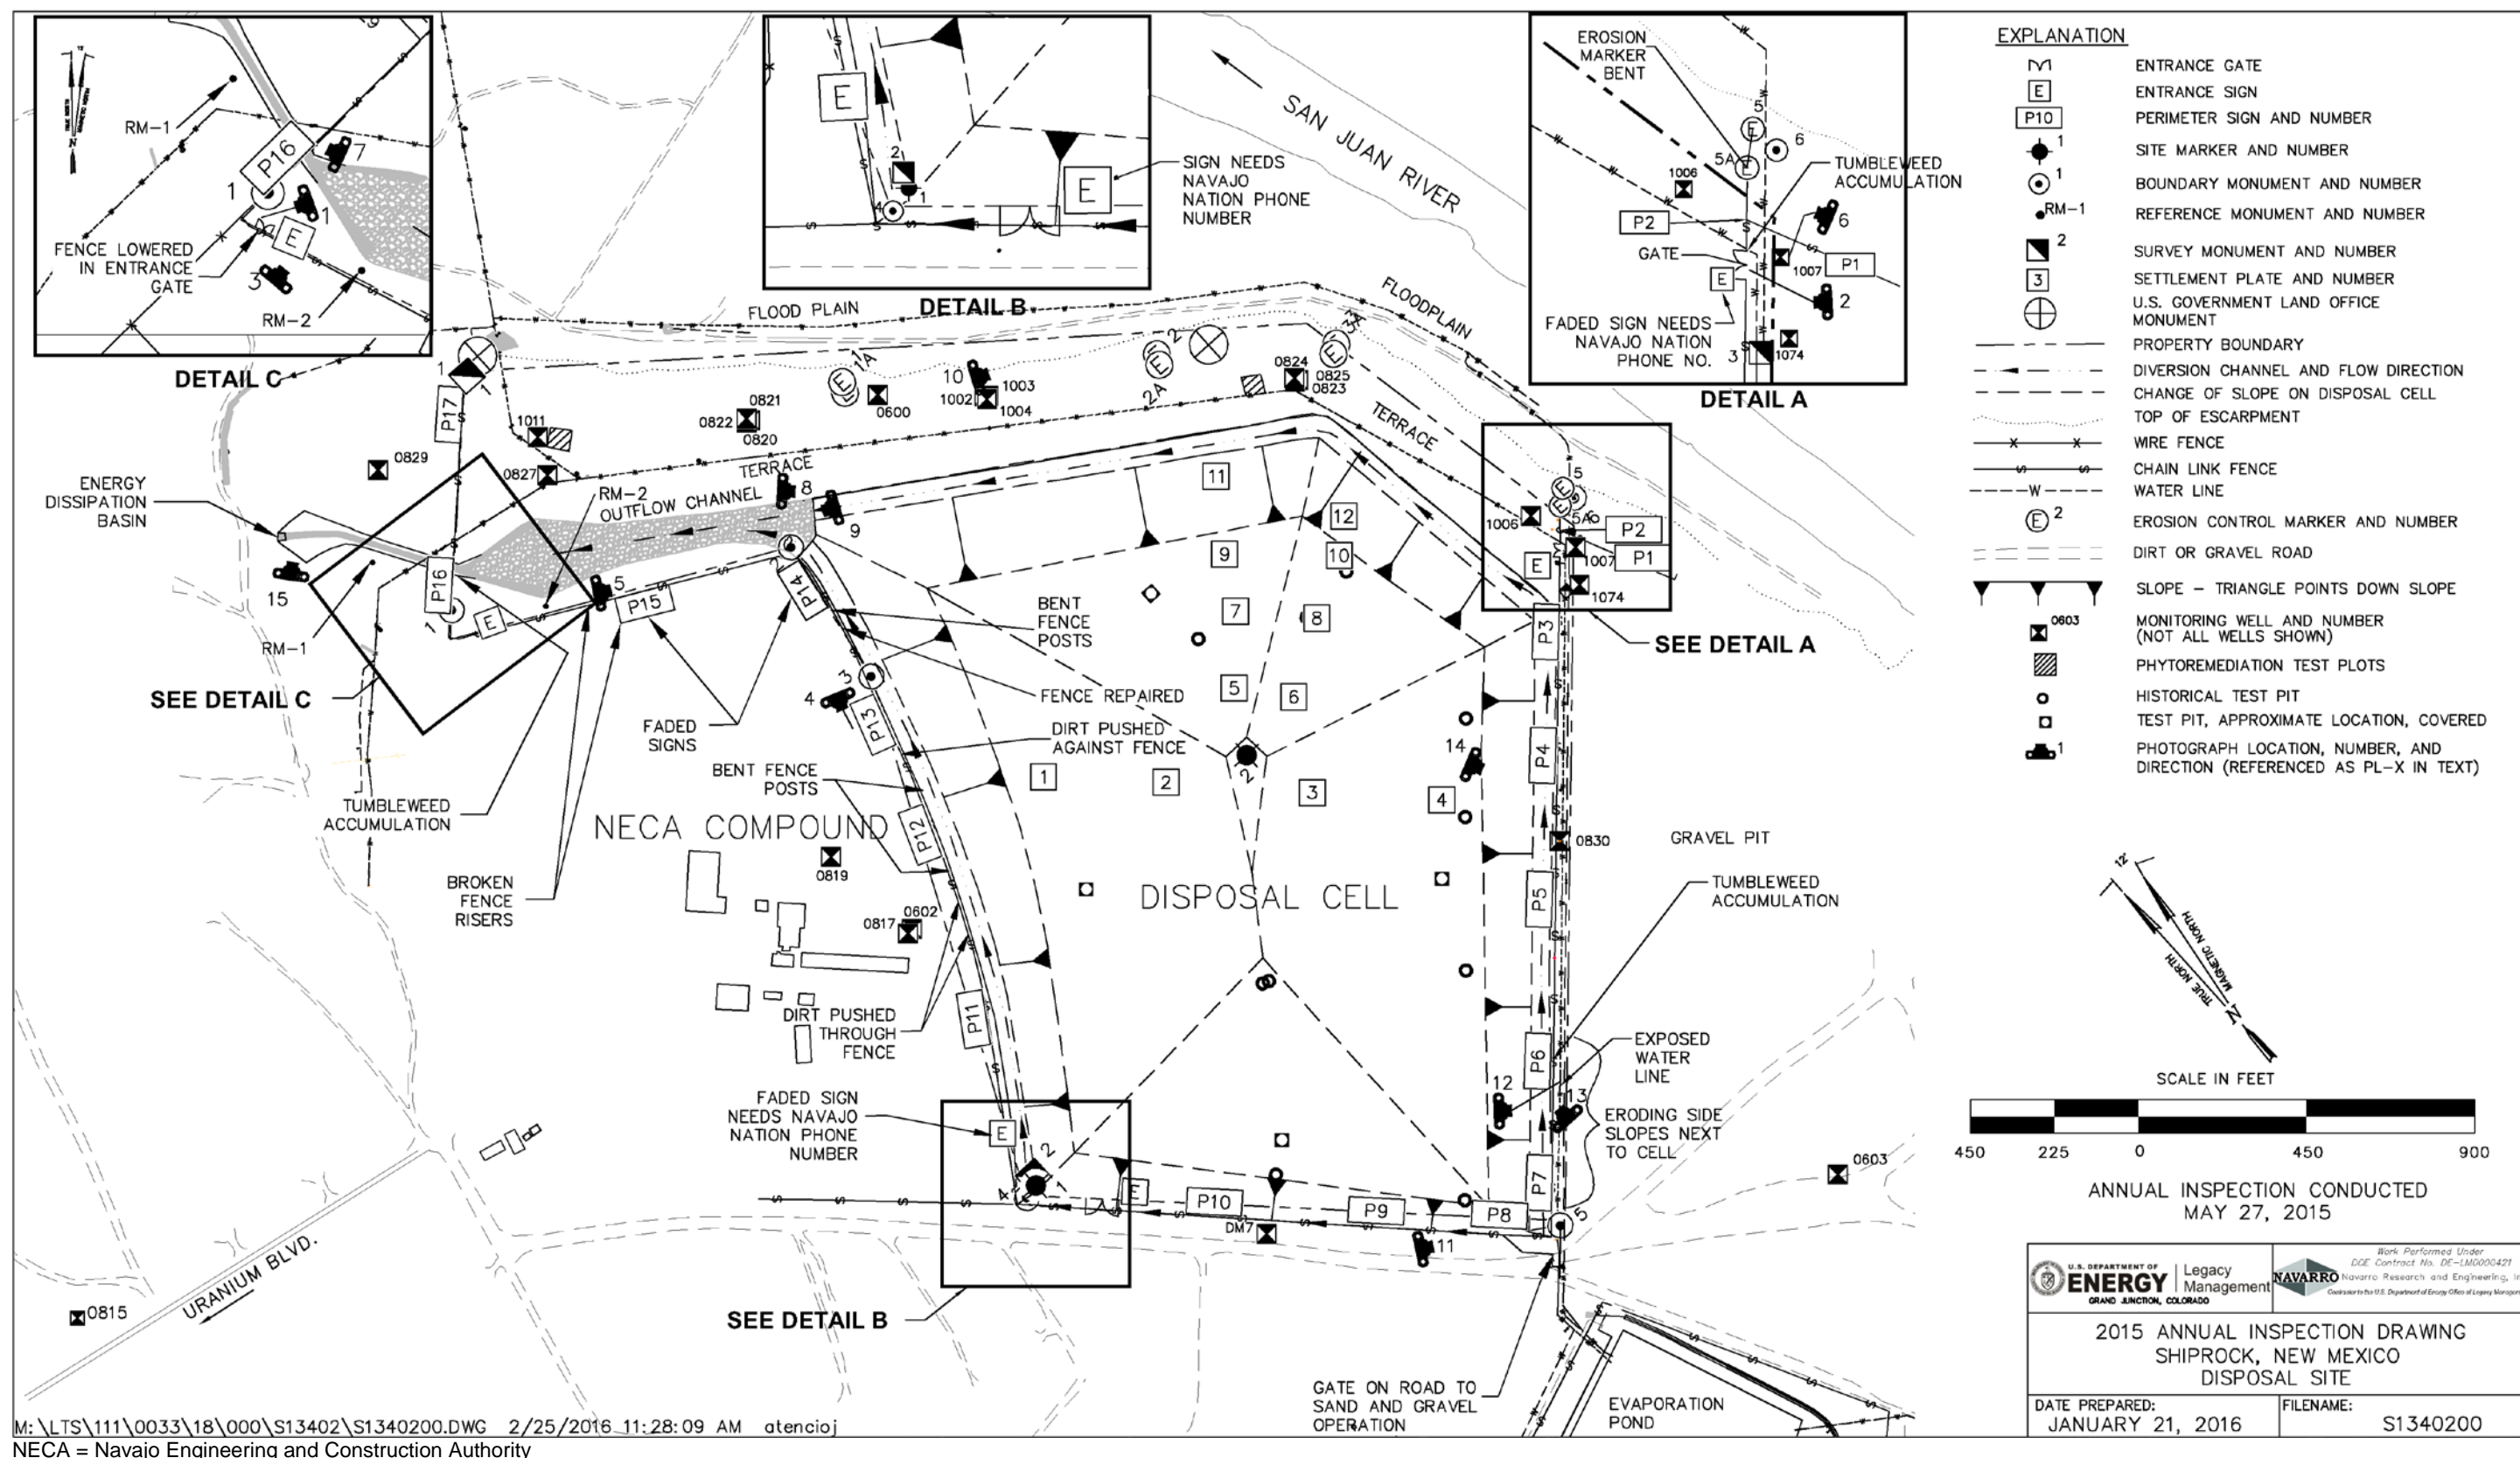
Figure 16-1. 2015 Annual Inspection Drawing for the Shiprock Disposal Site

Figure 16-1 shows the locations of site surveillance features. Inspection results and recommended maintenance activities associated with site surveillance features are included in the following subsections. Photographs to support specific observations are identified in the text and on Figure 16-1 by photograph location (PL) numbers.
