16.0 Shiprock, New Mexico, Disposal Site

16.1 Compliance Summary

16.4 Inspection Results

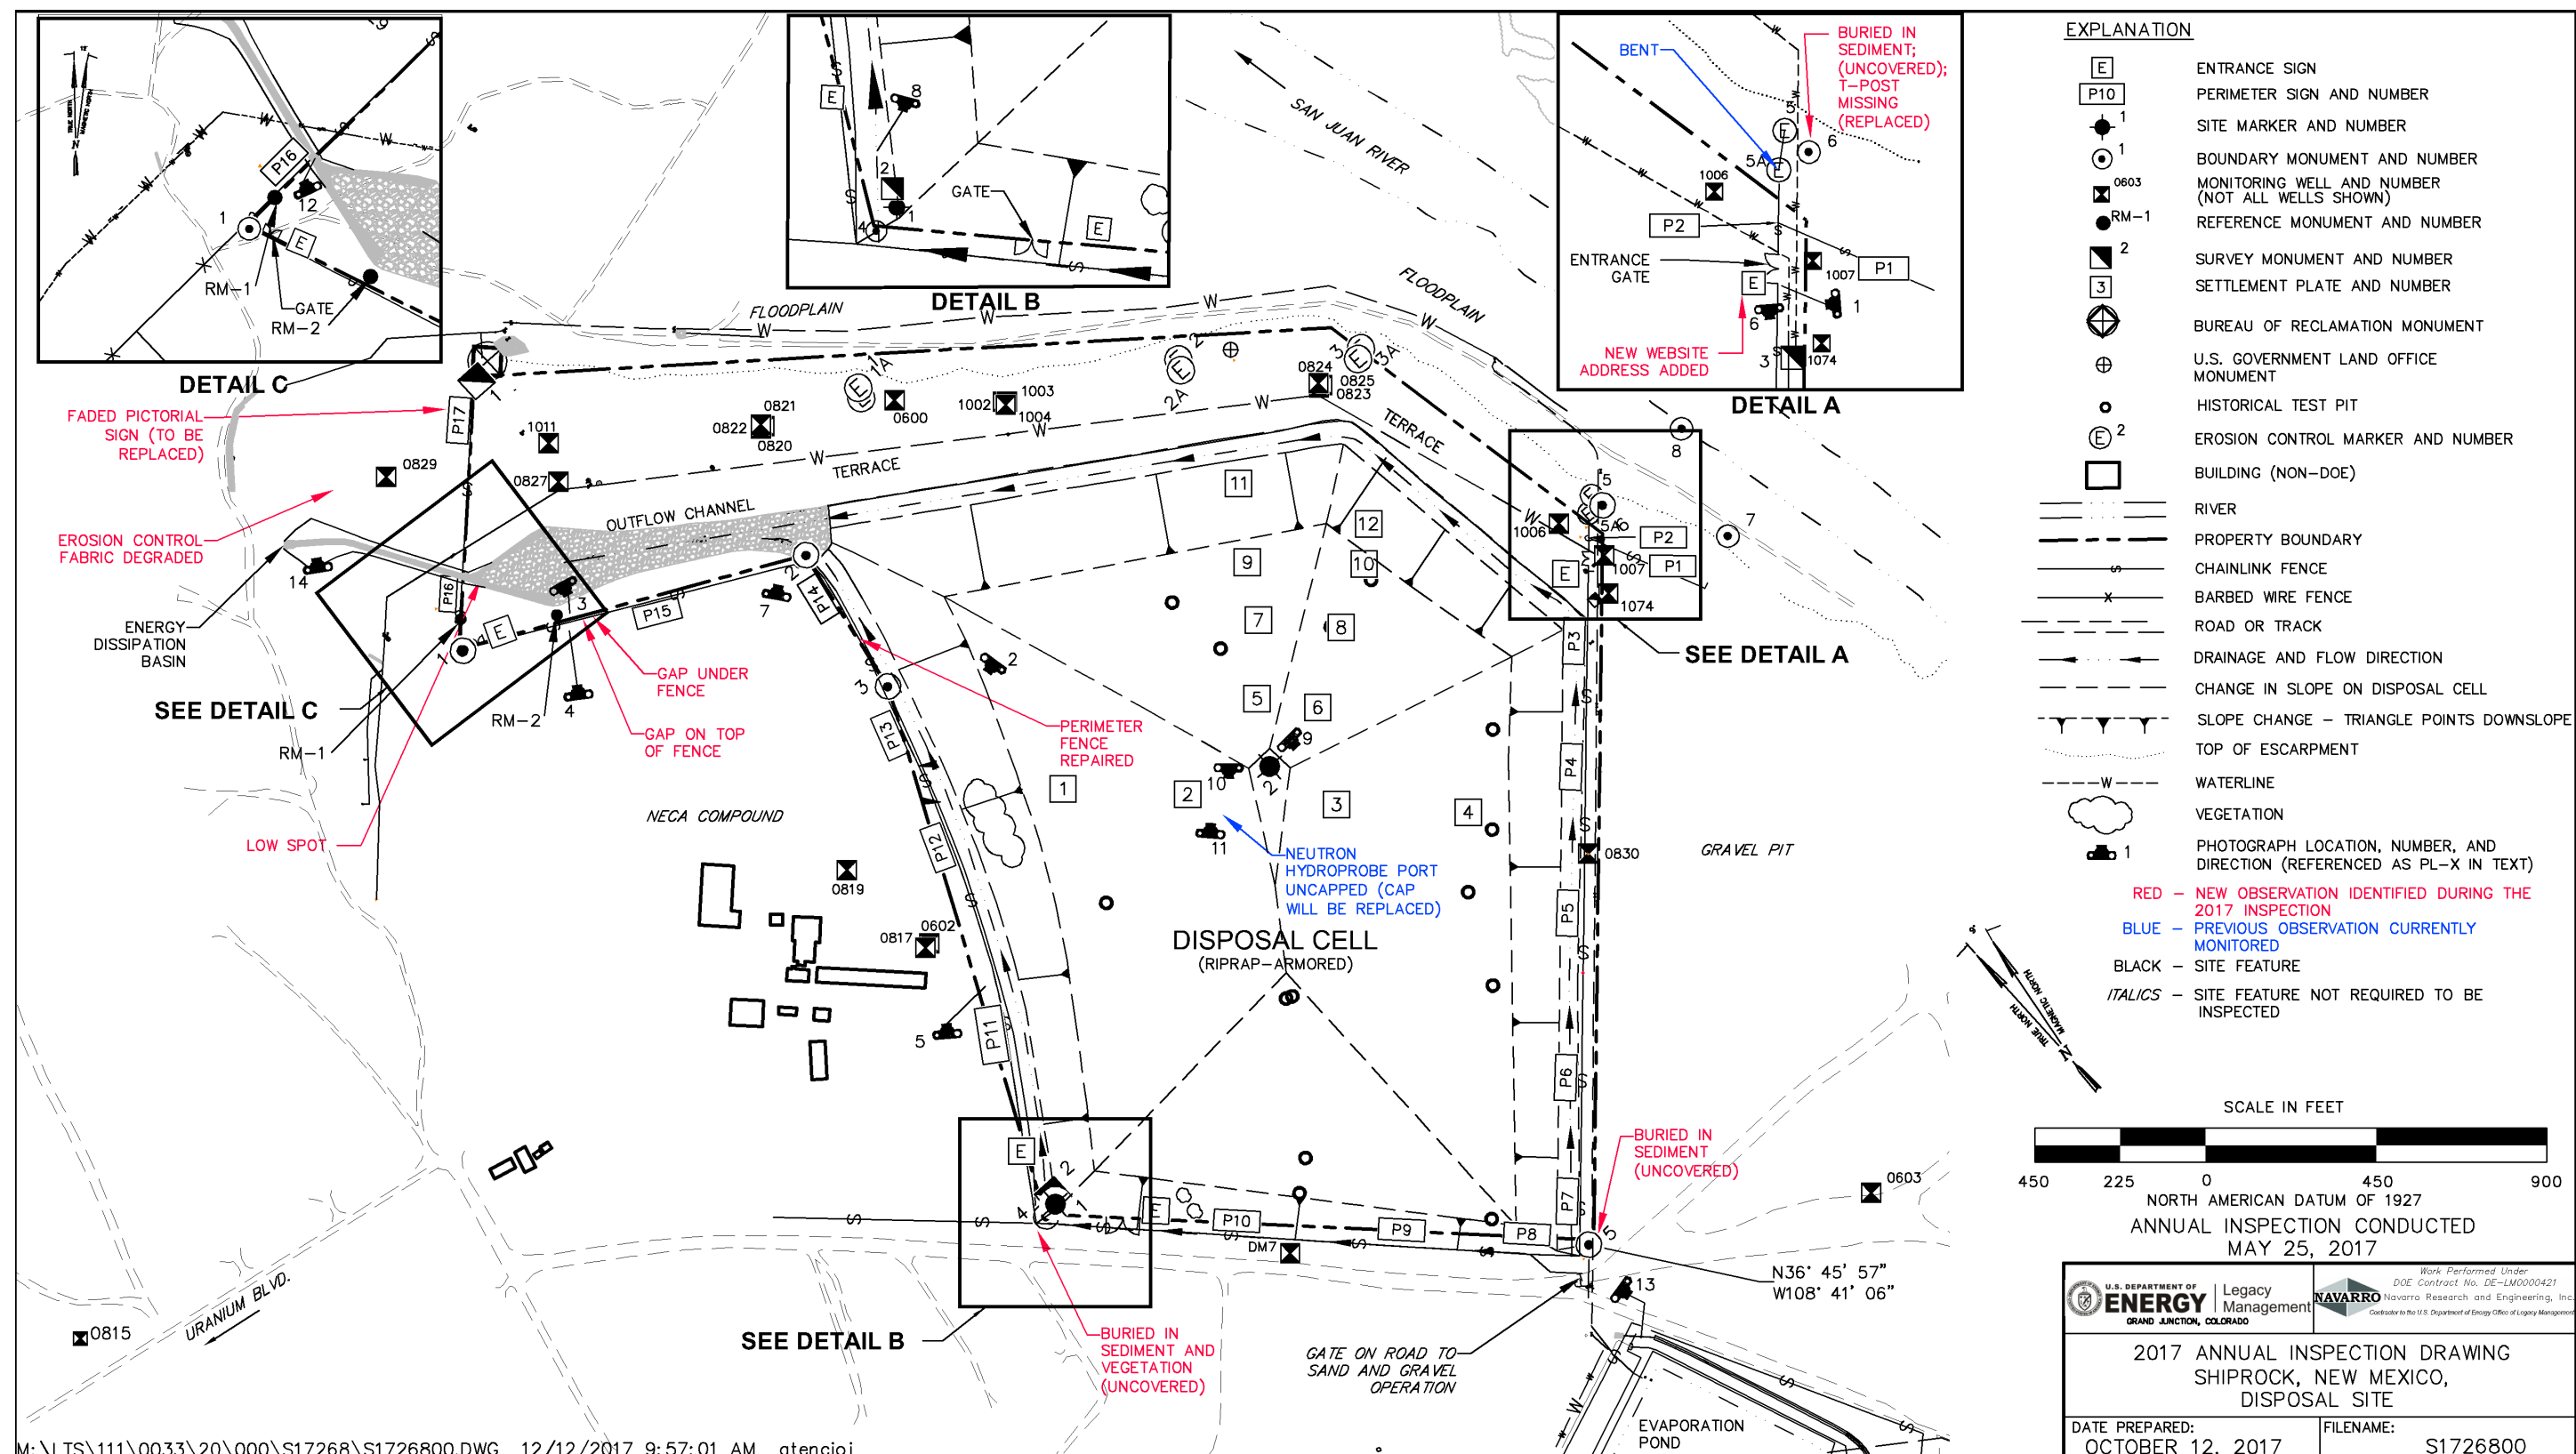
Figure 16-1. 2017 Annual Inspection Drawing for the Shiprock, New Mexico, Disposal Site

Figure 16-1 shows in black the locations of site features, including site surveillance features and inspection areas. Site features that are present but not required to be inspected are shown in italic font. Observations from previous inspections that are currently monitored are shown in blue text, and new observations identified during the 2017 annual inspection are shown in red. Inspection results and recommended maintenance activities associated with site surveillance features are described in the following subsections. Photographs to support specific observations are identified in the text and in Figure 16-1 by photograph location (PL) numbers. The photographs and photograph log are presented in Section 16.10.
