16.0 Shiprock, New Mexico, Disposal Site

16.1 Compliance Summary

The Shiprock, New Mexico, Uranium Mill Tailings Radiation Control Act (UMTRCA) Title I Disposal Site (site) was inspected on June 21, 2018. No changes were observed on the disposal cell or in the associated diversion channels. Inspectors identified several minor maintenance needs but found no cause for a follow-up or contingency inspection. Groundwater monitoring to evaluate disposal cell performance is not required.

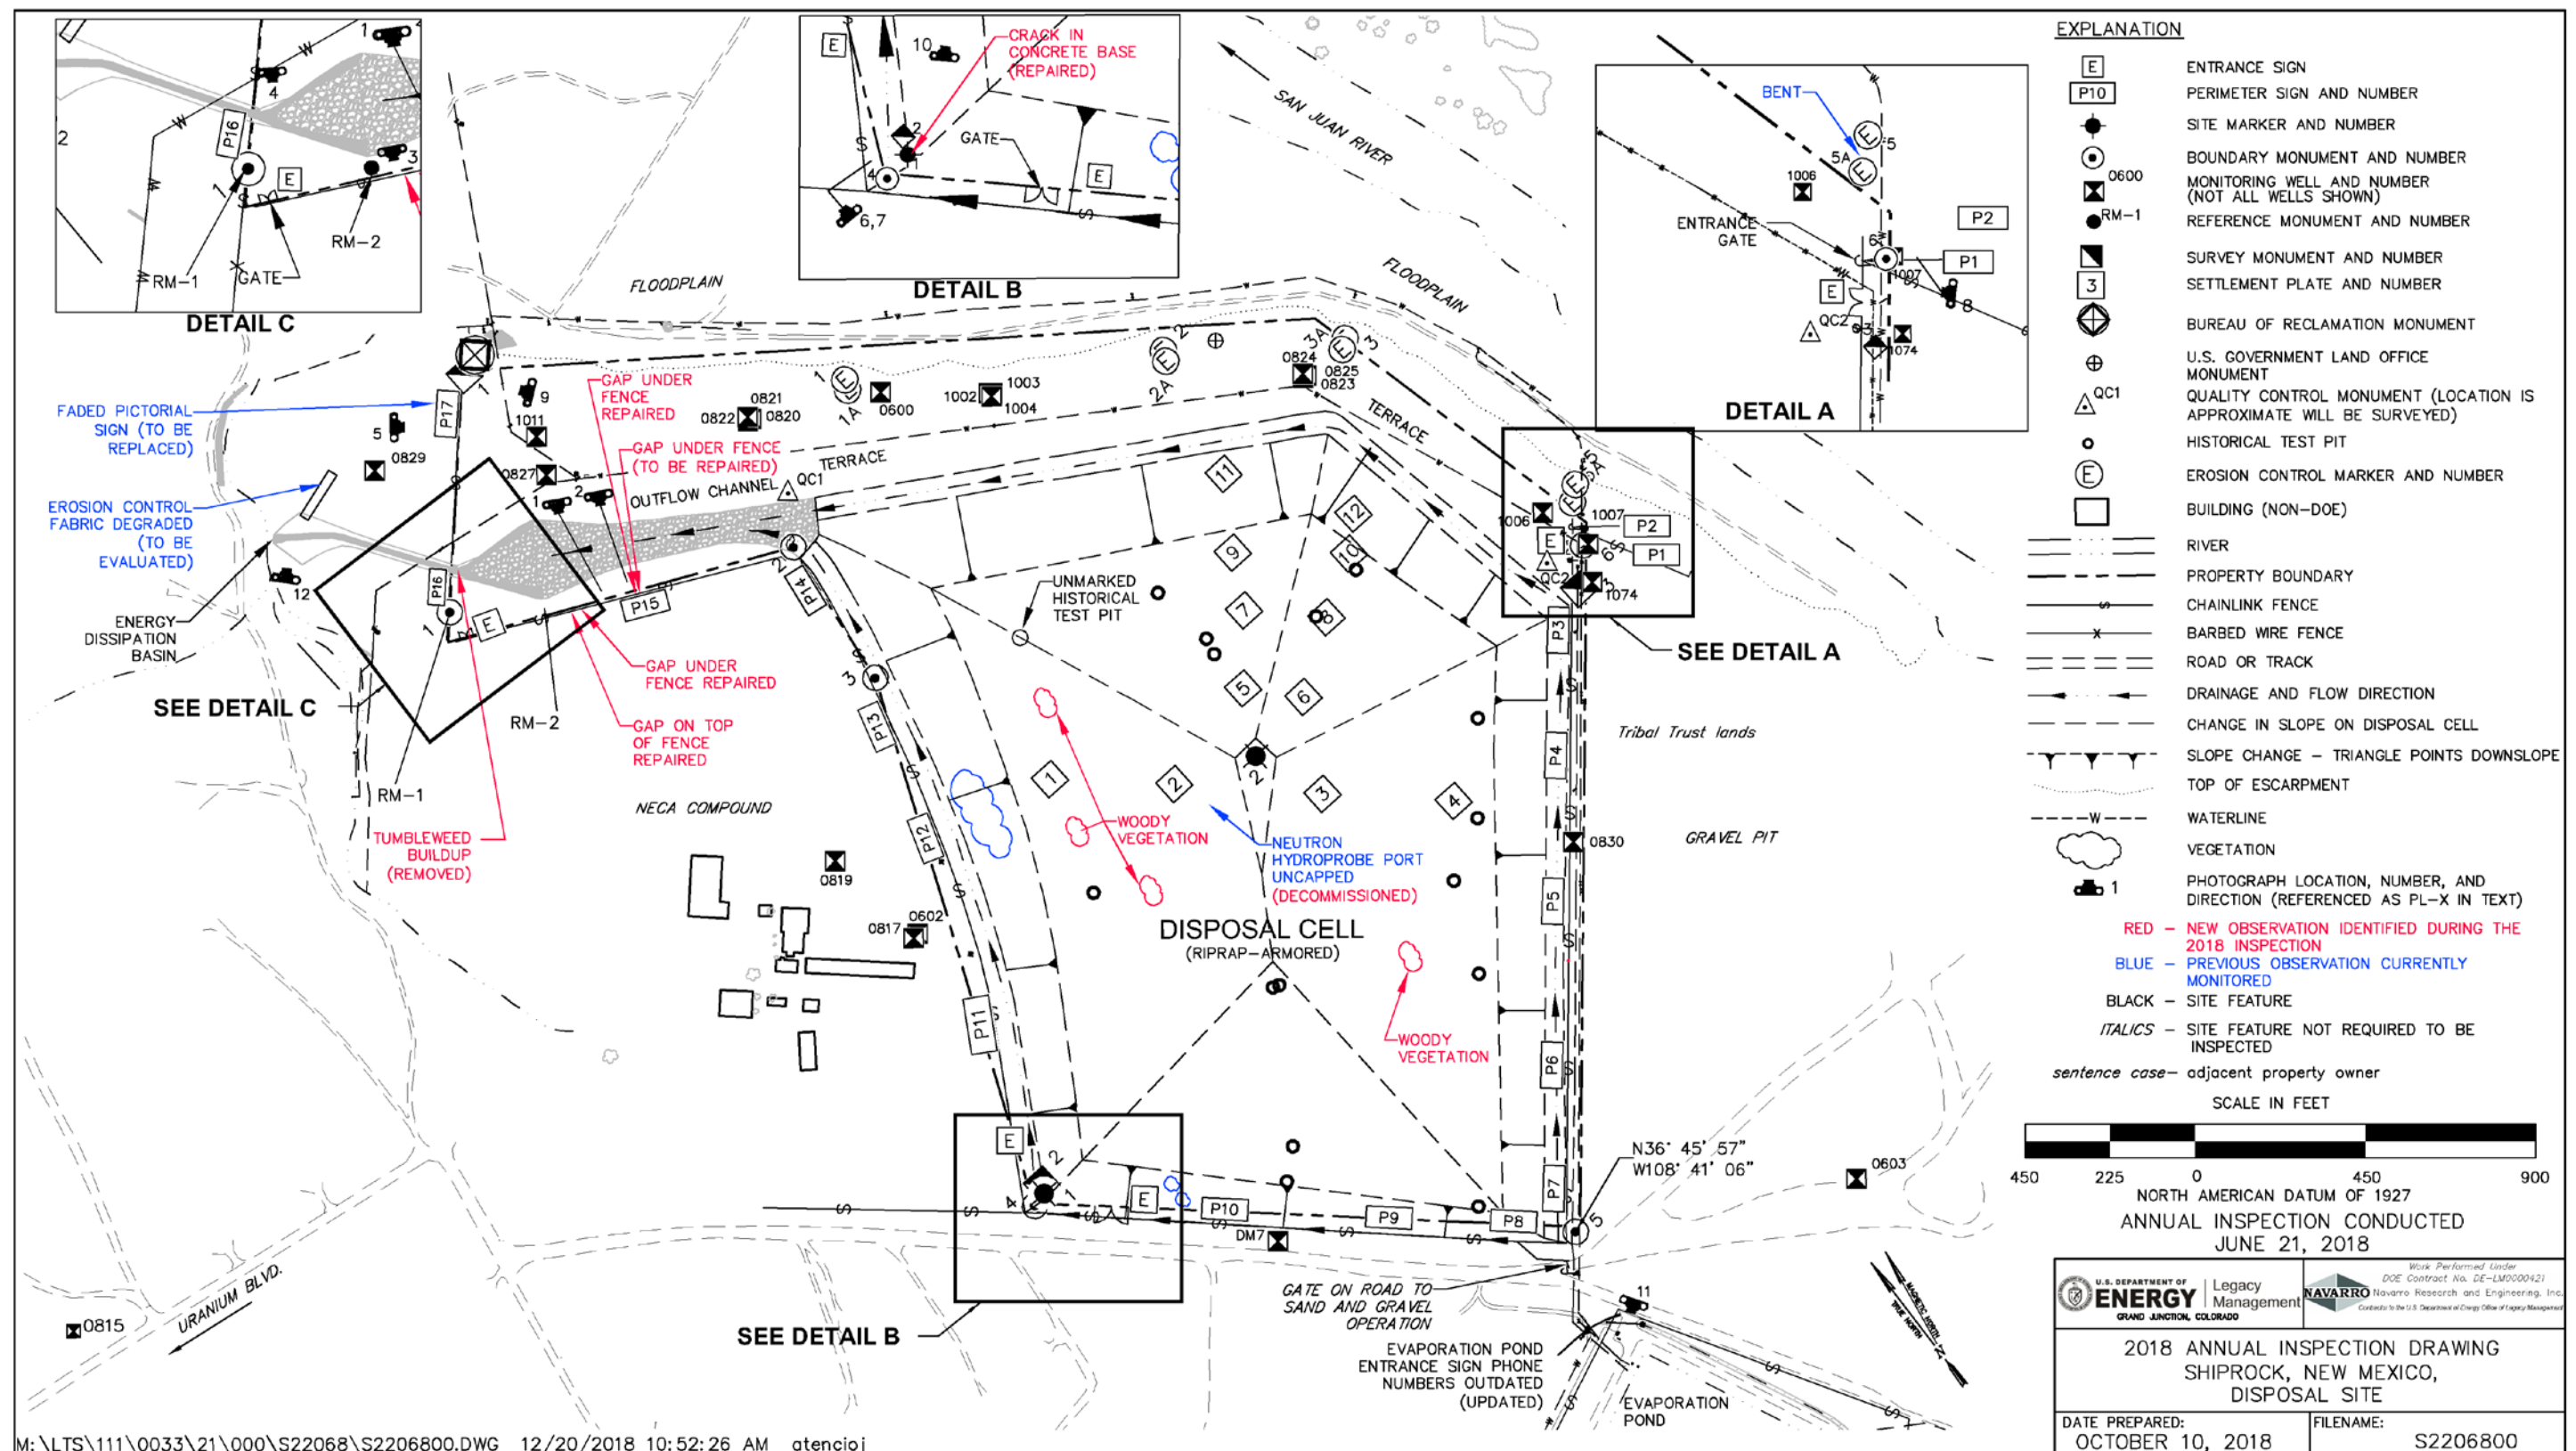
Figure 16-1. 2018 Annual Inspection Drawing for the Shiprock, New Mexico, Disposal Site

Figure 16-1 shows the locations of site features in black, including site surveillance features and inspection areas. Site features that are present but not required to be inspected are shown in italic font. Observations from previous inspections that are currently monitored are shown in blue text, and new observations identified during the 2018 annual inspection are shown in red. Inspection results and recommended maintenance activities associated with site surveillance features are described in the following subsections. Photographs to support specific observations are identified in the text and in Figure 16-1 by photograph location (PL) numbers. The photographs and photograph log are presented in Section 16.10.

In May 2018, before the inspection, five permanent quality-control monuments were installed at the site in preparation for a baseline aerial survey of the disposal cell. The quality control monument locations are shown in Figure 16-1. No maintenance needs were identified.
