16.0 Shiprock, New Mexico, Disposal Site

16.1 Compliance Summary

Figure 16-1. 2019 Annual Inspection Drawing for the Shiprock, New Mexico, Disposal Site

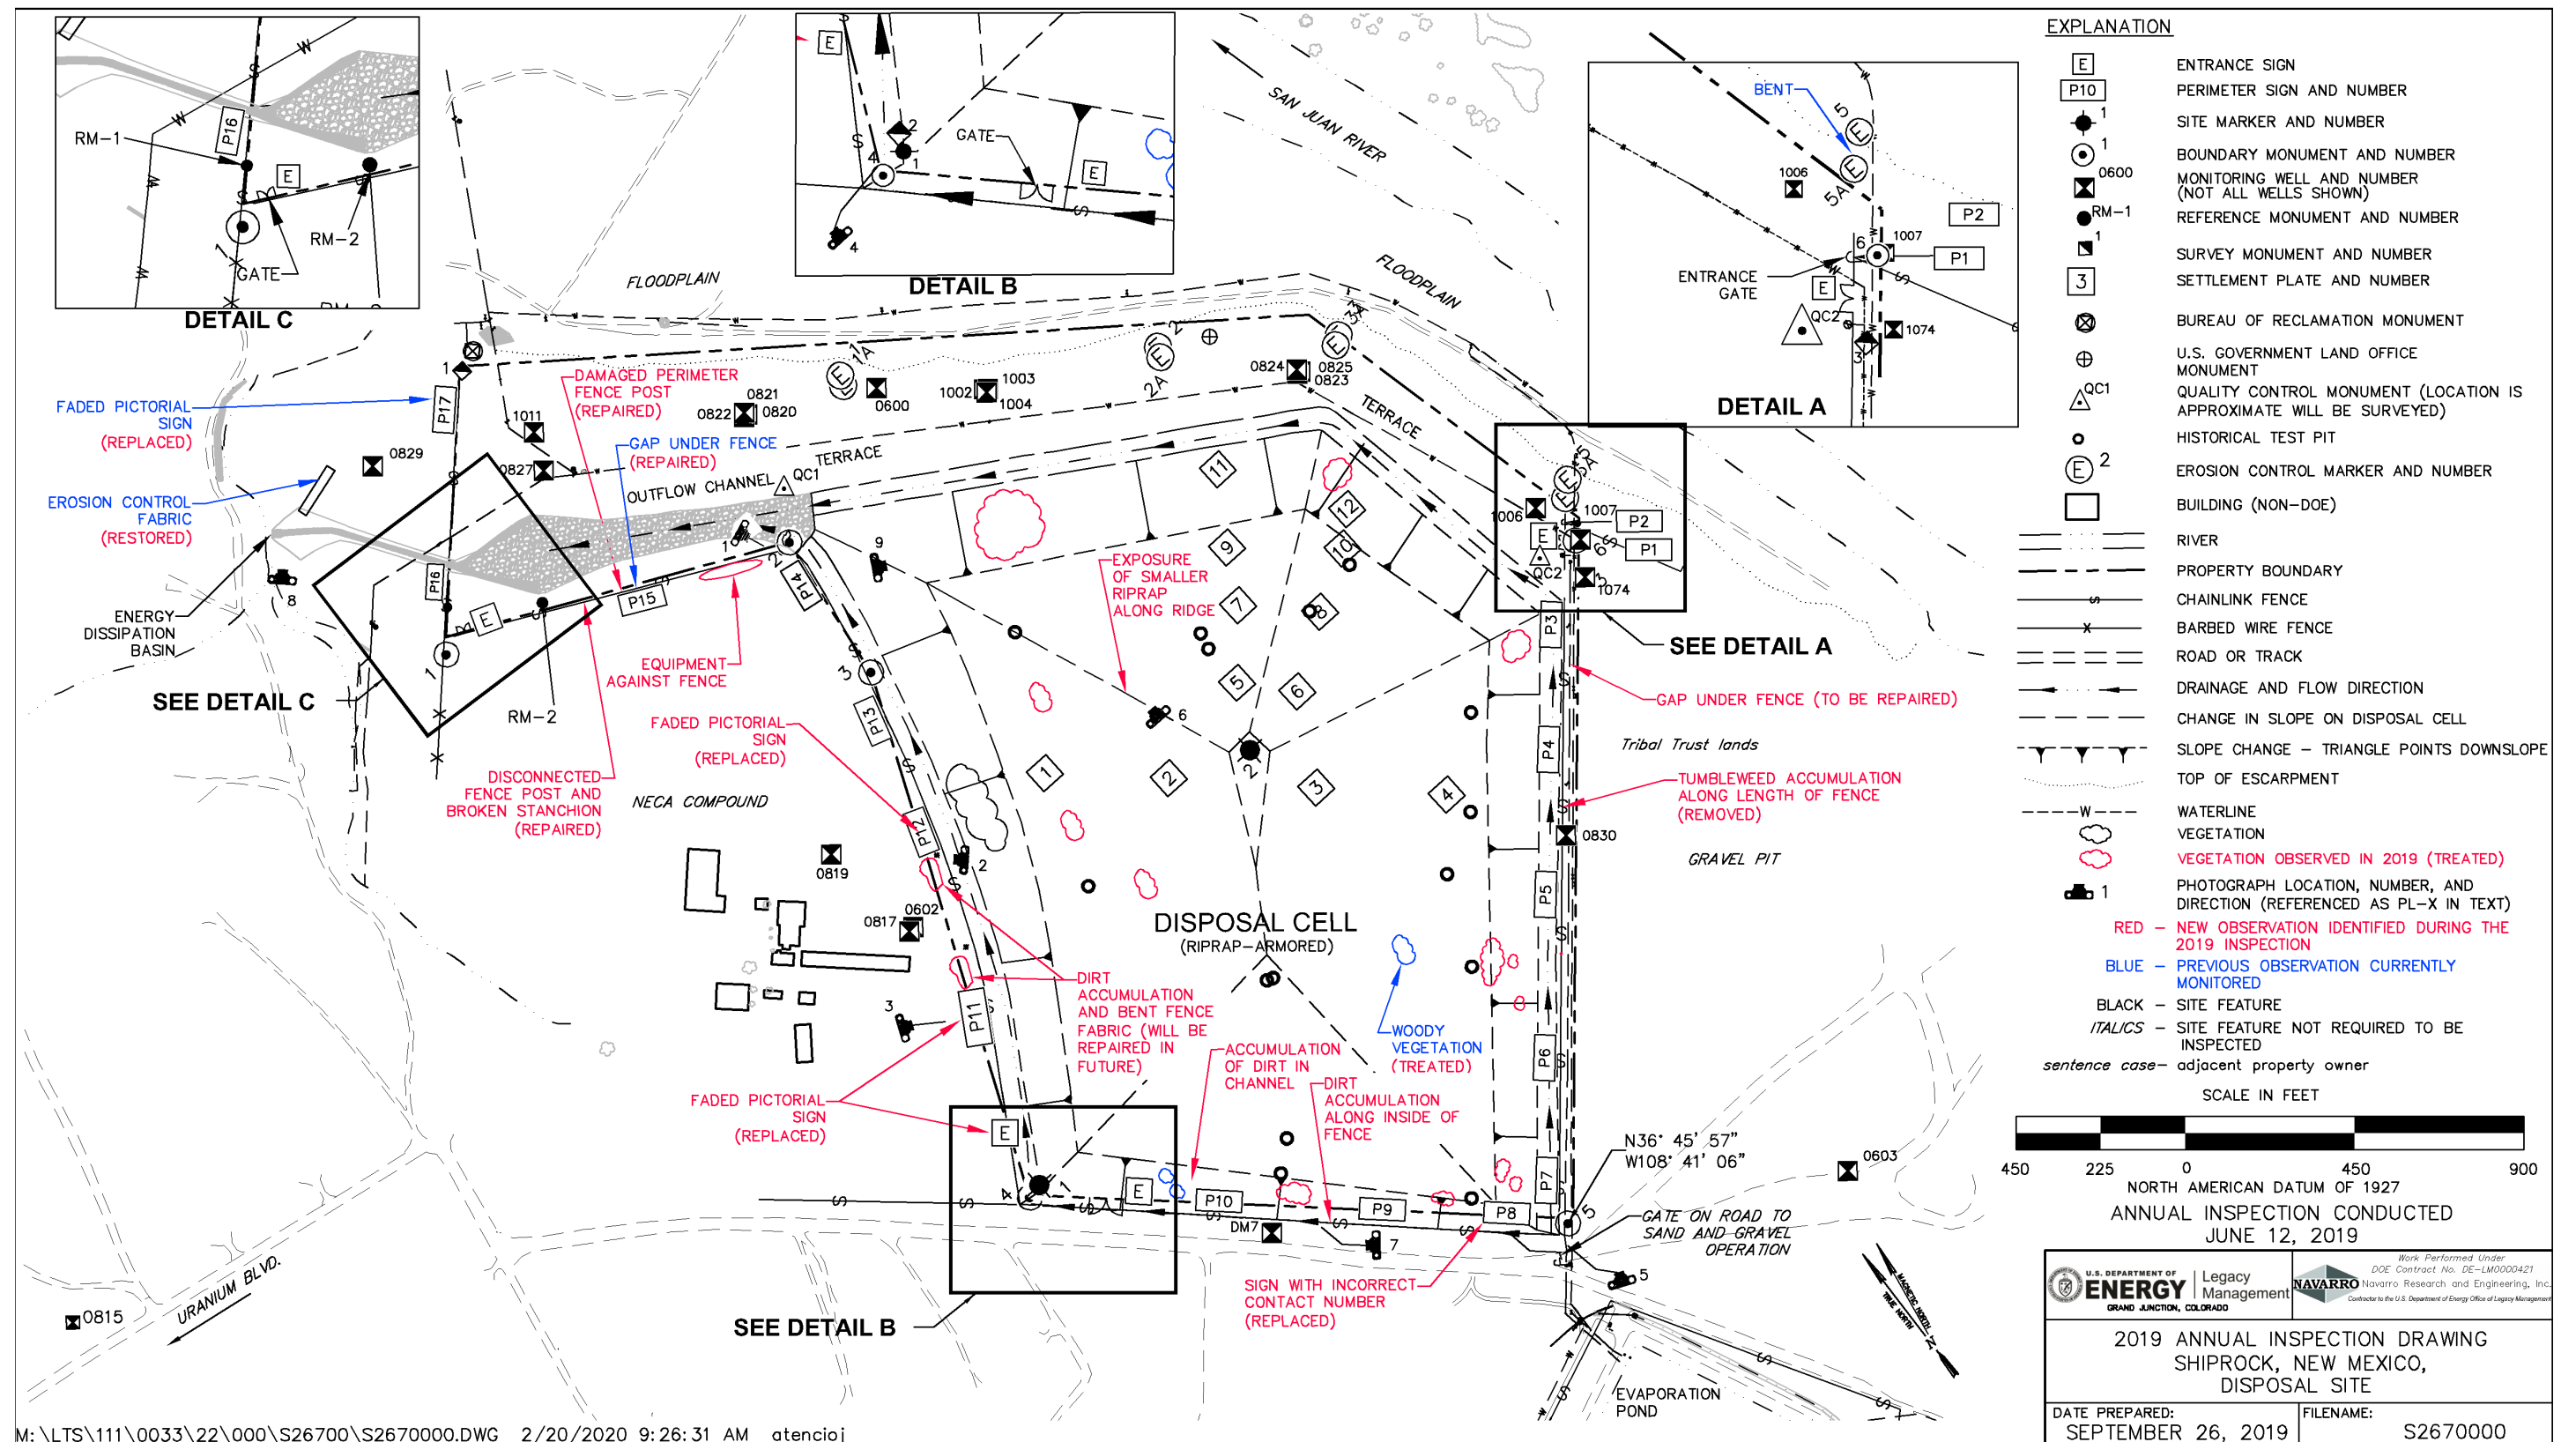
Figure 16-1 shows the locations of site features in black, including site surveillance features and inspection areas. Site features that are present but not required to be inspected are shown in italic font. Observations from previous inspections that are currently monitored are shown in blue text, and new observations identified during the 2019 annual inspection are shown in red. Inspection results and recommended maintenance activities associated with site surveillance features are included in the following subsections. Photographs to support specific observations are identified in the text and in Figure 16-1 by photograph location (PL) numbers. The photographs and photograph log are presented in Section 16.10.
