2023 Annual Inspection Report for the DOE Monticello, Utah, Mill Tailings Site and Monticello Vicinity Properties

February 2024

Legacy
Management

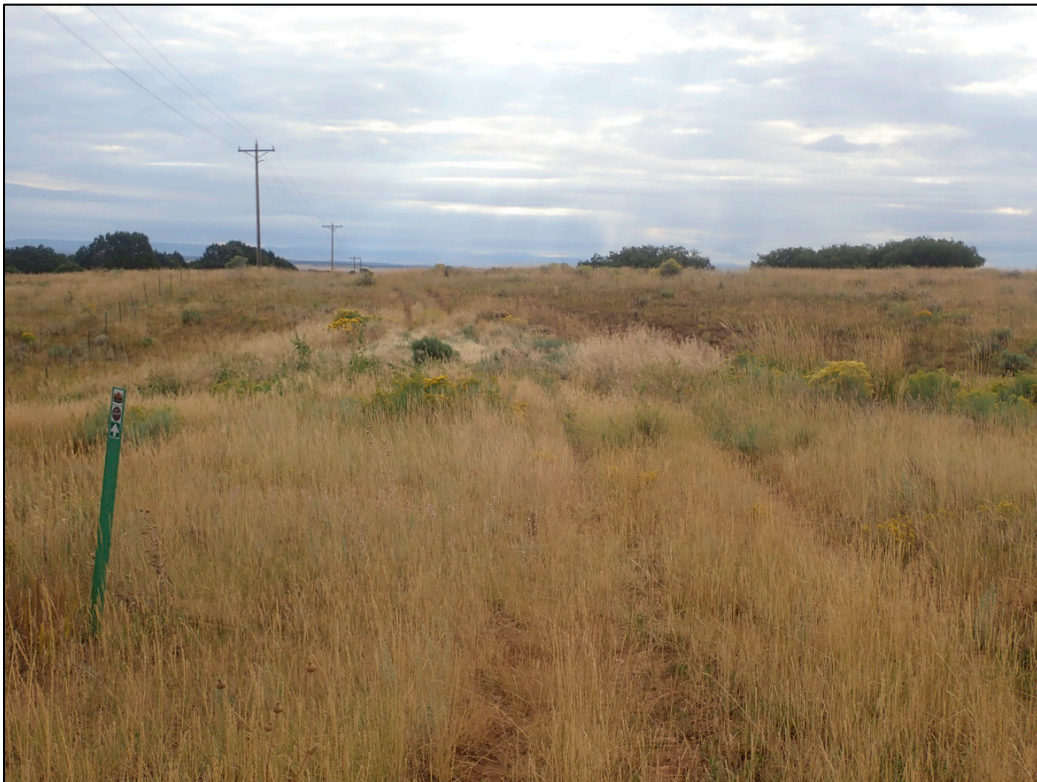
PL-25. Access Road near Deer Draw Dam

All riprap-armored structures, dams, check dams, berms, and runoff control drainages (Figure 4) were intact and functional. PL-25 shows a portion of the access road near Deer Draw Dam. The photograph illustrates the well-vegetated and intact soils that characterize the city-owned properties.
