**2023 Annual Land-Use Covenant
Inspection Report
for DOE Areas at the
Laboratory for Energy-Related
Health Research/Old Campus
Landfill Superfund Site
University of California, Davis**

January 2024

U.S. DEPARTMENT OF
ENERGY

Legacy
Management

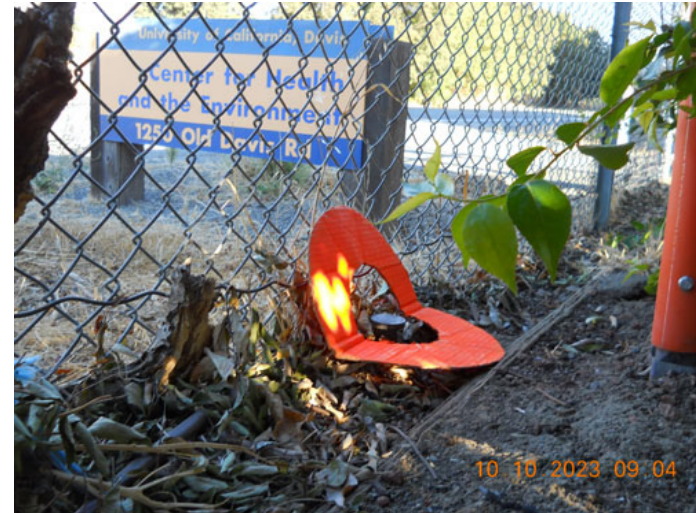
*View Northwest: Survey Monument 1 Within Orange Ring
(outside diameter, 14 inches); West Perimeter Fence and Center
for Health and the Environment Entrance Sign in Background
(Photo No. 4940)*

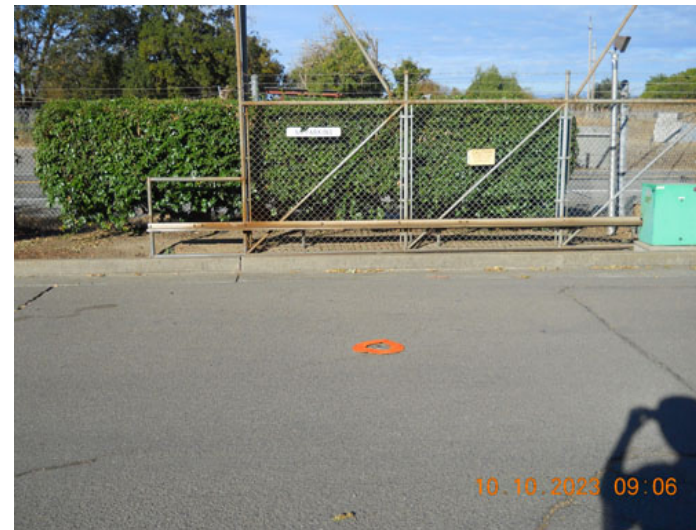
*View West: Survey Monument 2 Within Orange Ring; Retracted
Entrance Gate in Background (Photo No. 4941)*

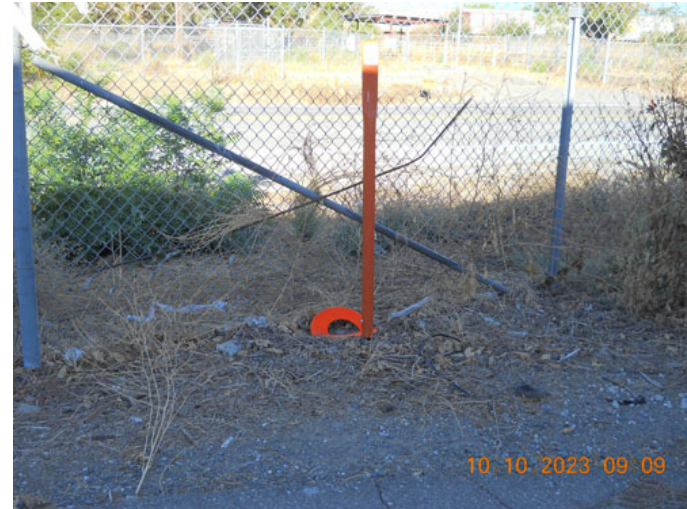
*View Northwest: Survey Monument 3 Within Orange Ring; West
Perimeter Fence Behind Survey Monument; Old Davis Road in
Background (Photo No. 4944)*

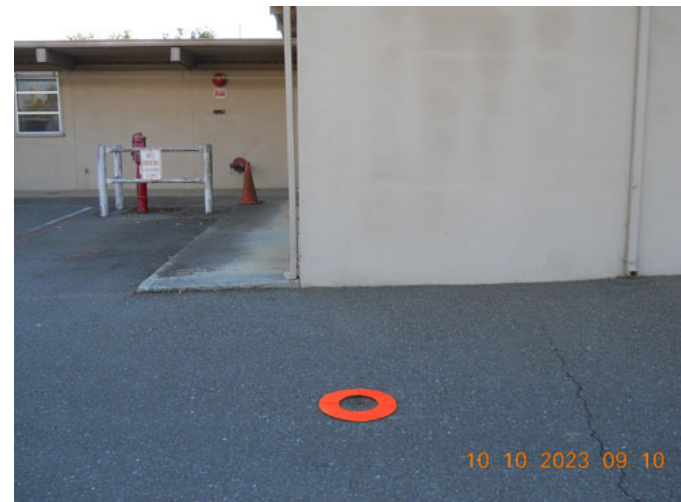
*View East: Survey Monument 4 Within Orange Ring;
Building H-219 in Background (Photo No. 4945)*

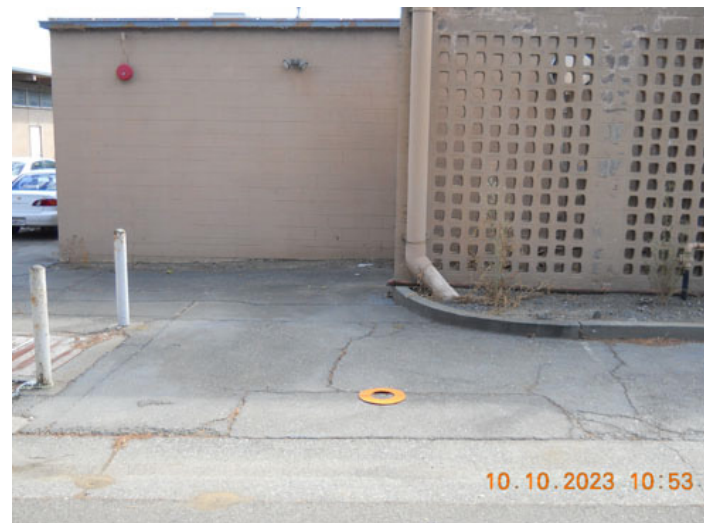
*View East: Survey Monument 5 Within Orange Ring;
Building H-215 in Background (Photo No. 4975)*

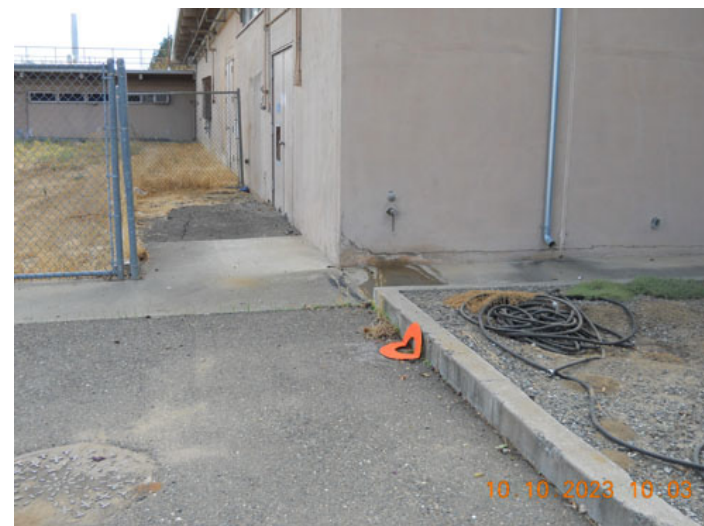
*View East: Survey Monument 6 Within Orange Ring; Corner of
Building H-218 in Background (Photo No. 4957)*

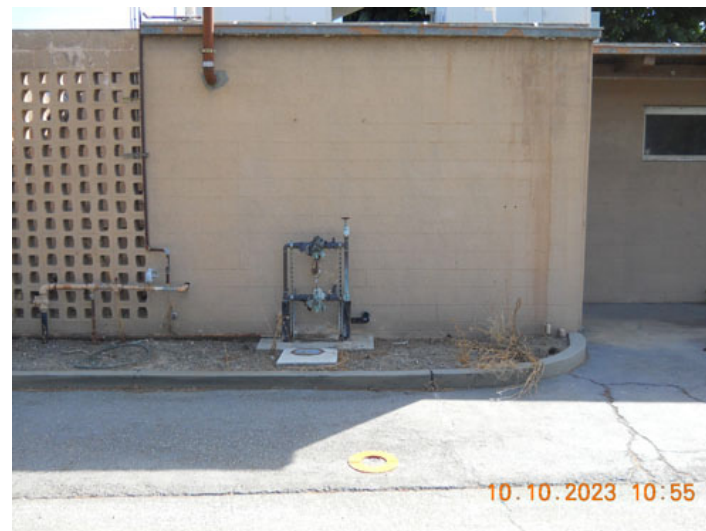
*View East: Survey Monument 7 Within Orange Ring;
Building H-215 in Background (Photo No. 4977)*

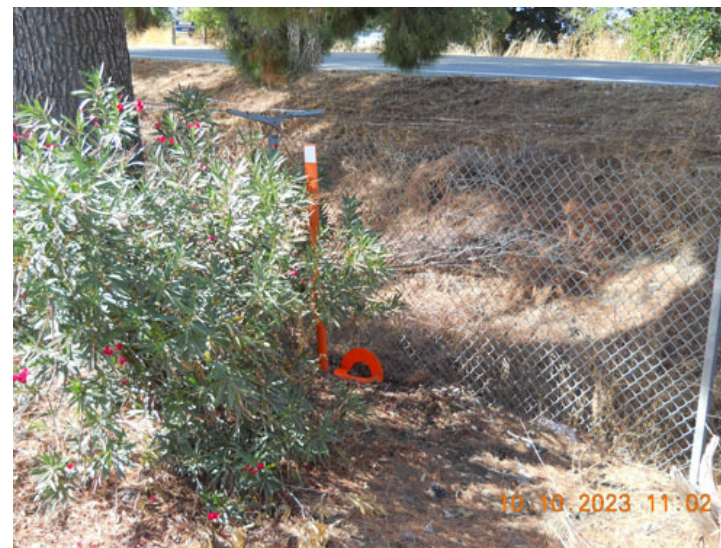
*View Southwest: Survey Monument 8 Within Orange Ring;
West Perimeter Fence Behind Survey Monument;
Old Davis Road in Background (Photo No. 4982)*

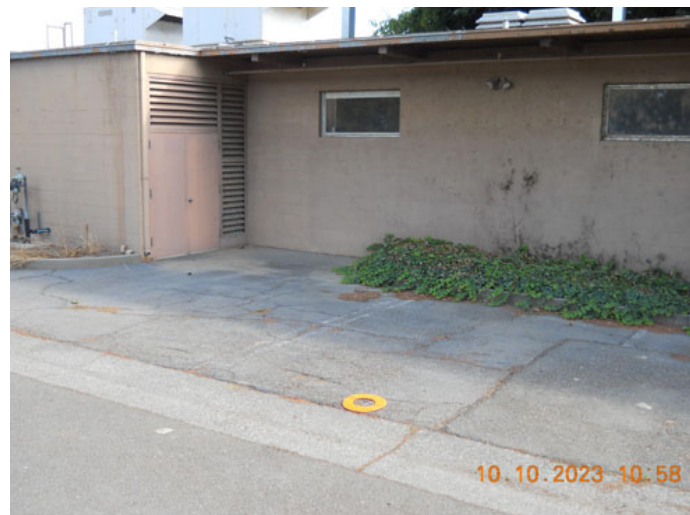
*View Northeast: Survey Monument 9 Within Orange Ring;
Building H-215 in Background (Photo No. 4979)*

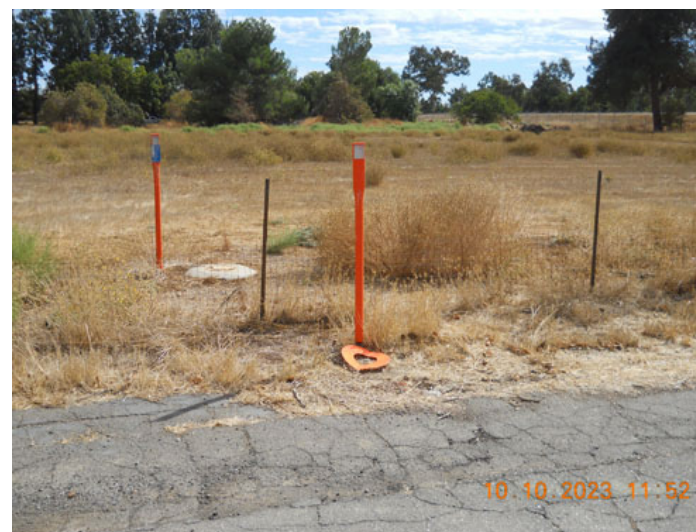
*View Southeast: Survey Monument 10 Within Orange Ring;
Delineator Behind Survey Monument;
EDPs Area in Background (Photo No. 5003)*

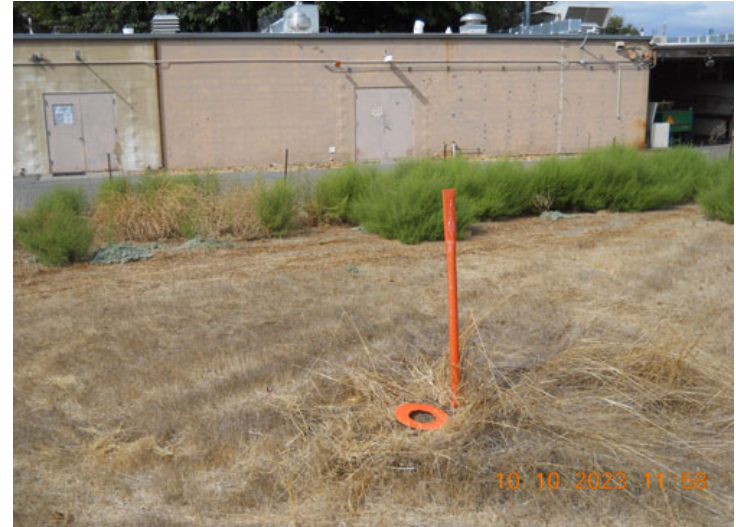
View Northeast: Survey Monument 11 Within Orange Ring; Delineator Right of Survey Monument; Building H-216 in Background (Photo No. 5006)

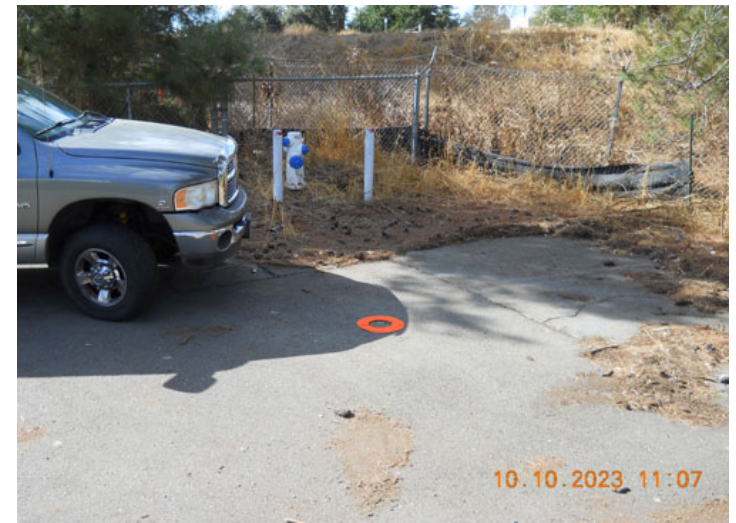
View Southwest: Survey Monument 12 Within Orange Ring in Center; Water Hydrant in Background (Photo No. 4984)

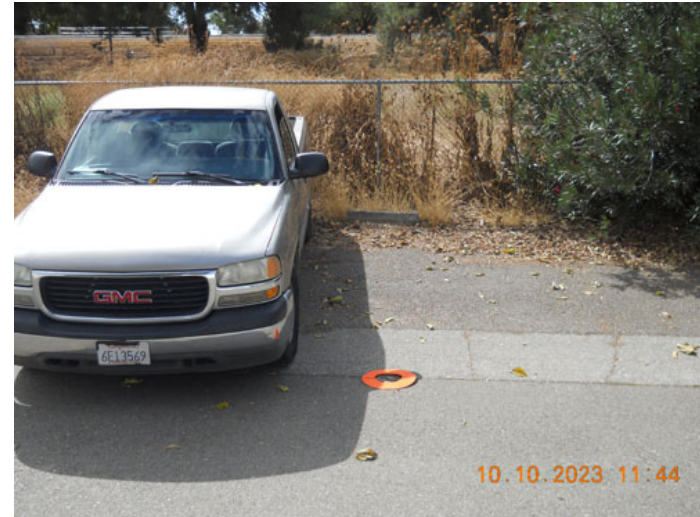
*View South: Survey Monument 13 Within Orange Ring at
Edge of Concrete Swale; Southwest
Trenches Area in Background (Photo No. 4997)*

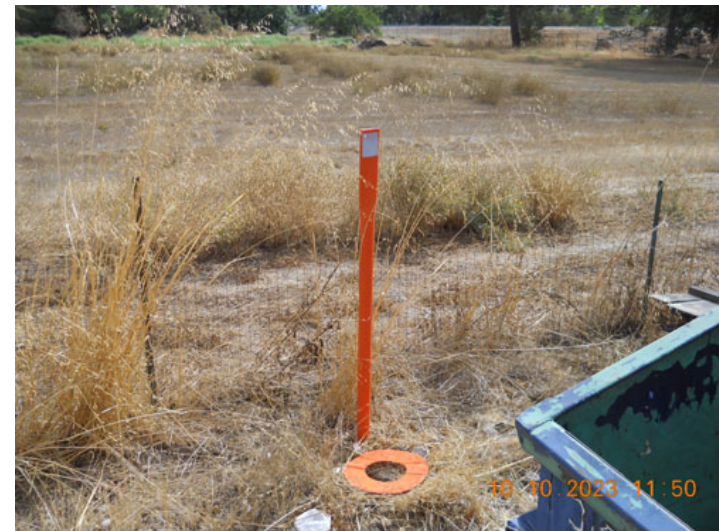
*View Southeast: Survey Monument 14 Within Orange Ring;
Delineator Behind Survey Monument; Western Dog Pens and
Southern Trenches Areas in Background (Photo No. 5001)*

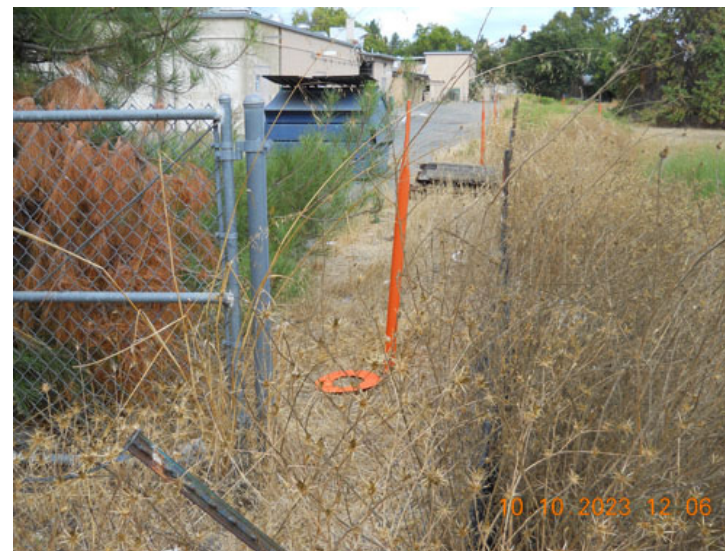
*View North: Survey Monument 15 Within Orange Ring;
Delineator Right of Survey Monument; Building H-216 in Top Left
(Photo No. 5008)*

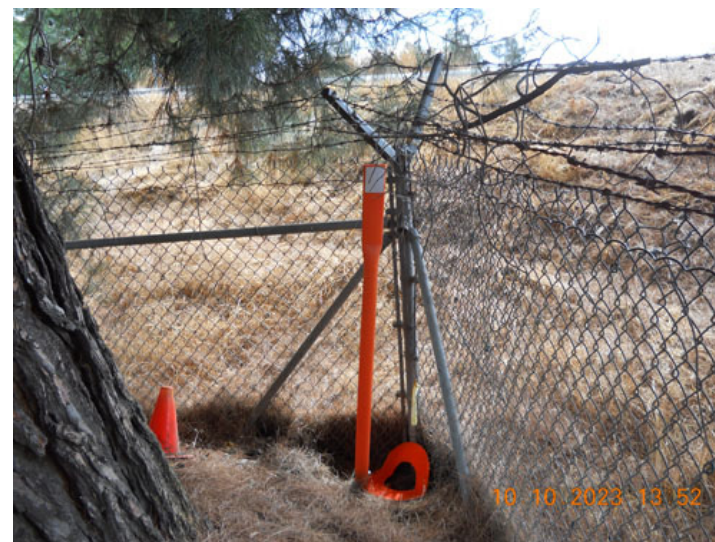
*View Southwest: Survey Monument 16 Within Orange Ring;
Delineator Left of Survey Monument; Southwest Corner of Perimeter
Fence Behind Survey Monument (Photo No. 5033)*

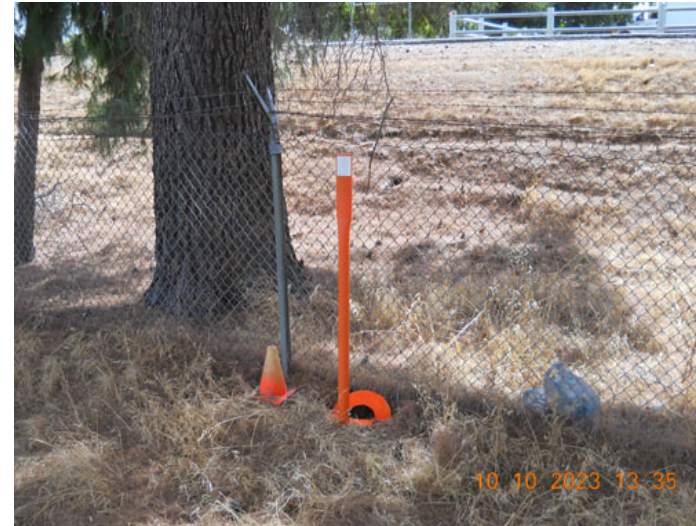
*View Southeast: Survey Monument 17 Within Orange Ring;
Delineator Left of Survey Monument; South Perimeter Fence
Behind Survey Monument; North Levee in Background
(Photo No. 5021)*

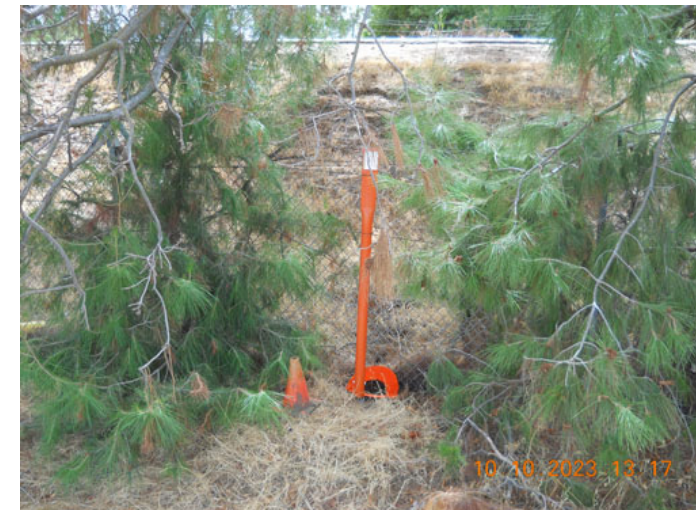
*View South: Survey Monument 18 Within Orange Ring;
Delineator Left of Survey Monument; South Perimeter Fence
Behind Survey Monument; North Levee in Background
(Photo No. 5015)*

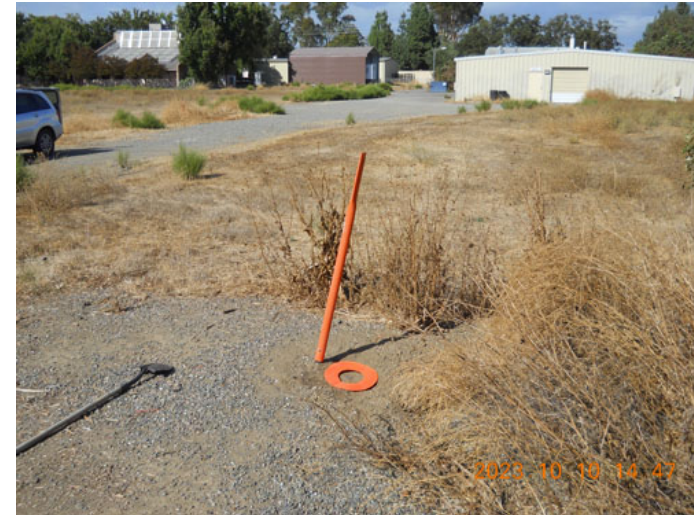
*View North: Survey Monument 19 Within Orange Ring;
Delineator Left of Survey Monument; Geriatrics Building 1 in Upper
Right (Photo No. 5045)*

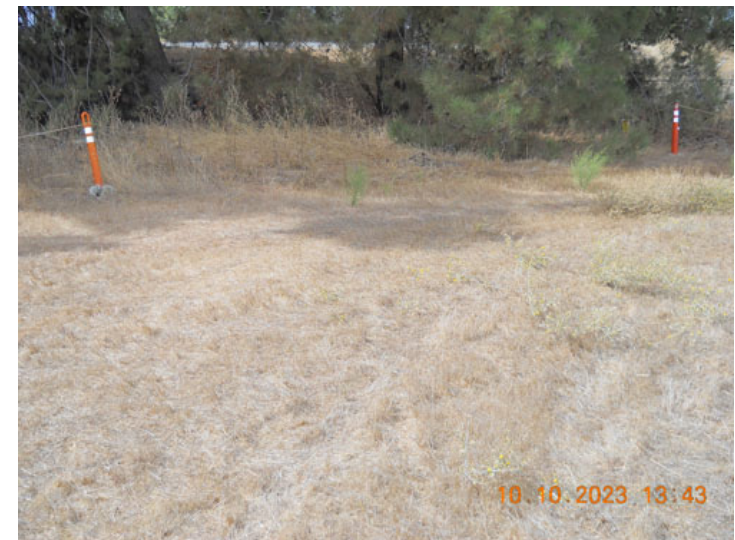
View West from Center of SWT Area; Stanchions and Rope Surrounding Fallen Limbs from Trees 16219 and 16220 in Upper Right and Upper Left of Photo, Respectively (Photo No. 5026)

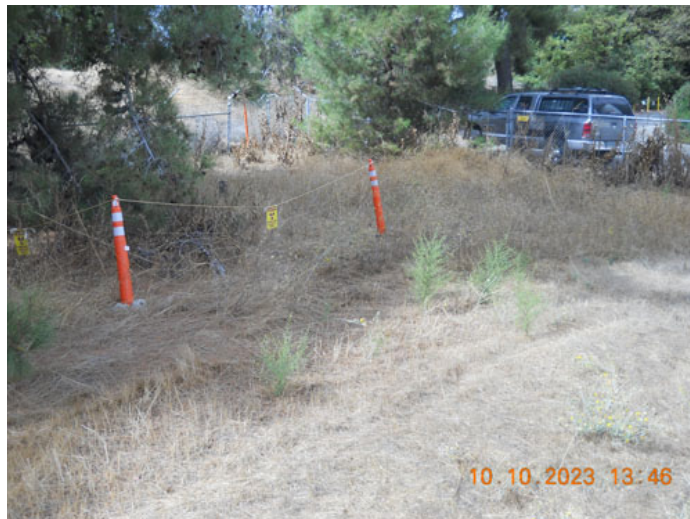
View North of Northwest Corner of SWT Area; Tree 16219 Fallen Limb Behind Stanchions, Posting, and Rope in Upper Left of Photo (Photo No. 5029)

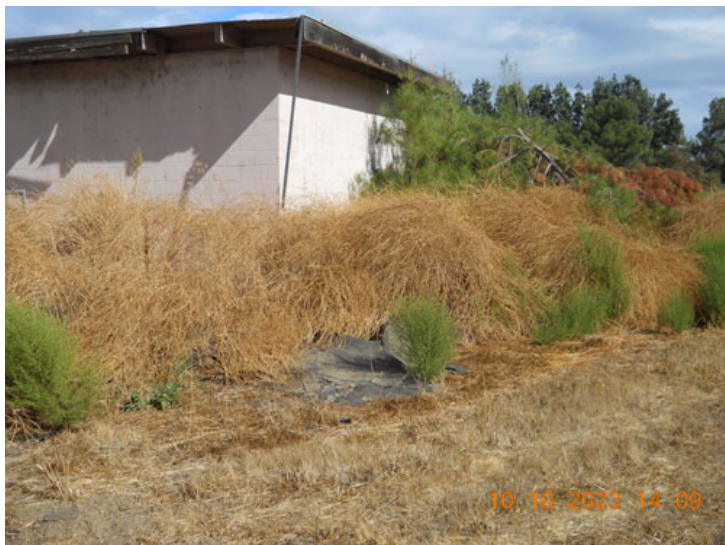
View Northeast from Northeast Corner of SWT Area; Former Washdown Pad Roofing Material in Center of Photo (Photo No. 5036)

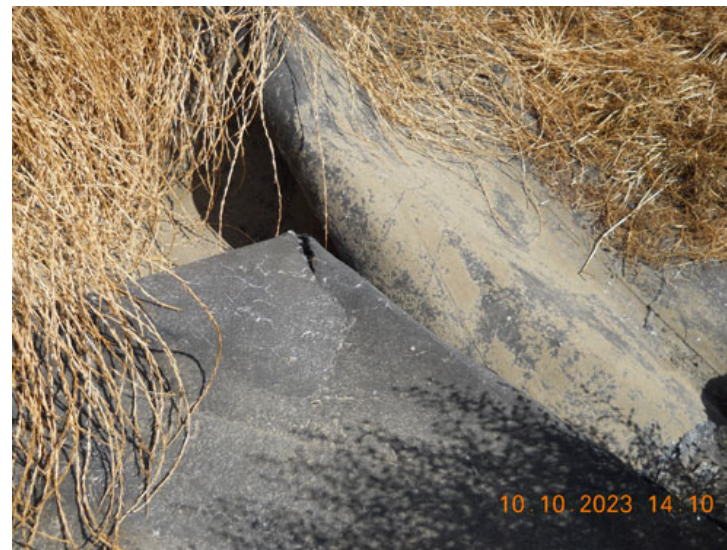
View Northeast from Northeast Corner of SWT Area; Former Washdown Pad Roofing Material in Center of Photo (Photo No. 5037)

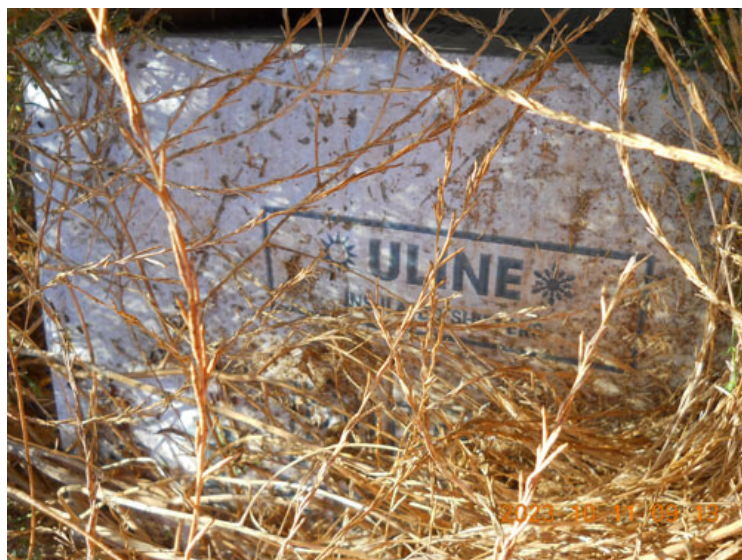
View Northeast from Northeast Corner of SWT Area; Box Found in Southwest Trenches Area, Center (Photo No. 5093)

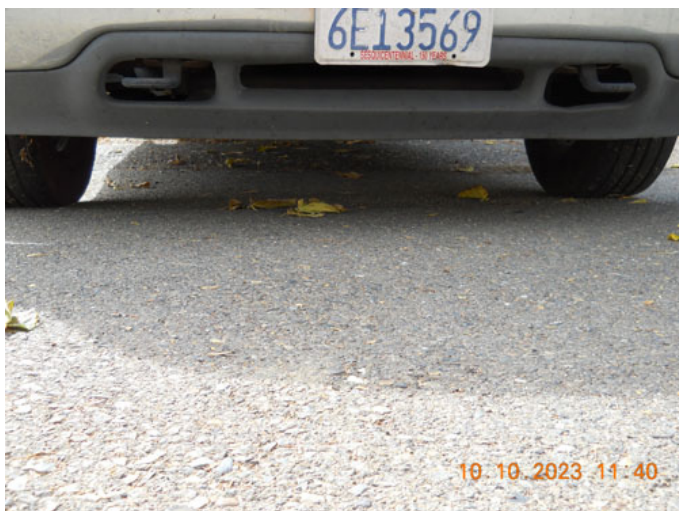
View South Below Vehicle Parked Partially Over South Boundary of DSS 3 Area Leach Field at Time of Inspection; Adjacent/East of Monument 13: (Photo No. 4995)

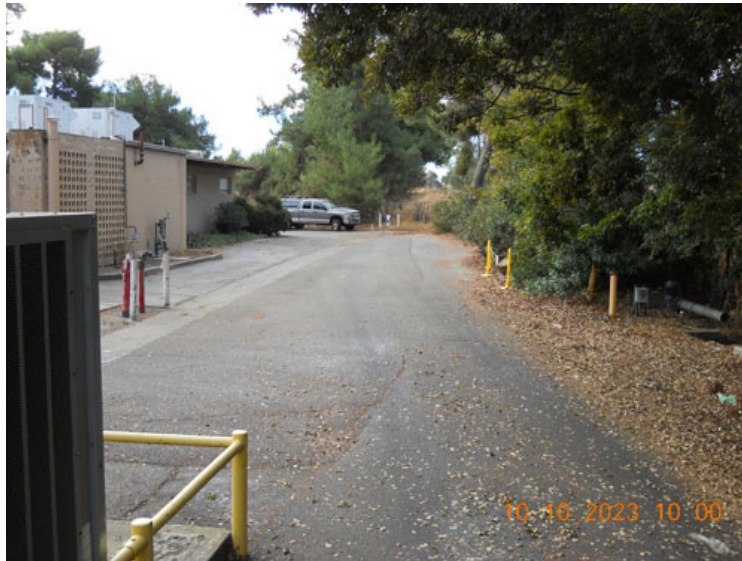
*View South of Southern Portion of Ra/Sr Treatment Systems Area:
Building H-215, Left (Photo No. 4956)*

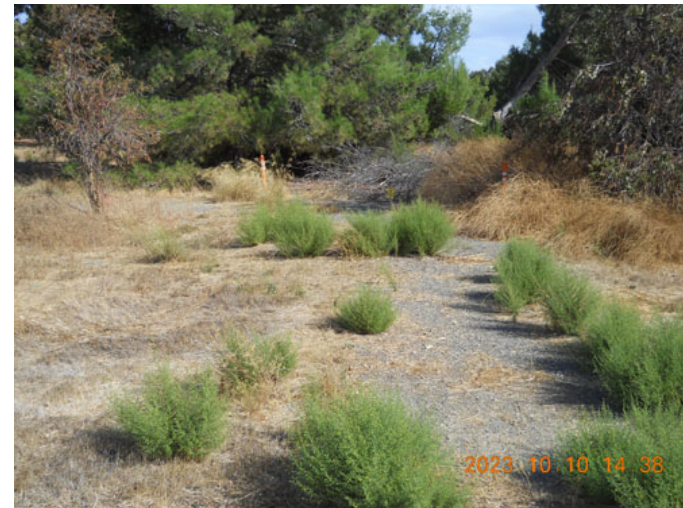
*View East of EDPs Area; Tree 16236 Fallen Limb in Upper Center,
Behind Stanchions and Rope (Photo No. 5043)*

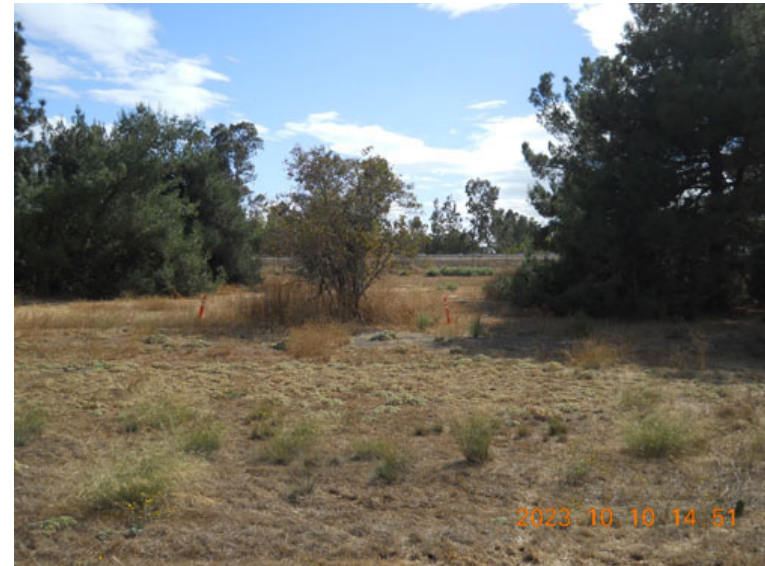
View South of EDPs Area; Shrub 16233 with Small Fallen Limbs in Center of Photo Behind Stanchions and Rope (Photo No. 5047)

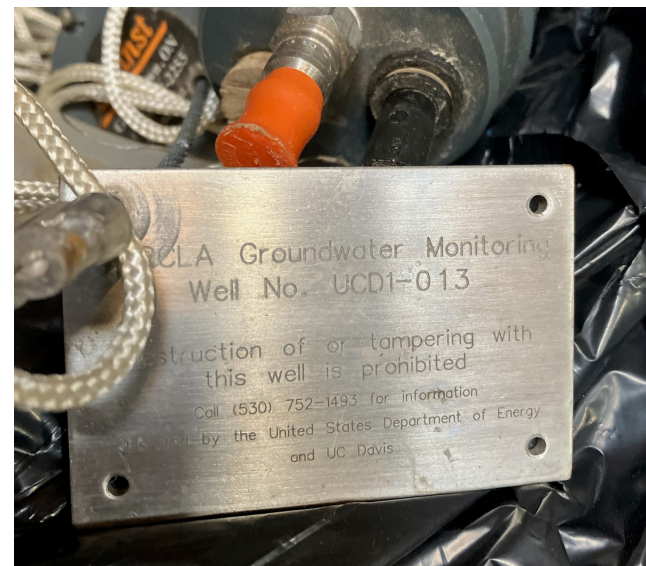
UCD1-013 Interior ID Plate Temporarily Stored with Pump in UC Davis Interim Removal Action Treatment System Building (Photo No. IMG_0384)

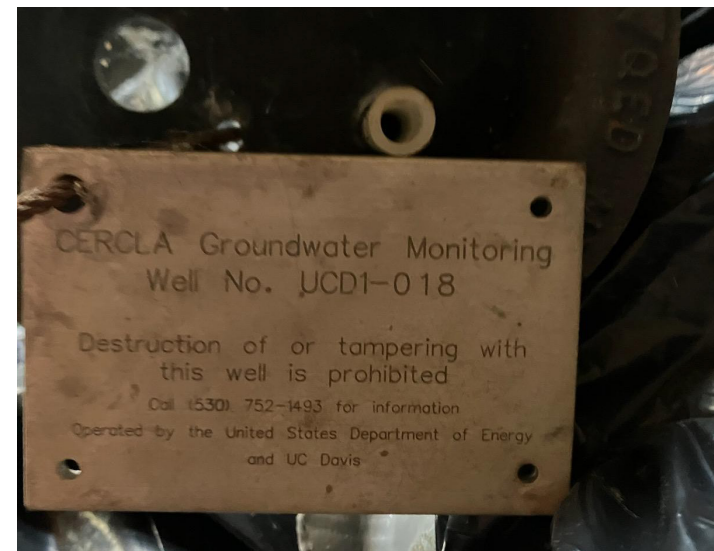
UCD1-018 Interior ID Plate Temporarily Stored with Pump in UC Davis Interim Removal Action Treatment System Building; (Photo No. IMG_0385)

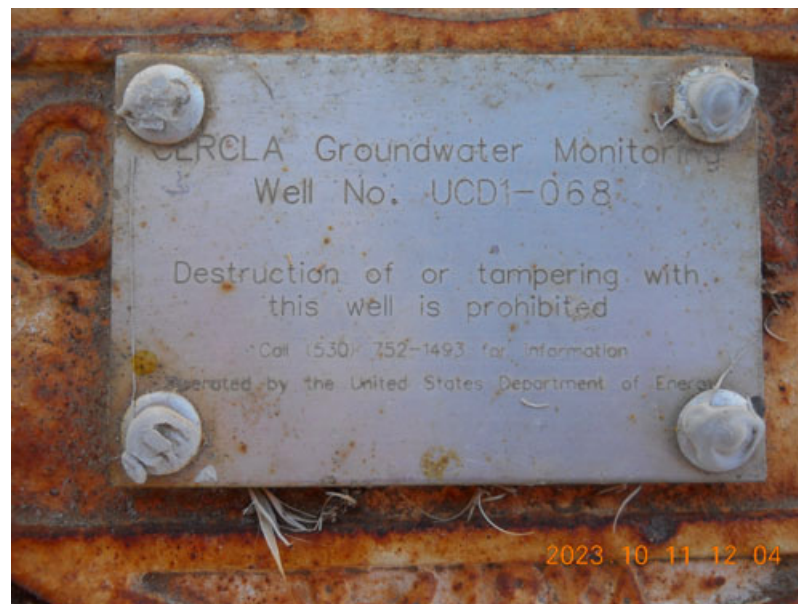
UCD1-068 Wellhead ID Plate (Photo No. 5152)

Well UCD1-072 identification plate within vault does not have attachment cable	10/11/2023	Repair planned: Install stainless steel attachment cable to identification plate	TBD	NA
Wells UCD1-068 and UCD1-073: Pump controller port plug missing	10/11/2023	Repair planned: Install new pump controller port plug	TBD	NA
