2010 Annual Inspection and Status Report for the Hallam, Nebraska, Decommissioned Reactor Site

This report presents the findings of the annual U.S. Department of Energy (DOE) inspection of the decommissioned Hallam, Nebraska, Reactor Site on April 28, 2010.

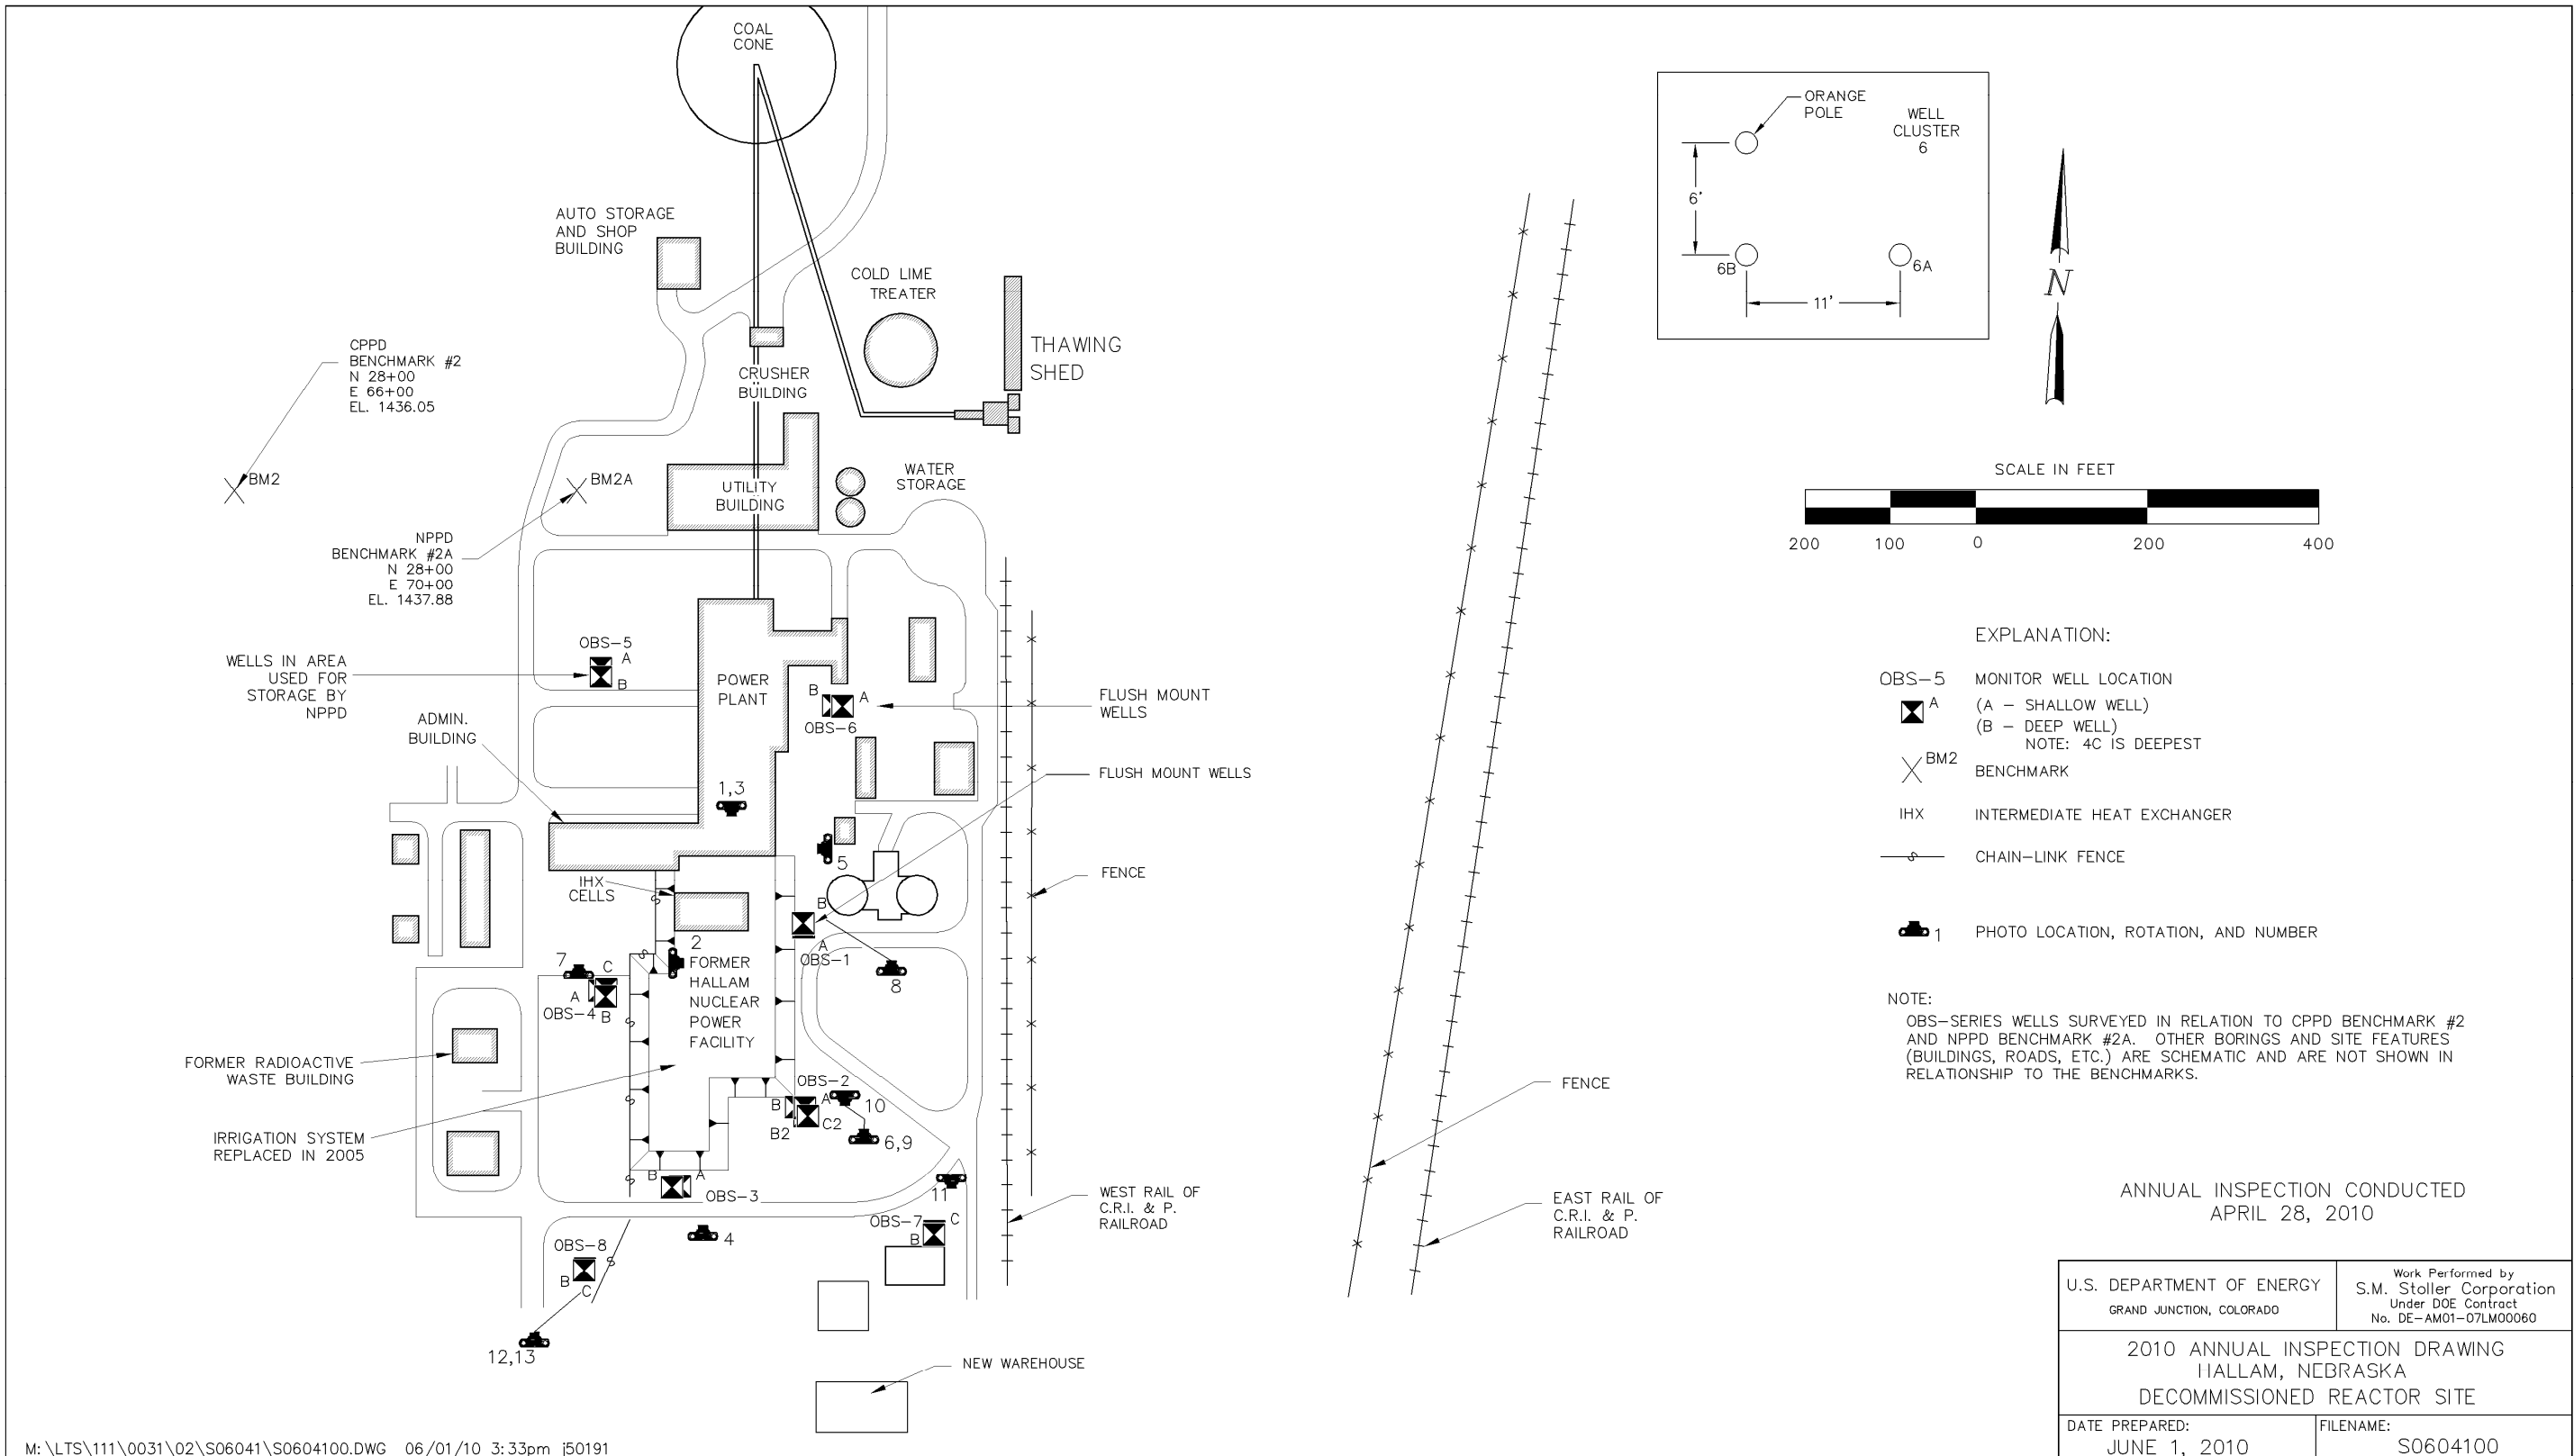
7. The southwest and northeast corners of the concrete pad at monitoring wells OBS-8A, OBS-8B, and OBS-8C are cracked (page 4).

PL-12	NA	Southwest corner of the concrete pad at wells OBS-8B and OBS-8C is cracked.
PL-13	205	Northeast corner of the concrete pad at Wells OBS-8B and OBS-8C is cracked.

HAL 4/2010. PL-13. Northeast corner of the concrete pad at Wells OBS-8B and OBS-8C is cracked.

Recommendation: It is recommended that the corners of the well pad at monitoring wells OBS-8A, B, and C be repaired.
