2011 Annual Inspection and Status Report for the Hallam, Nebraska, Decommissioned Reactor Site

This report presents the findings of the annual U.S. Department of Energy (DOE) inspection of the decommissioned Hallam, Nebraska, Reactor Site on April 27, 2011.

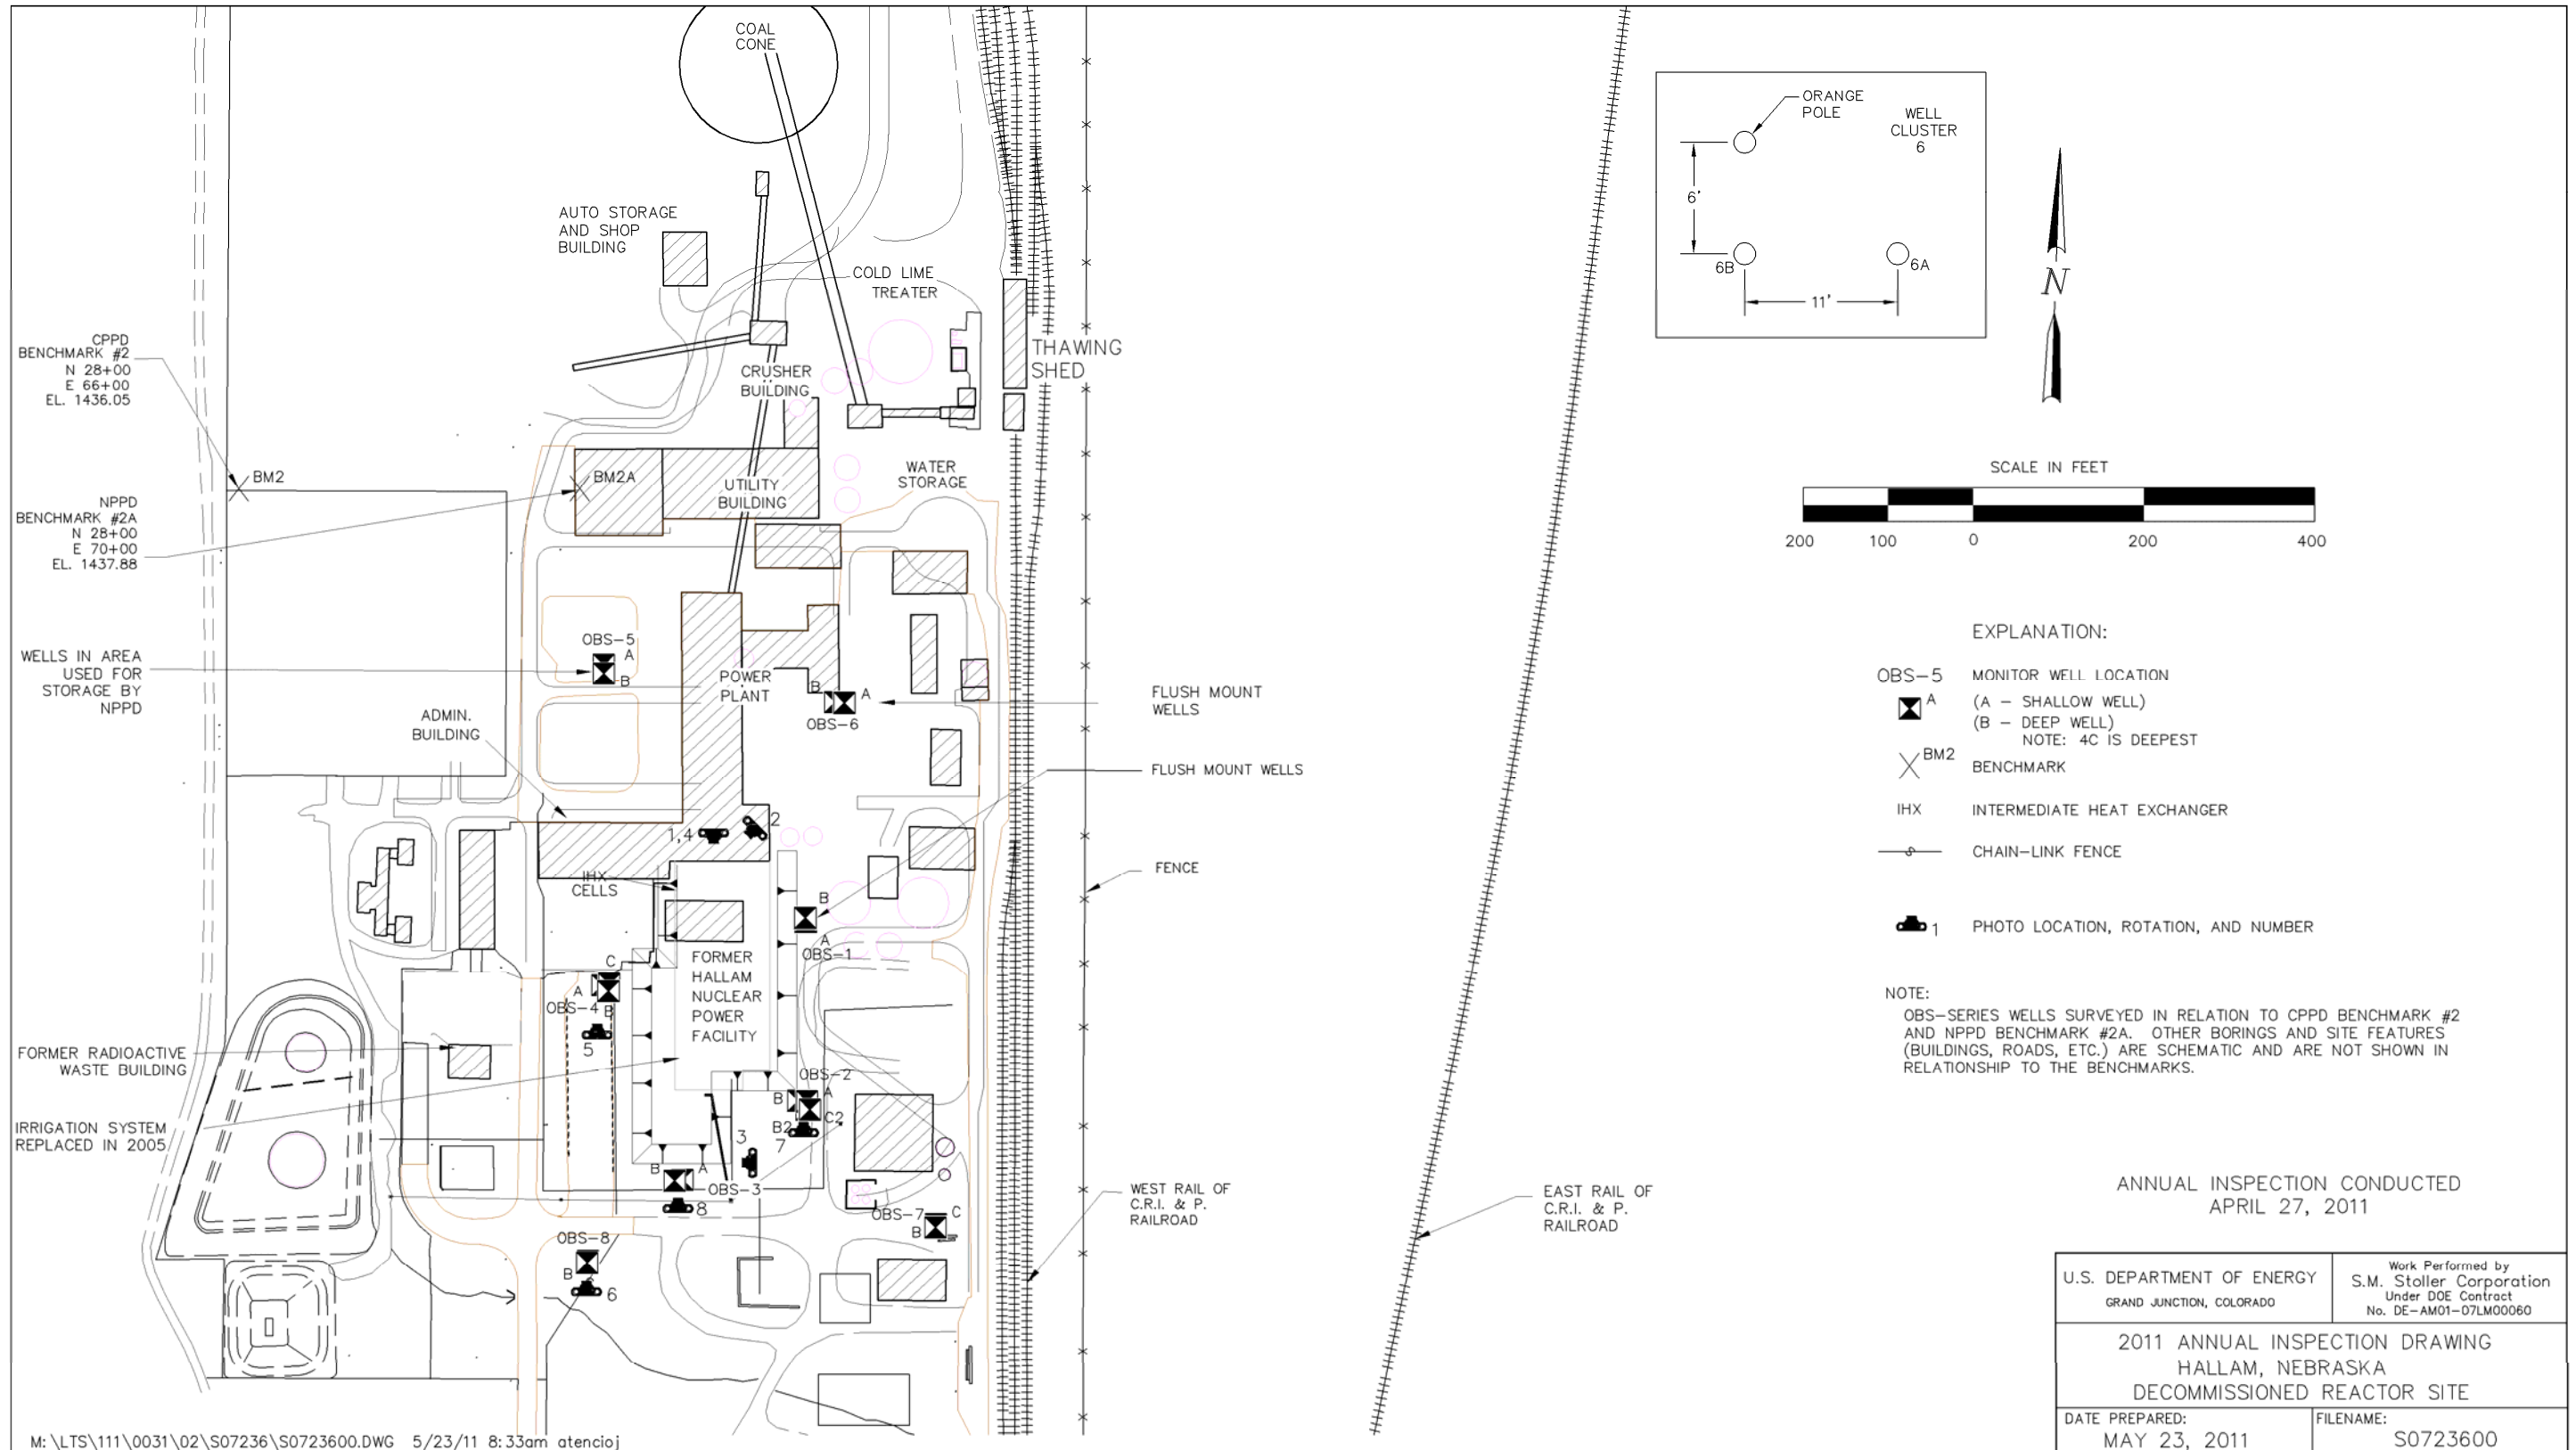
HAL 4/2011. PL-8. Monitoring Well OBS-3B.

- Monitoring wells 6A and 6B need to be re-labeled.
- The replacement hinges on the protective casing lids of monitoring wells OBS-2A and OBS-2B allow the protective casing lids to be partially opened when locked.
- The protective casing lid of monitoring well OBS-3B is functional but needs to be replaced.
