2014 Annual Inspection and Status Report for the Hallam, Nebraska, Decommissioned Reactor Site

This report presents the findings of the annual U.S. Department of Energy (DOE) inspection of the decommissioned Hallam, Nebraska, Reactor Site on April 8, 2014.

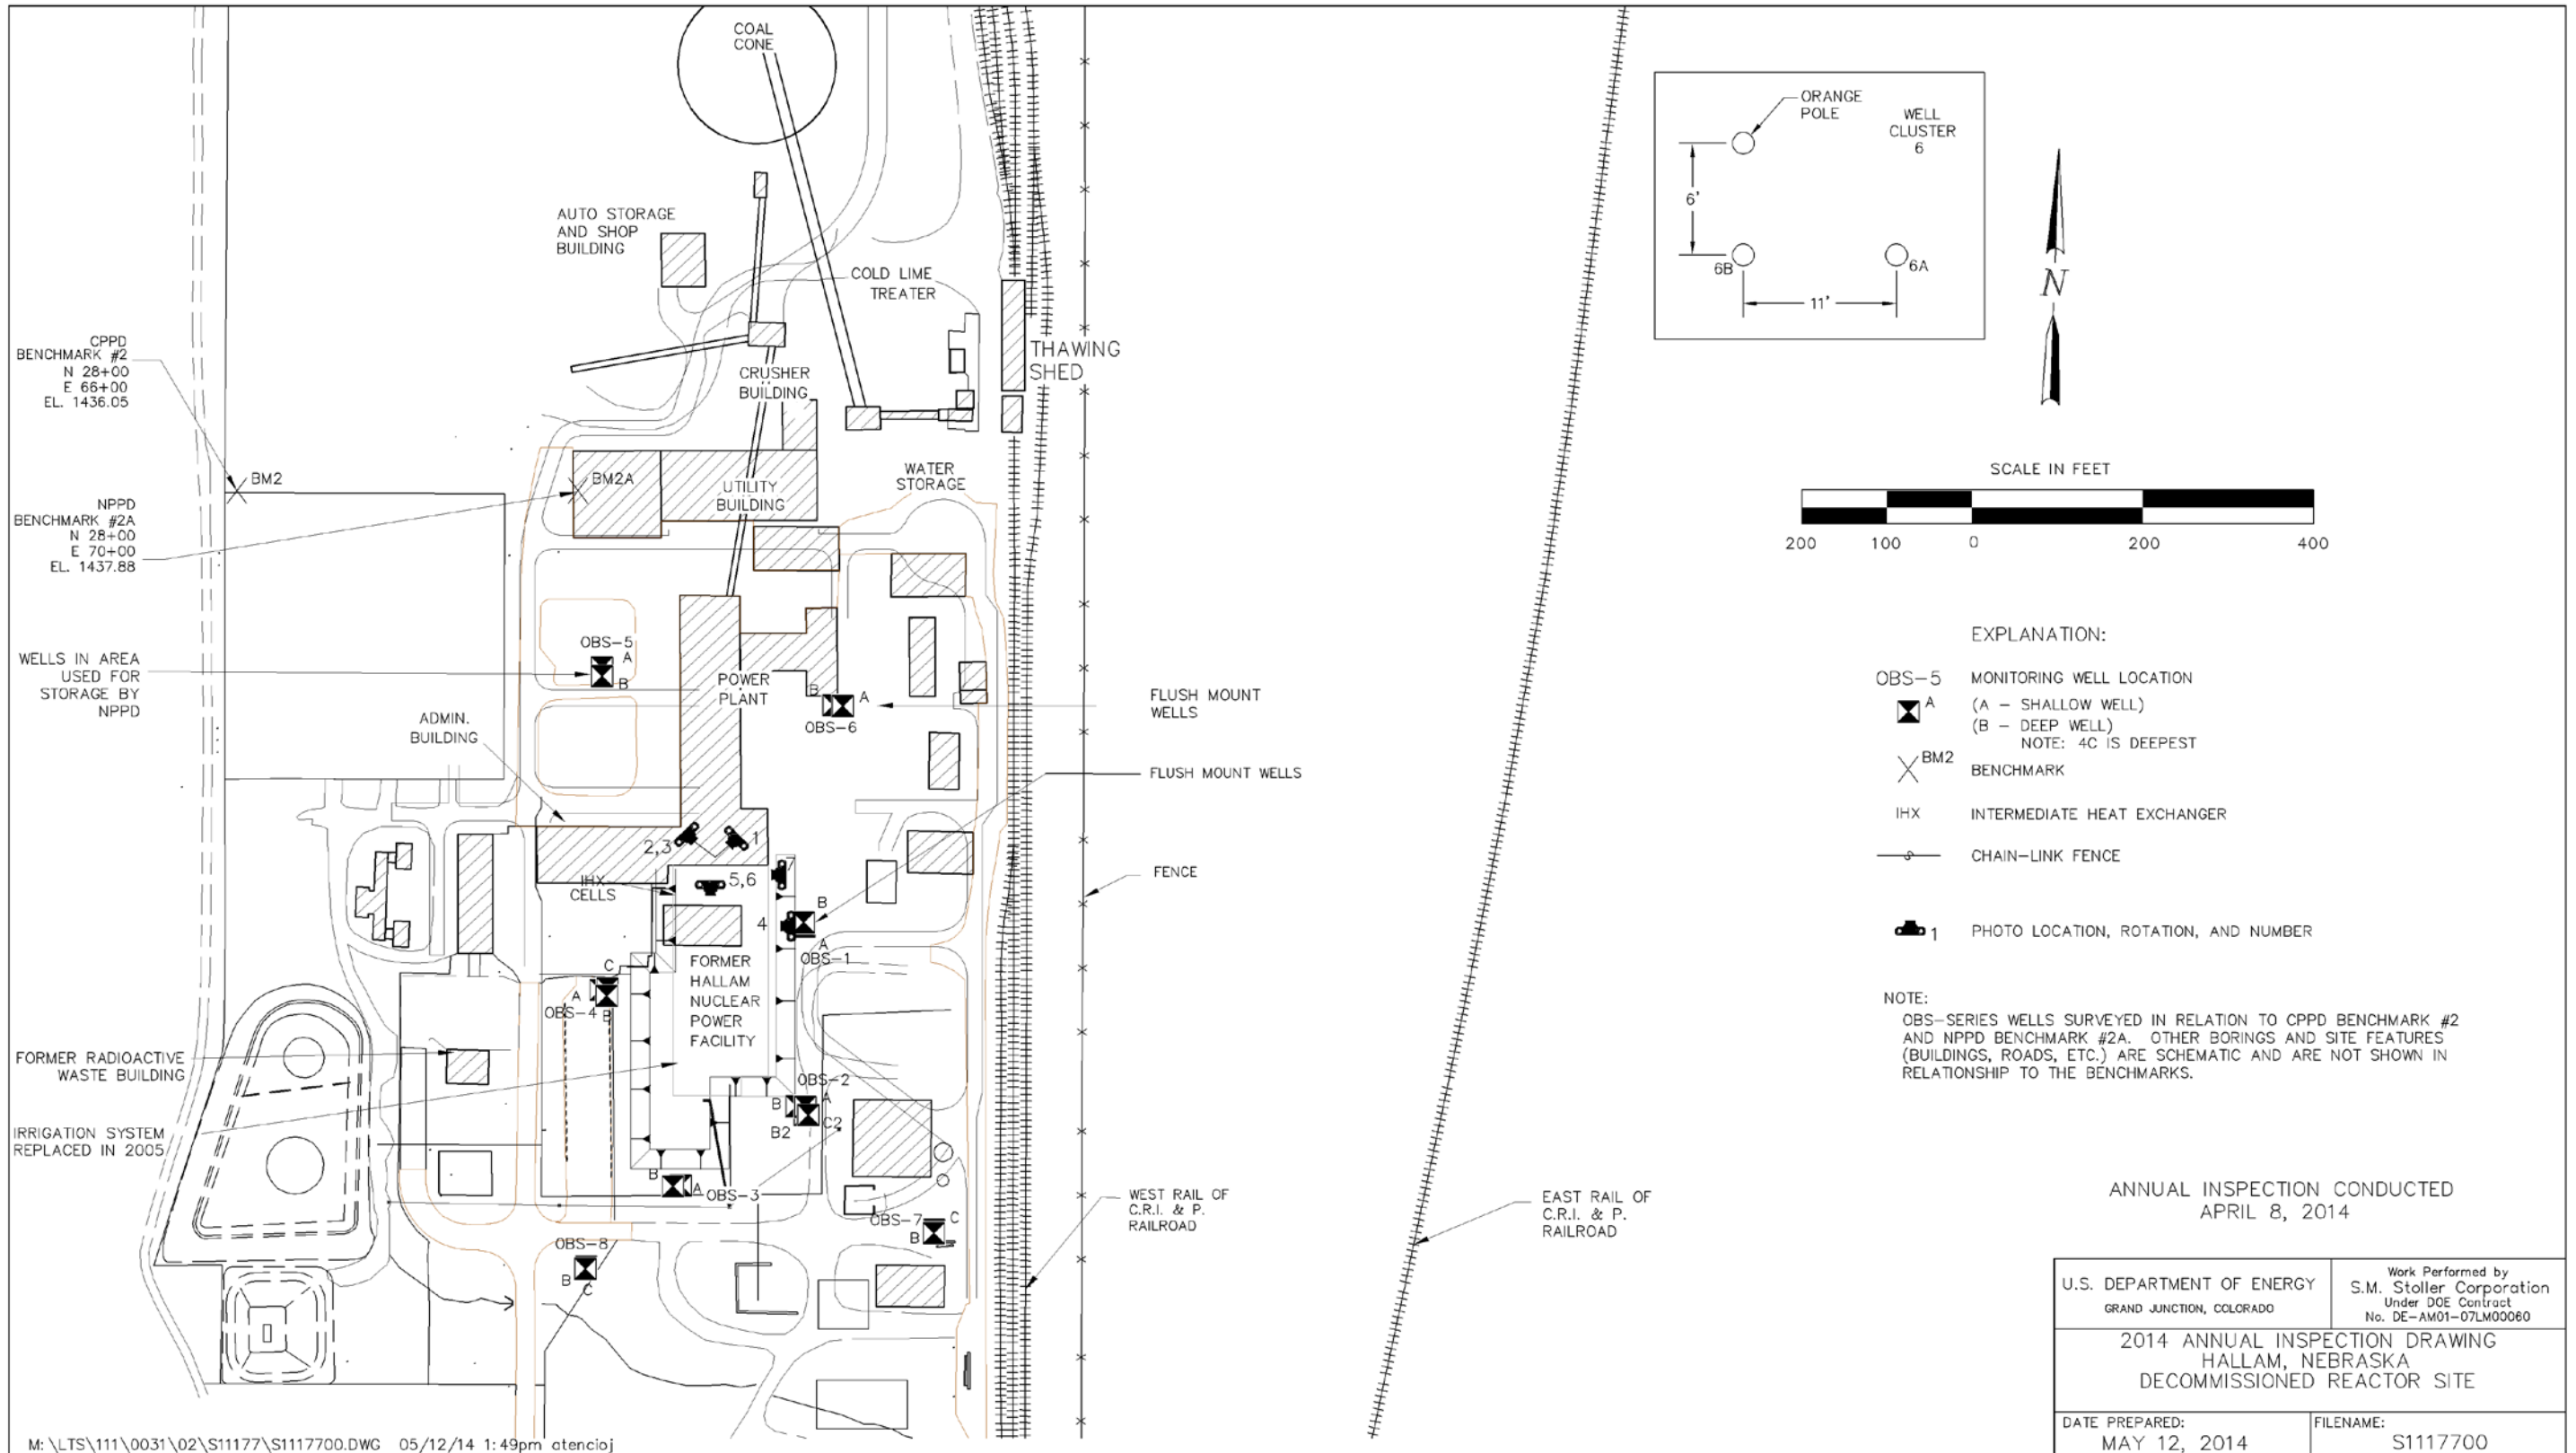
The old reactor foundation is buried beneath a waterproof membrane that is overlain by soil and grass. Today the buried structure appears as a low, flat-topped, grass-covered mound, 1.4 acres in extent, immediately south of the IHX building. Inspectors check that areas of erosion are not developing on the mound, and that the sprinkler system is operating adequately to maintain the grass on the mound. Grass on the mound was well established, in good condition, and is being maintained (PL-7).

HAL 4/2014. PL-7. Spreading fertilizer on grass covered mound.
