2010 Inspection and Annual Site Status Report for the Site A/Plot M, Cook County, Illinois Decontamination and Decommissioning Program Site

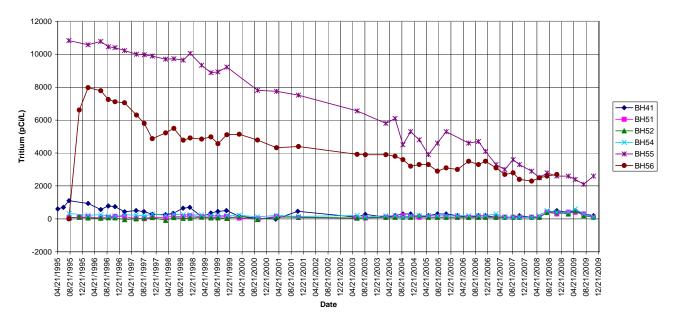
In 2009, tritium was detected in the groundwater at Site A in all six monitoring wells completed in the glacial drift. None exceeded the standard of 20,000 pCi/L. Activities ranged from non-detect (less than 100 pCi/L) to 3,000 pCi/L (Figure 2).

Figure 2. Tritium Activities in Groundwater in the Glacial Drift at Site A, Cook County, Illinois

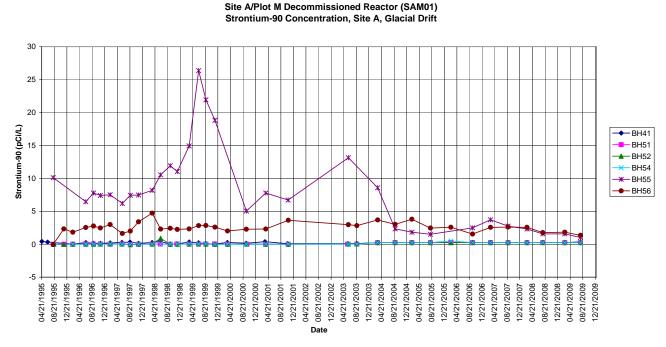
In 2009, strontium-90 was detected in the groundwater at Site A in three of the six monitoring wells completed in the glacial drift. Activities ranged from non-detect (less than 0.25 pCi/L) to 1.82 pCi/L, but none exceeded the State of Illinois standard of 8 pCi/L (Figure 3).

Figure 3. Strontium-90 Activities in Groundwater in the Glacial Drift at Site A, Cook County, Illinois

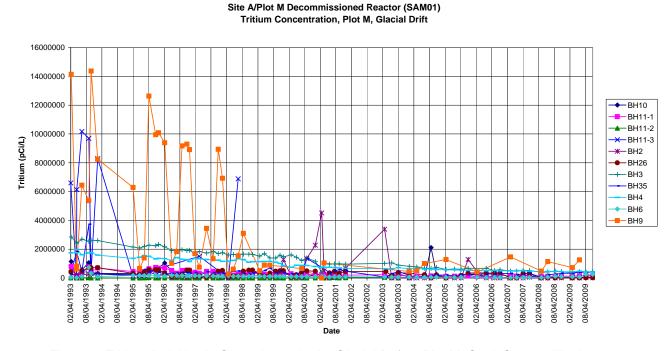
In 2009, tritium was detected in the groundwater at Plot M at all nine monitoring wells completed in the glacial drift. Tritium concentrations ranged from 600 pCi/L to 1,256,000 pCi/L (Figure 4). The highest reading was taken at BH–9 on May 26, 2009. BH–9 was dry for the remainder of 2009.

Figure 4. Tritium Activities in Groundwater in the Glacial Drift at Plot M, Cook County, Illinois

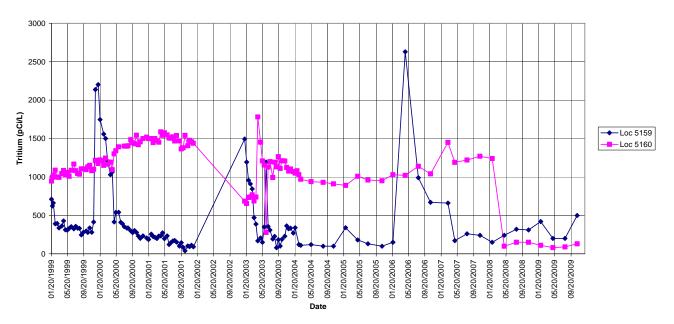
In 2009, tritium was detected in the groundwater at the picnic wells at the Red Gate Woods picnic area. Activities ranged from 80 pCi/L to 500 pCi/L (Figure 5). None exceeded the standard of 20,000 pCi/L.

Figure 5. Tritium Activities in Groundwater in the Picnic Wells, Site A/Plot M, Cook County, Illinois

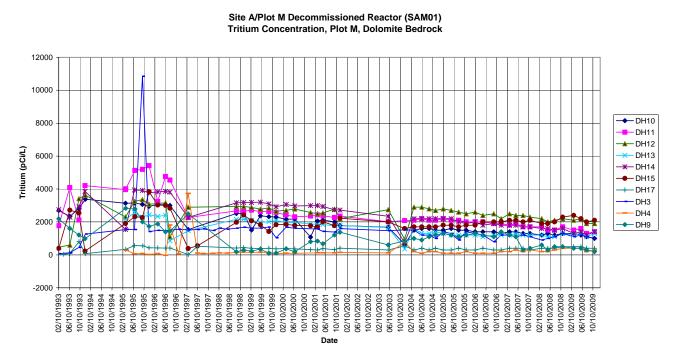
In 2009, tritium was detected in the groundwater at all ten monitoring wells completed in the dolomite bedrock north of Plot M. Activities ranged from 200 pCi/L to 2,200 pCi/L (Figure 6). Tritium is no longer sampled for in the dolomite bedrock beneath Site A. Monitoring stopped in 2004 after approximately 30 years of sampling failed to detect tritium

Figure 6. Tritium Activities in Groundwater in the Dolomite Bedrock, Site A/Plot M, Cook County, Illinois

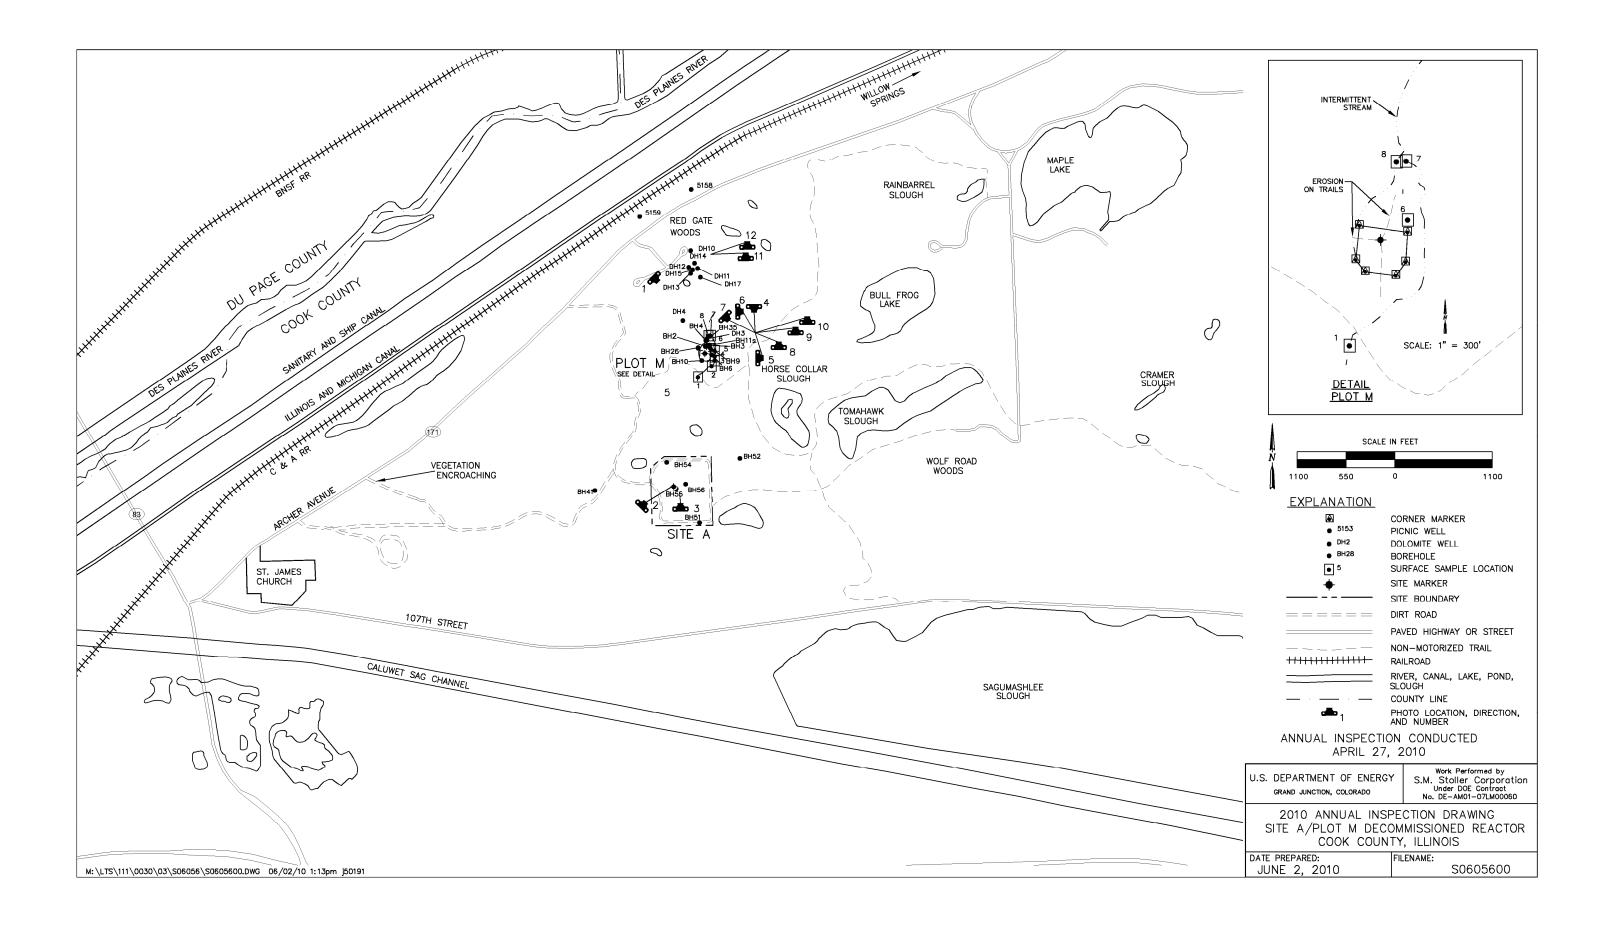
All nine monitoring wells at Plot M and ten monitoring wells north of Plot M were inspected and found to be secured with locks and identified with a well number on the outer casing. No monitoring wells were opened during the inspection. ANL personnel visit the wells quarterly for sampling, ensure well security, and perform required maintenance at that time. A couple of minor maintenance issues were identified in two of the ten wells north of Plot M. A panel on the well head of monitoring well DH–15 is missing, and wires are exposed to the public (PL–11). It is recommended that the cover be replaced or the wires removed. Metal grating is present around monitoring well DH–14 that could present a tripping hazard to the public and some wires also are exposed at the wellhead (PL–12). It is recommended that the metal grating and wires be removed.

4. Metal grating is present around monitoring well DH–14 that could present a tripping hazard to the public, and some wires are exposed at the wellhead (page 4).

SAM 4/2010. PL-12. Grate around monitoring well DH-14.

Recommendation: It is recommended that metal grating and exposed wires be removed.
