2019 Annual Inspection Report for the Parkersburg, West Virginia, Disposal Site

January 2020

U.S. DEPARTMENT OF
ENERGY

Legacy
Management

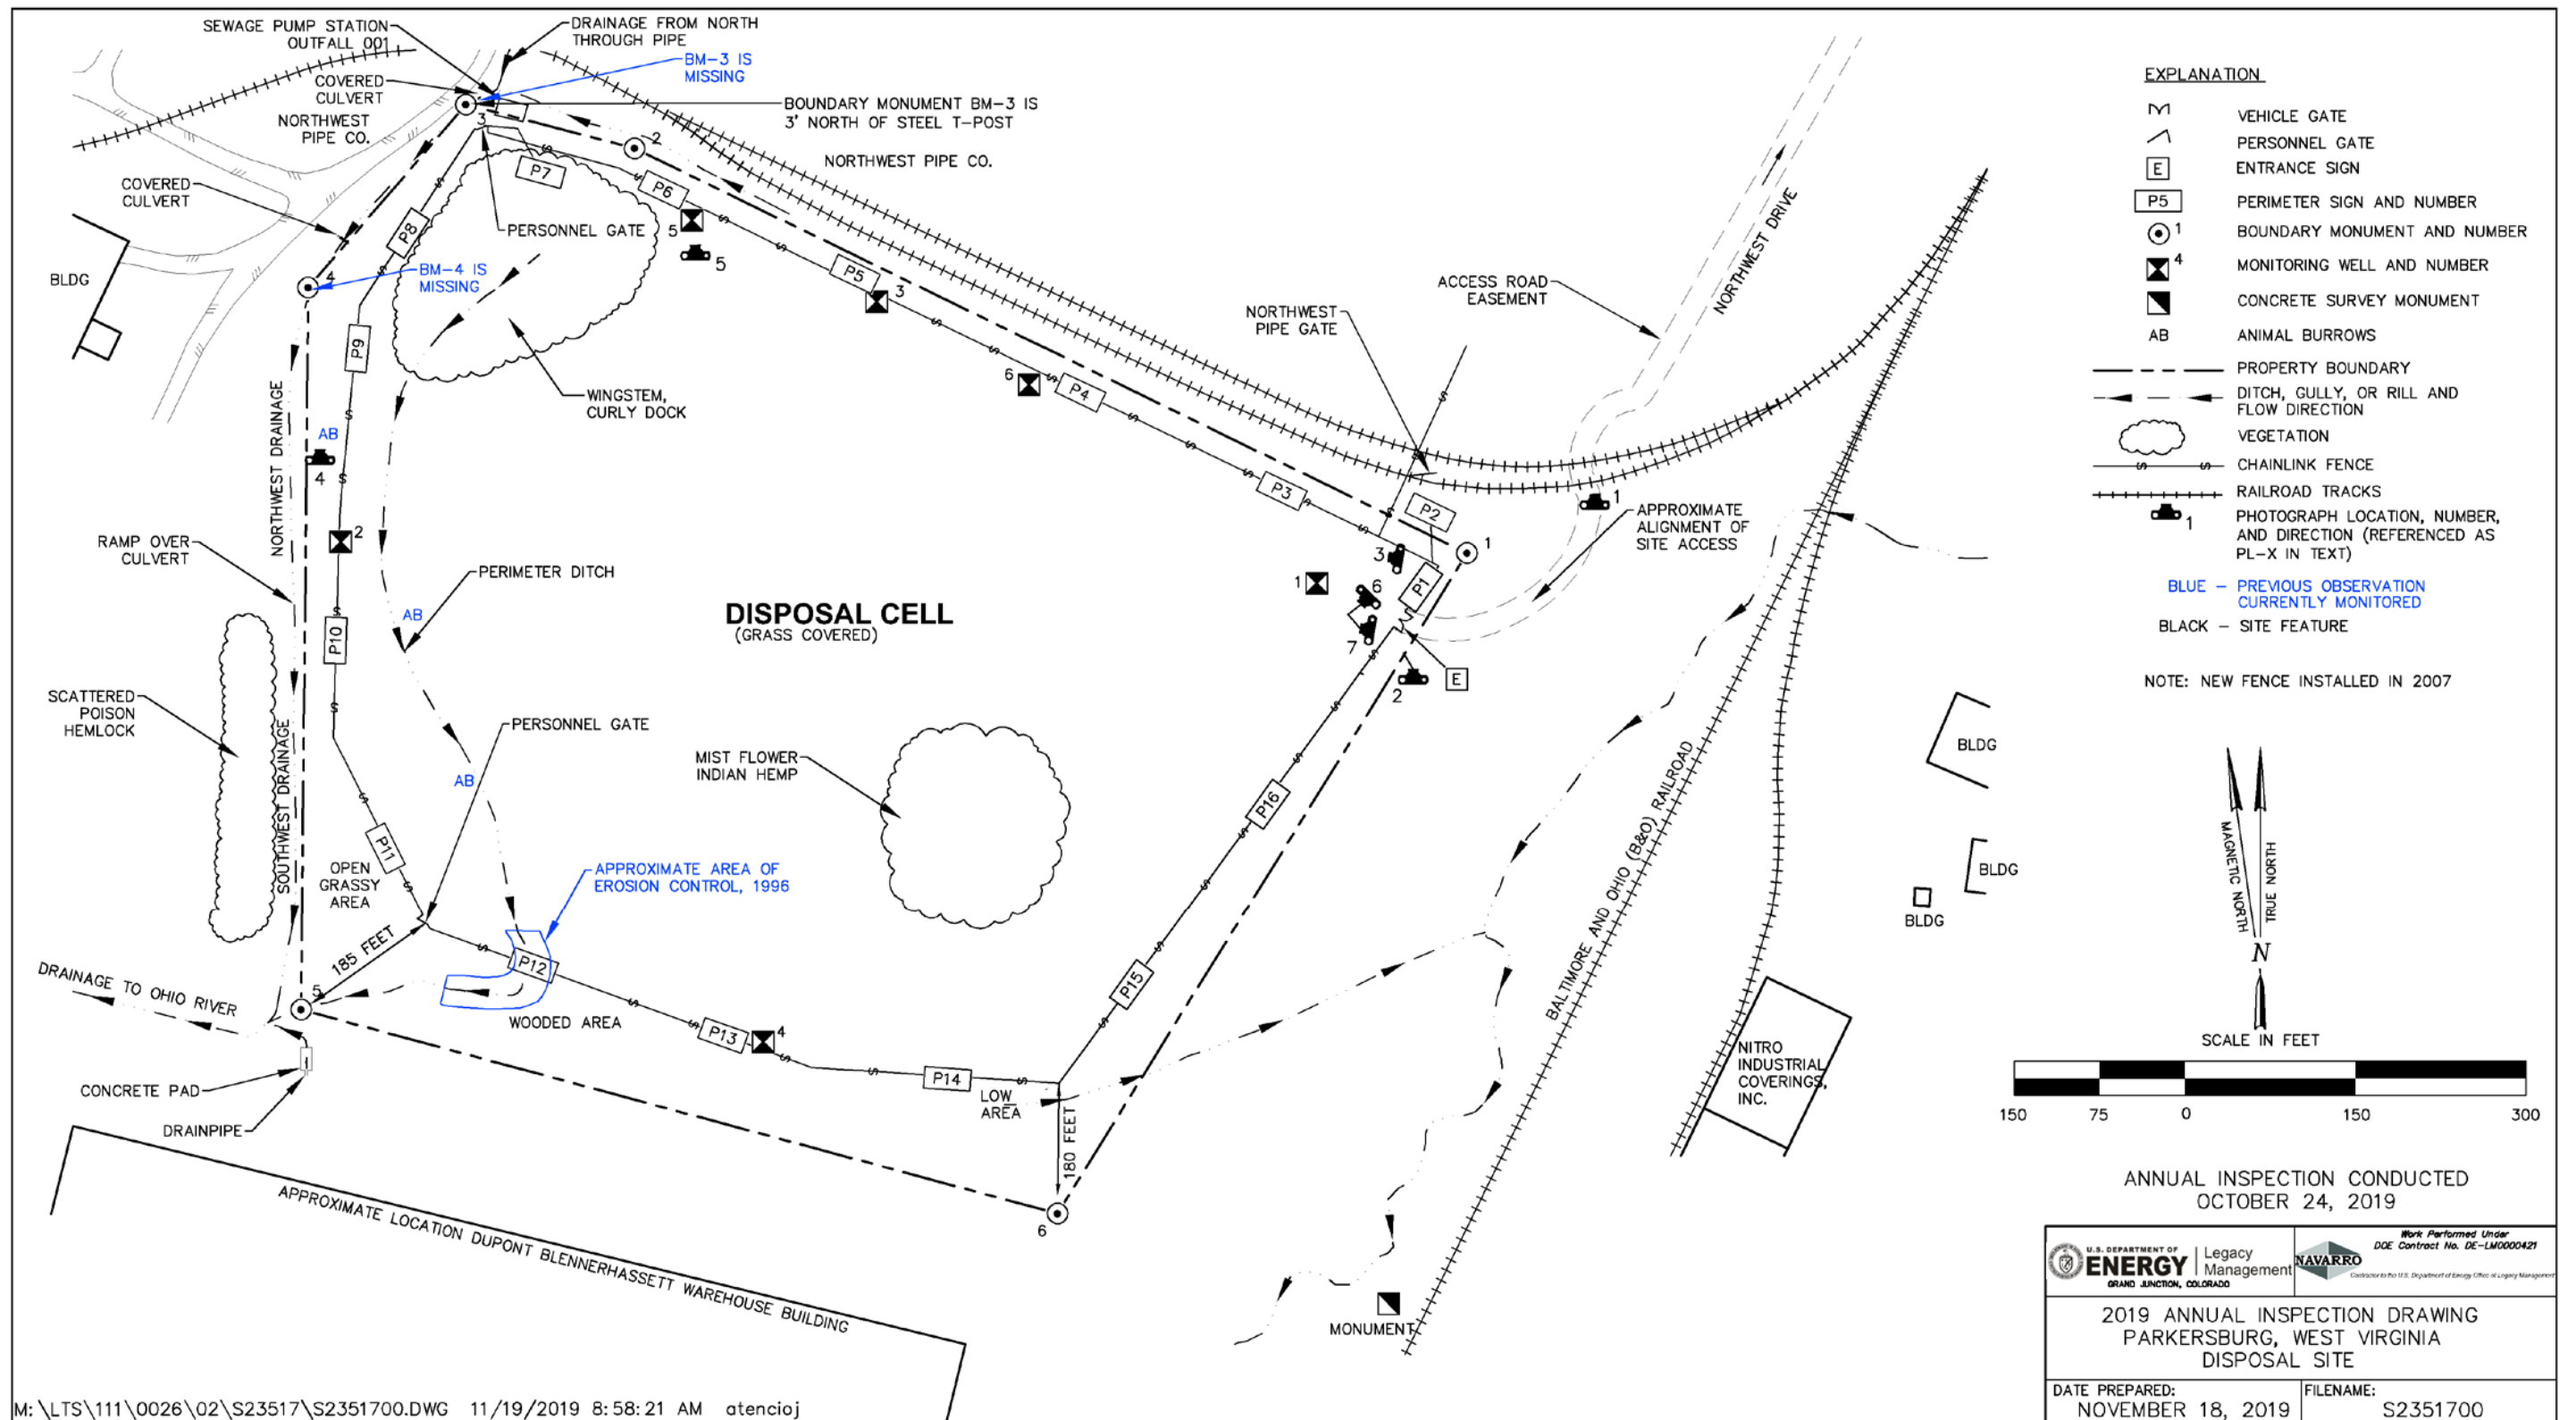
Figure A-1. 2019 Annual Inspection Drawing for the Parkersburg, West Virginia, Disposal Site

Animal burrows along the west perimeter fence (between perimeter signs P9 and P10) need to be addressed to eliminate a potential safety hazard to the vegetation management crew.

Boundary monuments BM-3 and BM-4 are scheduled to be replaced in 2010.
