**2024 Annual Land-Use Covenant
Inspection Report
for DOE Areas at the Laboratory
for Energy-Related Health
Research/Old Campus Landfill
Superfund Site
University of California, Davis**

January 2025

U.S. DEPARTMENT OF
ENERGY

Legacy
Management

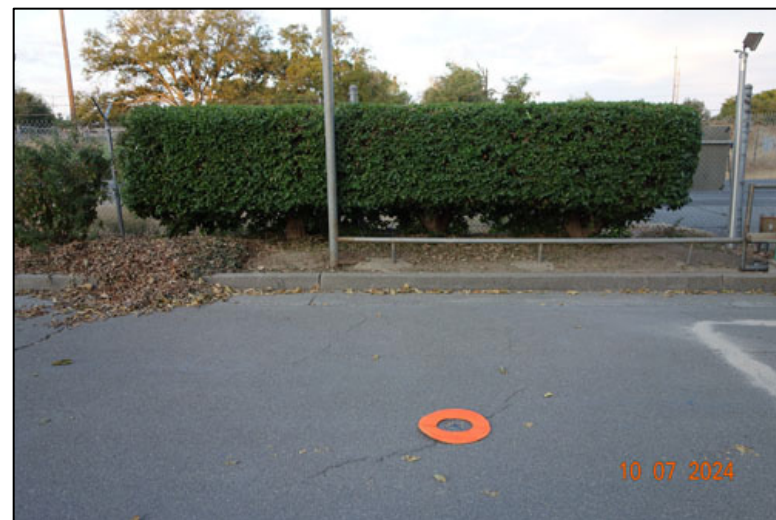
*View West: Survey Monument 2 Within Orange Ring; South Edge of
Asphalt Cut Located North (Center Right) of Monument; Hedge and
West Perimeter Fence in Background (Photo No. 8742)*

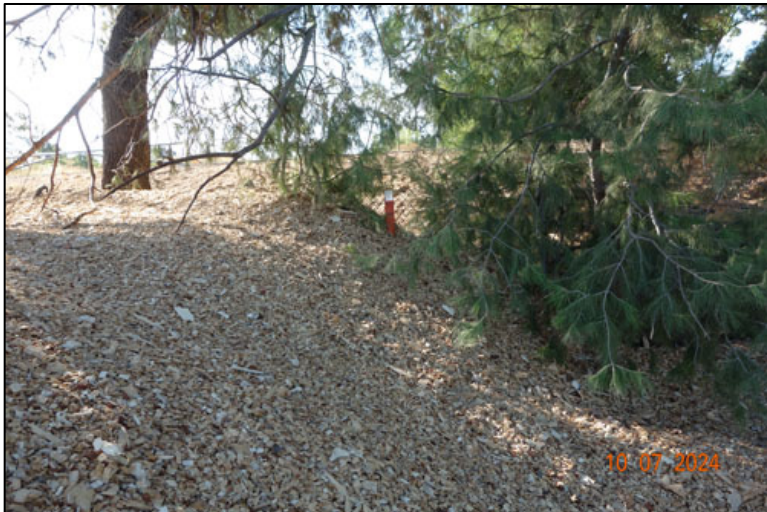
All 24 survey monuments (Figure 2) were found in good condition on October 7, 2024, as documented in the checklists and photographs in Appendixes A and B, respectively. However, monument 18, was inaccessible because it was covered up by wood chips generated by UC Davis as part of their tree removal activities. During the post-inspection walkthrough on December 9, 2024, monument 18 remained inaccessible due to the covering of wood chips. Monument 18 will be inspected in the next reporting period after UC Davis removes the stockpile.

*View South: Top of Survey Monument 18 Delineator in Center;
Monument Buried, North Levee in Background (Photo No. 8805)*

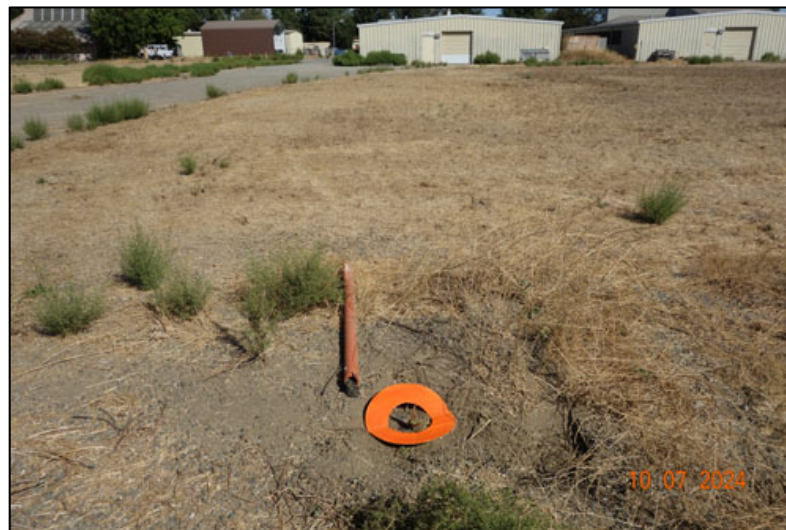
The monument 19 location delineator was found fallen and broken at the base (photo no. 8831; Appendix B). This delineator is scheduled for replacement (Appendix F).

View North: Survey Monument 19 Within Orange Ring;
Fallen Delineator Left of Survey Monument; Geriatrics Buildings in
Upper Right (Photo No. 8831)

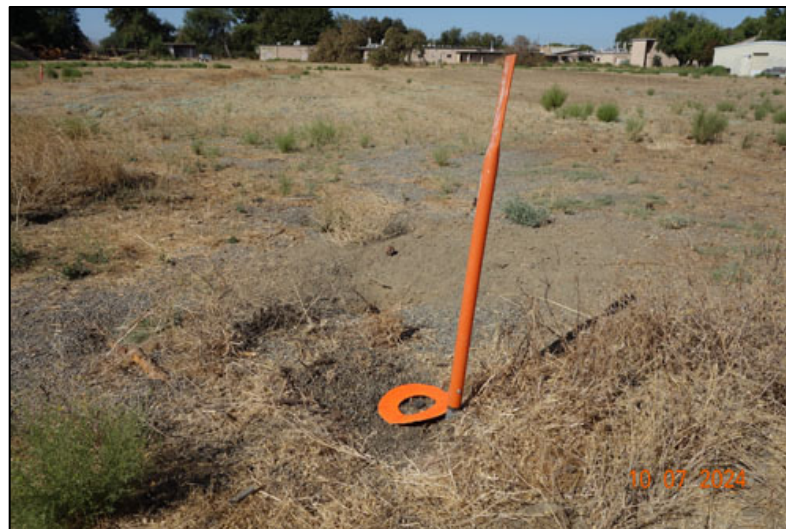
View Northwest: Survey Monument 20 Within Orange Ring;
Delineator Right of Survey Monument; Geriatrics Building 1 in
Upper Right (Photo No. 8840)

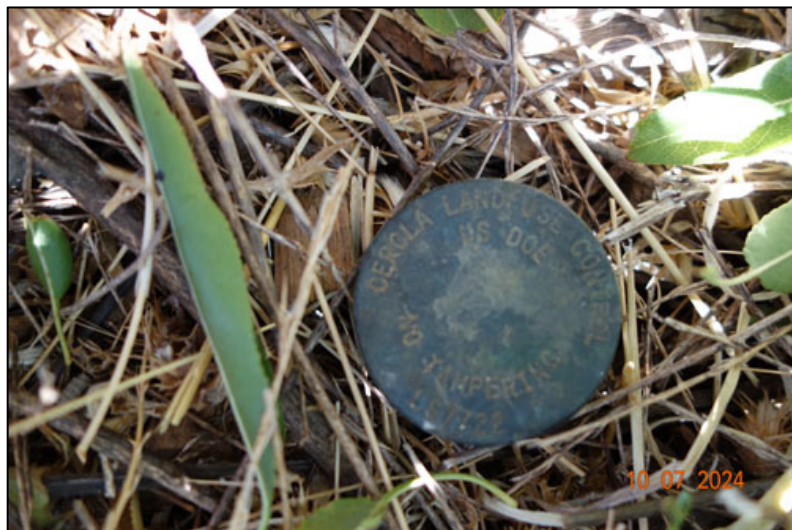
*Survey Monument 21: Southwest Corner of EDPs Area
(Photo No. 8824)*

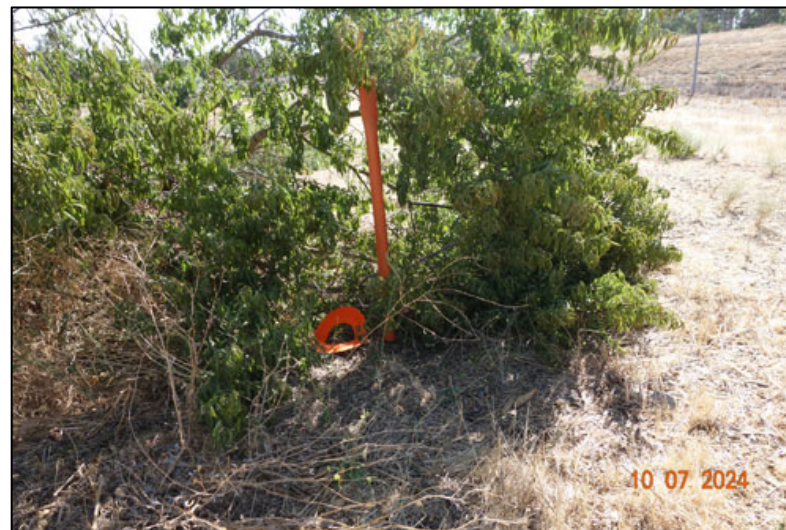
*View Southeast: Survey Monument 21 Within Orange Ring;
Delineator Right of Survey Monument; North Levee in Upper Right
(Photo No. 8827)*

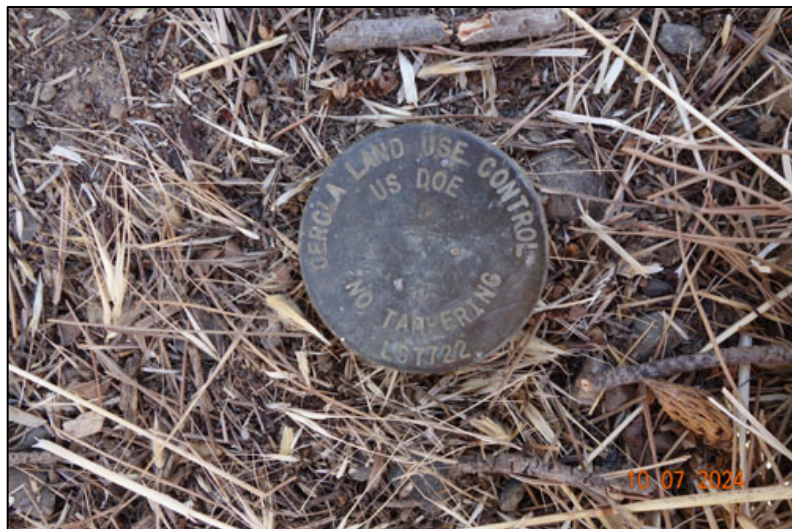
*Survey Monument 22: Southeast Corner of EDPs Area
(Photo No. 8842)*

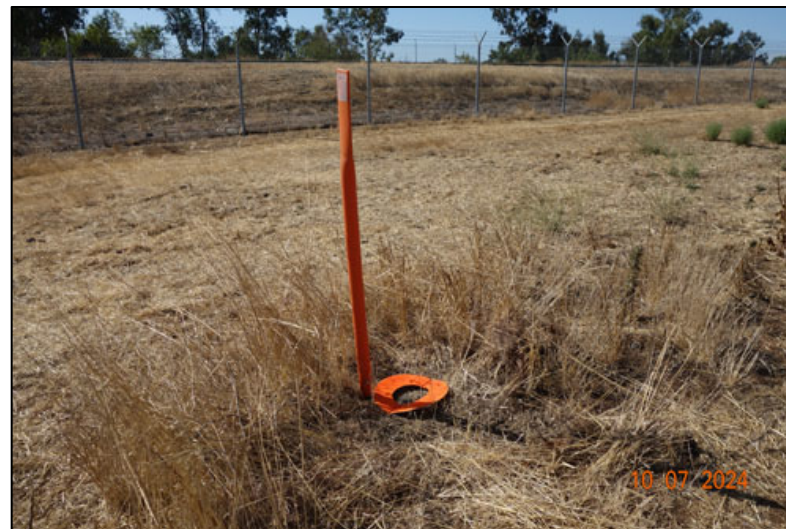
*View Southwest: Survey Monument 22 Within Orange Ring;
Delineator Left of Survey Monument, North Levee in Background
(Photo No. 8843)*

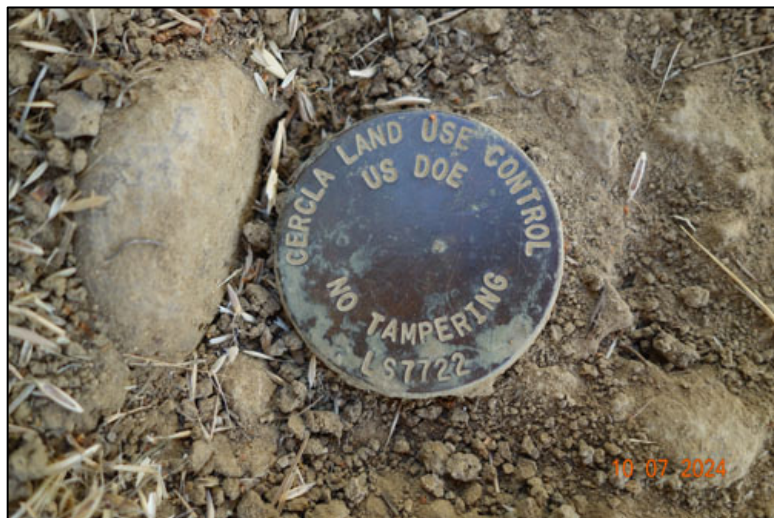
*Survey Monument 23: Western Perimeter Point of SWT Area
(Photo No. 8798)*

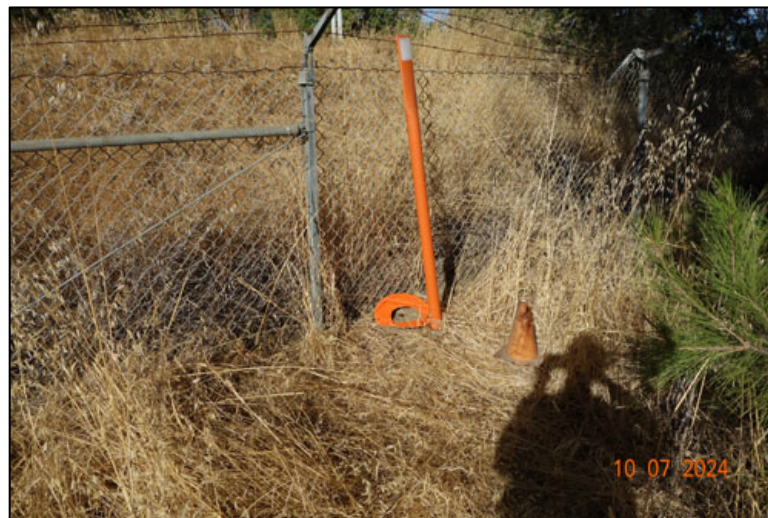
*View Northwest: Survey Monument 23 Within Orange Ring;
Delineator Right of Survey Monument; West Perimeter Fence
Behind Survey Monument (Photo No. 8799)*

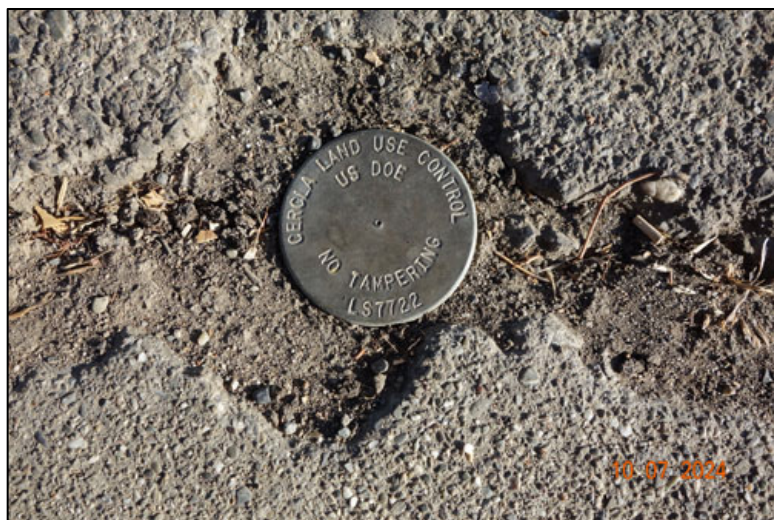
*Survey Monument 24: Northeast Corner of SWT Area at
Southern Perimeter of DSS 3 Area (Photo No. 8787)*

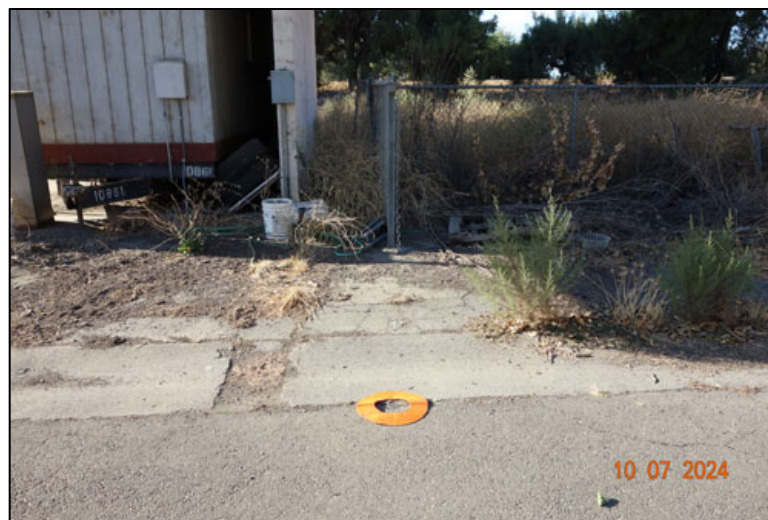
*View South: Survey Monument 24 Within Orange Ring on
Edge of Concrete Swale; Former Washdown Pad in Upper Left
(Photo No. 8788)*

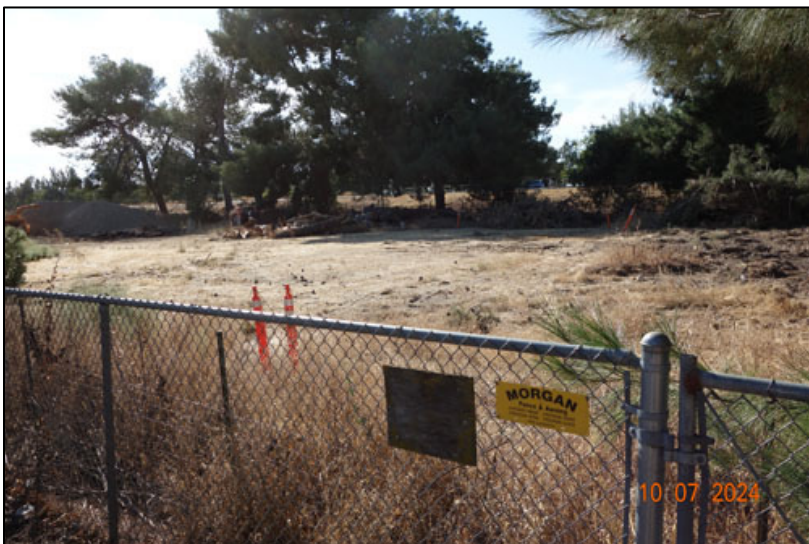
View Southeast of SWT Area: North Levee of South Fork of Putah Creek in Background (Photo No. 8806)

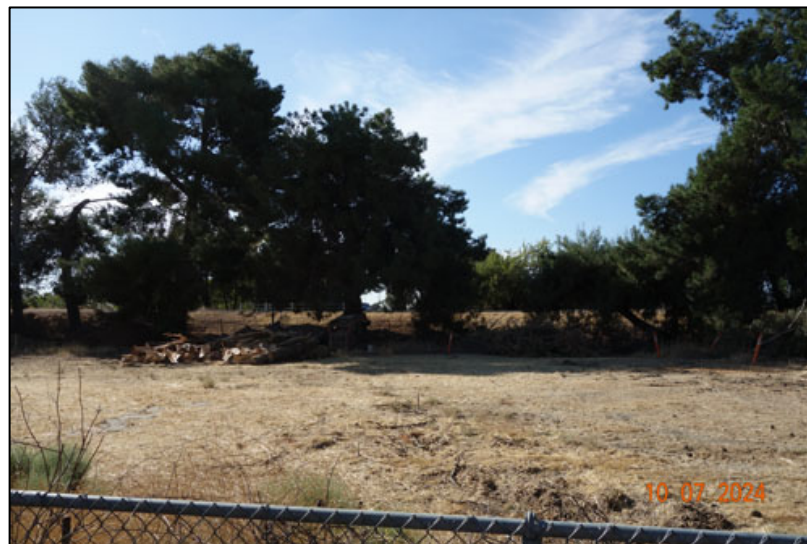
View South of SWT Area: North Levee of South Fork of Putah Creek in Background (Photo No. 8807)

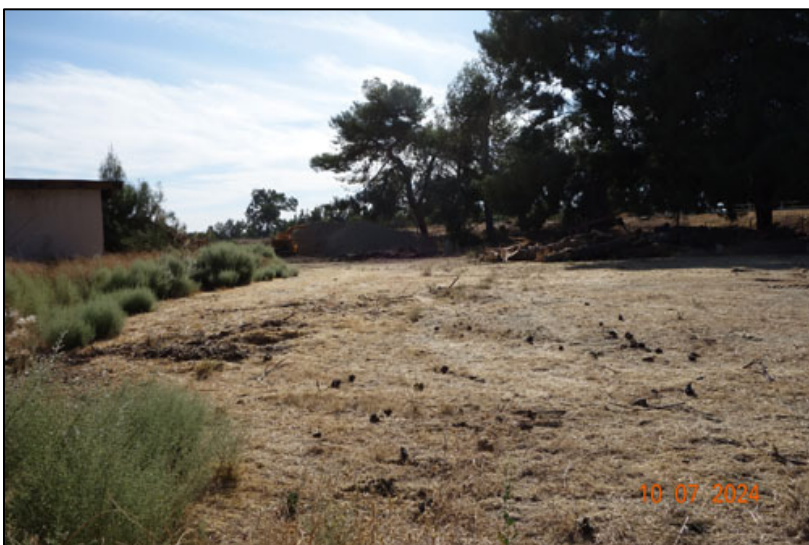
View Southeast of SWT Area: Former Washdown Pad at Left (Photo No. 8808)

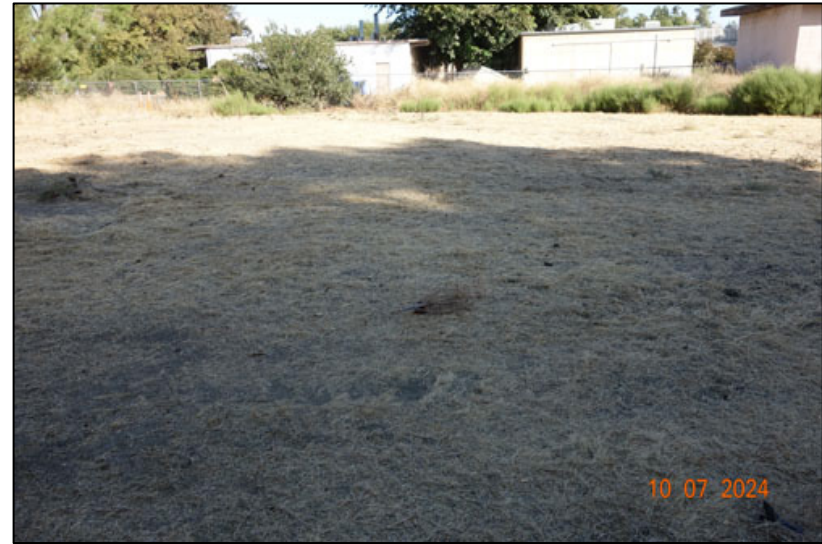
View North of SWT Area: Buildings H-215 and H-216 in Background (Photo No. 8811)

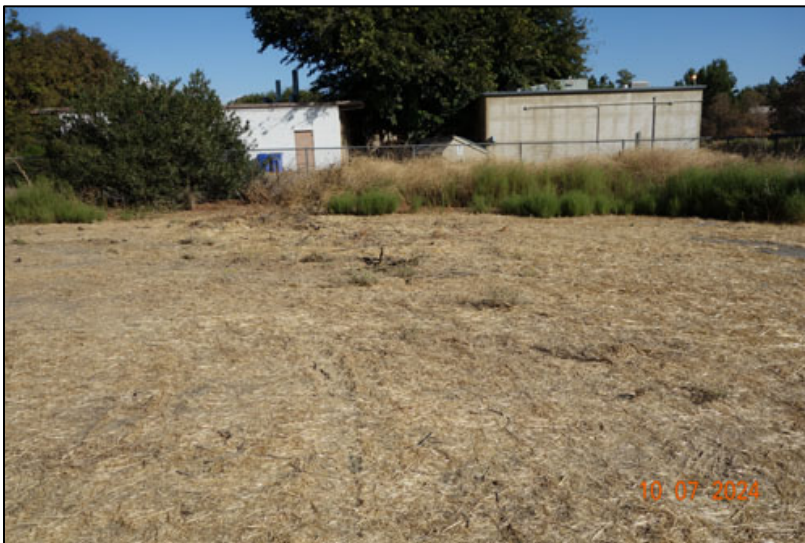
View North from Center of SWT Area: Buildings H-215 and H-216 in Background (Photo No. 8812)

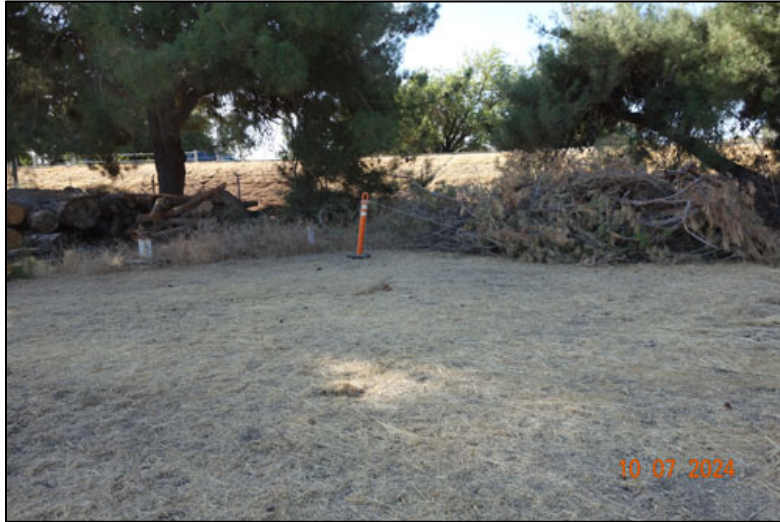
View South from Center of SWT Area: Stanchions and Rope Surrounding New Tree Debris Stockpile in Upper Right of Photo (Photo No. 8814)

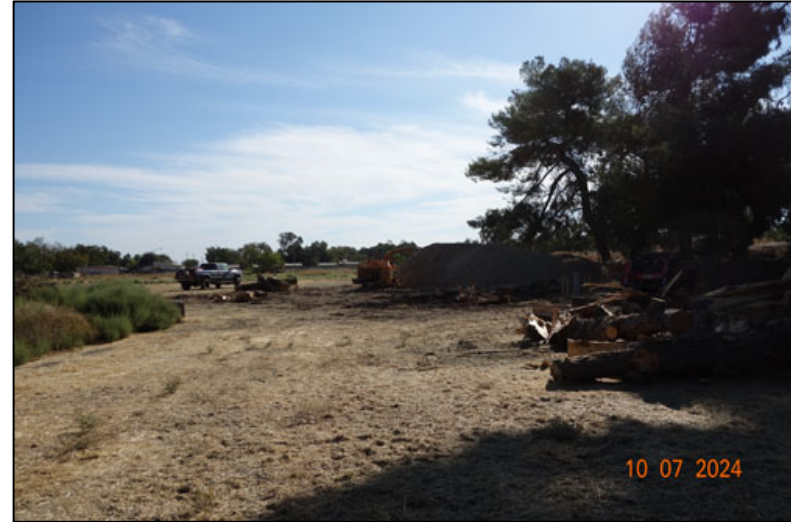
View East from Center of SWT Area: UC Davis Tree Debris in Center Right of Photo; Western Dog Pens Area in Background (Photo No. 8815)

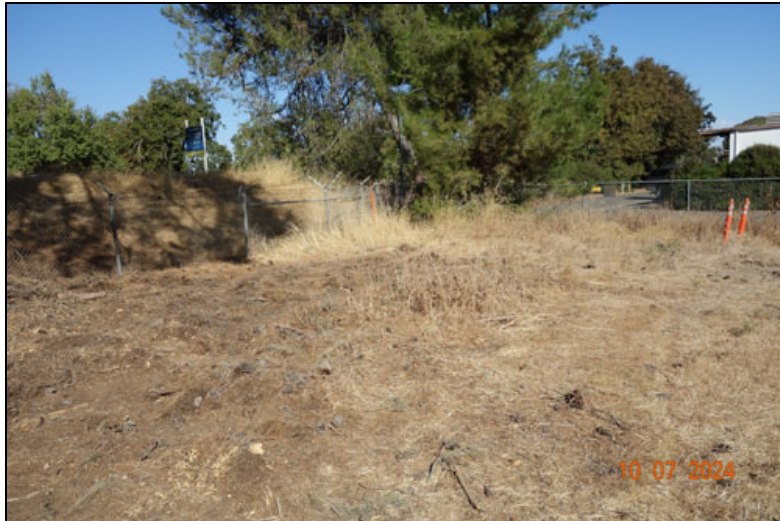
View North of Northwest Corner of SWT Area (Photo No. 8816)

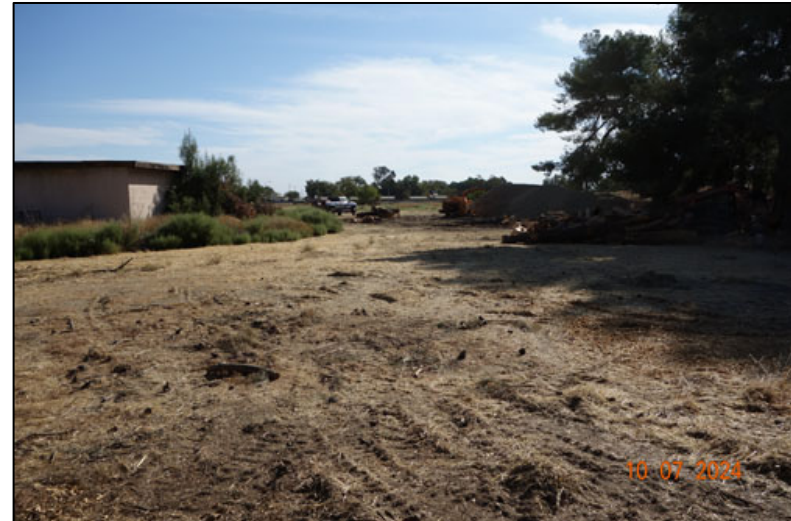
View East of SWT Area: Shallow Ruts from UC Davis Tree Work in Bottom Center of Photo; Western Dog Pens Area and UC Davis Southern Trenches Area in Background (Photo No. 8817)

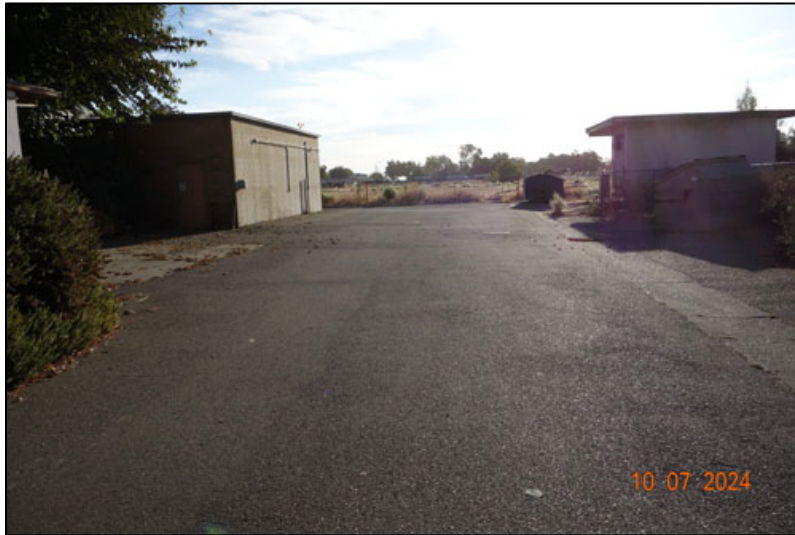
*View East over Former Leach Field Part of DSS 3 Area:
Building H-216 in Upper Left; Former Washdown Pad in Upper Right;
Western Dog Pens Area in Background (Photo No. 8771)*

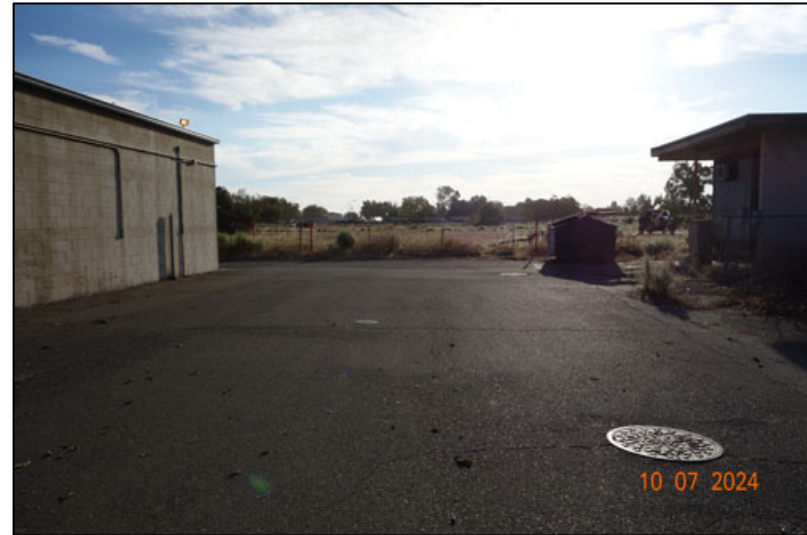
View East of Eastern Half of DSS 3 Area (Photo No. 8772)

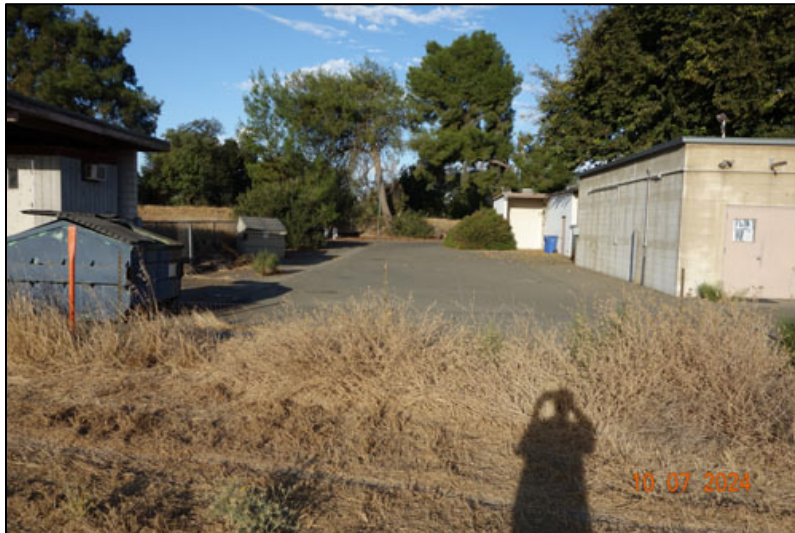
*View West of Former Leach Field Part of DSS 3:
Buildings H-215 and H-216, Right; Old Davis Road in Background
(Photo No. 8773)*

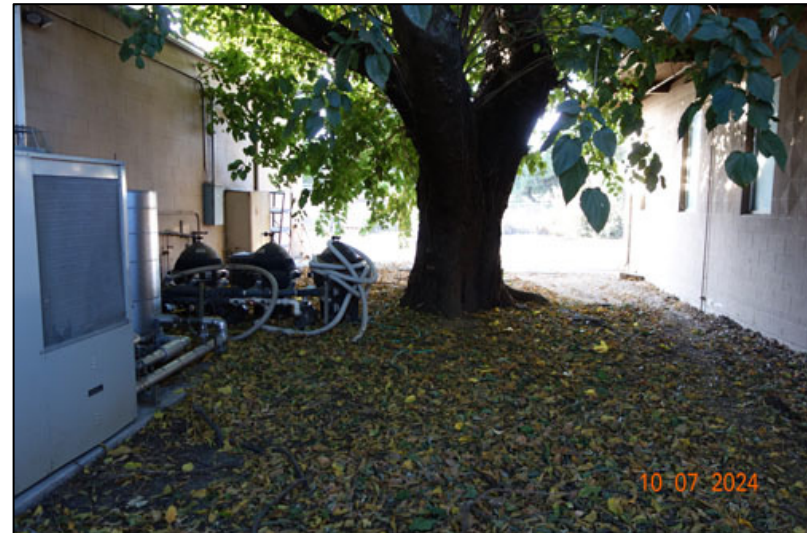
*View South of Septic Tank Part of DSS 3 Area:
Building H-216, Left; Building H-215, Right (Photo No. 8774)*

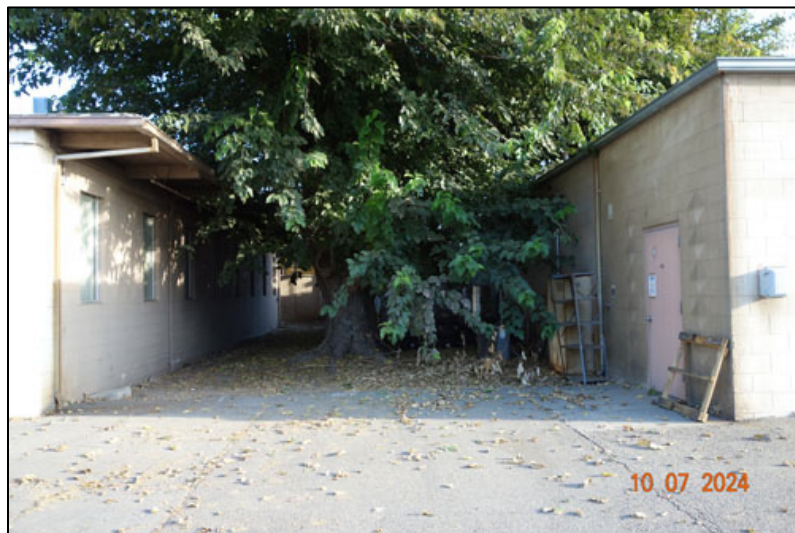
*View North of Portions of DSS 3 and 4 Areas:
Building H-215, Left; Building H-216, Right; DSS 4 Area in Background
(Photo No. 8775)*

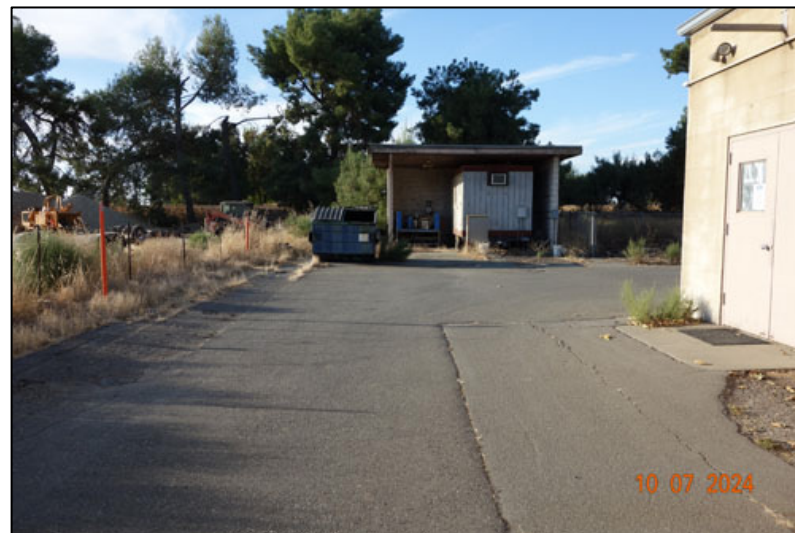
*View South of East End of DSS 3 Area Leach Field:
Building H-215, Right; Former Washdown Pad in Background
(Photo No. 8778)*

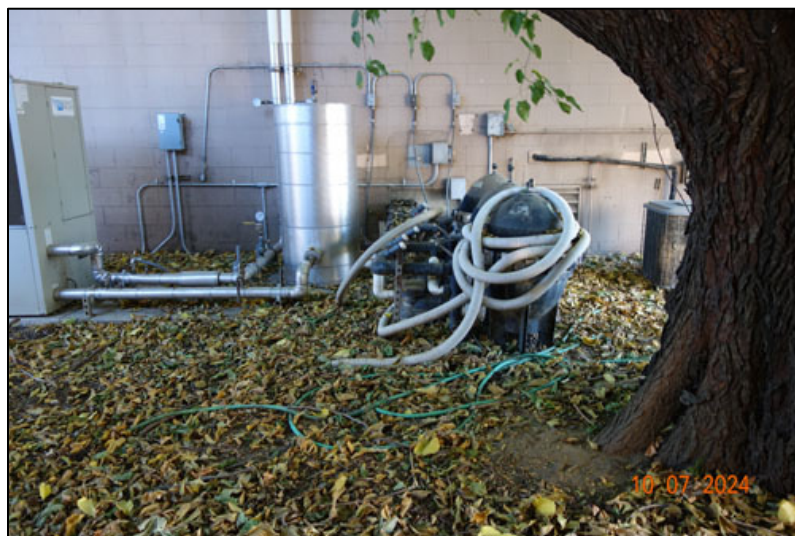
*View East of DSS 3 Area: Out-of-Service Filter Canisters
in Center; Building H-216 in Background, Standing North and
Left of Tree (Photo No. 8776)*

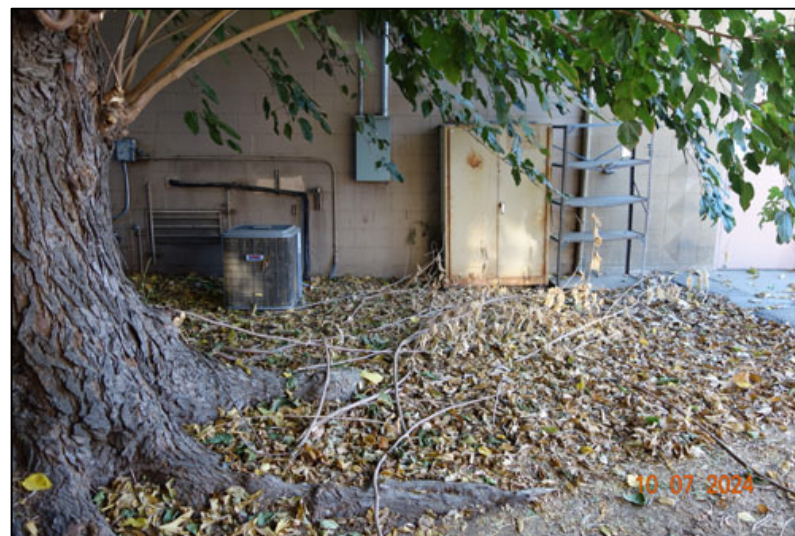
*View East of DSS 3 Area: Building H-216 in Background,
Standing South and Right of Tree (Photo No. 8777)*

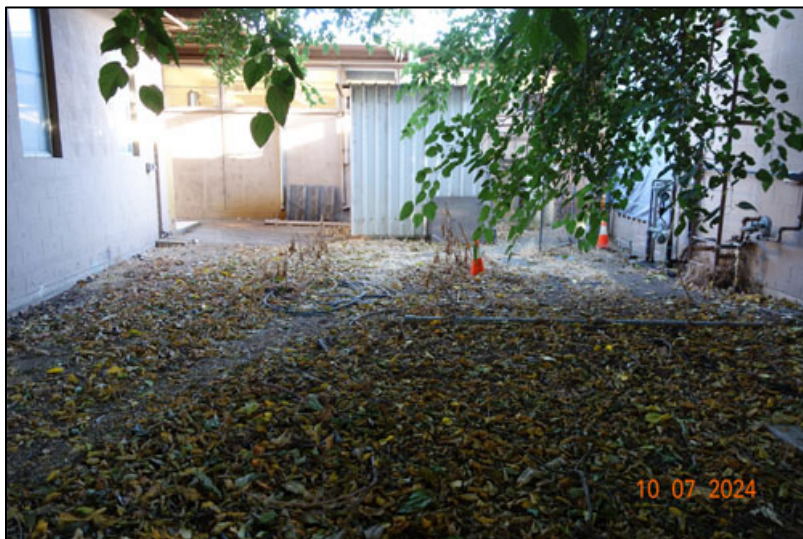
View North of DSS 4 Area Septic Tank Location and East End of Leach Field: Building H-215, Left; Building H-216, Right; Building H-217 in Background (Photo No. 8779)

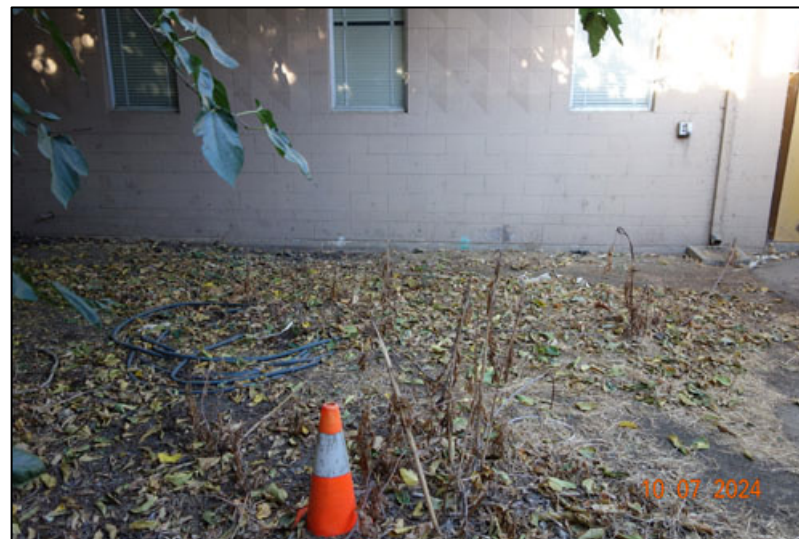
View West of East End of DSS 4 Area Leach Field: Building H-215 in Background (Photo No. 8780)

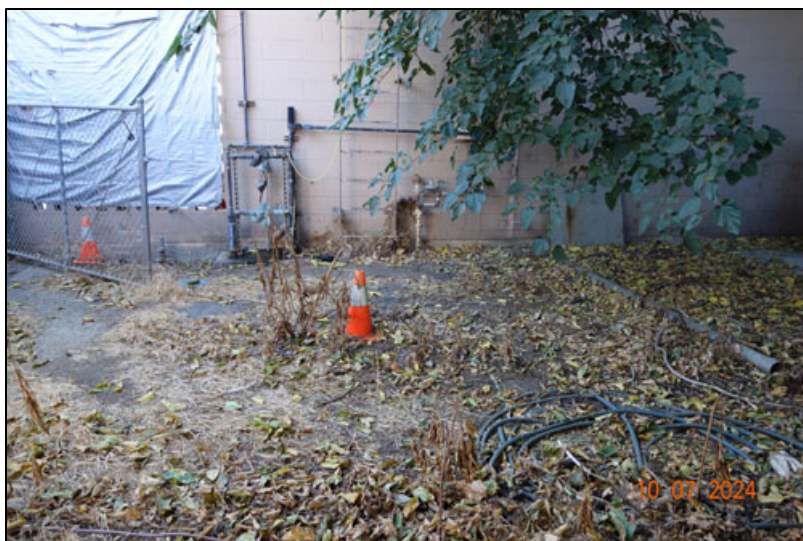
View East of DSS 4 Area Septic Tank Location: Building H-216 in Background (Photo No. 8781)

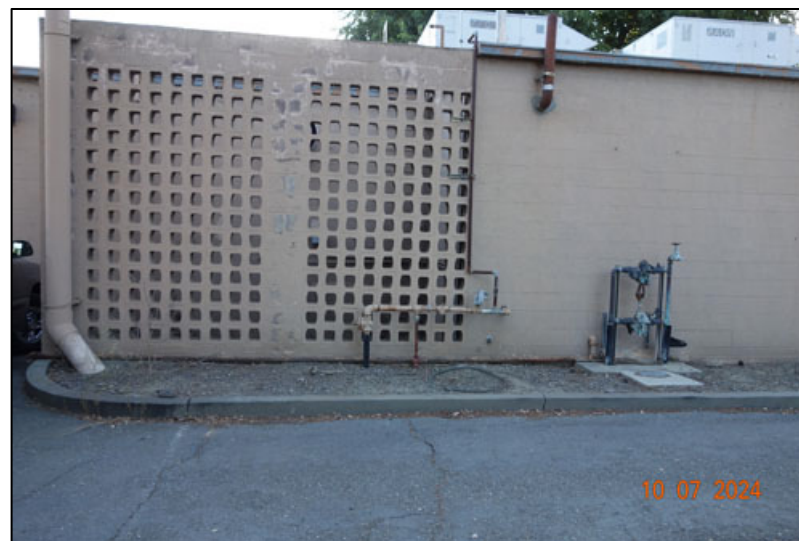
View East of Western Portion of DSS 4 Area: Building H-215 in Background, Center (Photo No. 8782)

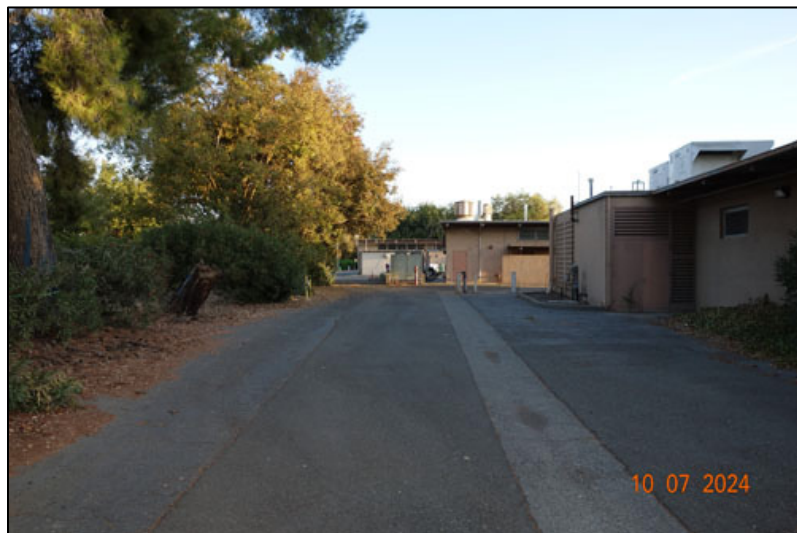
View North of Southern Portion of Ra/Sr Treatment Systems Area: Building H-215, Right; Buildings H-218 and H-219 in Background (Photo No. 8748)

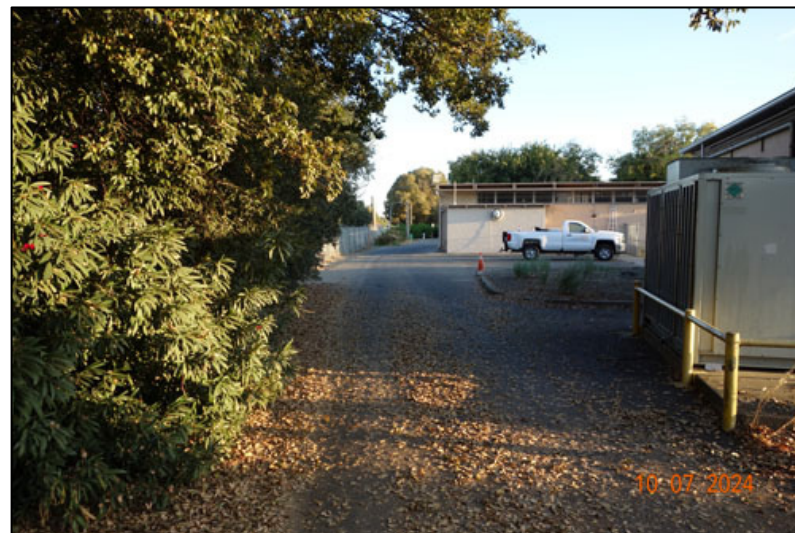
View North of Middle Portion of Ra/Sr Treatment Systems Area: Building Cooling Unit and Building H-218 Roof Line, Top Right; Building H-219 in Background (Photo No. 8749)

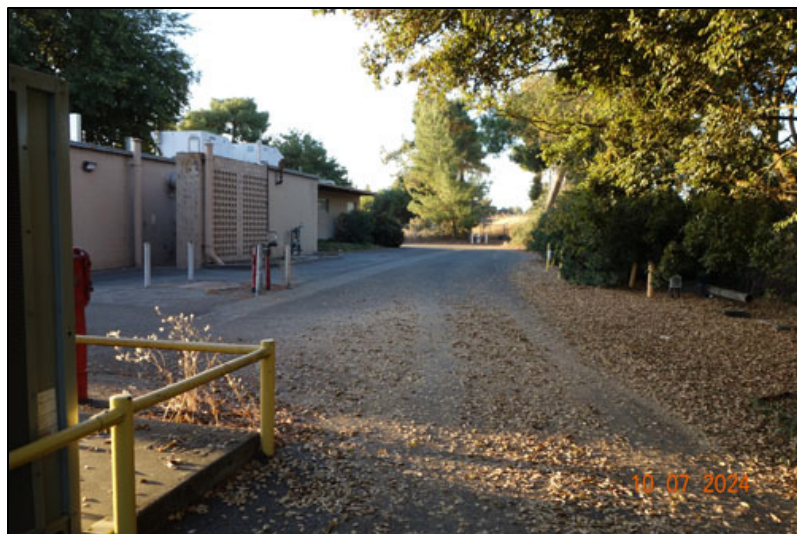
View South of Southern Portion of Ra/Sr Treatment Systems Area: Building H-215, Left (Photo No. 8750)

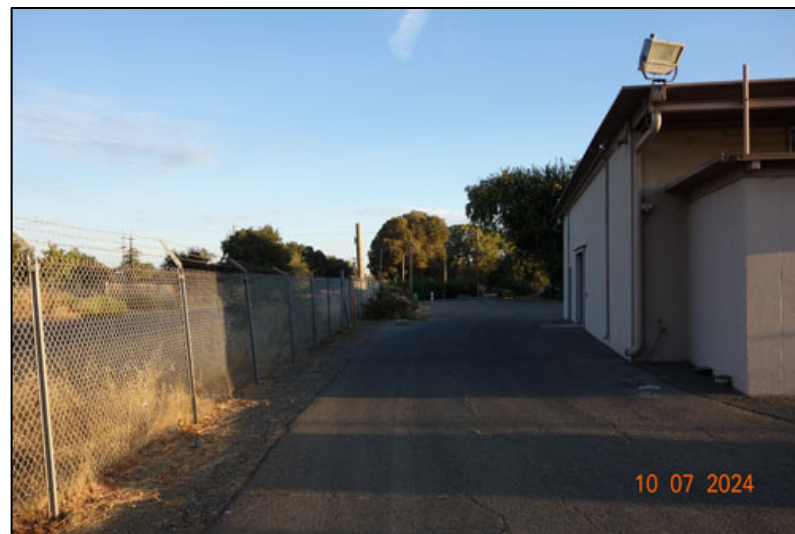
View North of Northern Portion of Ra/Sr Treatment Systems Area: Building H-219, Right (Photo No. 8751)

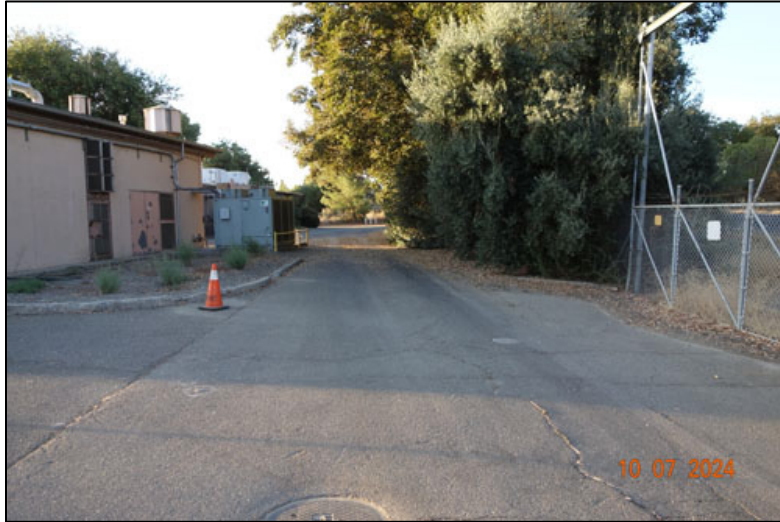
*View South of Middle-South Portion of Ra/Sr Treatment Systems Area:
Building H-218, Left; West Perimeter Gate and Fence, Right
(Photo No. 8752)*

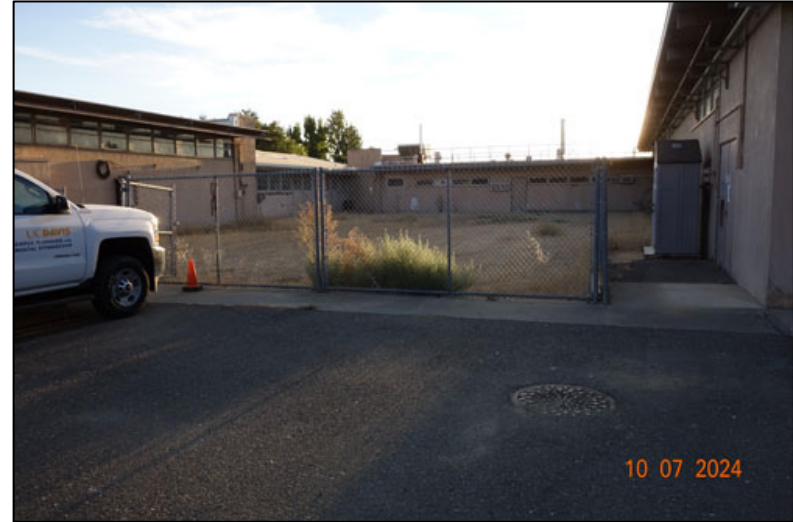
*View East of Central Portion of Ra/Sr Treatment Systems Area:
Building H-218, Right; Building H-219, Left (Photo No. 8753)*

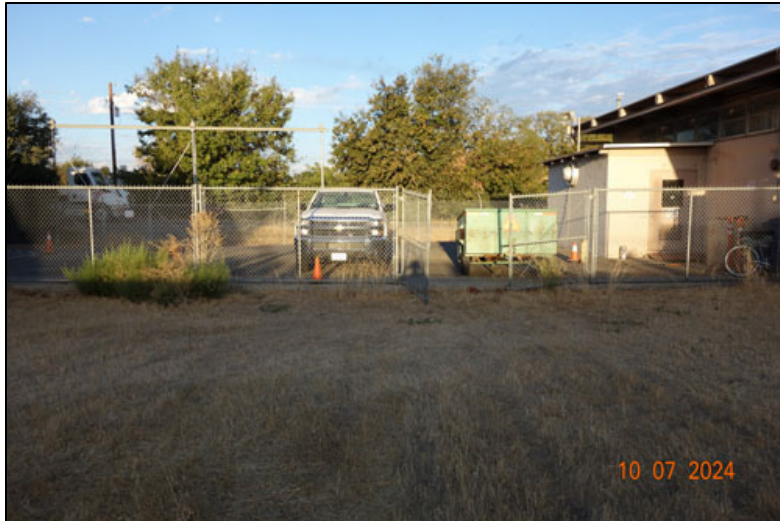
*View West of DSS 2 Area Within Middle-West Portion of
Ra/Sr Treatment Systems Area: Building H-219, Top Right
(Photo No. 8755)*

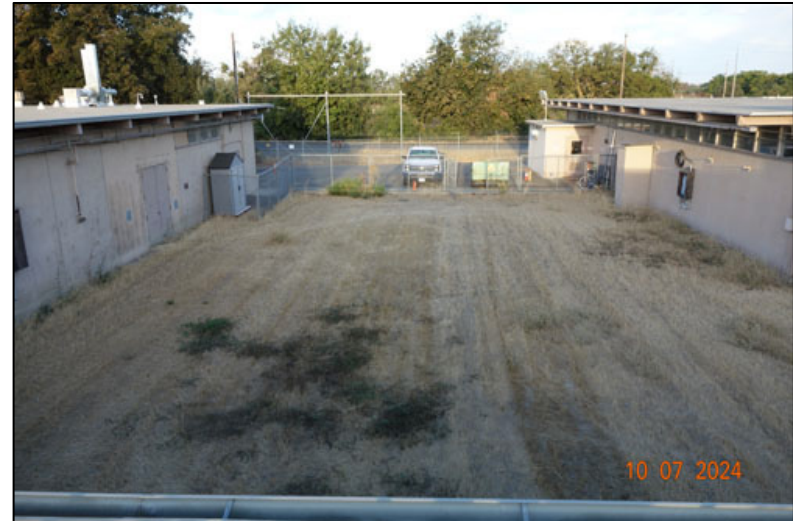
*Roof-Level View West of Central Portion of Ra/Sr Treatment
Systems Area: Building H-219, Right; Building H-218, Left
(Photo No. 8756)*

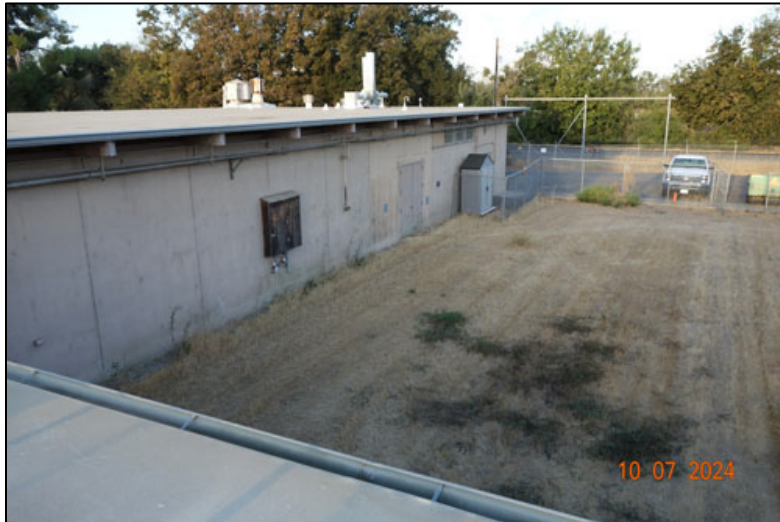
Roof-Level View Southwest of Central Portion of Ra/Sr Treatment Systems Area: Building H-218 in Background, Left (Photo No. 8757)

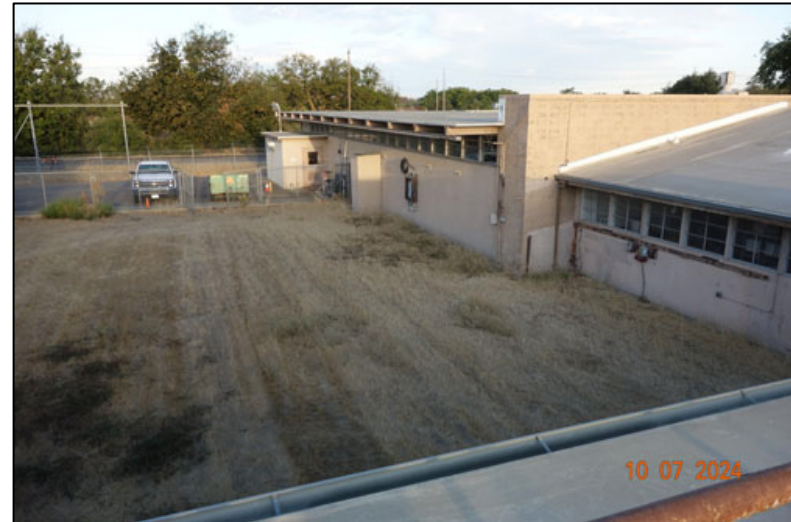
Roof-Level View Northwest of Central Portion of Ra/Sr Treatment Systems Area: Building H-219 in Background, Right (Photo No. 8758)

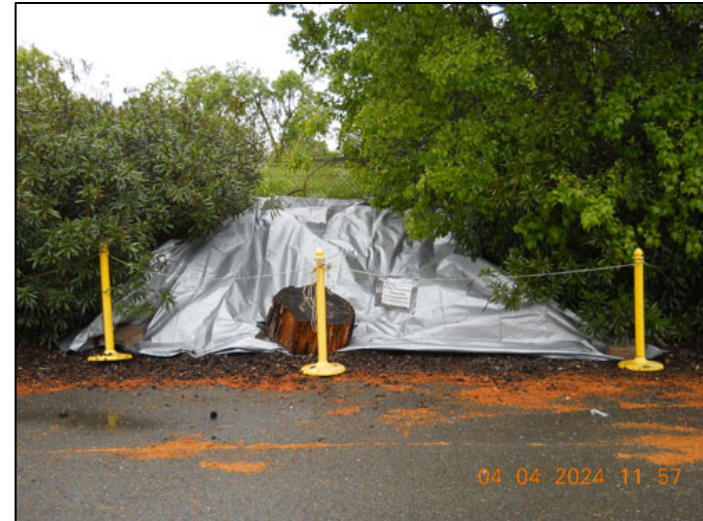
The tree debris stockpile that was generated when UC Davis removed trees 16204 and 16207 during the previous reporting period remains in a posted area adjacent to the western boundary of the Ra/Sr Treatment Systems Area (photo no. 5274; Appendix F).

View West over Vegetation Debris Stockpile in Ra/Sr Treatment Systems Area (Photo No. 5274)

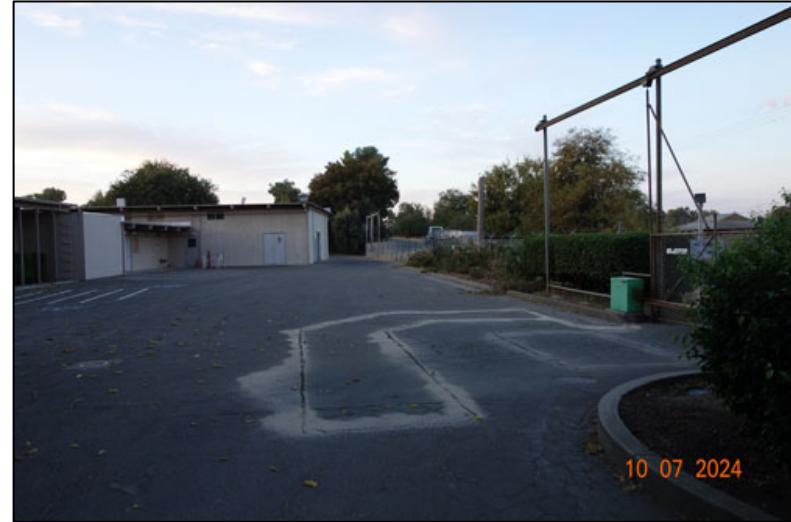
*View South of Dry Wells A–E Area: Building H-219 in
Background, Left; Asphalt Cuts in Bottom Center of Photo
Are North of Drywells A–E Area (Photo No. 8732)*

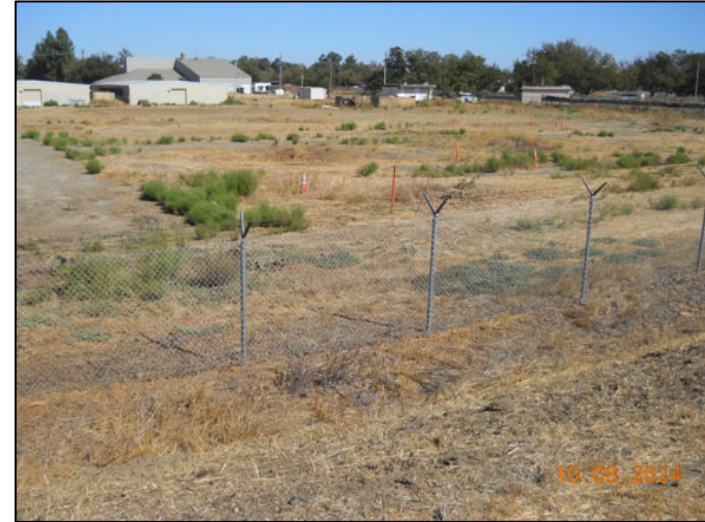
*October 8, 2024, View Northeast of EDPs Area from North Levee of South Fork of Putah Creek with Orange Delineator Showing Southwest Corner Monument Location in Center; All Trees Removed
(Photo No. 5344)*

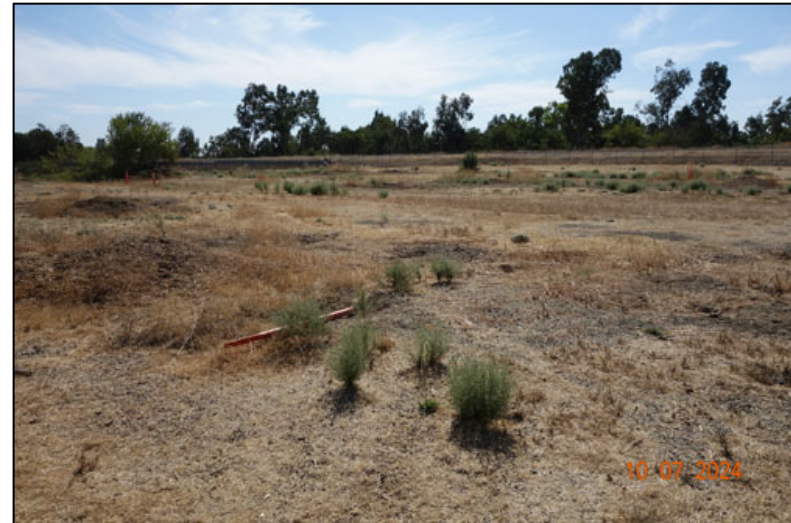
*View Southeast of EDPs Area from Northwest Corner; Fallen Orange Delineator Showing Northwest Corner Monument Location in Center Left
(Photo No. 8834)*

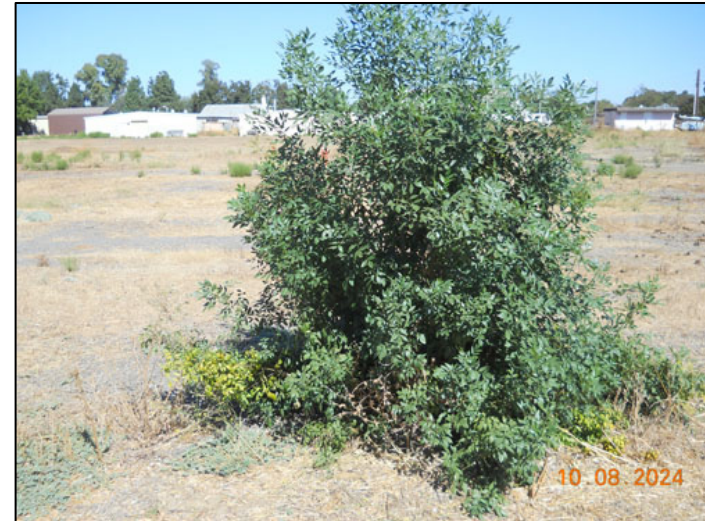
October 8, 2024, View North of One Remaining Shrub in EDPs Area (Photo No. 5347)

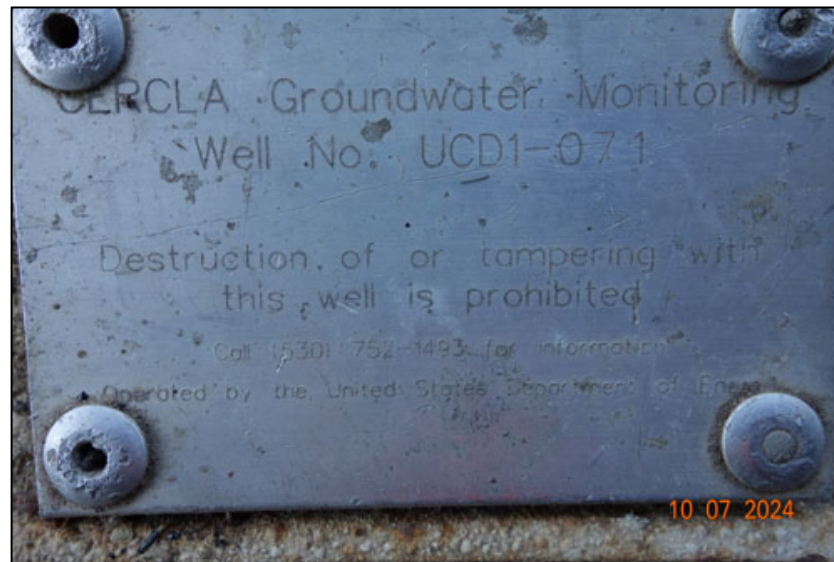
UCD1-071 Wellhead with Cracks in Concrete Apron (Photo No. 8848)
