5.0 Falls City, Texas, Disposal Site

5.1 Compliance Summary

5.4 Inspection Results

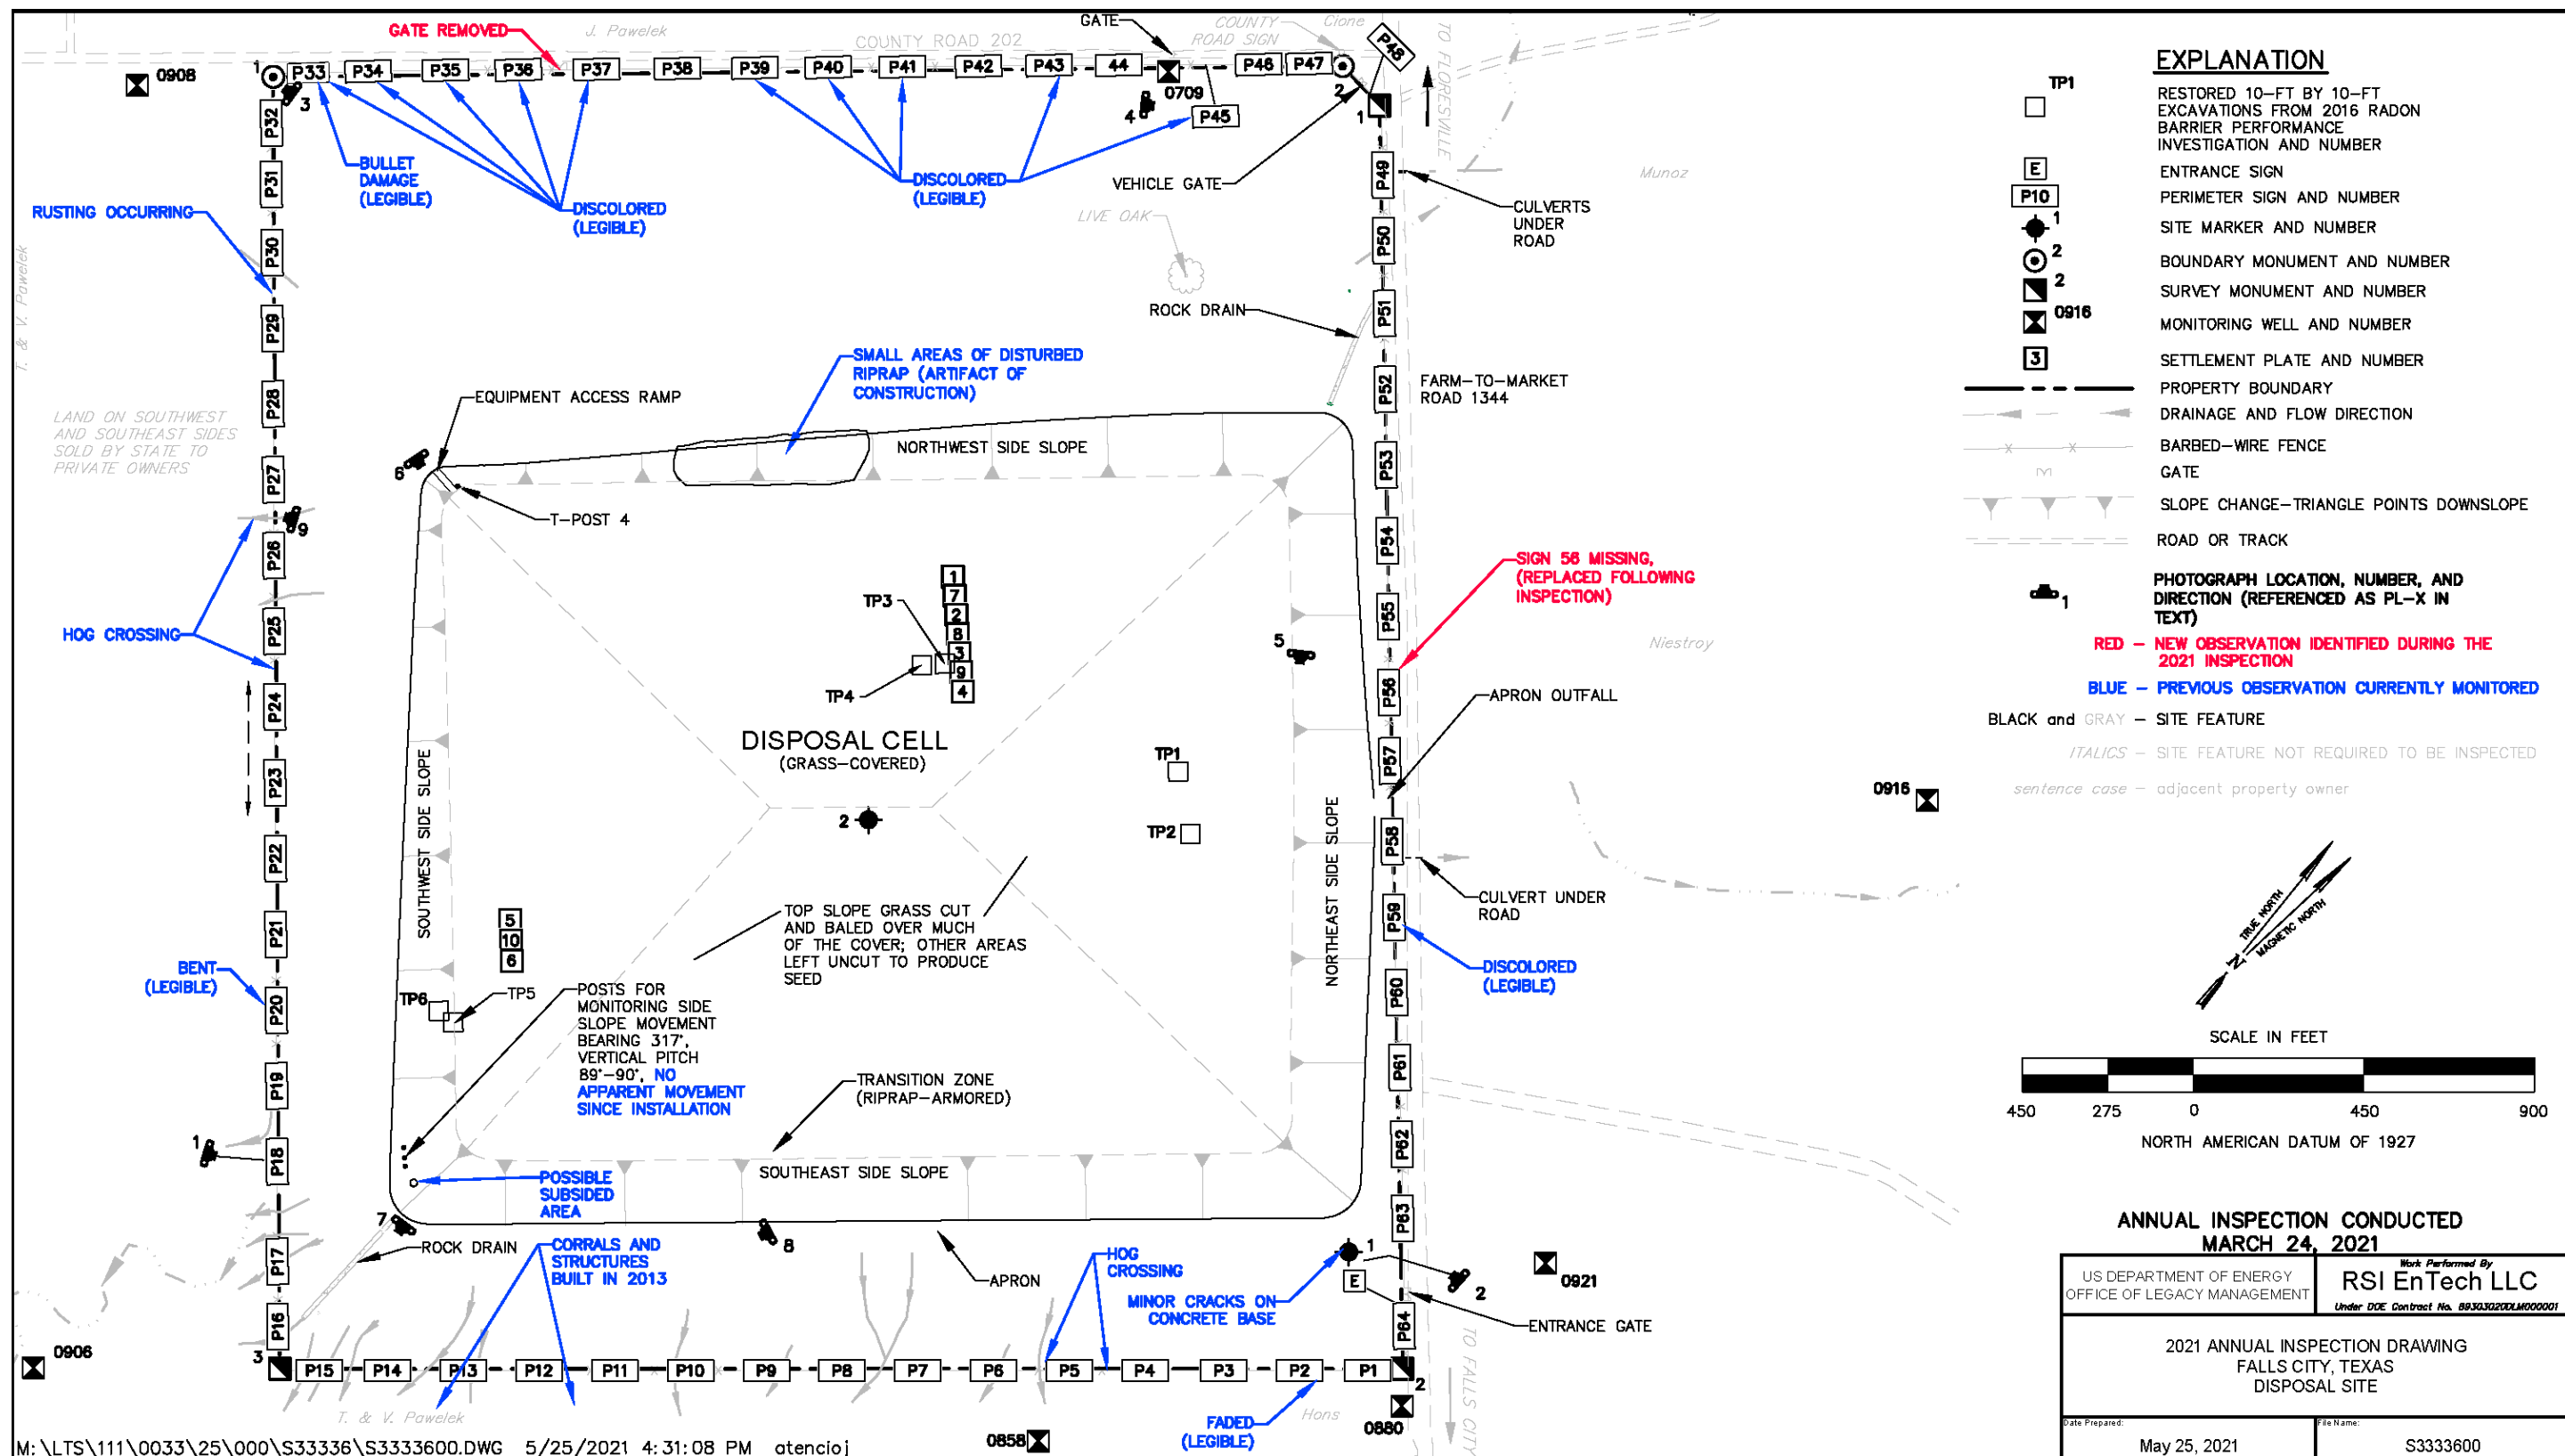
Figure 5-1. 2021 Annual Inspection Drawing for the Falls City, Texas, Disposal Site

Figure 5-1 shows the locations of site features, including site surveillance features and inspection areas, in black and gray font. Site features that are present but not required to be inspected are shown in italic font. Observations from previous inspections that are currently monitored are shown in blue, and new observations identified during the 2021 annual inspection are shown in red. Photographs to support specific observations are noted in the text and in Figure 5-1 by photograph location (PL) numbers. The photographs and photograph log are presented in Section 5.10.

Access to the site is from Farm-to-Market Road 1344. The entrance gate at the east corner of the site and the vehicle gate at the north corner were locked and functional. The entrance sign is next to the main entrance gate. No maintenance needs were identified.

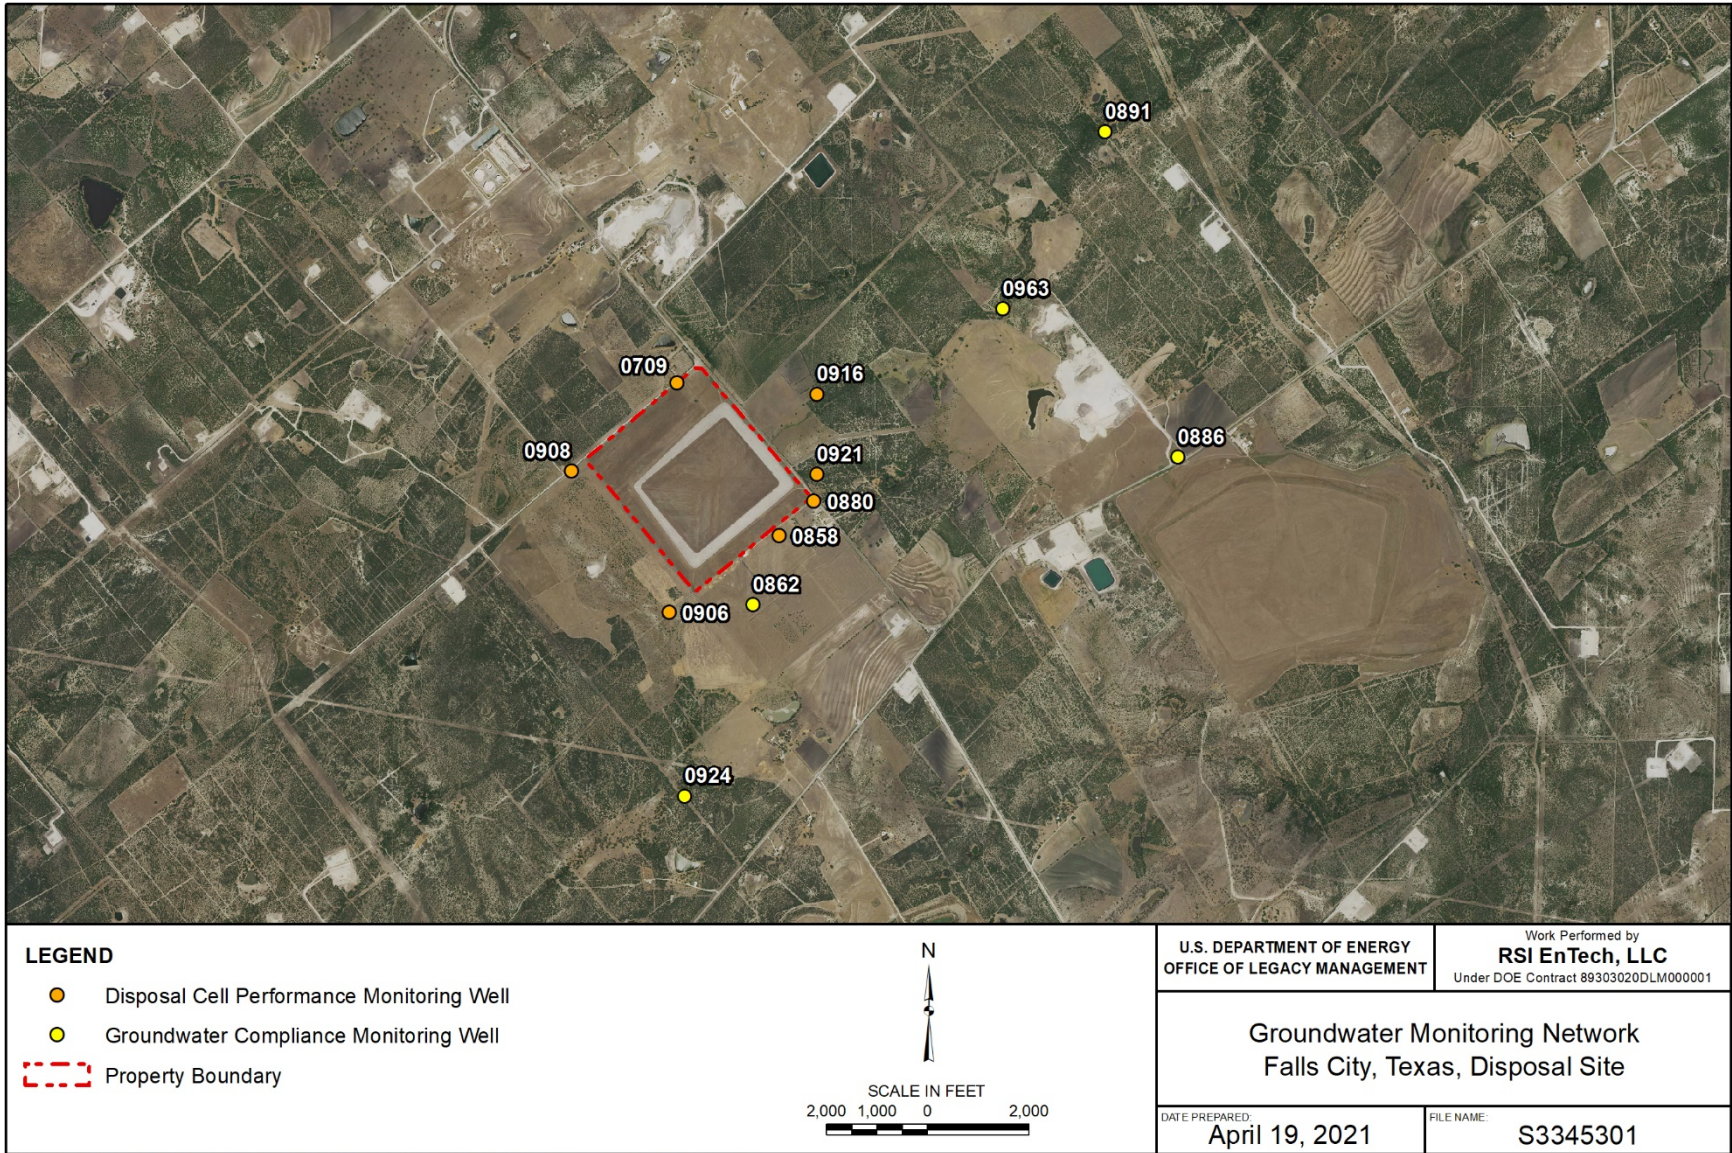
Figure 5-2. Groundwater Monitoring Well Network at the Falls City, Texas, Disposal Site

Table 5-2 and Figure 5-2 describe and illustrate the groundwater monitoring network at the site, which includes the groundwater compliance monitoring wells and the disposal cell performance monitoring wells. The disposal cell performance monitoring wells are near the disposal cell and are all completed in the Deweesville and Conquista units. The groundwater compliance monitoring wells are downgradient of the site and completed in the Deweesville and Conquista units and the Dilworth unit.

Groundwater Monitoring Purpose	Monitoring Wells
Disposal cell performance monitoring	0709, 0858, 0880, 0906, 0908, 0916, and 0921
Groundwater compliance monitoring	0862, 0886, 0891, 0924, and 0963

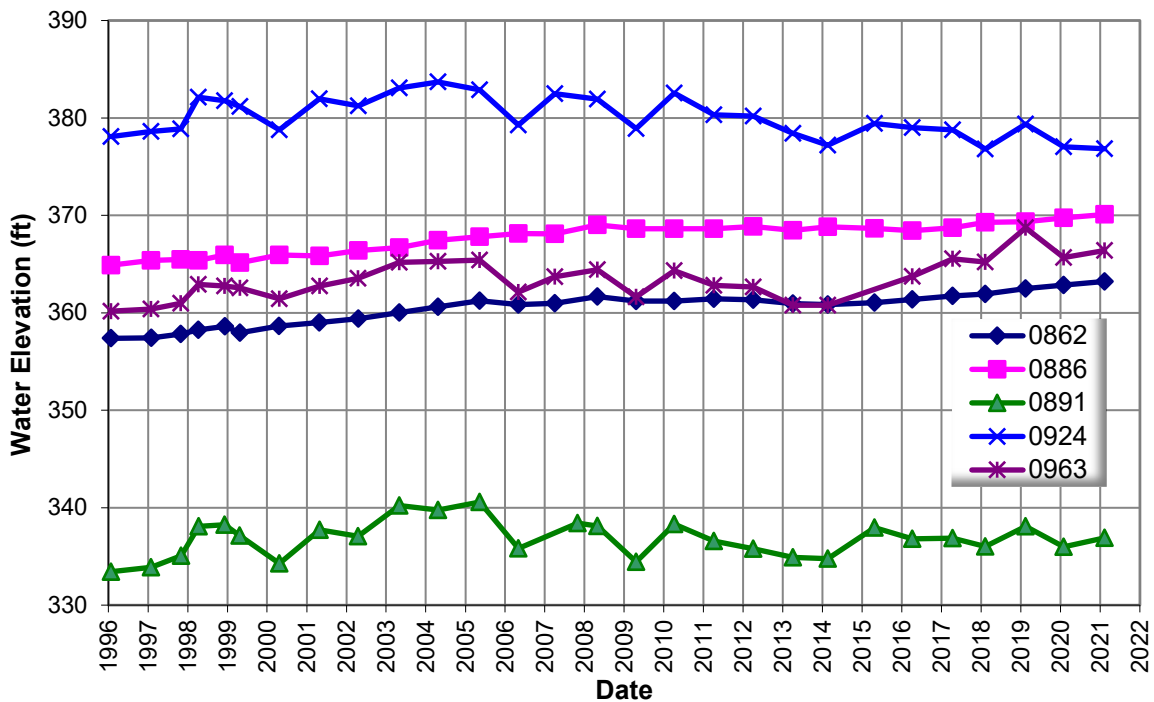
Figure 5-4. Water-Level Measurements at Groundwater Compliance Monitoring Wells at the Falls City, Texas, Disposal Site

Background groundwater quality in the uppermost aquifer varies by orders of magnitude in the area because it is in contact with naturally occurring uranium mineralization. Figure 5-3 and Figure 5-4 show the water level measurements over time at both the disposal cell performance monitoring wells and the groundwater compliance monitoring wells. Figure 5-5 through Figure 5-8 show the time-concentration plots for pH and uranium at disposal cell performance monitoring wells and groundwater compliance monitoring wells. All groundwater monitoring results for the site are reported and published on the LM Geospatial Environmental Mapping System (GEMS) website (<https://gems.lm.doe.gov/#site=FCT>).
