5.0 Falls City, Texas, Disposal Site

The Falls City, Texas, Uranium Mill Tailings Radiation Control Act (UMTRCA) Title I Disposal Site was inspected on May 10, 2022. No changes were observed in the disposal cell or associated drainage features, and personnel found no cause for a follow-up inspection.

The site, 8 miles southwest of Falls City, Texas, was inspected on May 10, 2022, by D. Marshall and J. Doebele of the Legacy Management Support (LMS) contractor. C. Boger (LM site manager) and R. Lyssy (LMS maintenance subcontractor) attended the inspection. The purposes of the inspection were to confirm the integrity of visible features at the site, identify changes in conditions that might affect conformance with the 2008 LTSP, and evaluate whether maintenance or follow-up inspection and monitoring are needed.

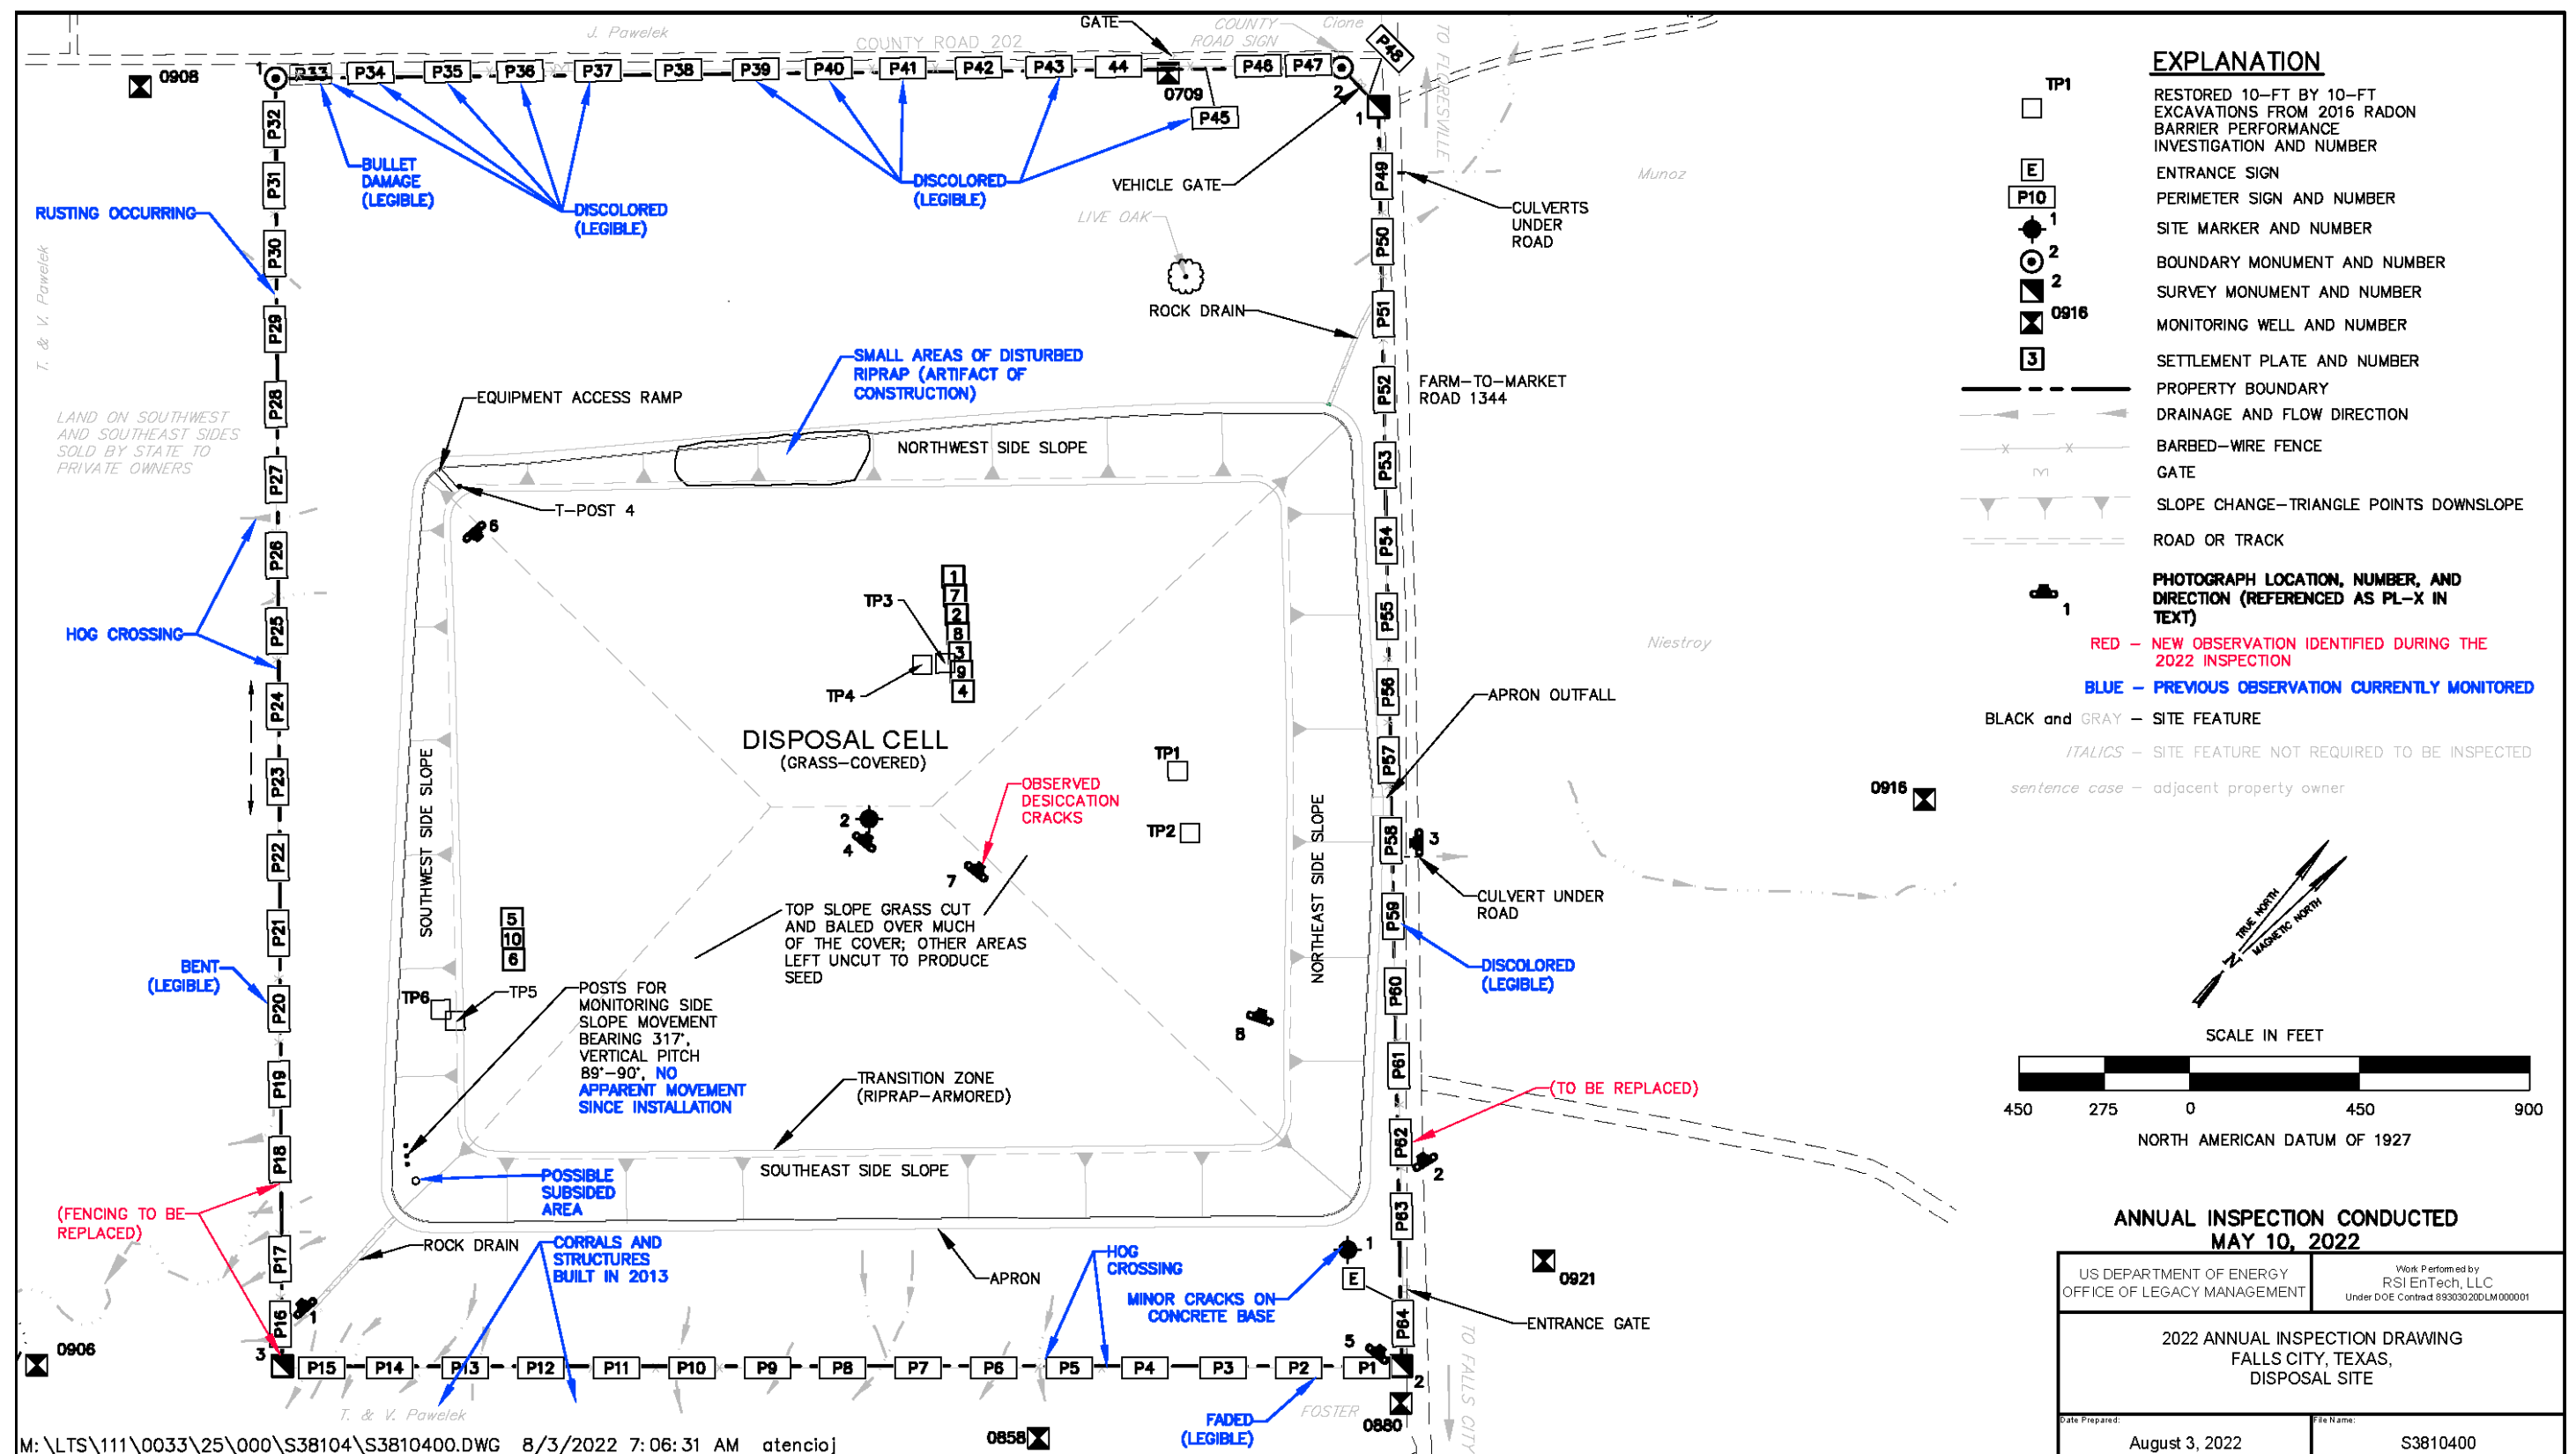
Figure 5-1. 2022 Annual Inspection Drawing for the Falls City, Texas, Disposal Site

Figure 5-1 shows the locations of site features, including site surveillance features and inspection areas, in black and gray font. Some site features that are present but not required to be inspected are shown in italic font. Observations from previous inspections that are currently monitored are shown in blue, and new observations identified during the 2022 annual inspection are shown in red. Inspection results and recommended maintenance activities associated with site surveillance features are described in the following subsections. Photographs to support specific observations are noted in the text and in Figure 5-1 by photograph location (PL) numbers. The photographs and photograph log are presented in Section 5.10.

A five-strand barbed-wire perimeter fence encloses the site. As noted in previous inspections, perimeter fence strands and posts are beginning to rust except along the northwest side, where the fence was replaced in 2006. The fence on the southwest side, between perimeter sign P18 and survey monument SM-3, showed signs of rust and damage from cattle crossing the fence and accessing the site (PL-1). This section of the fence will be replaced to ensure site security.

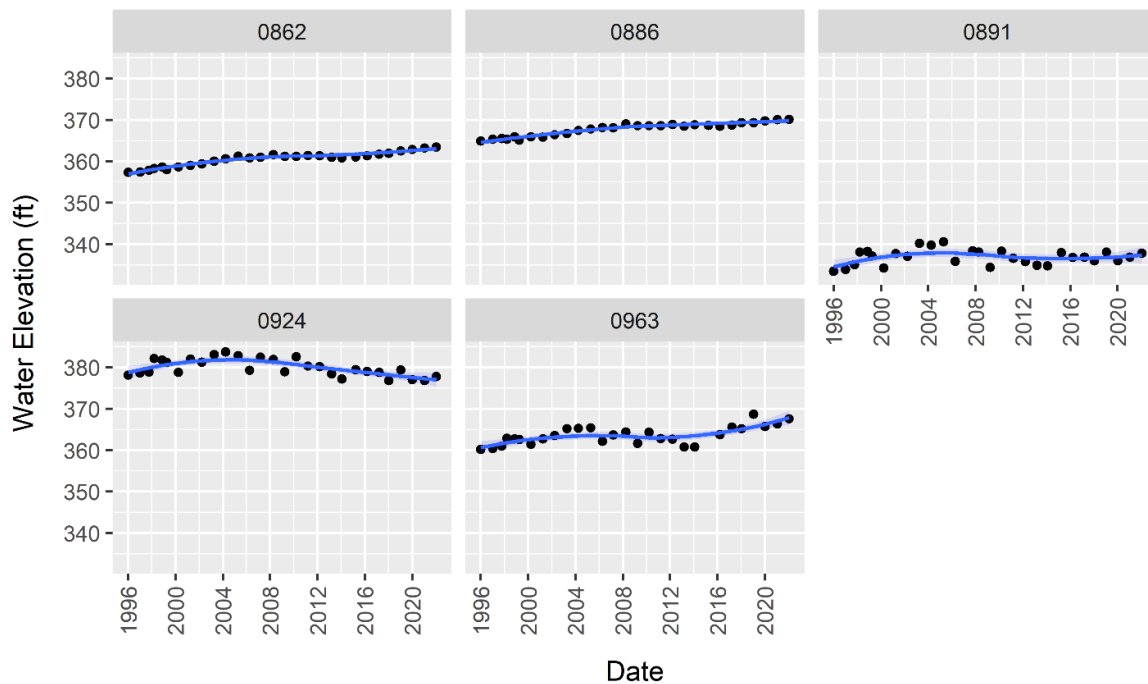
Figure 5-4. Water-Level Measurements at Groundwater Compliance Monitoring Wells at the Falls City, Texas, Disposal Site

No change in disposal cell performance is indicated by the following data from the disposal cell performance monitoring wells: (1) continued water level declines (Figure 5-3) compared to relatively stable or increasing water levels in groundwater compliance monitoring wells (Figure 5-4), (2) no declining pH trends (Figure 5-5), and (3) no significant increases in uranium concentrations since 2012 (Figure 5-7). Supporting trend analysis results are provided in Table 5-3.
