## 5.0 Falls City, Texas, Disposal Site

### 5.1 Compliance Summary

The Falls City, Texas, Uranium Mill Tailings Radiation Control Act (UMTRCA) Title I Disposal Site was inspected on May 23, 2023. No changes were observed in the disposal cell or associated drainage features, and personnel found no cause for a follow-up inspection.

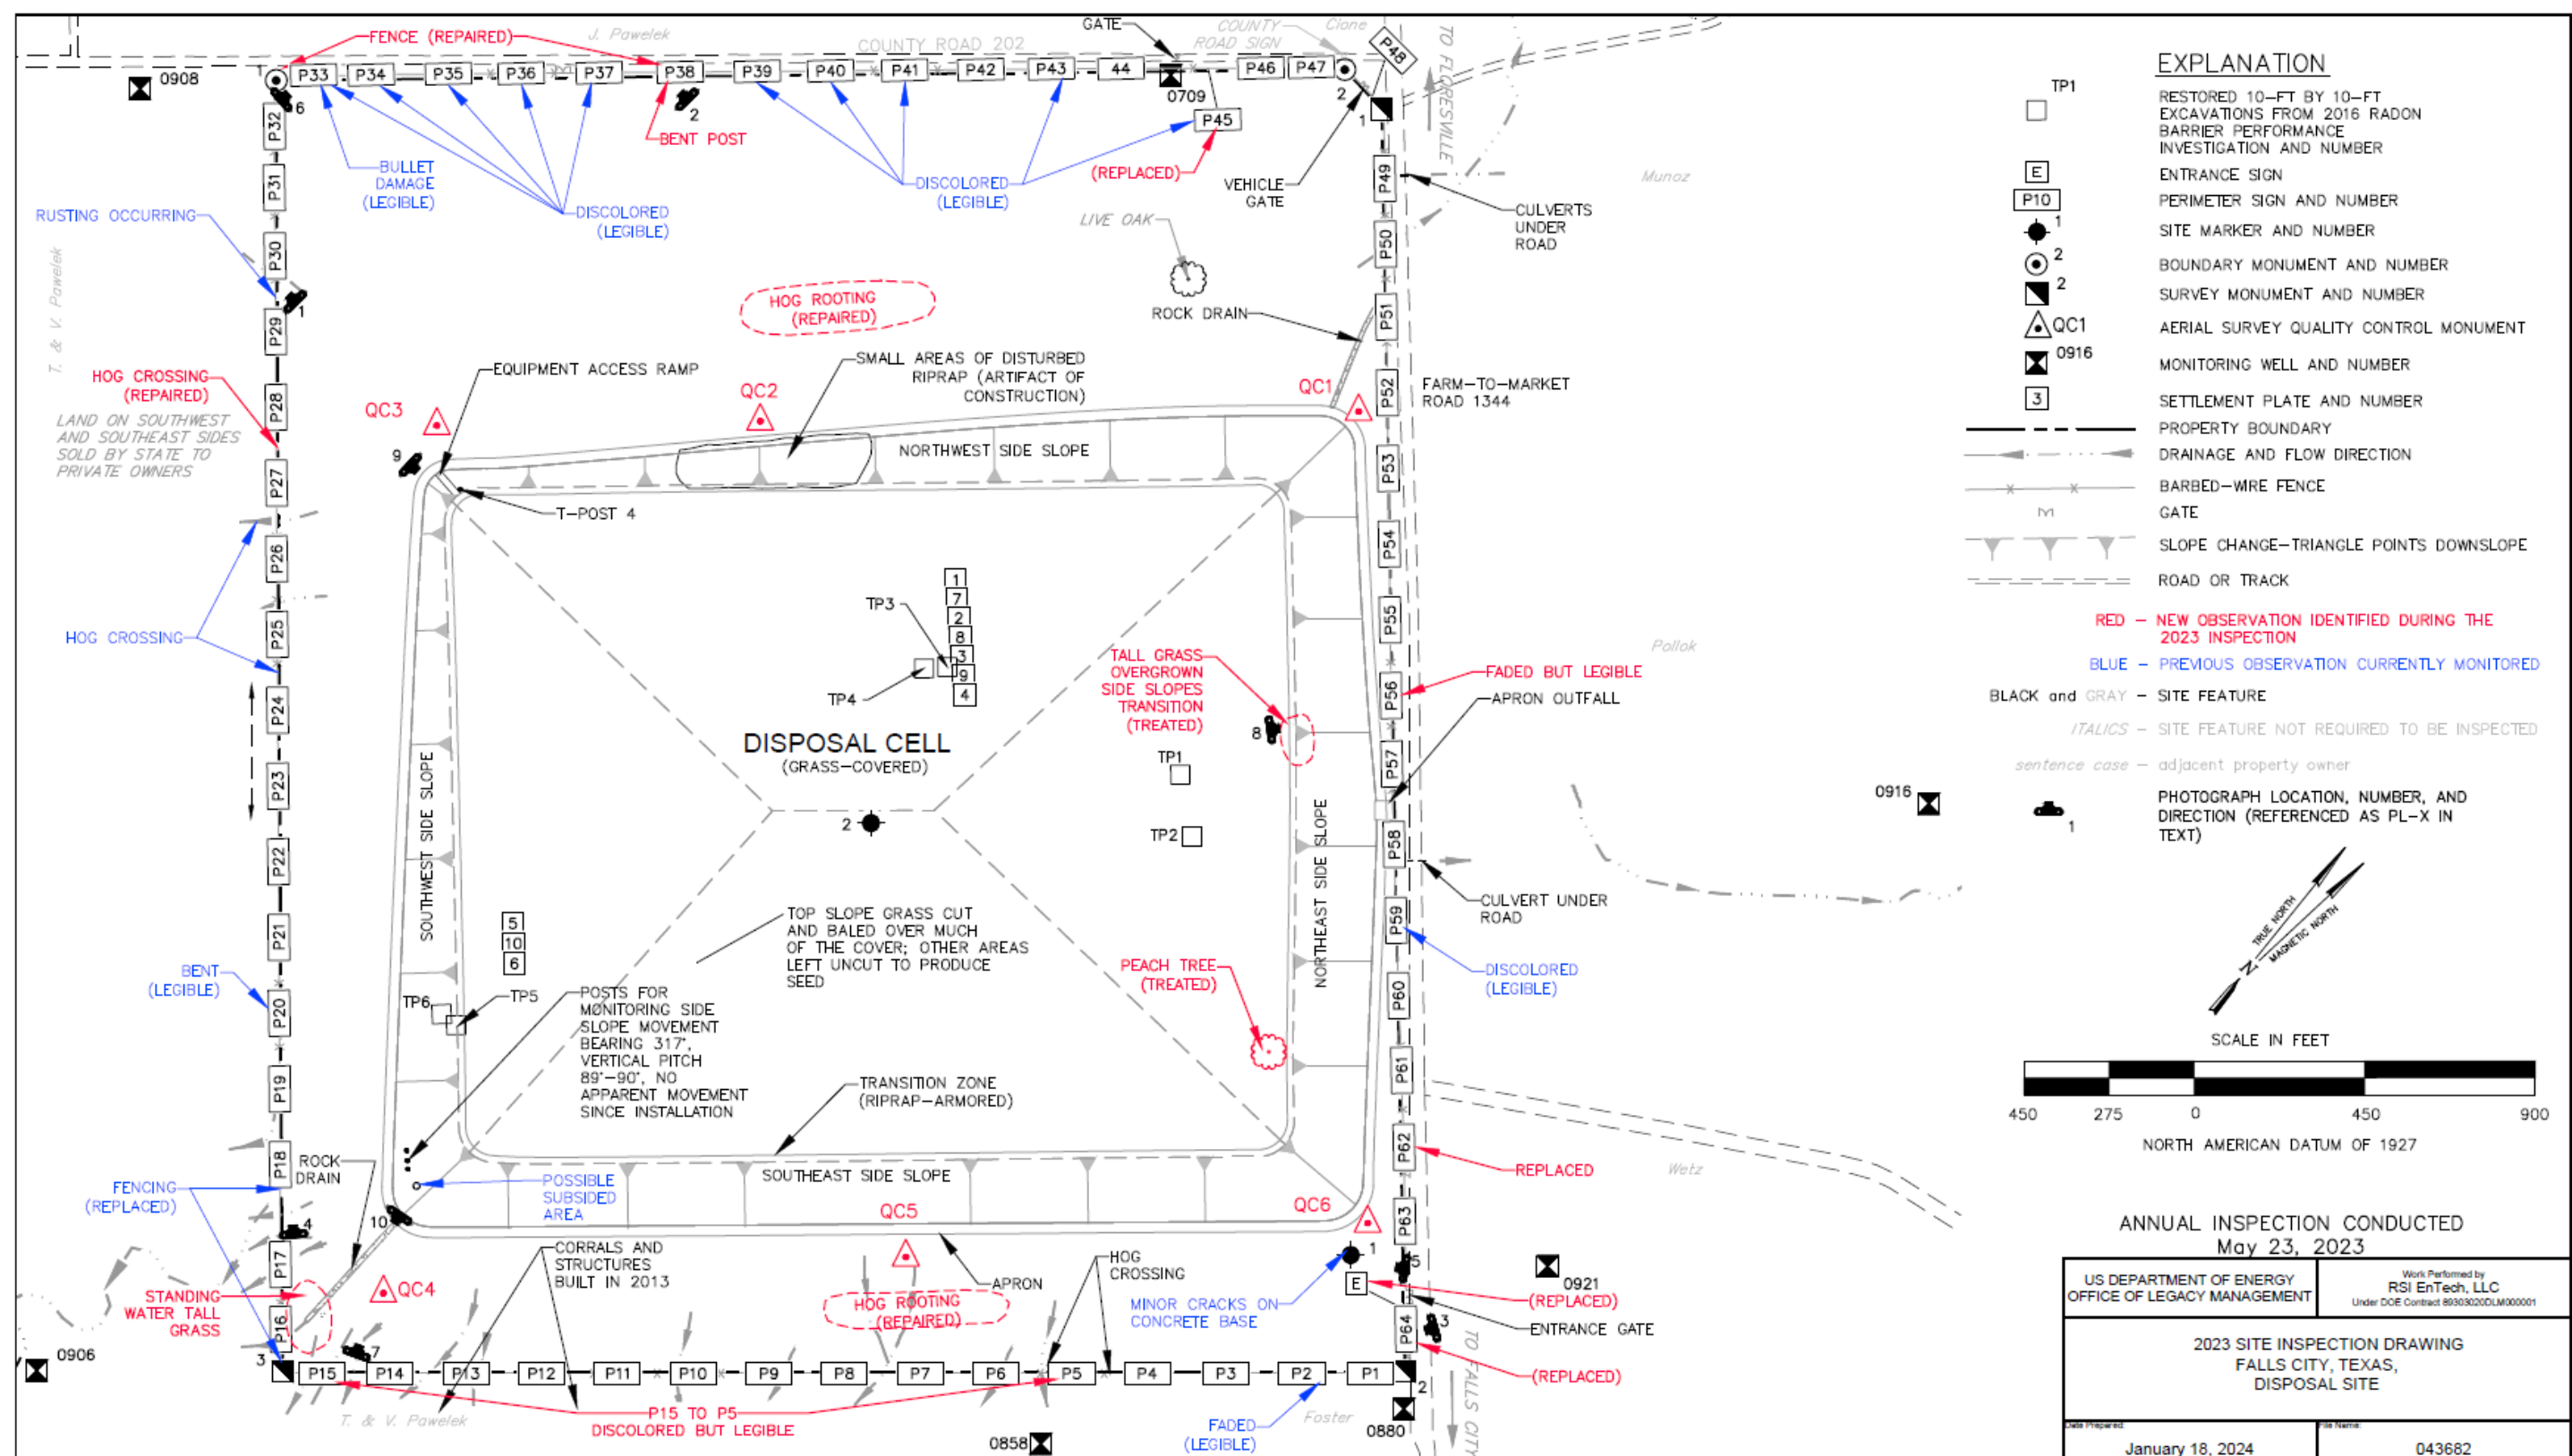
Figure 5-1. 2023 Annual Inspection Drawing for the Falls City, Texas, Disposal Site

Figure 5-1 shows the locations of site features, including site surveillance features and inspection areas, in black and gray font. Some site features that are present but not required to be inspected are shown in italic font. Observations from previous inspections that are currently monitored are shown in blue, and new observations identified during the 2023 annual inspection are shown in red. Inspection results and recommended maintenance activities associated with site surveillance features are described in the following subsections. Photographs to support specific observations are noted in the text and in Figure 5-1 by photograph location (PL) numbers. The photographs and photograph log are presented in Section 5.10.

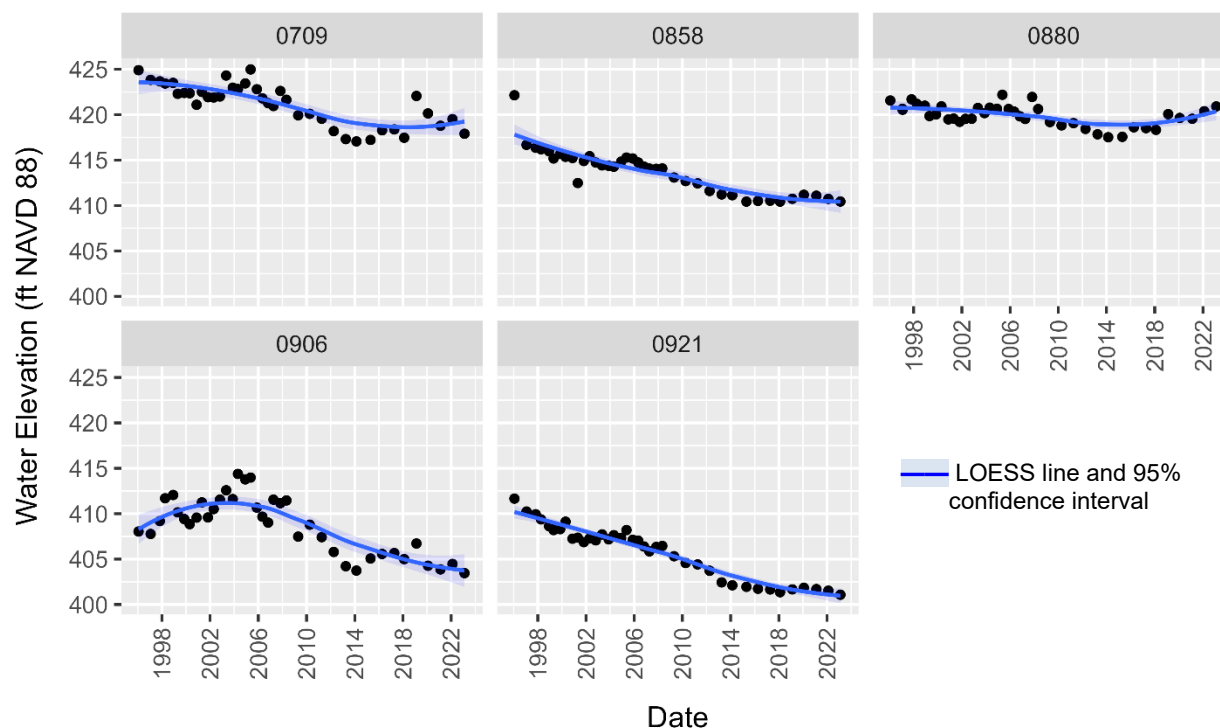
*Figure 5-3. Water-Level Measurements at Disposal Cell Performance Monitoring Wells at the Falls City, Texas, Disposal Site*

Figure 5-3 and Figure 5-4 plot groundwater elevations measured between 1996 and 2023 in disposal cell performance and groundwater compliance monitoring wells, respectively. The data plotted in these figures are referenced to the North American Vertical Datum of 1988 (NAVD 88). Water levels in all disposal cell performance wells have statistically significant decreasing trends from 1996 to 2023 based on Mann-Kendall trend analyses (Table 5-3). The greatest water-level declines have occurred in wells 0709, 0921, and 0858, with decreases of 7.0, 10.6, and 11.7 ft, respectively.

No change in disposal cell performance is indicated by the following data from the disposal cell performance monitoring wells: (1) overall decreasing water-level trends (Table 5-3 and Figure 5-3), and (2) no declining pH trends (Table 5-3 and Figure 5-5). These results are consistent with declining drainage rates of low-pH tailings pore water into the underlying geology. However, water levels in well 0880 have been trending higher since 2014 (Figure 5-3). Disposal cell performance wells 0858 and 0921 have statistically significant increases in uranium (Table 5-3), though the uranium increase in well 0921 occurred before 2014 (Figure 5-7). The uranium increase in well 0858 was mainly in the last 3 years (Figure 5-7).

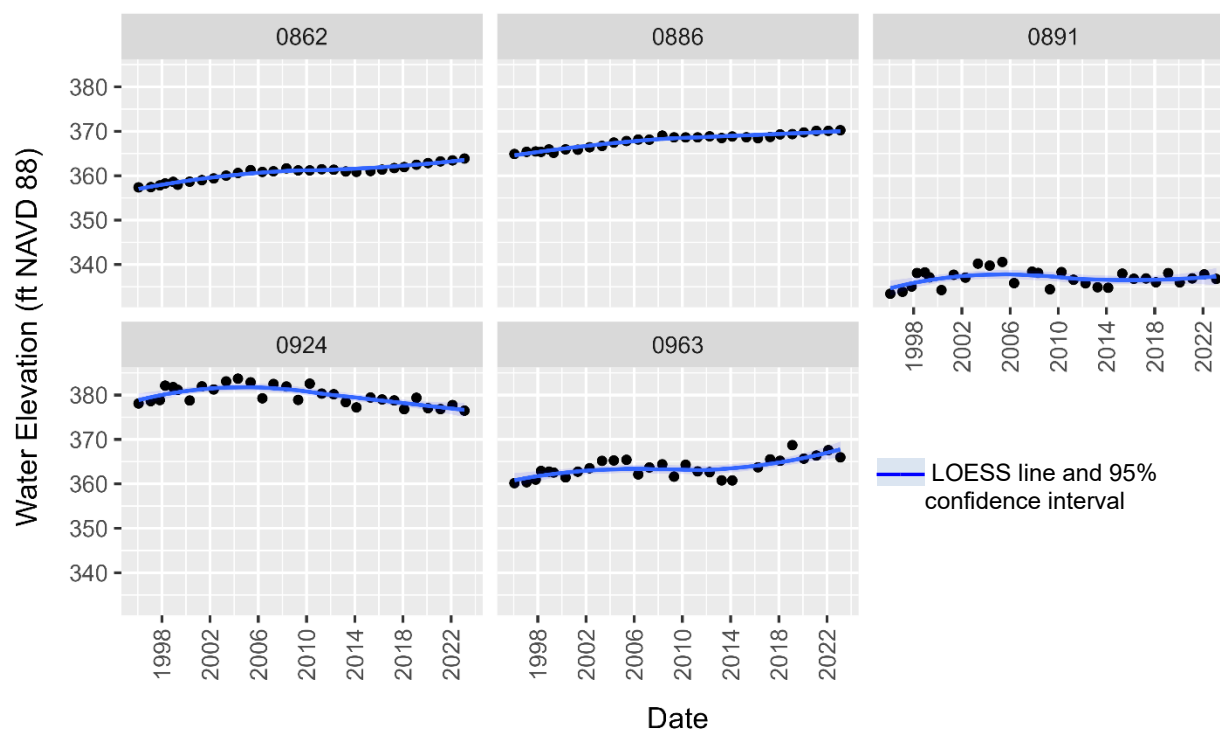
*Figure 5-4. Water-Level Measurements at Groundwater Compliance Monitoring Wells at the Falls City, Texas, Disposal Site*

Groundwater compliance wells 0862, 0886, and 0963 have statistically significant increasing water-level trends since 1996 (5–7 ft increases). Although water levels in well 0891 have increased 3.3 ft since 1996 (Figure 5-4), the trend is not significant (Table 5-3). In contrast, a statistically significant decreasing trend was identified for well 0924, where water levels have declined 1.6 ft since 1996.

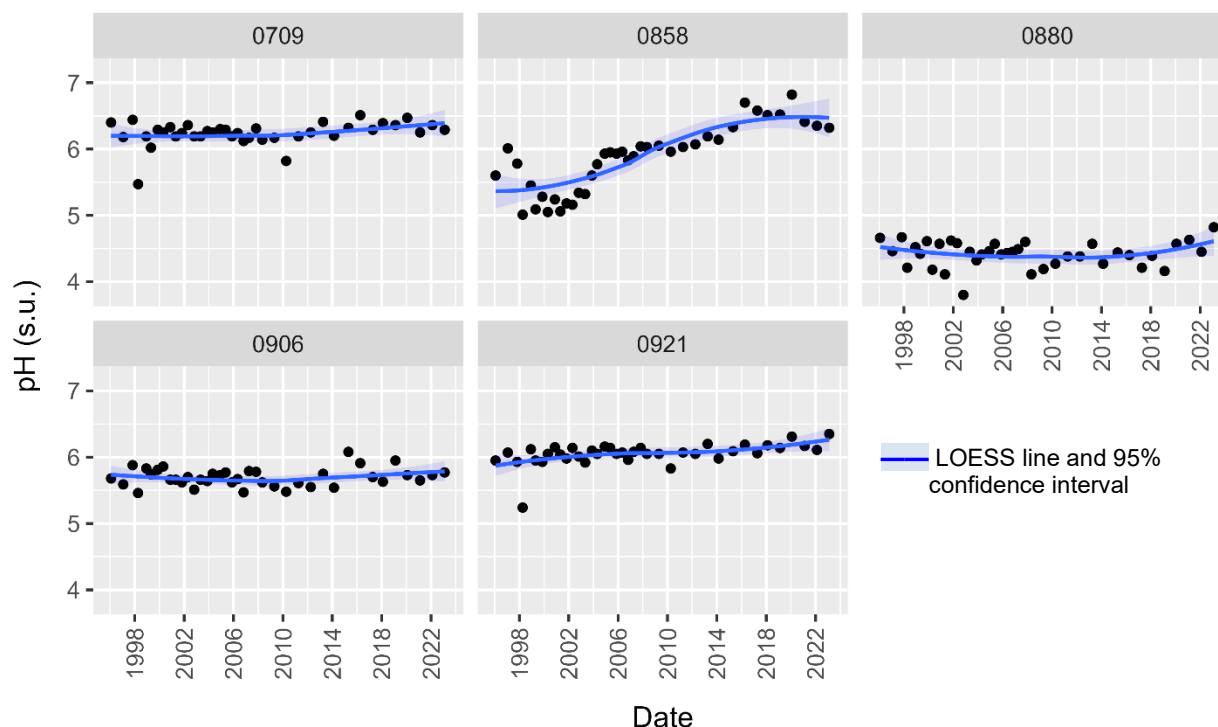
Figure 5-5. pH at Disposal Cell Performance Monitoring Wells at the Falls City, Texas, Disposal Site

**pH:** Consistent with the findings in the previous annual report (DOE 2023), Mann-Kendall trend analysis indicates significant increasing trends in pH (since 1996) for wells 0858 and 0921 (Table 5-3). No significant trends were identified for the remaining disposal cell performance wells. Although pH values in all disposal cell performance wells have been greater than that measured in tailings pore fluids (pH of 2.9 [DOE 1997a]), pH levels in well 0880 remain relatively low, ranging from 3.4–5.2 historically and 3.8–4.8 for the 1996–2023 period shown in Figure 5-5. The pH values for all disposal cell performance monitoring wells do not show any recent significant changes (Figure 5-5).

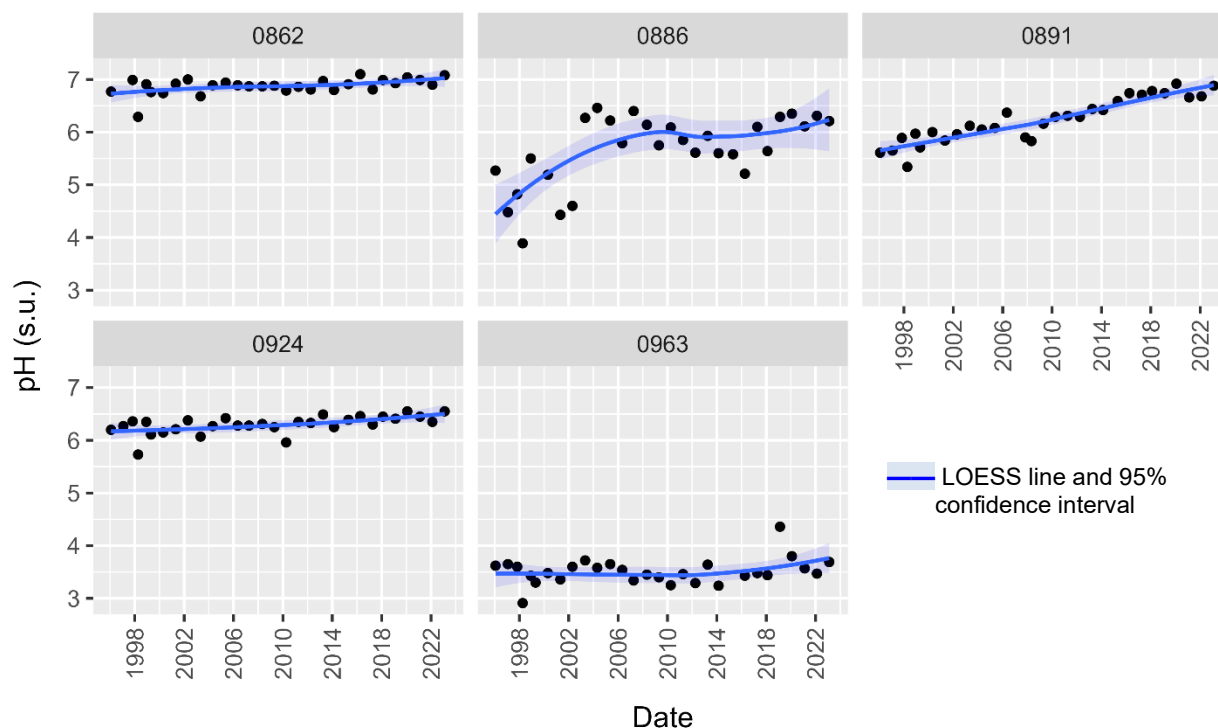
*Figure 5-6. pH at Groundwater Compliance Monitoring Wells at the Falls City, Texas, Disposal Site*

For compliance monitoring wells, statistically significant increasing trends in pH have been identified in all wells except 0963 (Figure 5-6, Table 5-3). The pH values measured in 2023 were within the range of historical values for all groundwater compliance monitoring wells. The pH in monitoring well 0963 historically has been lower than at the other groundwater compliance wells (and the disposal cell performance monitoring wells), with a pH of 3.7 in 2023 compared to between 6.0–7.0 in the other wells.

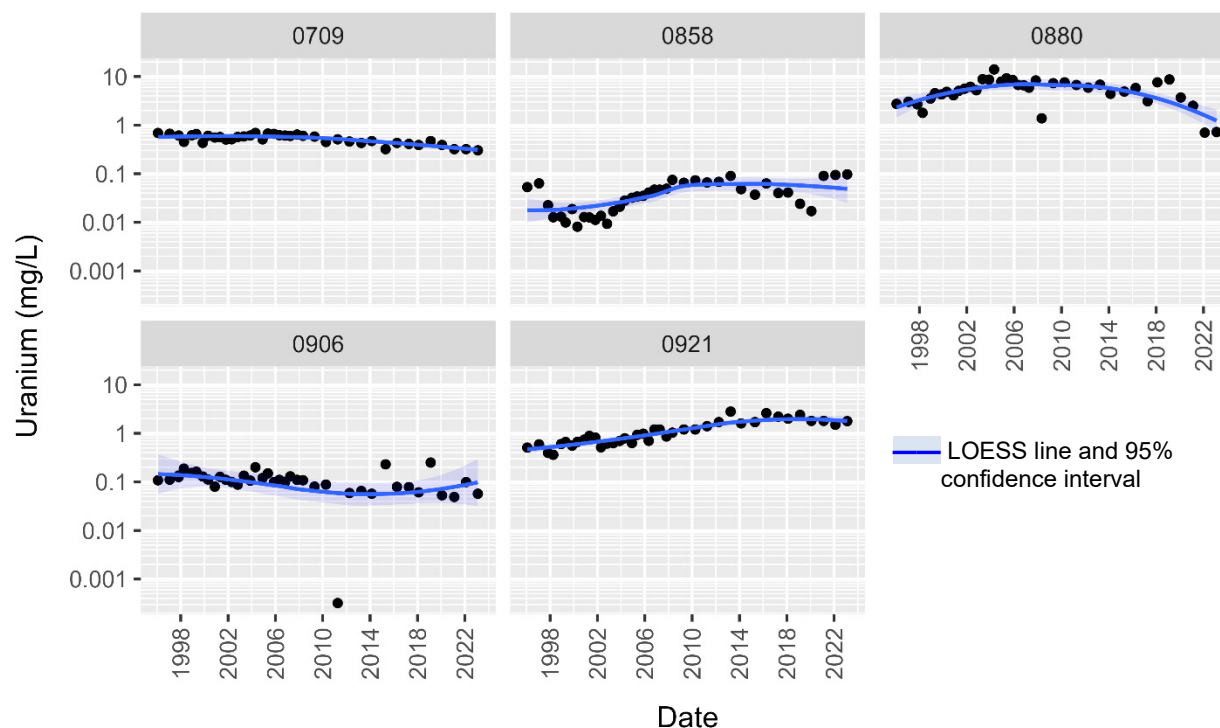
*Figure 5-7. Uranium Concentrations at Disposal Cell Performance Monitoring Wells at the Falls City, Texas, Disposal Site*

**Uranium:** The 2023 uranium concentrations for disposal cell performance monitoring wells are similar to those reported in recent years (Figure 5-7). Using data since 1996, Mann-Kendall trend analysis identified statistically significant trends in uranium concentrations in all disposal cell performance monitoring wells except well 0880 (Table 5-3). Significant increasing trends were found for wells 0858 and 0921, while significant decreasing trends were identified for wells 0709 and 0906. Uranium concentrations in monitoring well 0880 are most variable, ranging from 0.7 mg/L (result from 2022 and 2023) to 14 mg/L in 2004, but with no significant trend.

<sup>e</sup> The decreasing trend for uranium in well 0906 is still statistically significant if the extreme low outlier (0.00032 mg/L in April 6, 2011, sample [Figure 5-7]) is removed from the analysis. The results were nearly equivalent to those cited above, with a Kendall's tau and p-value of −0.413 and 0.00029, respectively.

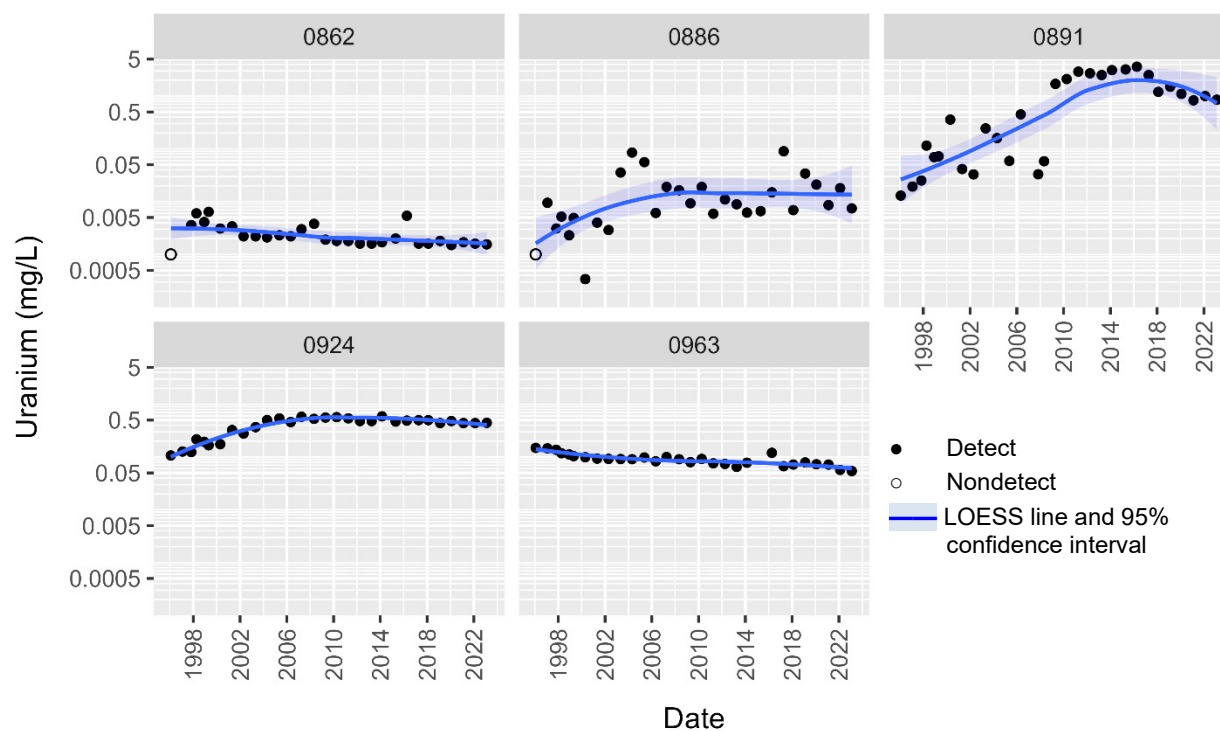
*Figure 5-8. Uranium Concentrations in Groundwater Compliance Monitoring Wells at the Falls City, Texas, Disposal Site*

In 2023, uranium concentrations in groundwater compliance monitoring wells were consistent with the findings reported in the previous annual report (Figure 5-8) (DOE 2023).

Mann-Kendall trend analysis identified statistically significant uranium concentration trends in all wells, with increasing trends found for wells 0886, 0891, and 0924, and decreasing trends in wells 0862 (characterized by low uranium concentrations) and 0963 (Table 5-3). Although a significant increasing trend was identified for well 0924, uranium concentrations have been relatively stable since 2004, fluctuating between approximately 0.4 mg/L and 0.6 mg/L.

Uranium concentrations in well 0886 have stabilized in recent years (most recent result of 0.0075 mg/L). The latter is also true for monitoring well 0891, where uranium concentrations have decreased since 2018 (Figure 5-8).

For the groundwater compliance monitoring wells, wells 0886, 0891, and 0924 have statistically significant increasing uranium concentrations (Table 5-3), though these increases occurred before 2010 (Figure 5-8). According to DOE (1997a) and the 2008 LTSP, these results are not unexpected, as these three wells were at the downgradient edge of low-pH groundwater plumes with mill processing-derived fluids and elevated uranium concentrations. Currently, the pH values in these three wells are increasing (Figure 5-6 and Table 5-3), thereby confirming that in the longer term, the low-pH areas do not necessarily define areas with uranium contamination. This correlation was true in the past (DOE 1997a) during the continued addition of low-pH fluids from uranium processing and low-pH fluids produced from the oxidation of the tailings. Currently, these processes are no longer occurring, and uranium can continue to be mobile with increasing pH values.
